#04-03-08-006D: Steering and Front Suspension Noise Concerns - Clunk, Thump, Rattle, Knocking, Pop, Shudder, Vibration (Diagnosis and Perform Necessary Repairs) - (Feb 24, 2009)

**Models: 2005-2009 Chevrolet Cobalt (Including SS)
2006-2009 Chevrolet HHR (Including SS)
2005-2006 Pontiac Pursuit (Canada Only)
2007-2009 Pontiac G5
2003-2007 Saturn ION**

This bulletin is being revised to add Condition #3. Please discard Corporate Bulletin Number 04-03-08-006C (Section 03 - Suspension).

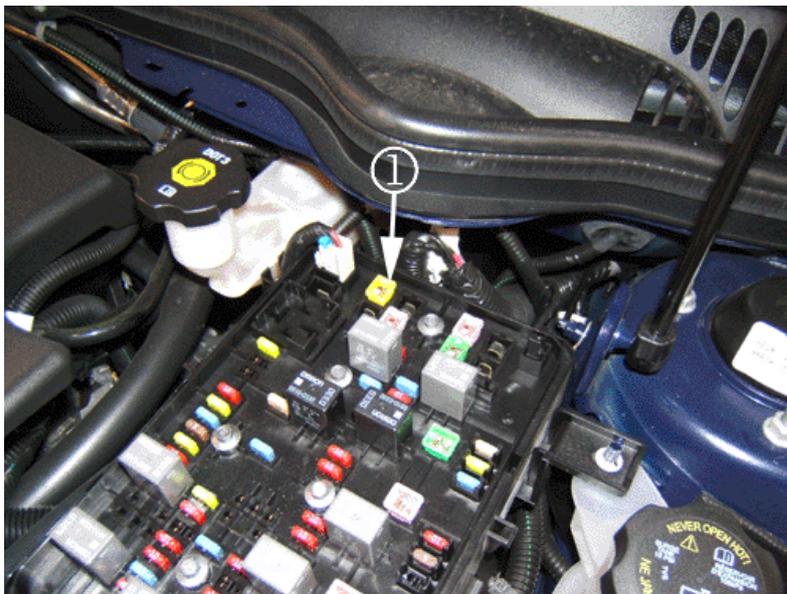
Some customers may comment on a rattle or knocking noise that is heard in the front of the vehicle while driving at low speeds 8-24 km/h (5-15 mph). This condition may be more noticeable while making a slow turn or on a loose/rough surface.

Important: The noise in the steering column is generated from the metal to plastic gear backlash of the assist motor mechanism and will have a different sound than that from the steering gear. If the customer comments that they still hear a noise, it may be a different sound from either the I-shaft or the steering rack.

3. Remove the 60 amp EPS fuse (1) in the underhood fuse block.
4. Test the vehicle as in Step 1. Since the EPS motor is no longer powered, only the I-shaft and steering gear/rack will be loaded as you make the turn. If you hear the rattle/knocking noise during the turn, then the noise is being generated by the backlash within the steering column (assist motor gear mechanism).
5. Replace the 60 amp EPS fuse and repeat Steps 1 and 2 to verify that the rattle/knocking noise disappears when turning (loading steering mechanism) and can only be heard when releasing the steering wheel.

If the steering column is identified as the source of the rattle/knocking noise in the above test, replace the steering column.

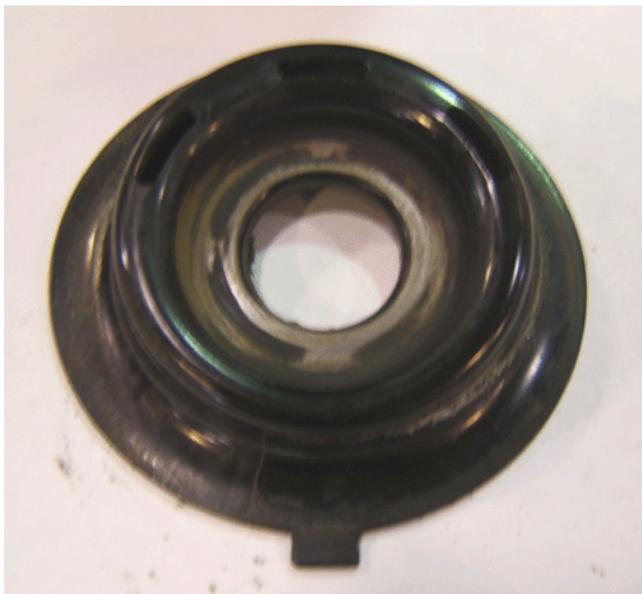
Some customers may comment on a clunk or thump noise coming from the front suspension while driving over rough road surfaces. This noise will typically occur when the front suspension is returning to the upward position after a hard downward stroke, such as after driving through a large rut or pothole.

This condition may be caused by the jounce bumper slamming into the upper spring seat because it is not retained in the correct up position. The jounce bumper loses position due to oil being deposited onto its retention fingers. The oil is from the strut leaking.

Inspect the front strut(s) for evidence of oil. The leak may be slight but will still cause the concern. If oil is present, replace the affected strut, jounce bumper and dust boot (shield). Before reassembling the strut assembly, glue the new jounce bumper and new dust boot (shield) to the upper spring seat using the steps listed below. To further confirm this concern, the shield/bumper will easily slide up and down the strut shaft.

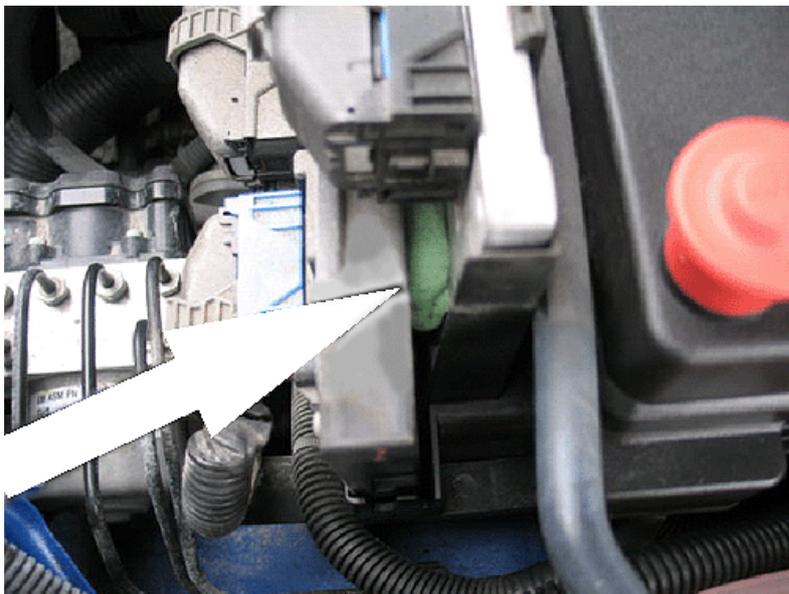
Some customers may comment on a rattle/clunk type noise coming from the steering column when driving over bumps.

1. Check for the possibility of the PCM and the TCM rattling/clunking together. If there is contact between these two modules, insulate the modules from each other using a small piece of foam.

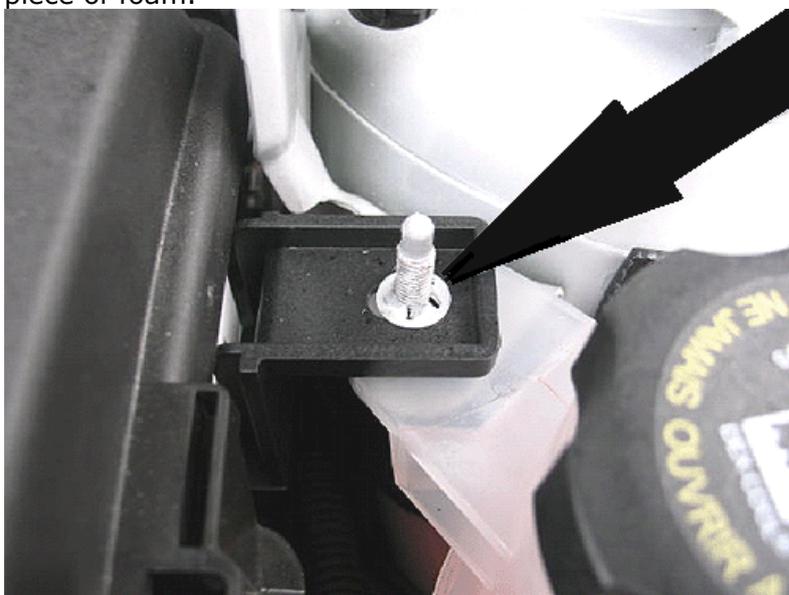
Rattles/clunks in this area of the engine compartment may be heard as coming from the steering column while driving.

2. Check that the retaining clip on the engine coolant surge tank is fully seated. If not, push down to seat.

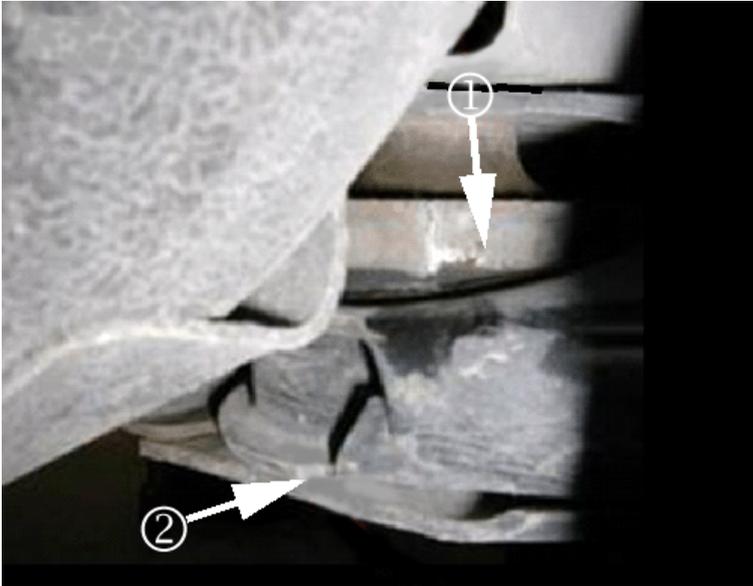
This condition may be caused by the lower control arm rubber bushing (rear) coming out of its steel sleeve (1). This will cause the lower control arm to make hard contact (2) with the body structure. This condition may be more prevalent in regions that use road salt during the winter months.

If the rubber bushing has moved out of the steel sleeve, replace the lower control arm bushing. Do not replace the bushing if it is still centered in the steel sleeve.

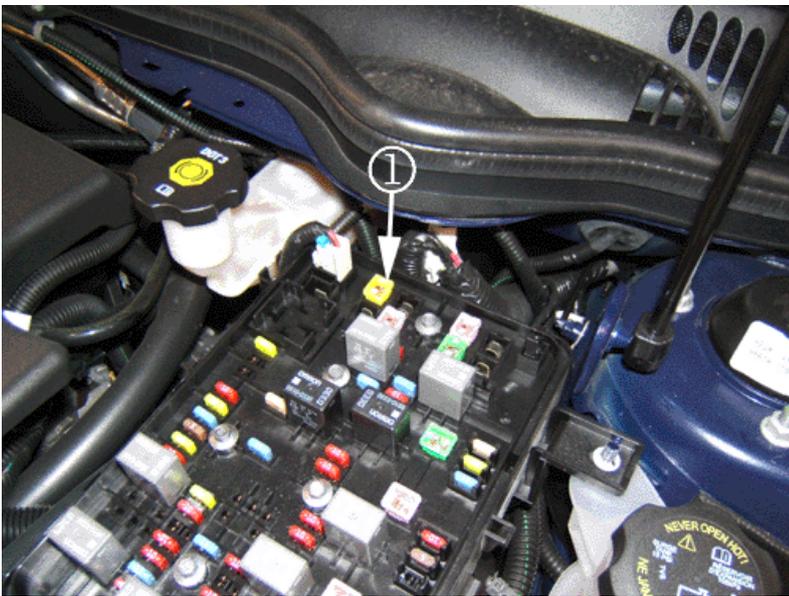
Some customers may comment on a whine/hum noise from the steering column while making right hand turns at 5-15 mph (8-24 km/h). A slight whine/hum noise is considered to be normal for EPS so it will be helpful to compare to another like vehicle. If the vehicle exhibits excessive feedback/noise when compared to another vehicle, follow the correction procedure below.

Pull the 60 amp steering fuse (1) in the underhood fuse block. If this eliminates the whine/hum concern, contact the Technical Assistance Center for further information in order to repair the vehicle. If this does not eliminate the noise, continue to diagnose the vehicle according to the diagnostics in SI.
