#08-07-30-021H: Loss of High Speed GMLAN Communications, Intermittent No Crank, IP Gauge Fluctuation, Intermittent Door Lock Cycling / Chime Operation, Various IP Warning Lamps Illuminated, Transmission May Not Shift, Communication DTCs U0073, U0100, U0101, U0102, U0109, U0121 or U0140 Set - (Jun 25, 2015)

Subject: Loss of High Speed GMLAN Communications, Intermittent No Crank, IP Gage Fluctuation, Intermittent Door Lock Cycling, Intermittent Chime Operation, Various IP Warning Lamps Illuminated, Transmission May Not Shift, Engine May Stall, Communication DTCs U0073, U0100, U0101, U0102, U0109, U0121 or U0140 Set (Repair Terminals in Transmission Harness Connector, Repair Open or Shorted GM High Speed LAN Circuits, Open or Shorted Data Link Resistor, Corrosion or Poor Connections in Various Control Module Connectors)

Models: 2007-2009 Cadillac XLR

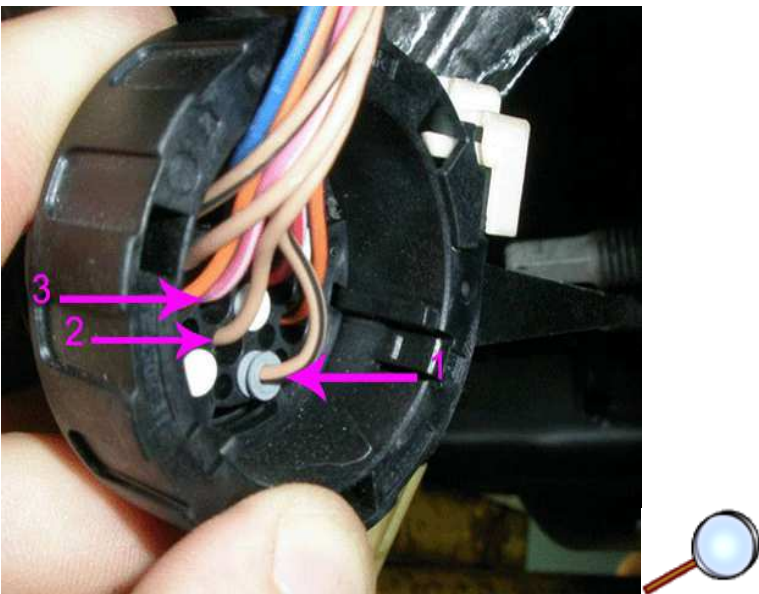
5. **Before** disconnecting the 16-way connector, **inspect** for any backed out terminals (1) as shown. Fully seated terminals (2,3) are shown for comparison.
 - 5.1. If a backed out terminal (1) is found, identify the terminal(s) on the **repair order**.
 - 5.2. Look at the connector in order to identify the number of the cavity with the backed out terminal. Refer to Wiring Systems and Power Management > Component Locator > Master Electrical Component List in SI.

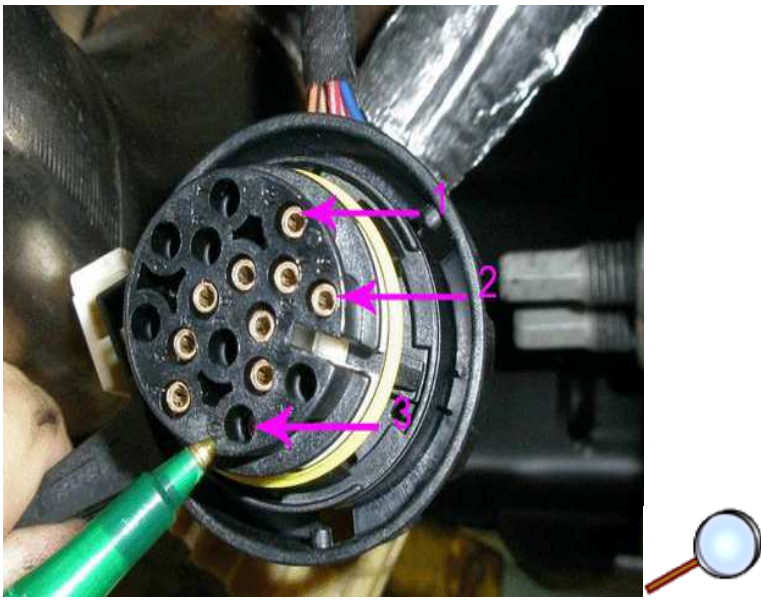
7. **Inspect** for any backed out terminals (3) as shown. Fully seated terminals (1,2) are shown for comparison.
 - 7.1. If a backed out terminal (3) is found, identify the terminal(s) on the **repair order**.
 - 7.2. Look at the connector in order to identify the number of the cavity with the backed out terminal. Refer to Wiring Systems and Power Management > Component Locator > Master Electrical Component List in SI.
8. Repair or replace the terminal(s) as necessary using the following procedure:

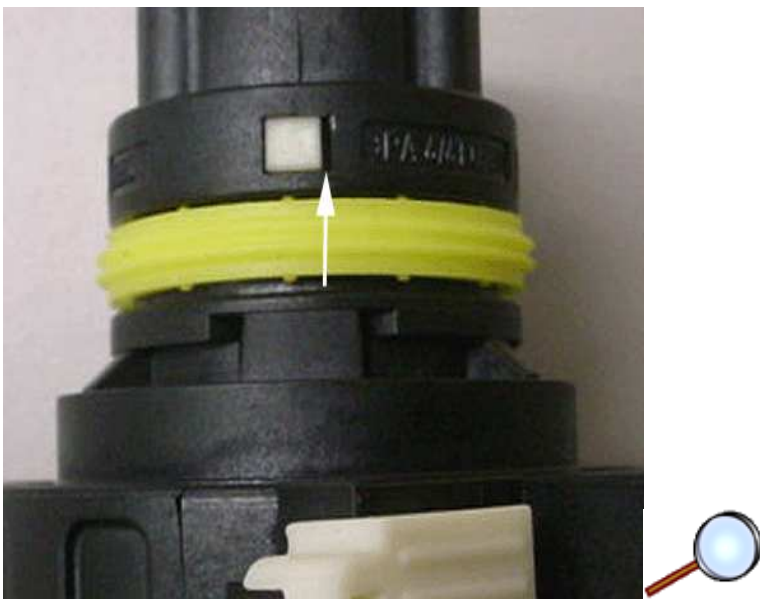
- If the TPA is off-center in the check window as shown, then it is only partially seated. Note the large gap at the arrow. Reseat the TPA lock and ensure that it is fully seated.

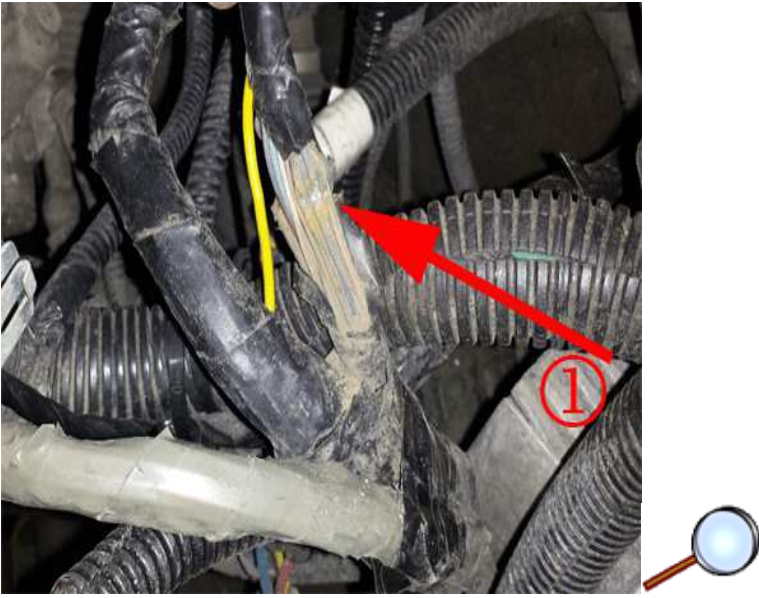
(1) Engine Harness

Multiple Wires Cut and/or Corroded Due to Contact Between the Engine Wiring Harness and the Right Front Brake Pipe on the Left Front Frame Rail

3. Inspect for chafed, damaged, pinched, open or shorted wiring on the engine harness in areas illustrated above.
 - ⇒ If the wiring is damaged, repair as needed. Refer to Power and Signal Distribution > Wiring Systems and Power Management > Diagnostic Information and Procedures in SI. Protect the harness by covering any sharp edge with butyl tape and the harness with woven polyester (PET) electrical tape. Secure the harness as needed.
4. Connect the negative battery cable. Refer to Battery Negative Cable Disconnection and Connection in SI.
5. Clear any DTCs that may be present with a scan tool and verify the proper operation of the vehicle.

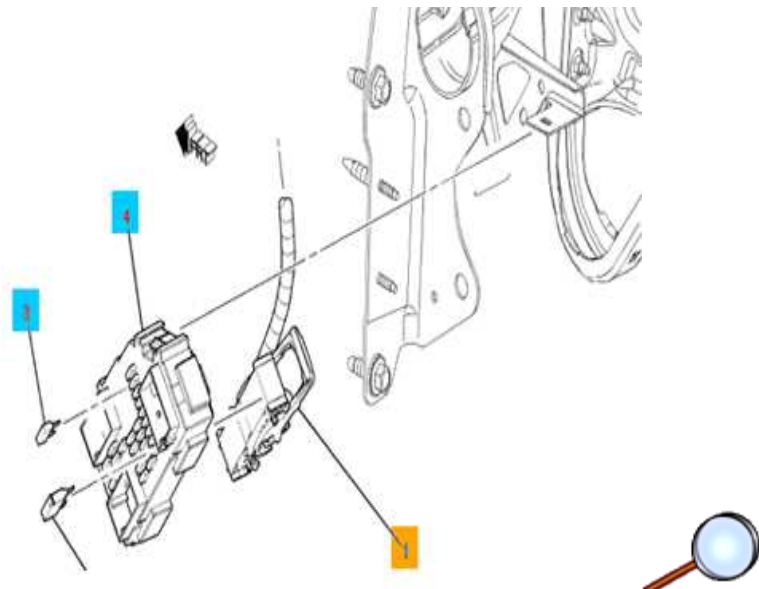
4. Inspect connector X1 (1) on the back of the fuse block for a loose connection. Secure the connector as needed.
5. Install the left side fuse block.

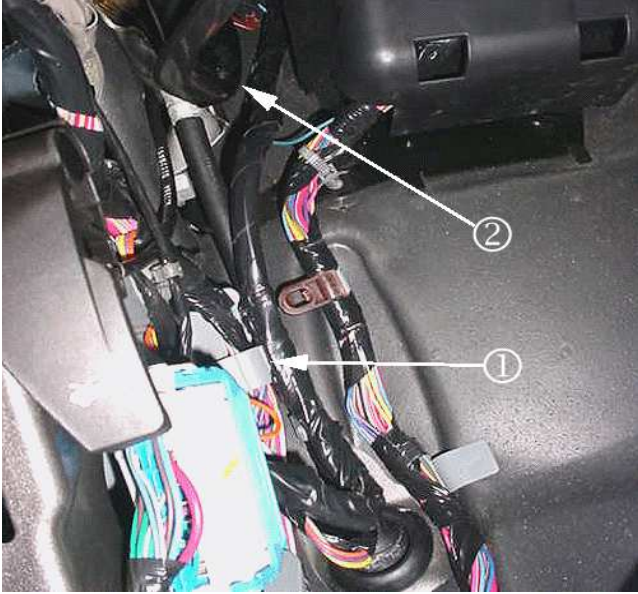
- The IP wiring branch to C202 may have been routed outboard of the junction block (left IP) and the retaining clip (1) off the branch may not have been fully seated. Possible point of contact (2).

- ⇒ If the wiring is damaged, repair as needed. Refer to Power and Signal Distribution > Wiring Systems and Power Management > Diagnostic Information and Procedures in SI. Protect the harness by covering any sharp edge with butyl tape and the harness with woven polyester (PET) electrical tape.

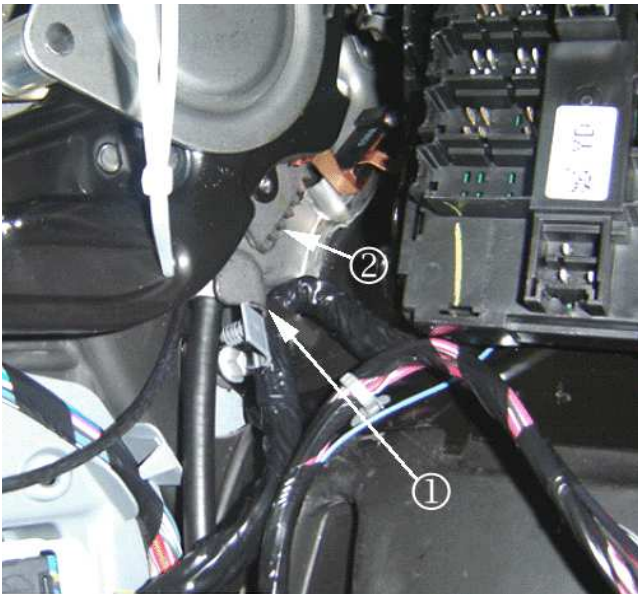
- The IP wiring branch to C202 may have been pushed up and forward into the park brake assembly and the retaining clip off the branch may not have been fully seated. Possible points of contact (1, 2).

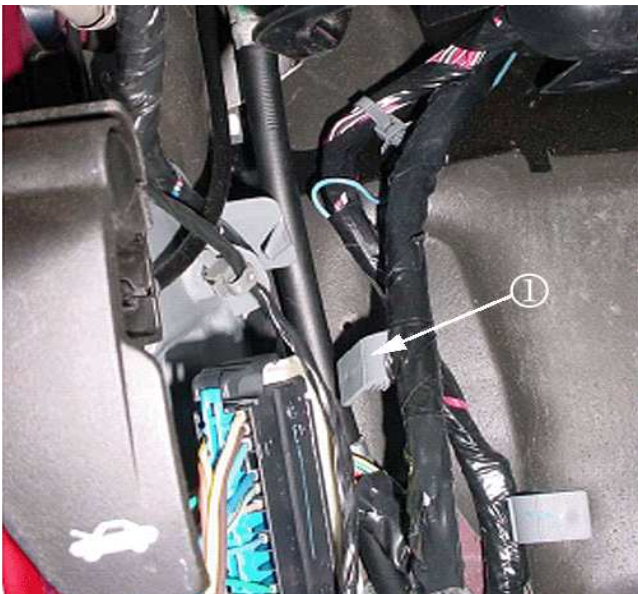
- The IP wiring branch to C202 may not have been secured into place as the gray retaining clip (1) off the branch was never seated.

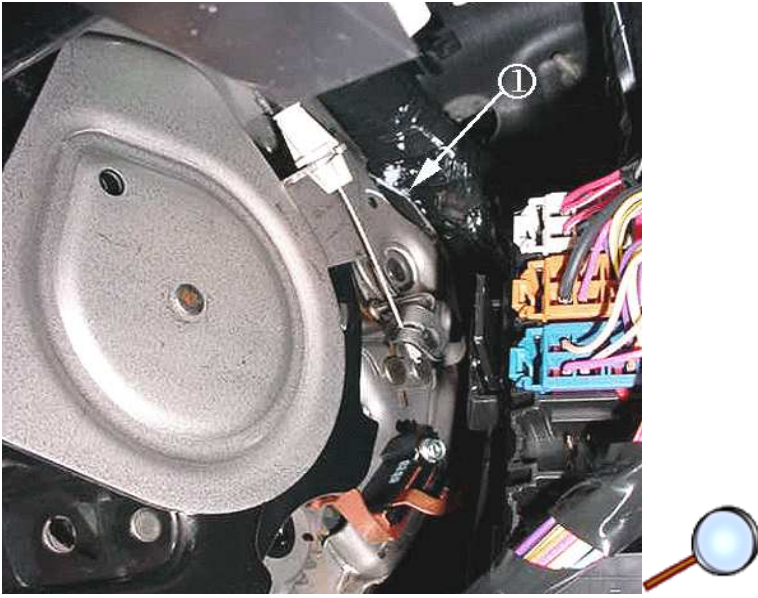
- The IP harness may be in hard contact with the top rear edge (1) of the park brake assembly.

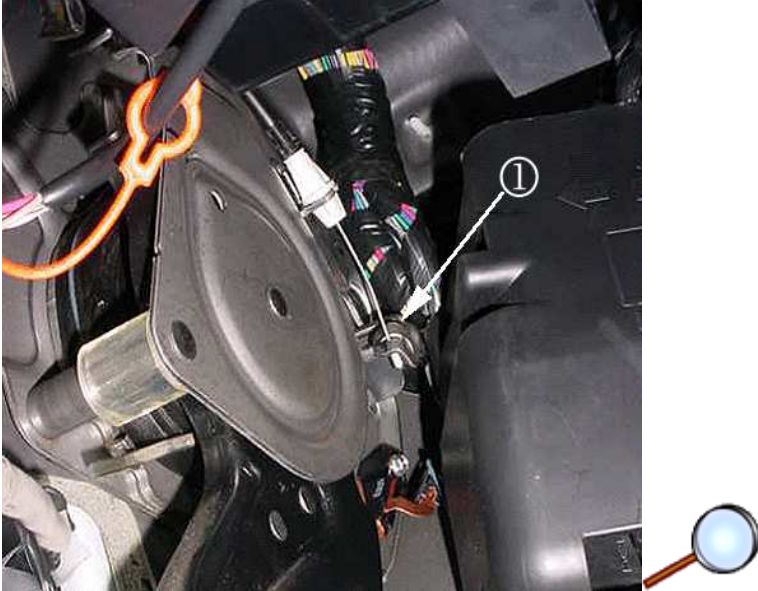
- When releasing the park brake pedal, the moving part (1) at the end of the park brake release cable may be coming into hard contact with the IP harness.

3. Engage and release the park brake several times. Observe the moving part at the end of the park brake release cable as it may contact and damage the IP harness. Inspect the IP harness at this possible contact point. Note that any damage may be covered by electrical tape and/or hid from view.

Engage and release the park brake several times. Verify the harness is no longer making contact with any sharp edge or point of the park brake assembly. If it is still making contact, route it away from the contact point and secure it with tie straps. Proceed to Step 4.

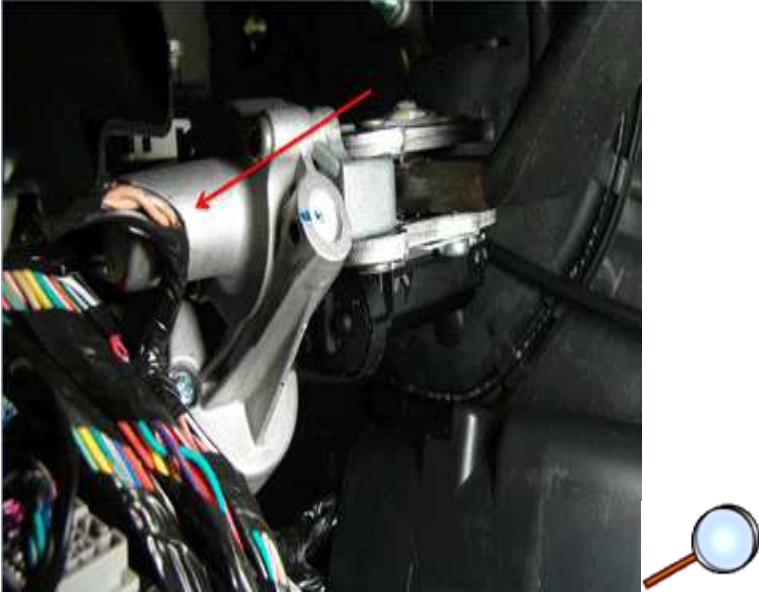
2. Inspect for chafed, damaged, pinched, open or shorted wiring at the adjustable pedals motor as shown.
3. If the wiring is damaged, repair as needed. Refer to Power and Signal Distribution > Wiring Systems and Power Management > Diagnostic Information and Procedures in SI. Protect the conduit by covering any sharp edge with butyl tape and the harness with woven polyester (PET) electrical tape. Secure the harness as needed.
4. Clear any DTCs that may be present with a scan tool and verify the proper operation of the vehicle.

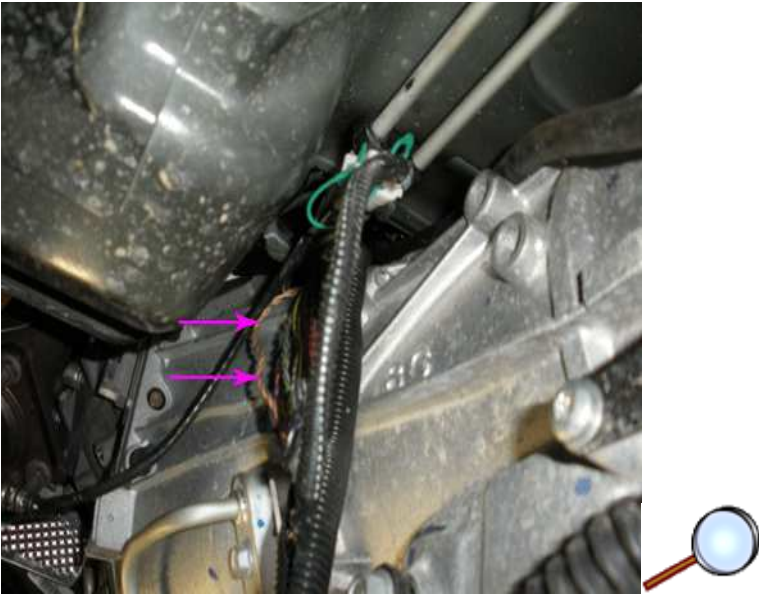
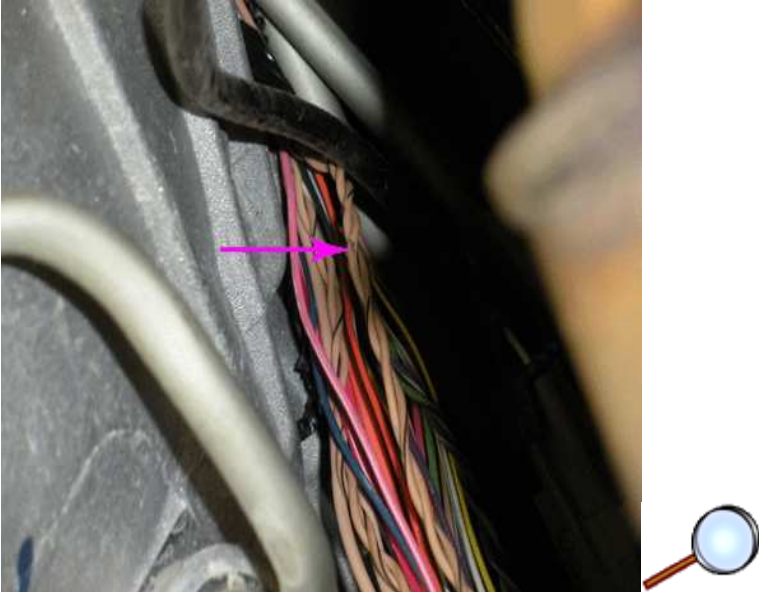
8. Examine the harness for wiring that may be exposed outside of the conduit. Inspect all areas for chafed, damaged, pinched, open or shorted wiring as shown. If damage to the wiring is not observed, then extract the wiring from the conduit and inspect all remaining areas as needed.

- ⇒ If the wiring is damaged, repair as needed. Refer to Power and Signal Distribution > Wiring Systems and Power Management > Diagnostic Information and Procedures > Wiring Repairs in SI. Protect the conduit by covering any sharp edge with butyl tape and the harness with woven polyester (PET) electrical tape. Secure the harness as needed.

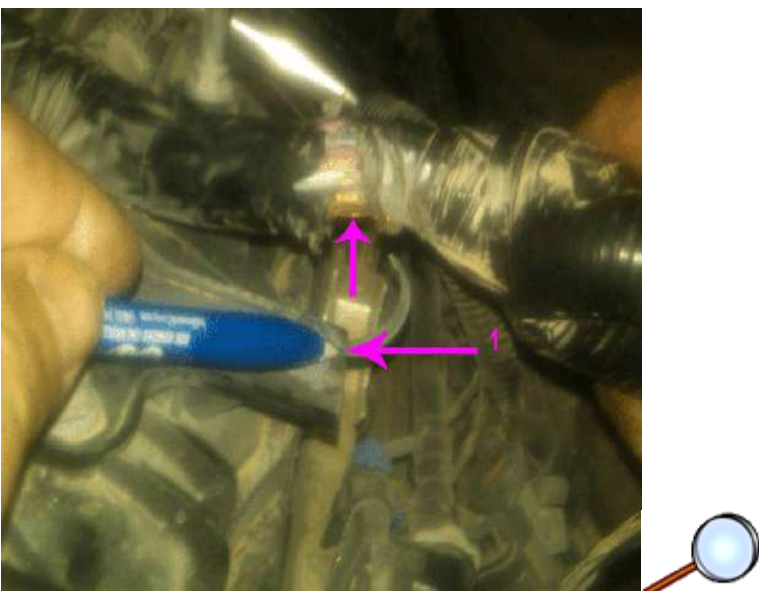
4. Inspect the wiring harness for damage from contact with the steel bracket (1).
⇒ If the wiring is damaged, repair as needed. Refer to Power and Signal Distribution > Wiring Systems and Power Management > Diagnostic Information and Procedures > Wiring Repairs in SI.
5. Cover any sharp edge on the bracket with butyl tape and the harness with woven polyester (PET) electrical tape.

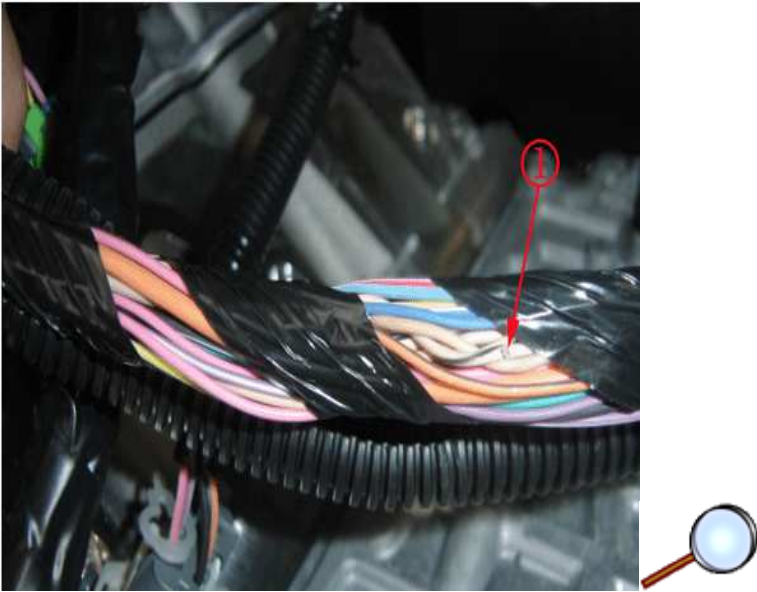
Inspect for chafed (1), damaged, pinched, open or shorted wiring. If damage is not observed, then extract the wiring from the conduit and inspect all of the remaining areas as needed.

⇒ If the wiring is damaged, repair as needed. Refer to Power and Signal Distribution > Wiring Systems and Power Management > Diagnostic Information and Procedures.

7. Protect the conduit by covering any sharp edges on the engine or transmission with butyl tape and the harness with woven polyester (PET) electrical tape.
8. Secure the wiring harness within the conduit as needed.
9. Attach the wiring harness conduit to the retainers that secure it to the rear of the engine and at the top of the transmission bell housing.

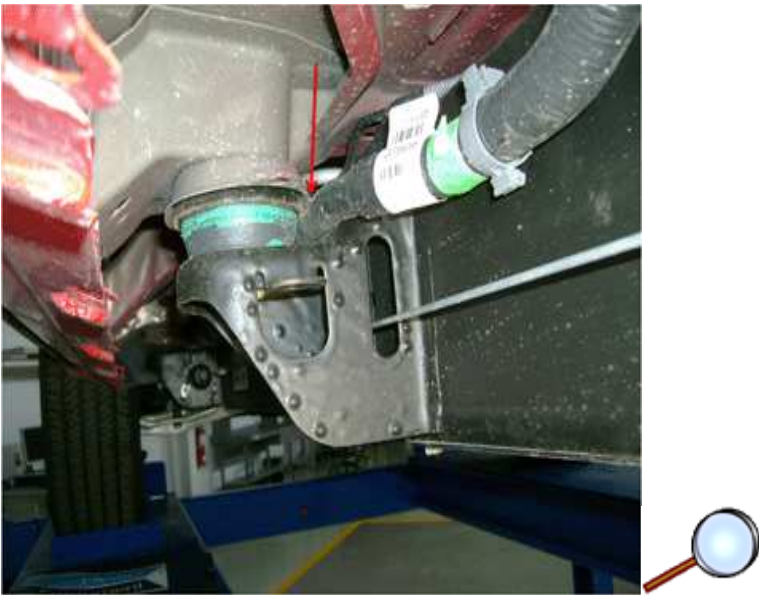
3. Inspect the wiring harness along the left side frame rail at the body mounts as shown for chafed, damaged, pinched, open or shorted wiring.
4. If the wiring is damaged, repair as needed. Refer to Power and Signal Distribution > Wiring Systems and Power Management > Diagnostic Information and Procedures. Protect the conduit by covering any sharp edge with butyl tape and the harness with woven polyester (PET) electrical tape. Secure the harness as needed.
5. Lower the vehicle.
6. Clear any DTCs that may be present with a scan tool and verify the proper operation of the vehicle.

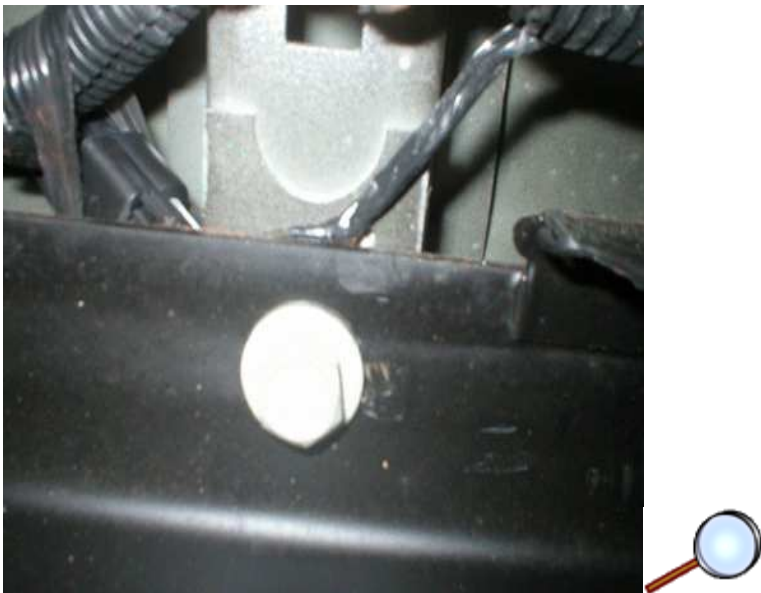
4. Inspect the wiring harness leading to the rear data link resistor 1, between the truck box and frame for chafed, damaged, pinched, open or shorted wiring as shown.
 - ⇒ If the wiring is damaged, repair as needed. Refer to Power and Signal Distribution > Wiring Systems and Power Management > Diagnostic Information and Procedures. Protect the conduit by covering any sharp edge with butyl tape and the harness with woven polyester (PET) electrical tape. Secure the harness as needed. Proceed to Step 9.
 - ⇒ If the wiring is not damaged, proceed to Step 5.
5. Disconnect the electrical connector from the data link resistor 1.
6. Test the data link resistor 1 for 110–130Ω.
 - ⇒ If the resistance is not within the specified range, replace the data link resistor 1 and proceed to Step 7.

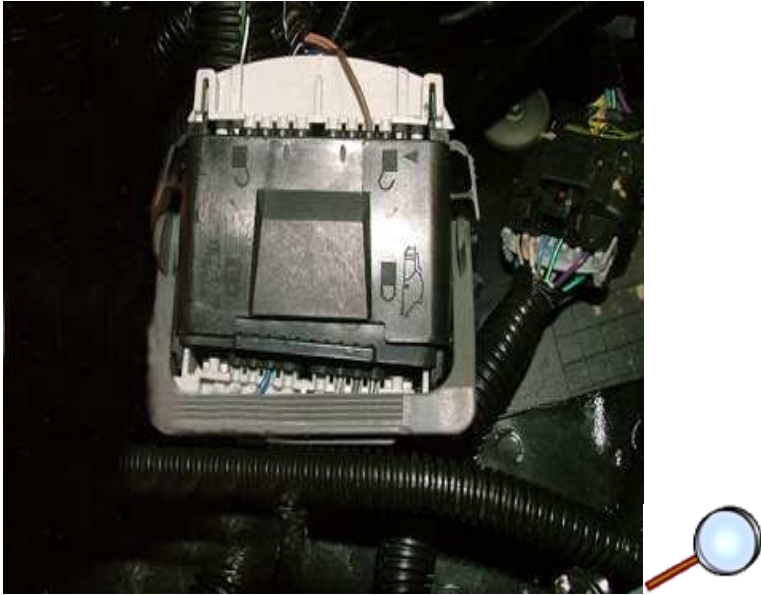
3. **Before** disconnecting, verify the connector is fully seated together even though the lever is locked down as shown. If the connector is not fully seated, repair as needed. Refer to Power and Signal Distribution > Wiring Systems and Power Management > Diagnostic Information and Procedures > Connector Repairs in SI.
4. Inspect the connector for the following conditions:
 - Backed out terminals
 - Bent pins
 - Corrosion
 - Poor terminal tension (use the correct test probe)
 ⇒ If a condition is found, repair as needed. Refer to Power and Signal Distribution > Wiring Systems and Power Management > Diagnostic Information and Procedures in SI.

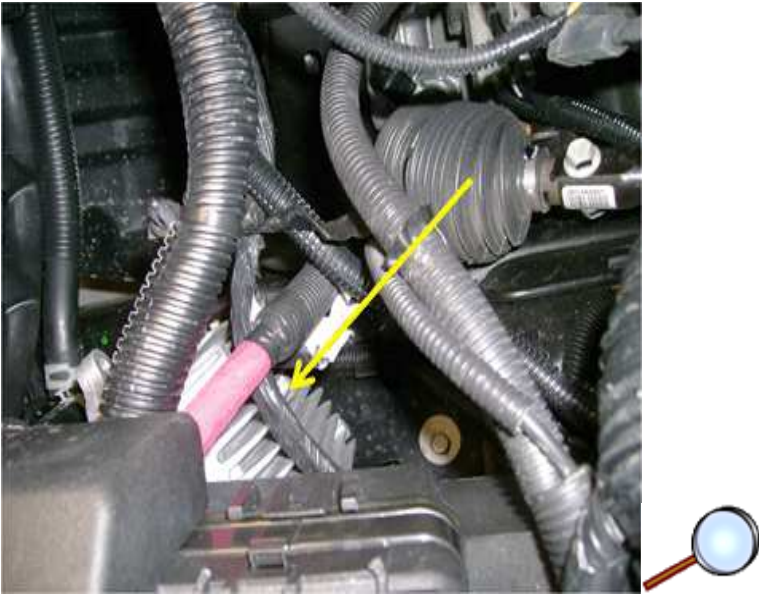
4. Inspect for a misrouted harness having chafed, damaged, pinched, open or shorted wiring from rubbing on the cooling fins of the Transmission Auxiliary Fluid Pump Control Module as shown.
 - ⇒ If the wiring is damaged, repair as needed. Refer to Power and Signal Distribution > Wiring Systems and Power Management > Diagnostic Information and Procedures in SI. Protect the conduit by covering any sharp edge with butyl tape and the harness with woven polyester (PET) electrical tape. Secure the harness as needed. Proceed to Step 8.
 - ⇒ If the wiring is not damaged, proceed to Step 5.

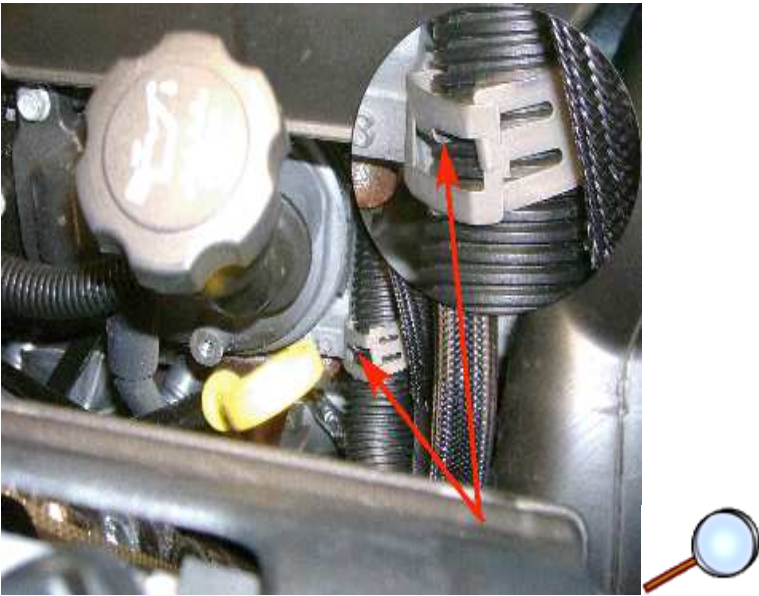
5. Inspect for chafed, damaged, pinched or shorted wiring caused by a mispositioned harness retaining clip as shown. This condition usually occurs when the tab of the clip is aligned with a slot in the conduit.

- ⇒ If the wiring is damaged, repair as needed. Refer to Power and Signal Distribution > Wiring Systems and Power Management > Diagnostic Information and Procedures in SI. Protect the conduit by covering any sharp edge with butyl tape and the harness with woven polyester (PET) electrical tape. Secure the harness as needed. Proceed to Step 8.

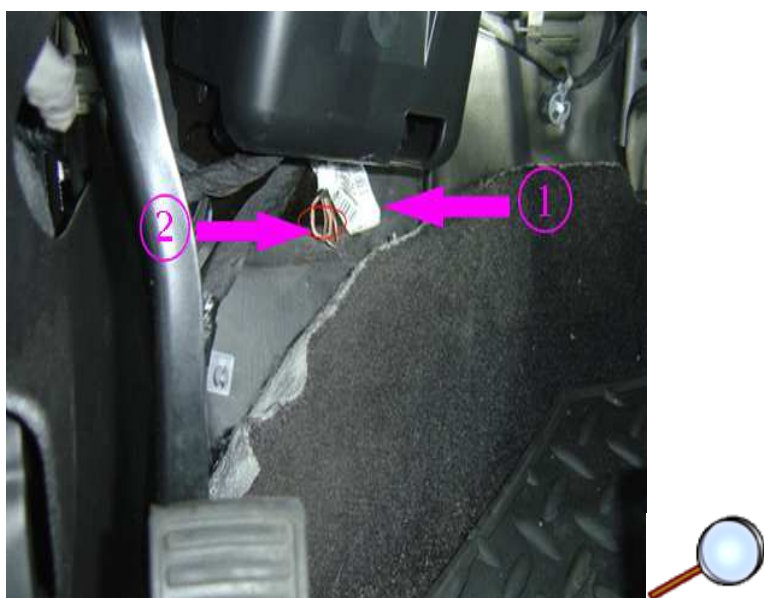
5. Inspect the jumper harness loop connector (1) for chafed (2), damaged, pinched, open or shorted wiring from contact with the IP brace.
 - ⇒ If the wiring is damaged, repair as needed. Refer to Power and Signal Distribution > Wiring Systems and Power Management > Diagnostic Information and Procedures in SI. Protect the harness by covering any sharp edge with butyl tape and the harness with woven polyester (PET) electrical tape. Secure the jumper harness loop connector as needed. Proceed to Step 6.

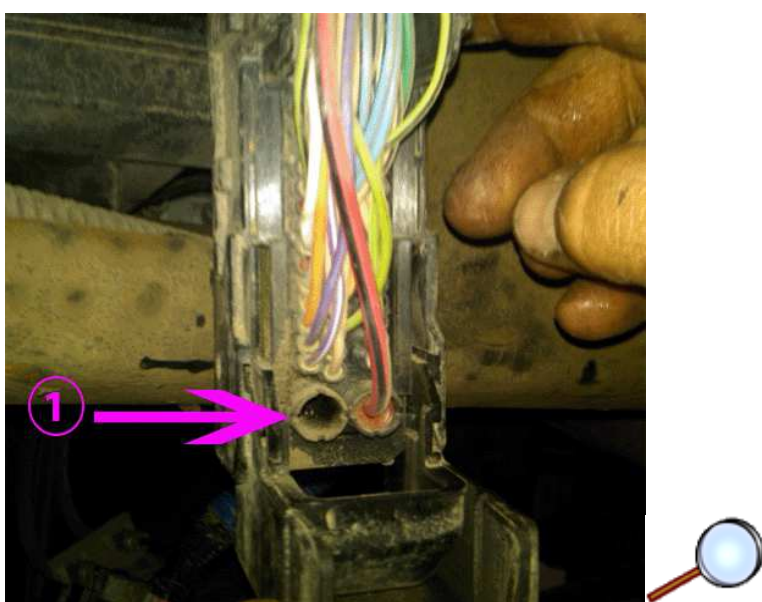
4. Inspect the connector of the ESC module for weather plugs that are missing from: **Not Used** cavities (1). Refer to > Power and Signal Distribution > Wiring Systems and Power Management > Component Locator > Master Electrical Component List > Electronic Suspension Control (ESC) Module > Connector End View for a list of cavities that are: **Not Used**.

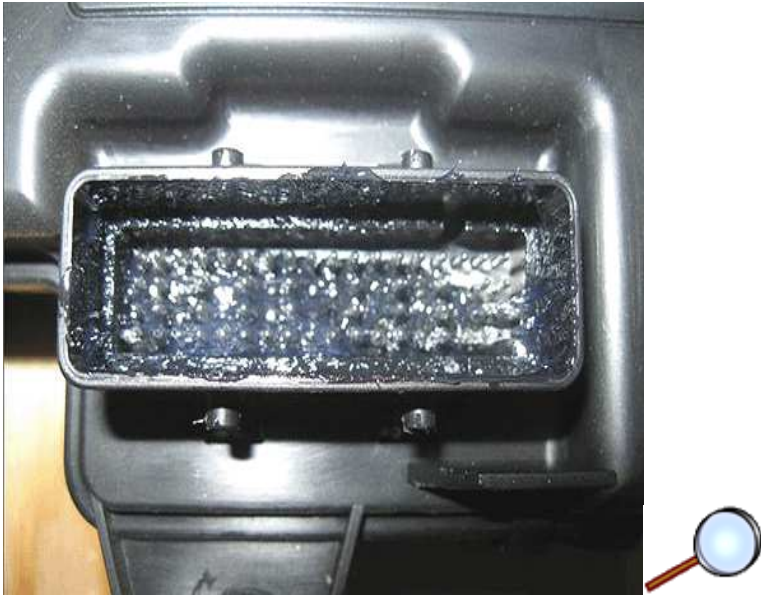
2. **DO NOT** apply an excessive amount of dielectric lubricant as shown, to the connectors as hydrolock may result when attempting to mate the connectors. This could cause terminals to back out, resulting in an intermittent connection.
