#10-08-67-001C: Headliner Wet, Water Leak from Front or Rear Sunroof Glass or Rear Compartment Carpet Wet - (May 22, 2015)

Models: 2008-2016 Buick Enclave
2009-2016 Chevrolet Traverse
2007-2016 GMC Acadia
2007-2010 Saturn OUTLOOK

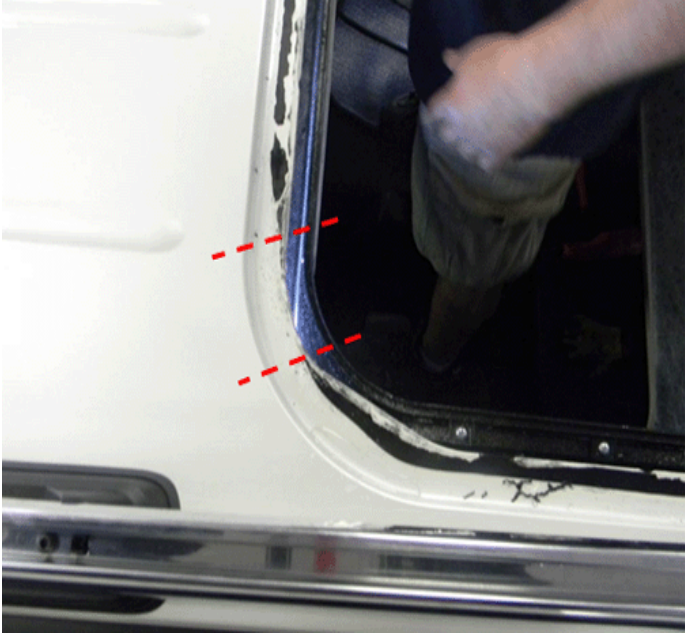
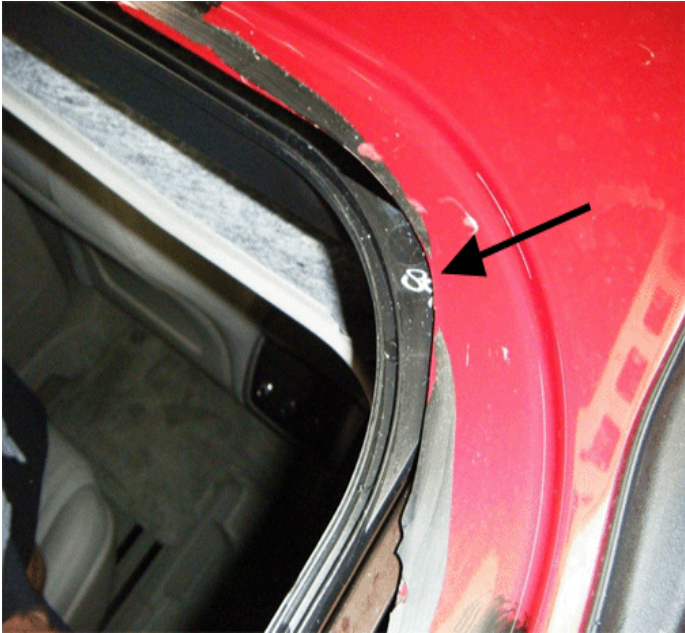
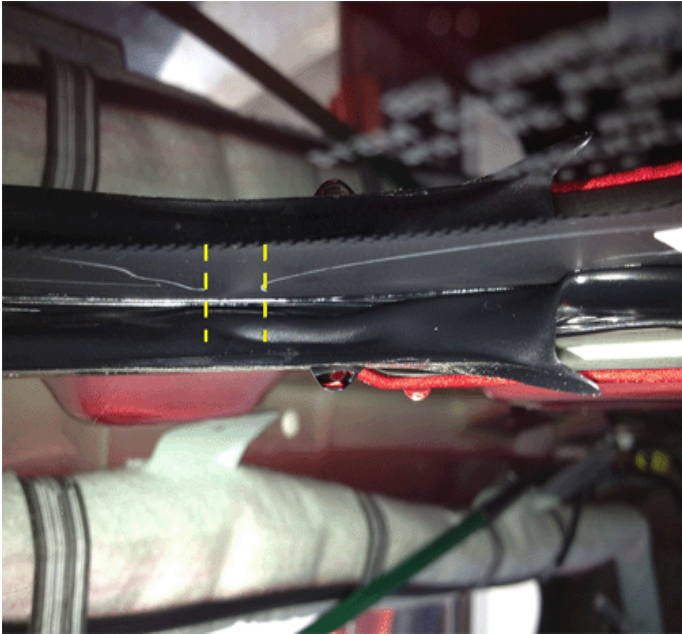
The cause of this condition may be from the urethane of the sunroof rear stationary window not sealing the glass to the body. This may allow water to leak between the urethane and roof flange, then onto the headliner.

To properly verify that the leak is from the sunroof rear stationary glass, use a soapy solution and compressed air. The more common areas where leaks may be found is at the center rear edge of the glass, or in the front or rear corners of the glass. Several examples are shown in the graphics below.

If a leak is confirmed, remove and reseal the glass. Refer to Roof Stationary Window Replacement in SI.

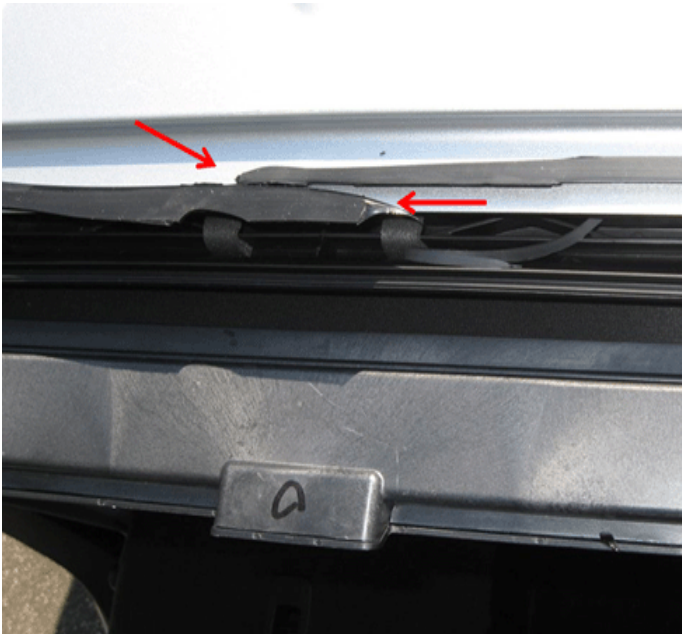
The graphic below shows an example of a leak caused by the urethane not being properly aligned.

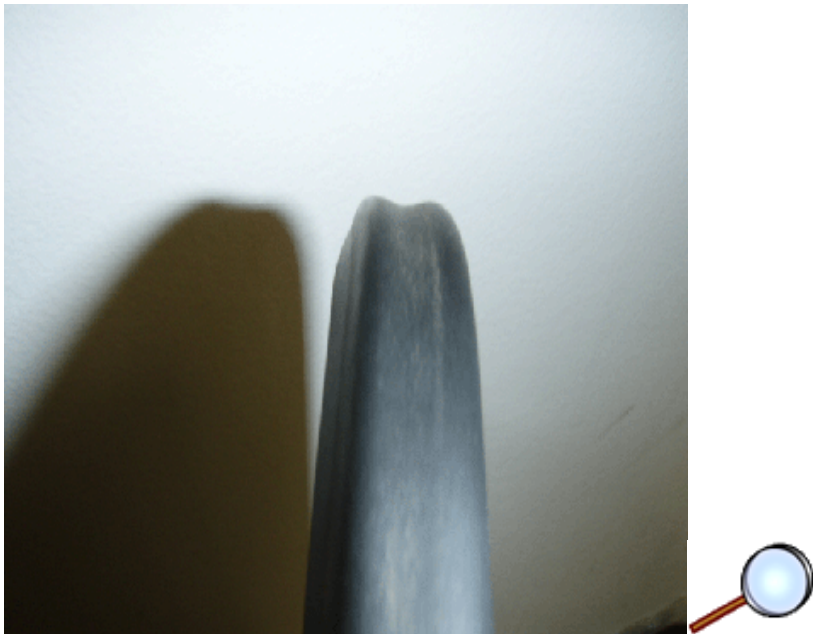
The sunroof glass panel weather-strip/seal may have failed to retain its designed shape, resulting in a water leak that overwhelms the sunroof module water trough or allows sufficient dirt and debris into the drain location to plug up the drains.

Technicians are to inspect the glass panel weather-strip/seal appearance at the corners and around the glass panel. If the seal looks depressed or concave in the middle, as shown above, replace the seal. Refer to Sunroof Window Weatherstrip Replacement in SI.

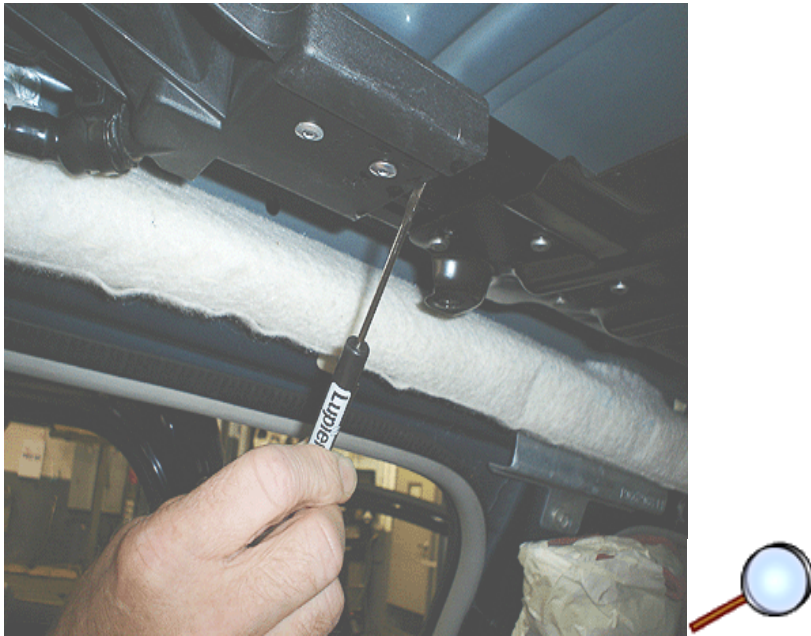
Important: All vehicles built prior to April 1, 2008 have drain holes in the roof sheet metal around the rear stationary glass. These holes are pierced through the roof structure and allow water to flow in to the vehicle. To confirm that water is entering through these holes, remove the sunroof frame and pour water around the rear fixed glass on the outside of the vehicle.

Important: Water dripping from the middle drain hose connection area, shown above, is due to the stationary glass holes leaking water, NOT the sunroof frame. Water flowing through these roof structure drain holes may miss the water management gutter, dripping onto the topside of sunroof frame and running to the underside of the frame where the black plastic drain spout attaches to the aluminum.

TECHNICIANS MUST SEAL THESE HOLES TO STOP WATER FROM ENTERING THE VEHICLE. ONCE THESE LOCATIONS ARE SEALED, NO WATER CAN ENTER THE VEHICLE IN THESE AREAS.

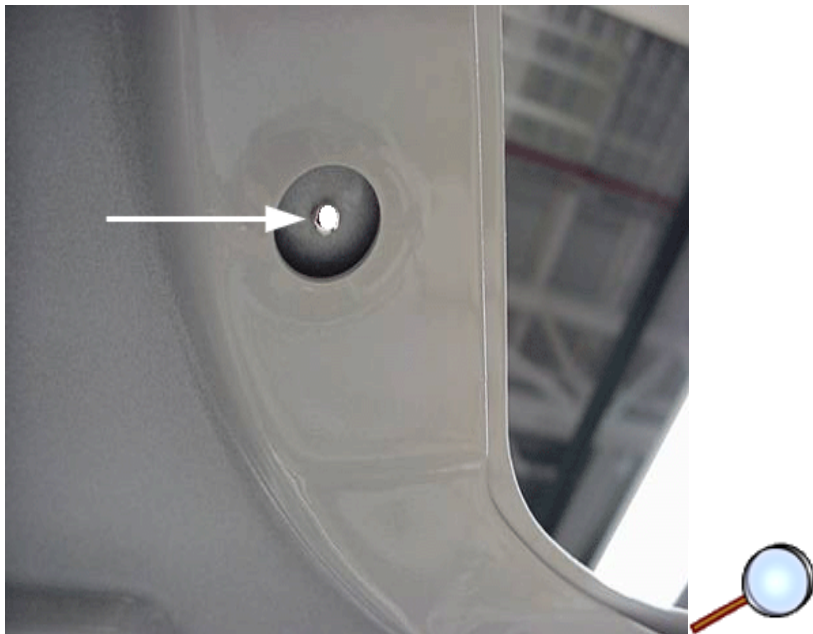
Note: The photo above, taken after the sunroof module was removed, is the view from inside the vehicle looking up at the drain holes around the rear fixed glass.

- Whether two or four holes are present, seal the holes in the roof sheet metal from inside the vehicle. Refer to the illustration above.

Important: When plugging the holes, make sure to use a windshield urethane sealant and NOT a silicone sealant. See the Parts Information section of this bulletin for the proper sealant.

Important: Ensure the urethane fills directly into the center of the hole (noted by the white area the illustration above) and pushes upward to completely seal the hole.

- Clean the four holes in the roof sheet metal and fill with a small amount of windshield urethane sealant.
- Reinstall the sunroof module.
- After the repair, run a second water test for leaks.

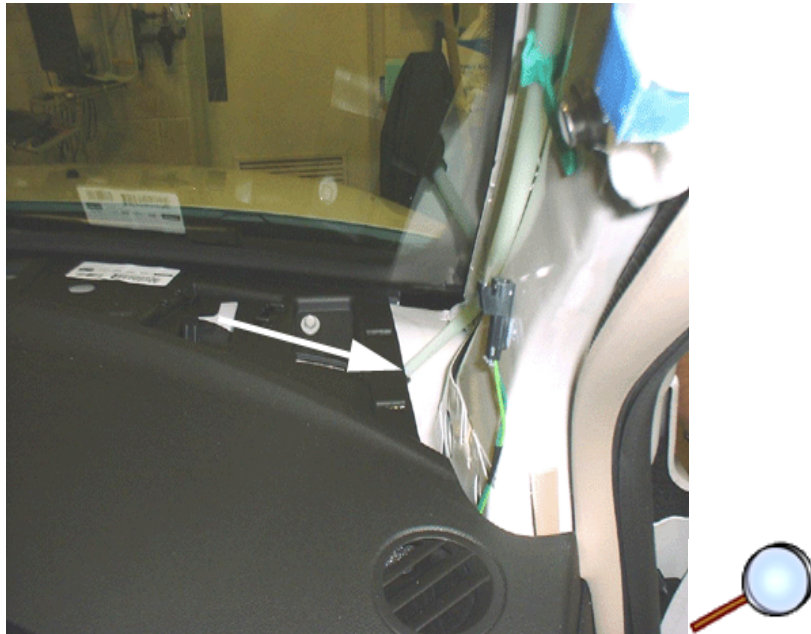
The cause of this condition may be that the end of one of the front drains may be plugged with grease from the sunroof, or debris may be caught in the cross hatch at the end of the drain tubes.

3. Remove the rubber grommet at the end of the drain tube. Refer to the illustration above.

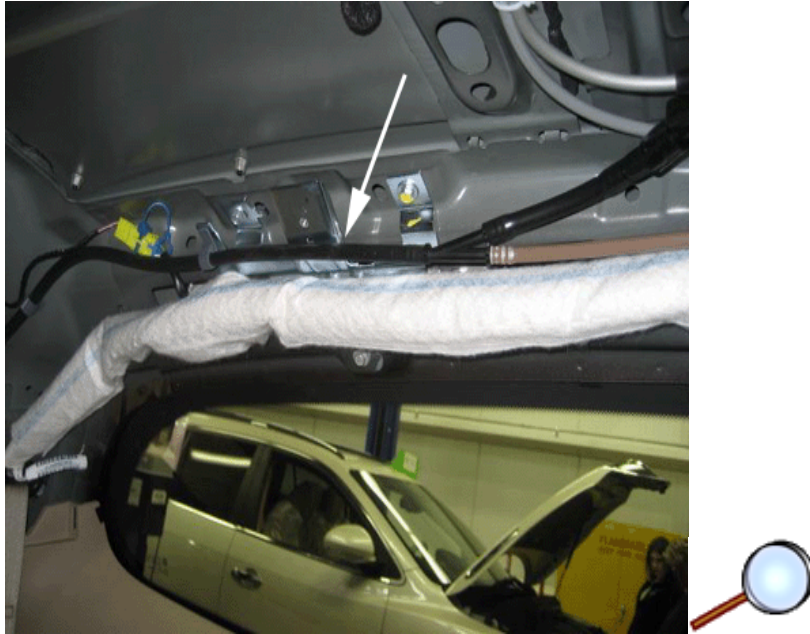
Figure 1 — Incorrect Routing

The cause of this condition may be a sunroof drain hose being improperly routed.

- Make sure that the hose is routed in back of the air bag bracket. Figure 1 shows the incorrect routing and Figure 2 shows the correct routing.
- Also make sure that there are no bends pointing upward in the drain tubes.
