4R44E/55E and 5R44E/55E TCC Concerns How to Test the system

Torque converter concerns on 4R44E/4R55E/5R55E have been a constant concern. In recent years there have been a number of concerns related to torque converter apply as well as No cooler flow, Harsh TCC and Soft TCC engagement, No Lock-up or loss of TCC when hot. Diagnosing torque converter problems can be troublesome. The following pages have tips you can use to determine the fix.

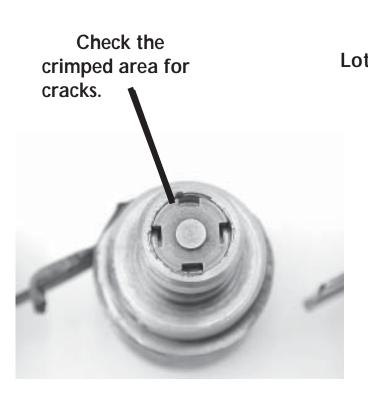
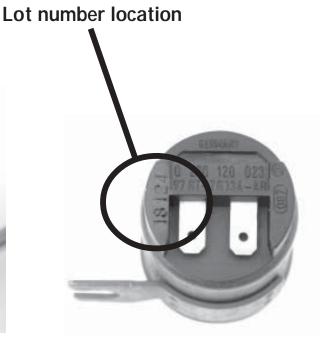
4R44E/55E and 5R44E/55E TCC Concerns (continued) Damaged TCC Solenoid

Concern: A no TCC apply on 1995 trough 1998 with a flashing overdrive light, DTC 628, P0741, P1740 or P1744.

Common Cause: TCC solenoid (there were certain TCC solenoid's that were poorly designed and the result was the tip blowing out and the brackets were cracking.

Note: Make sure not to reuse lot numbers between 769 and 771, these solenoids are defective.

Repair: Replace solenoid.

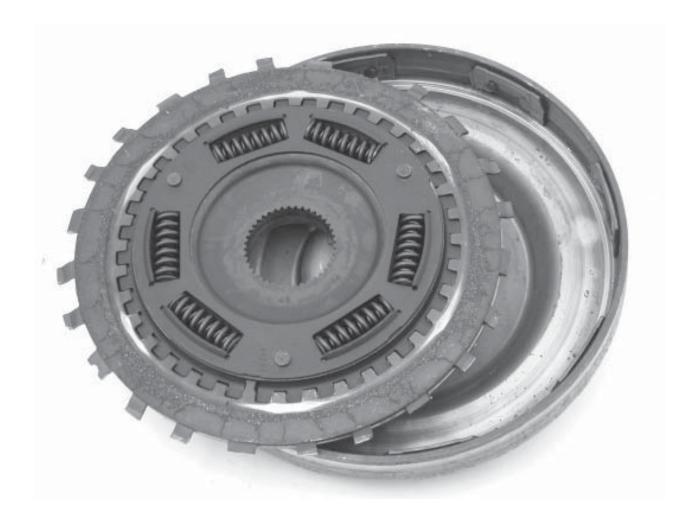
4R44E/55E and 5R44E/55E TCC Concerns (continued) Torque Converter Clutch Failure

Slip codes are very common. Make sure to diagnose converter codes correctly before replacing converter.

Concern: No converter clutch apply.

Common Cause: Torque converter lining burnt or flaked off.

Repair: Replace converter.

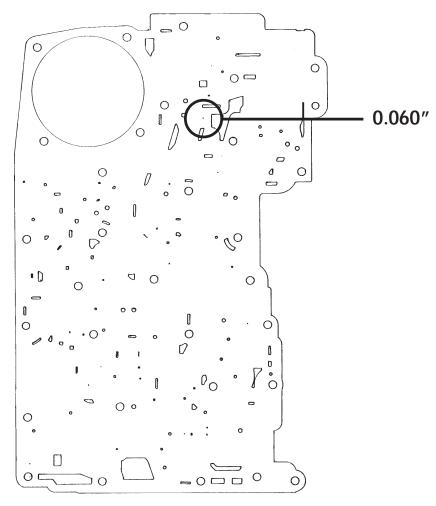
4R44E/55E and 5R44E/55E TCC Concerns (continued) Separator Plate Feed Hole Modification

Modify the Separator plate to increase cooler flow. Cooler flow should be a minimum of 1 quart in 20 seconds. Make sure line pressure is within specification, high line pressures can cause low cooler flow.

Concern: TCC slip, or insufficient cooler flow.

Common Cause: The separator plate may have the wrong size feed holes. The converter feed holes are normally between 0.032" and 0.048".

Repair: Drill the converter feed hole in the separator plate to 0.060" for increased cooler flow.

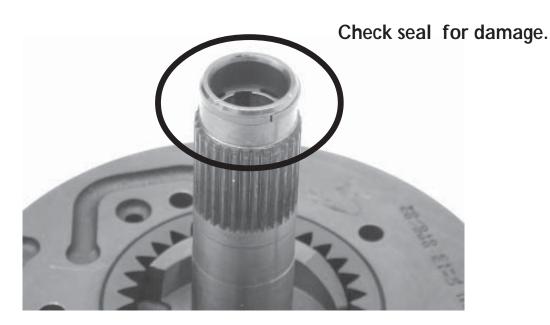
4R44E/55E and 5R44E/55E TCC Concerns (continued) Butt-cut Seal Damaged

Concern: Slip or no TCC apply.

Common Cause: Seal broken or stator shaft worn or cracked.

Repair: Replace seal and check stator support for shaft wear or cracking around the seal area. If crack is evident replace stator.

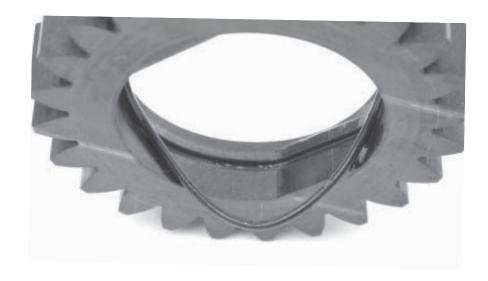
4R44E/55E and 5R44E/55E TCC Concerns (continued) Inner Pump Gear Seal Damaged

Concern: TCC slip

Common Cause: Installing A4LD pump gears that don't have an O-ring, or correct pump gear inner O-ring damaged or missing. This will allow converter charge oil to leak into the converter bushing lube or drain back passage creating low converter charge.

Repair: Install correct pump gears and O-ring. Inspect converter hub and lubricate prior to installation.

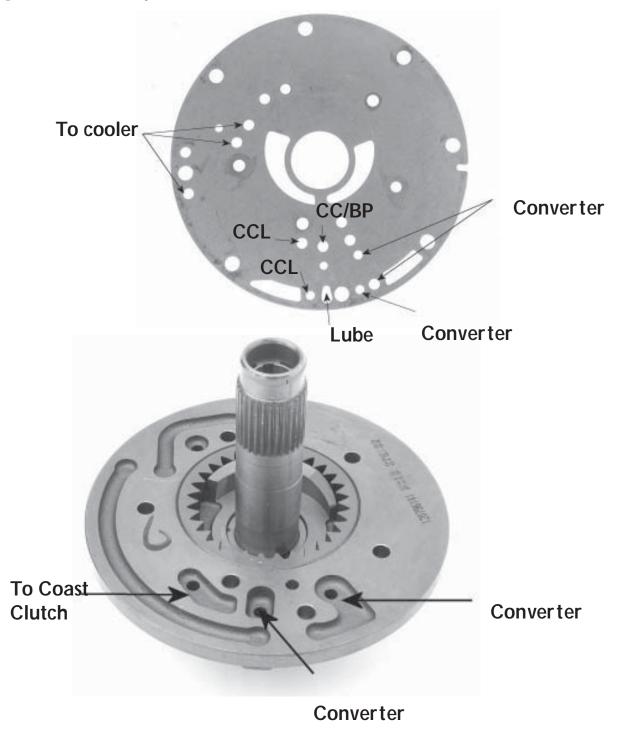
TCC Concerns (continued) Pump and Spacer Plate Damage

Always inspect Pump assembly for damage, note any wear marks or warping and replace if necessary.

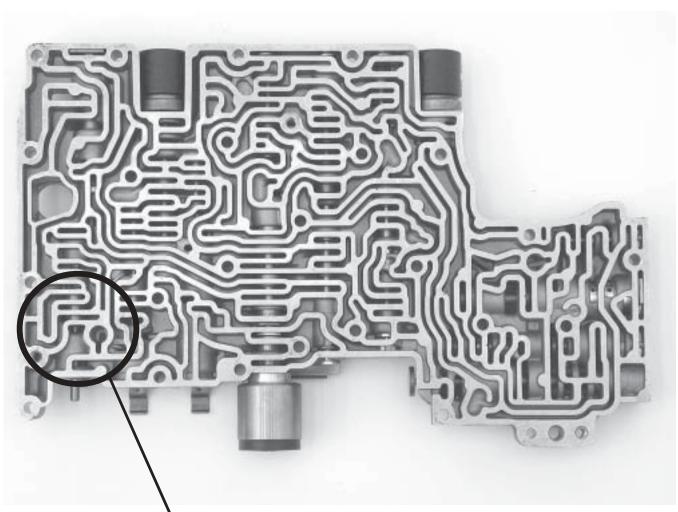
TCC Concerns (continued) Valve Body Damage

Always check valve body surface for warping
