Remarkable case histories regarding S. Vitale church, Ravenna, Italy

A. Mazzucato^a, G. Ricceri^a, F. Selleri^b, M. Soranzo^c

The article presents a critical analysis of the results achieved in the study regarding the properties of the subsoil, the foundations and the evolution of the cracking phenomena occurring on the monument, enabling us to make plans concerning possible consolidation measures.

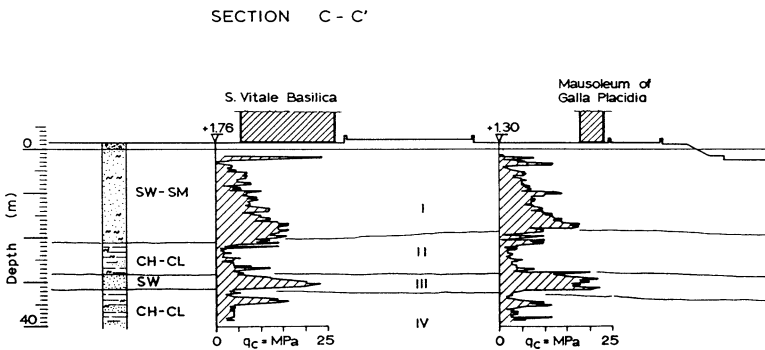
Fig. 3 - Geotechnical cross-sections of the soil, obtained from survey data and static penetration tests.

Section C-C' (Fig.3), which runs approximately NE - SW, yielded many on-site and laboratory test data and provided the best picture of the stratigraphic situation under S. Vitale. Analysis of the stratigraphic columns allows certain hypotheses regarding the nature and configuration of the underlying formations.

The first of these is granular, featuring sporadic silt and clay bodies in some cases. From visual inspection, this formation was found to be a fine sand, somewhat silty in certain points, dark grey to greenish-grey in colour. Its thickness varies from 16.40 to 20.00 metres. The Dutch cone strength q_c varies between 2 MPa at the shallowest point and 15 MPa at the deepest. The variation, which shows a generally linear increase with depth, is mainly due to increasing geostatic stresses in the soil.

The second formation is of cohesive nature and consists of a silty, dark-grey or greenish-grey clay. Thickness ranges from 3.60 to 6.50 metres. Strength q_c varies from 2 to 3 MPa.

The third formation is granular and consists of a medium-fine grey sand. Strength q_c ranges from 13 to 23 MPa, and thickness from 3.55 to 6.25 metres. The fourth formation consists of a silty, greenish-grey clay with inclusions of sandy and silty bodies. The top of this formation, which extends down to the maximum depth reached by this survey, ranges from -33 to -34 metres; strength q_c ranges from 2.5 to 4.0 MPa.

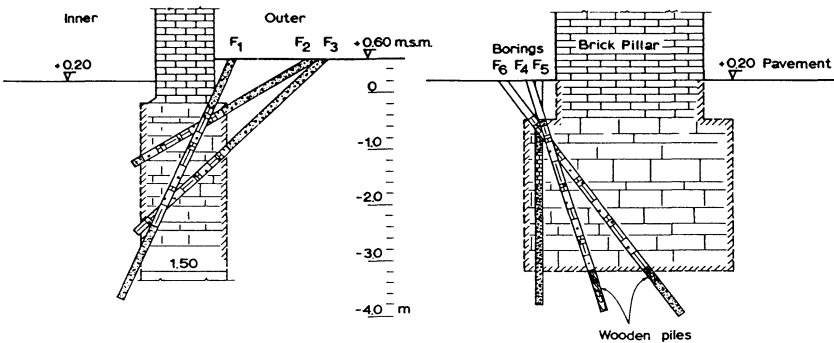
Fig. 4 - a) Cross-section of external wall foundations.
b) Internal pillar foundations.

Survey of the structural situation of the foundations of S. Vitale started in 1983 (Riccieri [1]), with a series of measurements both near and within its load-bearing structures. The 1.50-metre wide wall foundations consist of limestone elements and trachyte blocks bound together by lime mortar. The intrados is approximately 3.00 metres below the floor level of the church, which is in turn 0.20 metres above sea level. The foundation elements are supported by upright oak piles whose tips reach -3.00 metres, embedded in the sandy silt found at these depths.

This was the situation observed in the foundation structures of all the internal walls and pillars, whereas there was no evidence of oak piles under the outer walls. Fig.4 shows the characteristic dimensions of the foundations.

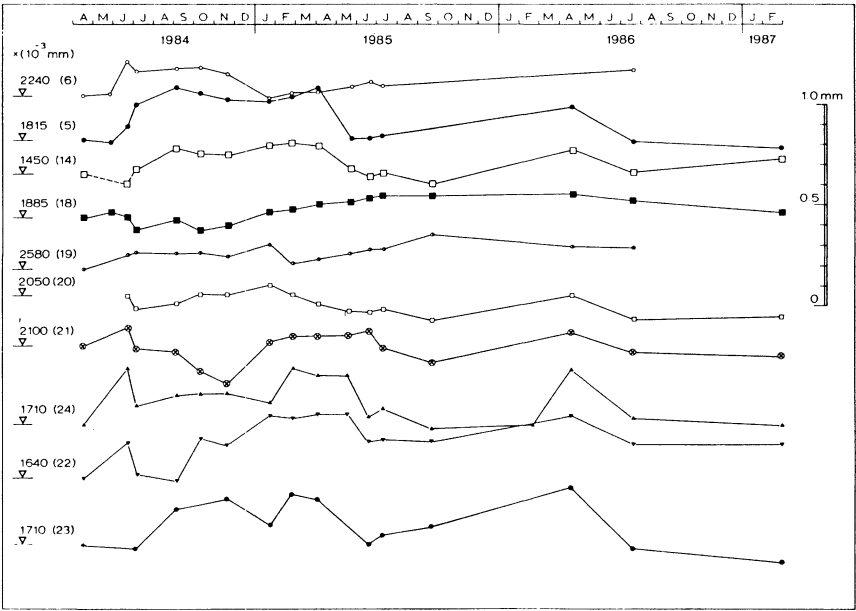
Fig. 6 - Deformation recordings of S. Vitale basilica

DAG 10 level measurement devices were installed on the floor of the women's gallery and connected to the expansion vessels in order to measure relative variations in floor level at the points of installation with an accuracy of 1/100 mm. Fig.6 lists recordings of the opening and closing of cracks.

Fracture movement trends on the various structural components ranged from 0.20 to 0.58 mm for the cross-arches, from 0.20 to 0.25 mm for the windows, from 0.10 to 0.20 mm for the cross-vault, and from 0.25 to 0.45 mm for the arches supporting the vaults between the central pillars.

Comparison of these figures shows that the opening and closing of cracks follow seasonal variations in temperature, with a certain delay in response. Measurements of daily variations reveal that temperature only moderately affects cracking.

The opening of cracks was found to follow seasonal temperature trends with practically no relative residual movements.

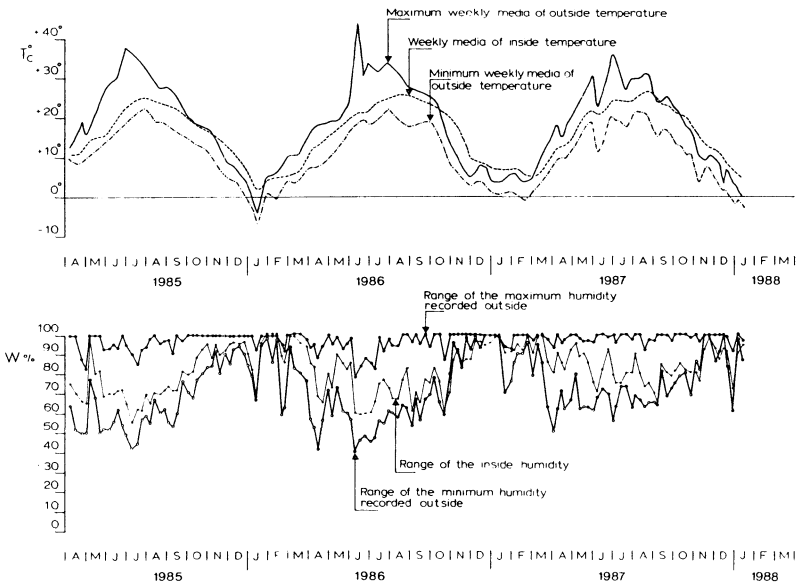
Fig. 7 - Variations in temperature and relative humidity at S. Vitale basilica

Fig.7 shows temperature and relative humidity trends in the survey period, revealing considerable thermal inertia of the building with respect to daily and seasonal variations.

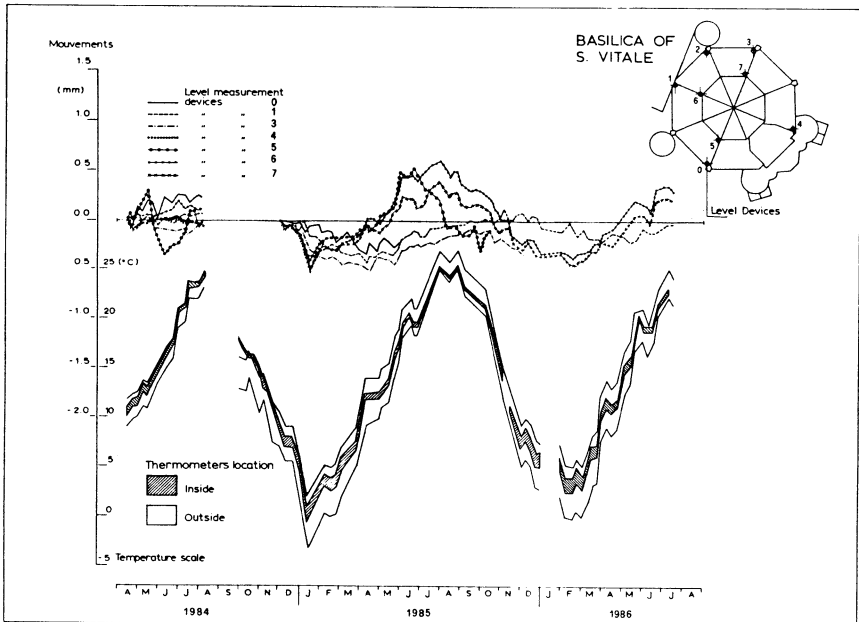
Fig. 8 - Vertical displacements at S. Vitale basilica recorded by level measurement devices.

Fig.8 reports values recorded by the level measurement devices from April 1984 to July 1986. Fig.9 illustrates the variations in height of the women's gallery, detected by the varying length of the deformation rods connecting the floor with the vaults overhead.

Measurements of uneven structural sinking indicate moderate values, within a range of less than 1 mm. Sinking exhibits seasonal oscillations, correlated basically to variations in temperature and ground water movements.
