# Your Inspection Report

32 Sample Avenue  
Rochester, NY 14624

RE: Report No. 2366, v.2  
32 Sample Avenue  
Rochester, NY  
14624

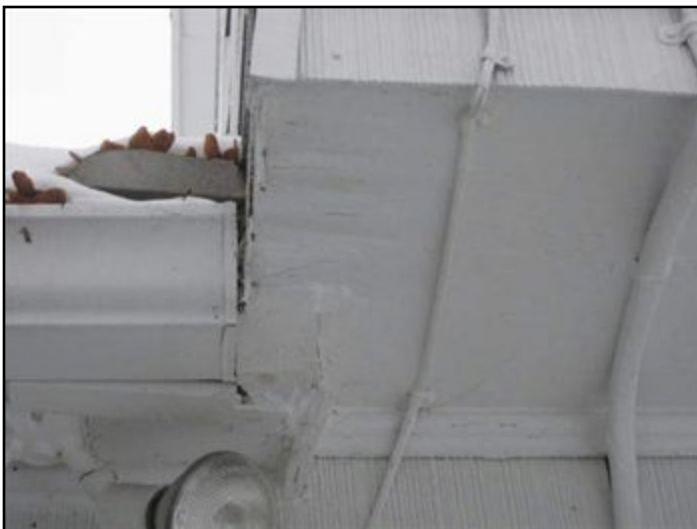
There was ice build-up in the gutters at the time of the inspection. Also, there was some minor water damage to the lower rear soffit adjacent to the garage that was likely a result of ice damming. Improved attic ventilation and insulation will reduce the risk of ice damming. Sometimes, heat tapes are needed to control ice damming.

minor damage to lower rear soffit

**Task:** Improve

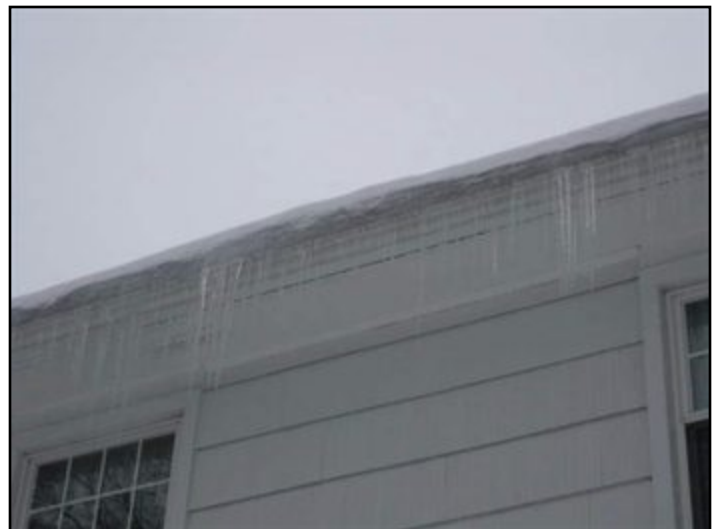
ice buildup in gutters

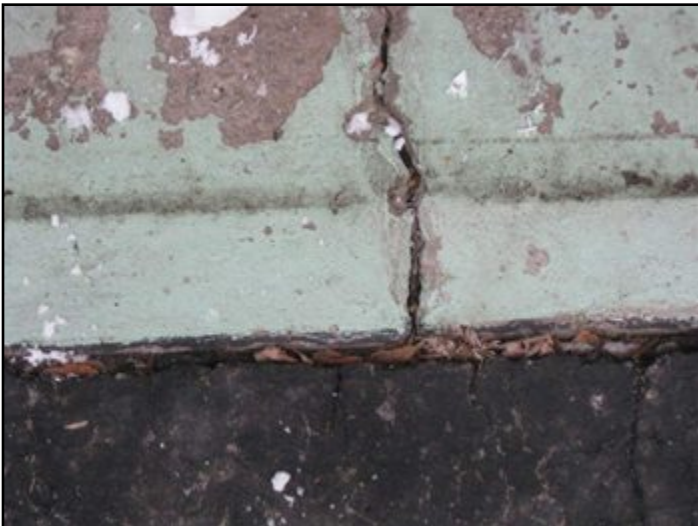
**Condition:** • [Cracked or damaged surfaces](#)

*gap between driveway and garage*

**Task:** Budget for Replacement

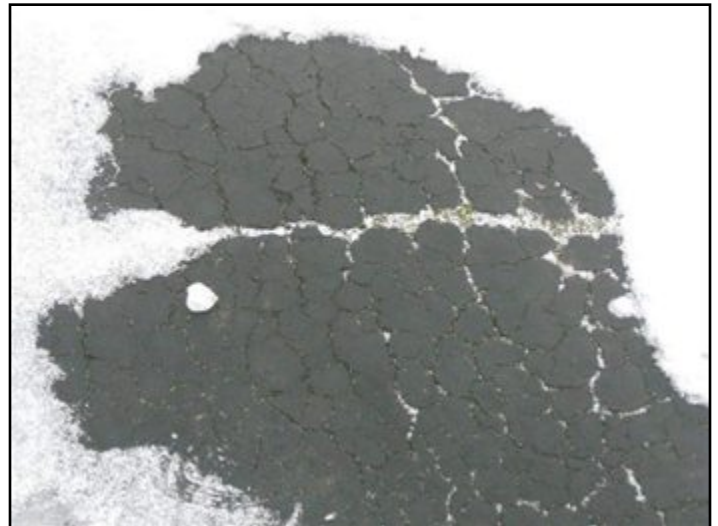
*surface cracking in driveway*

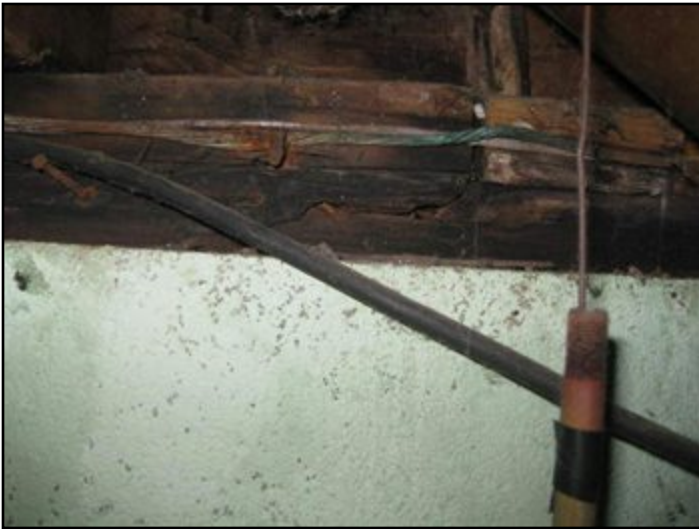
There is a small area of rotted sill plate on the rear basement wall in the laundry area. It is thought that a previous plumbing vent roof leak was the cause. The area was dry at the time of the inspection. Inquire with the sellers for more information.

*rotted sill plate on rear basement wall*

**Task:** Request disclosure

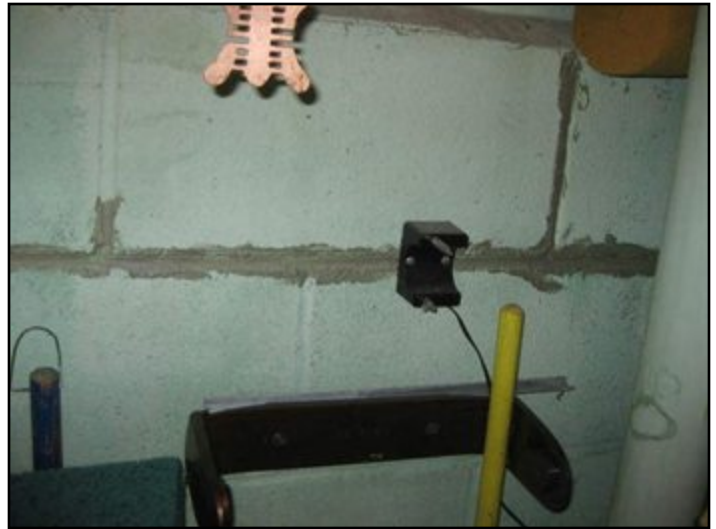
There is a very small horizontal crack in the mortar joint of the rear basement wall. This is likely a clue that the grading is not properly pitched away from the house.

*previous repairs to small crack in rear wall*

**Task:** Further evaluation of grading / Improve as needed

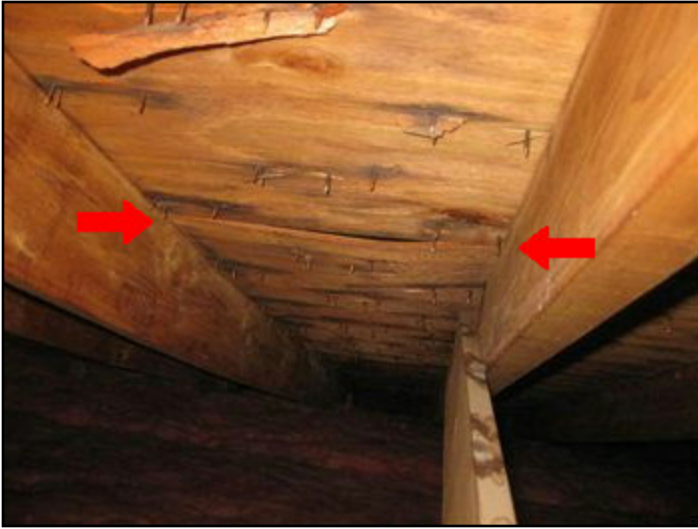
**Condition:** • [Buckled](#)

*buckled plywood sheathing in attic*

**Task:** Replace

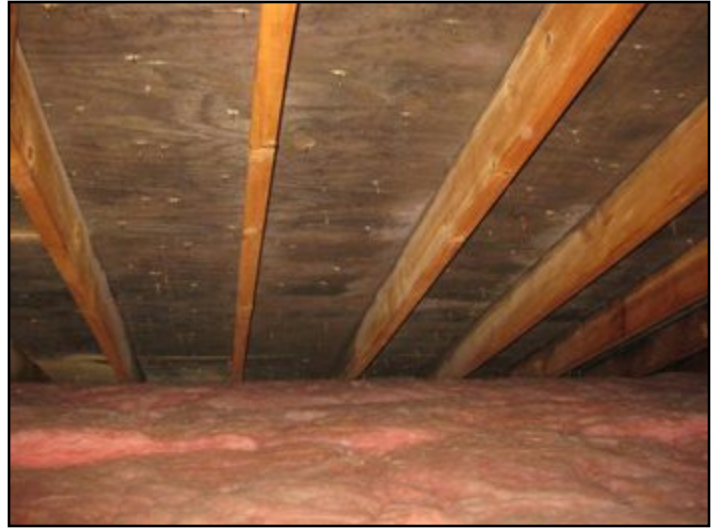
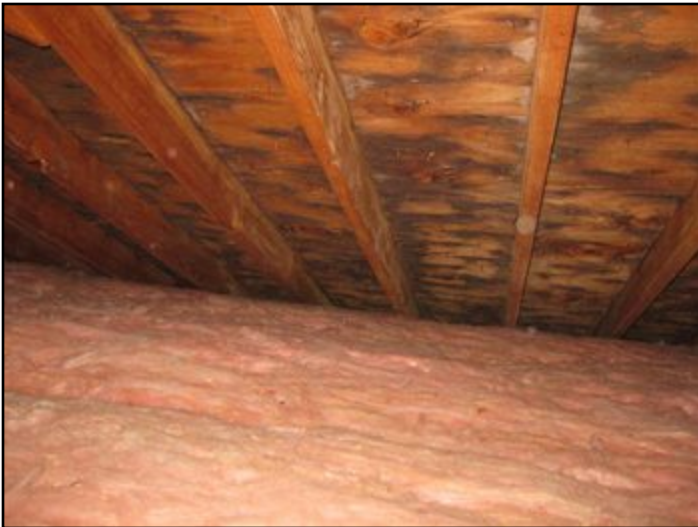
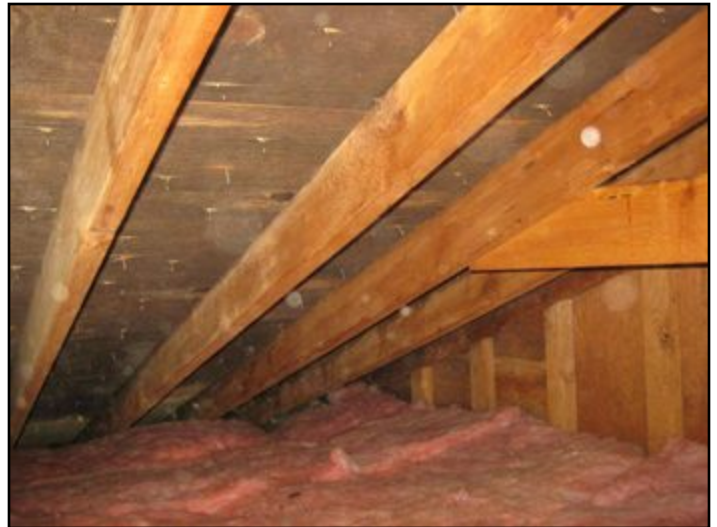
What is believed to be mold/mildew was seen on the roof sheathing in the attic space. Recommend contacting a mold expert prior to closing for further evaluation.

*mold on roof sheathing in attic*

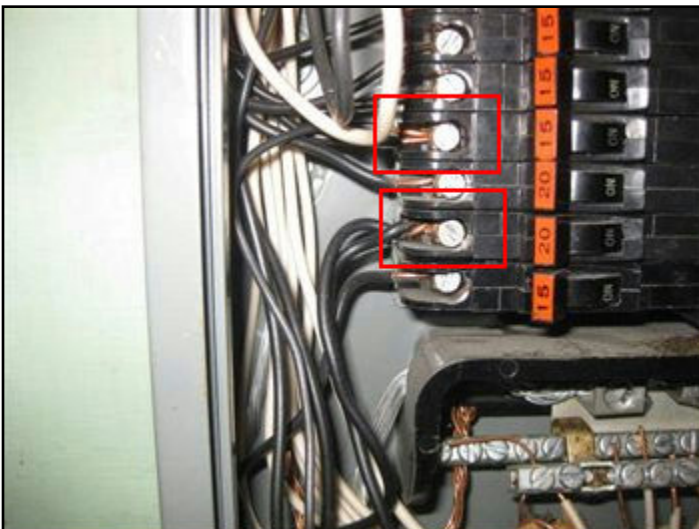
**Condition:** • [Double taps](#)

*double tapped breakers*

**Task:** Repair

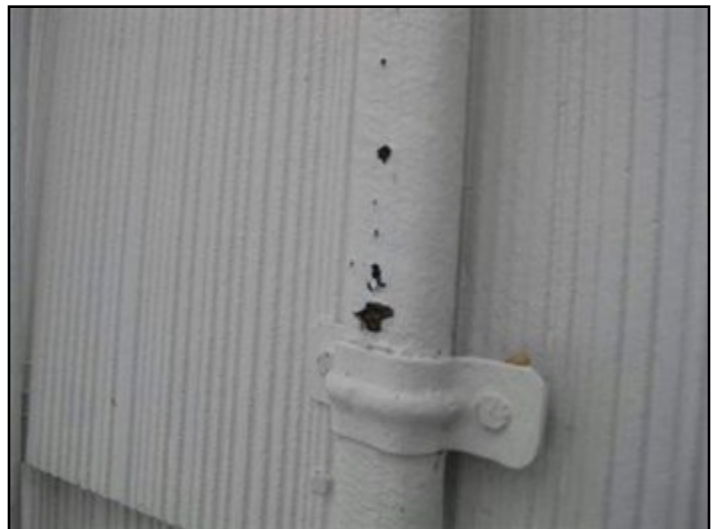
**Condition:** • [Insulation missing or damaged](#)

*damaged insulation on riser cable*

**Task:** Replace

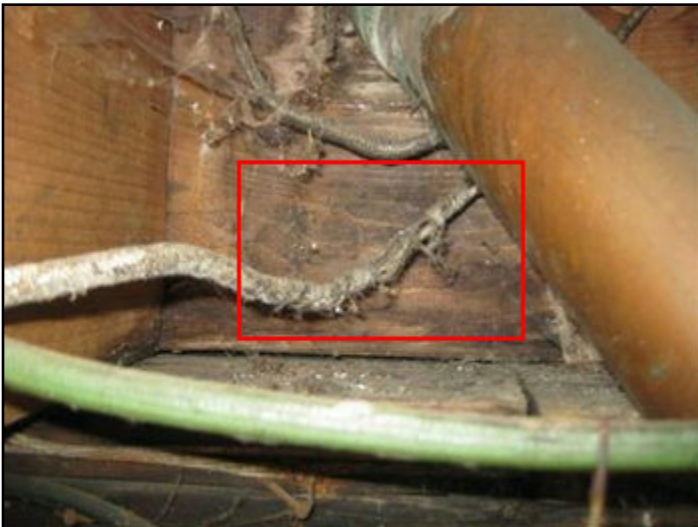
The insulation on a wire in the band joist of the basement laundry area is damaged.

*damaged wire in rear band joist*

**Task:** Repair

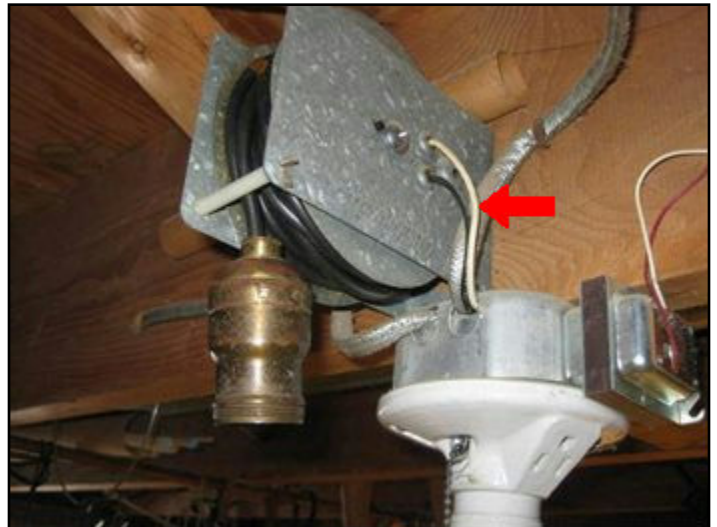
**Condition:** • Inappropriate wiring at light fixture

*inappropriate wiring at light fixture*

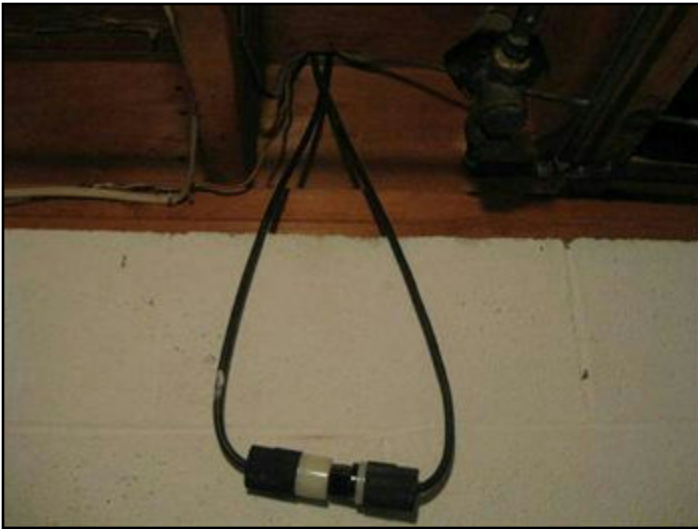
**Condition:** • [Extension cord used as permanent wiring](#)

*extension cord in basement*

**Task:** Repair Further evaluation / Repair as needed

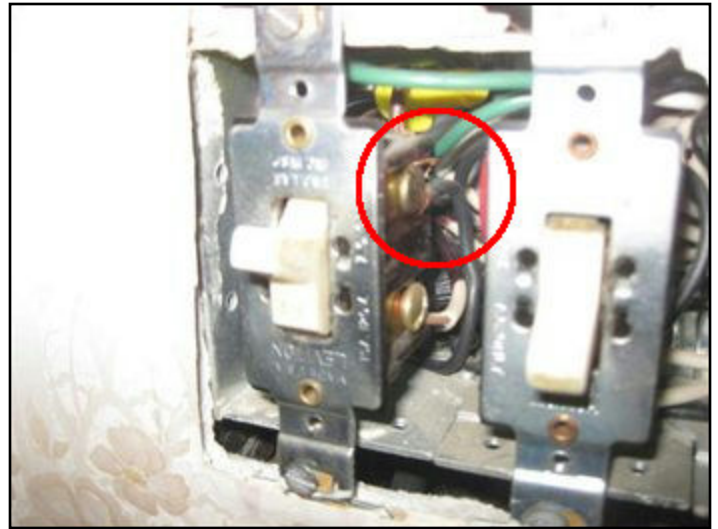
*stranded wire entering switch box from basement*

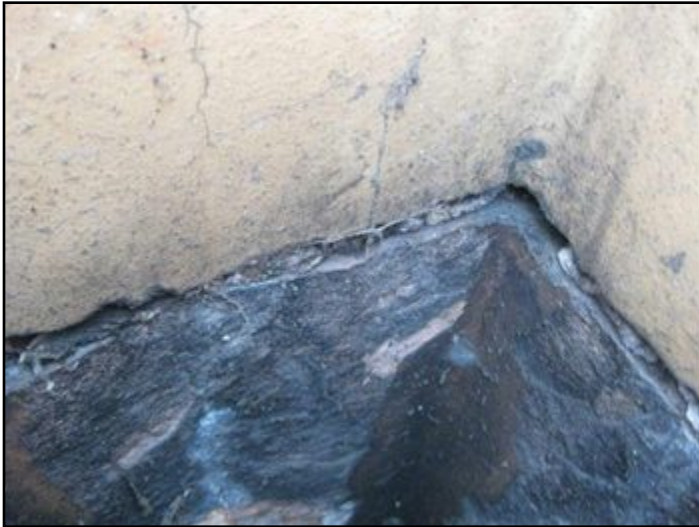
There are deteriorated, spalled flue tiles toward to top of the chimney and voids between tiles. Recommend consulting a chimney expert prior to closing for more information.

*spalled tile, voids between tiles*

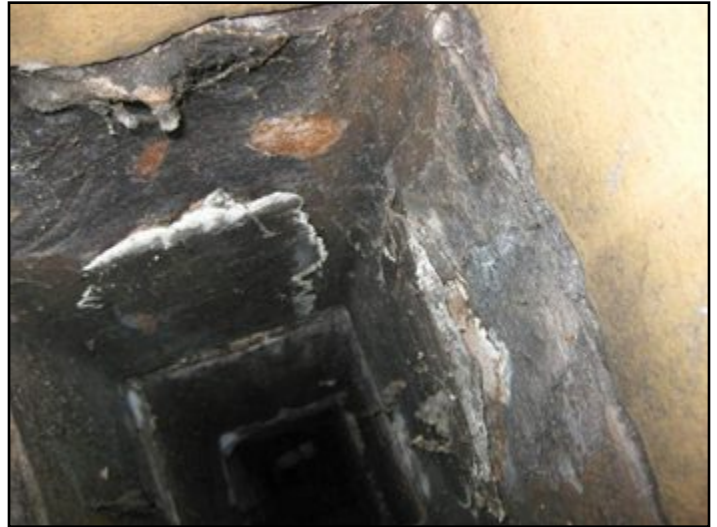
*deteriorated, spalled flue tiles*

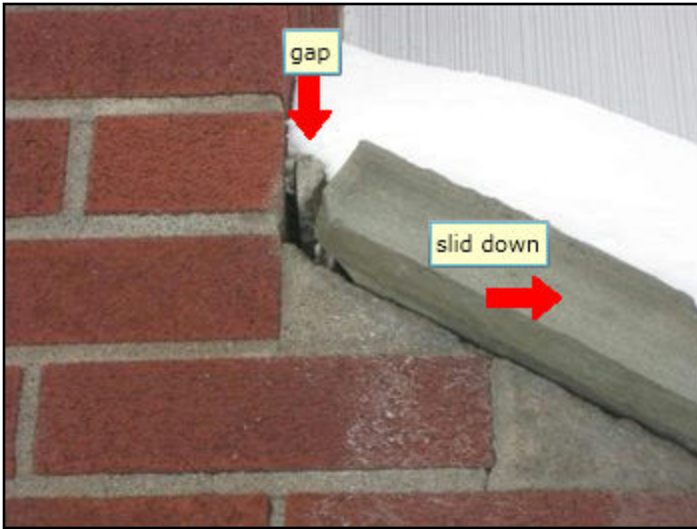
Additional Conditions: Previous repairs, Loose weathering slate

*loose weathering slate*

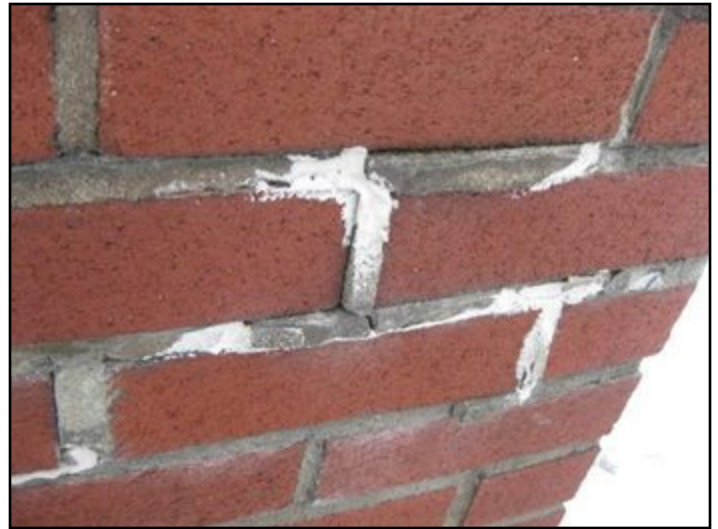
**Condition:** • [Loose, missing or deteriorated mortar](#)

*loose mortar, previous repairs*

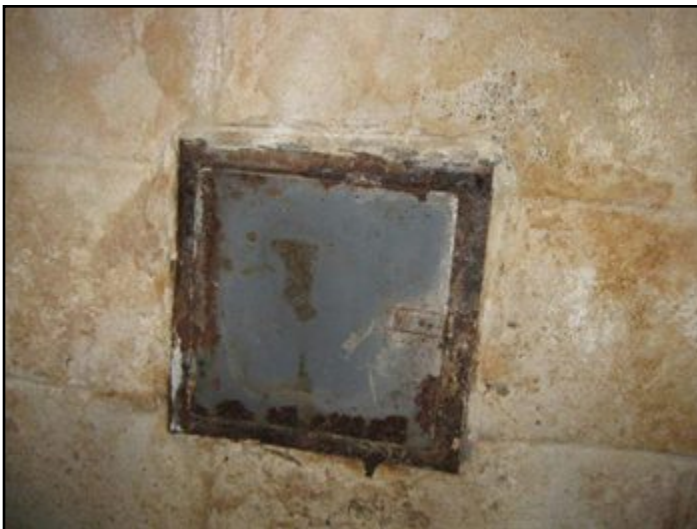
**Condition:** • [Ash pit door problems](#)

*rusted out ash dump door in crawl space*

**Task:** Replace (rusted out)

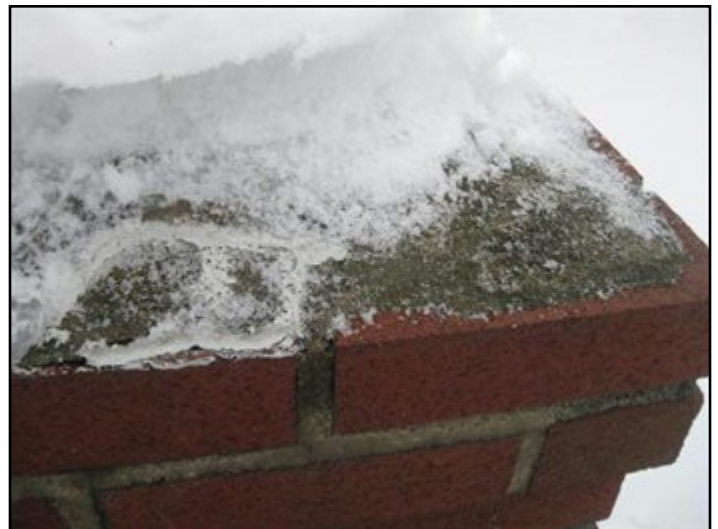
**Condition:** • [No drip edge on cap](#)

The chimney crown was snow covered; however, some previous repairs were noted.

*previous repairs, no drip edge (thin at edge)*

**Task:** Replace

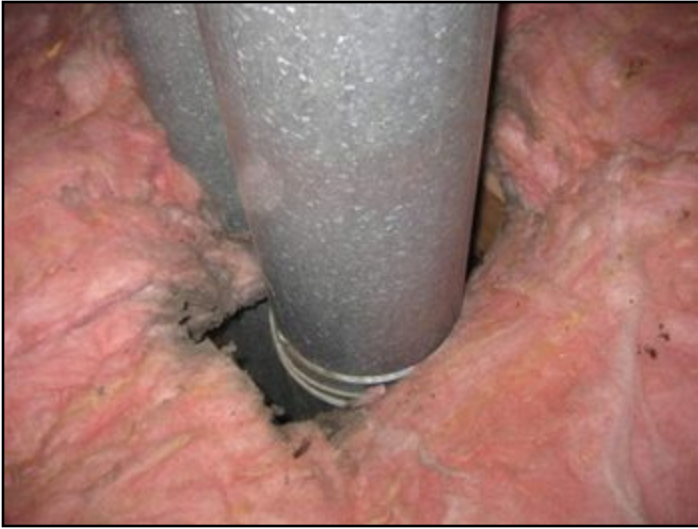
Additional Conditions: Gaps and voids around heating vent pipes

*gaps and voids around heating vent pipes*

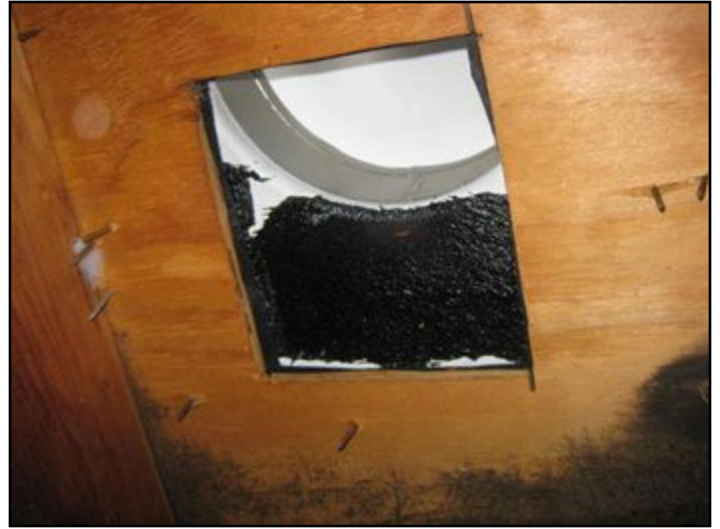
**Condition:** • [Obstructed](#)

*obstructed roof vent*

**Task:** Repair

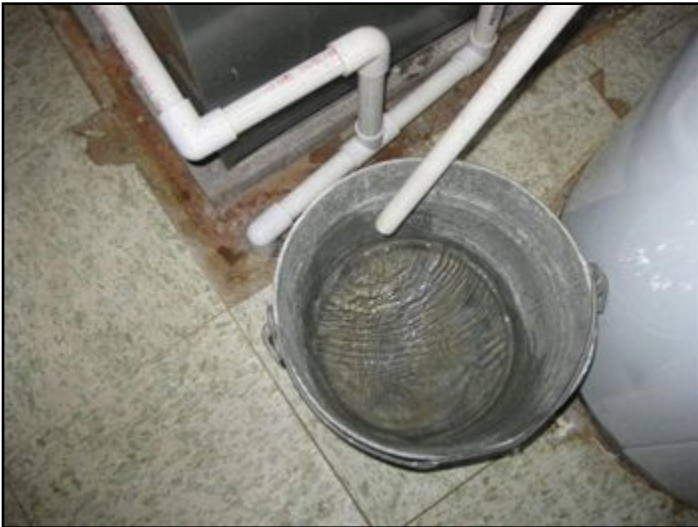
**Condition:** • [Leaking](#)

*bucket of water from PRV*

**Task:** Replace

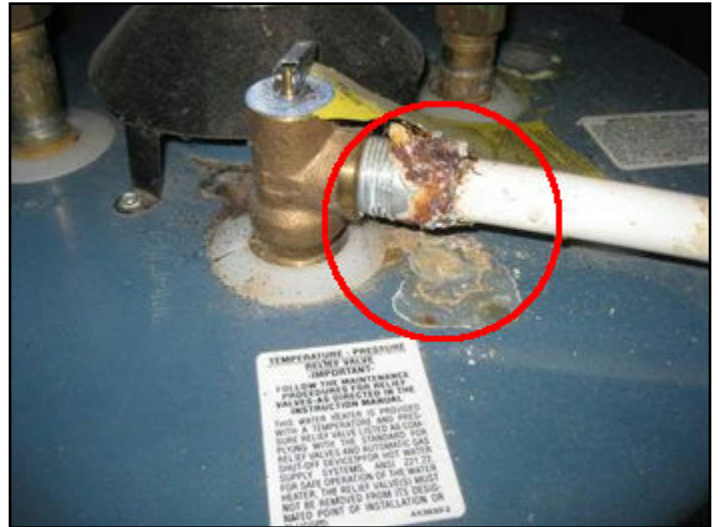
*dripping pressure relief valve (PRV)*

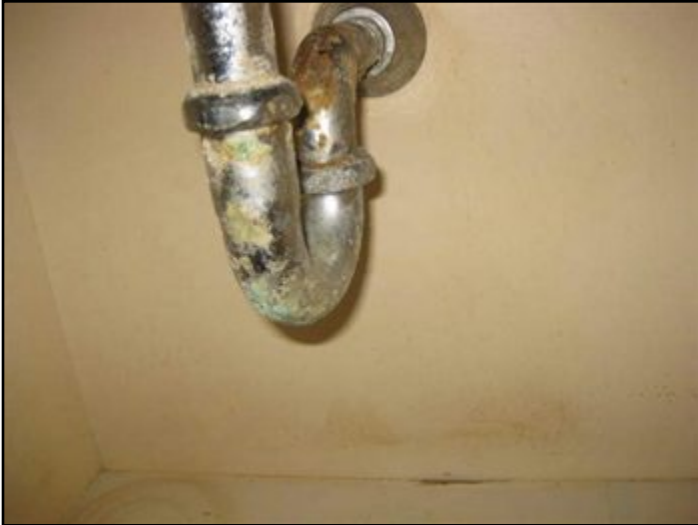
**Condition:** • Corroded

*corroded sink trap*

**Task:** Replace

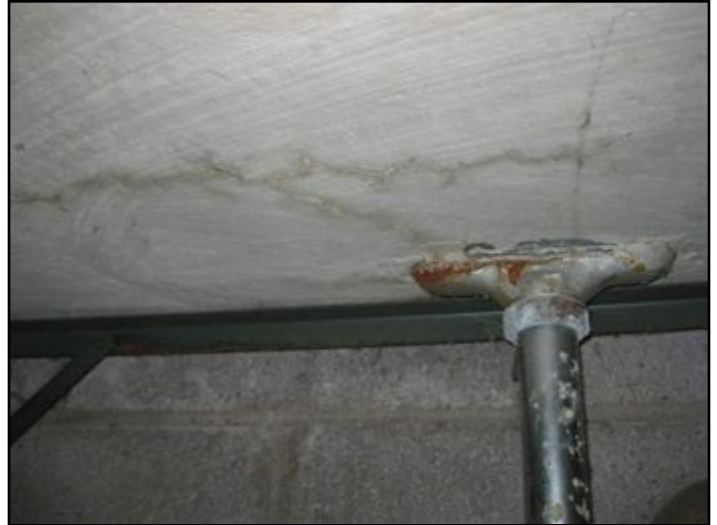
The laundry tub is cracked in several places but not leaking at the time of the inspection.

*cracks in bottom of laundry tub***FIXTURES AND FAUCETS \ Faucet****Condition:** • [Drip, leak](#)

**Location:** Rear Basement Laundry Tub**Task:** Replace**Time:** When necessary**Cost:** Minor

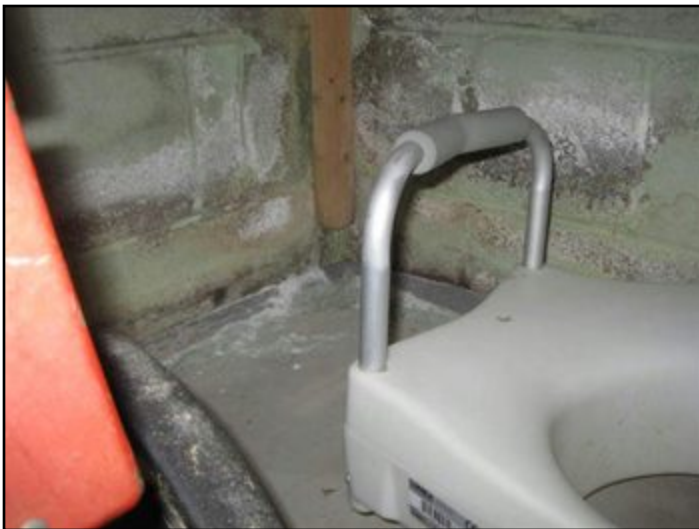
*stains on basement walls*

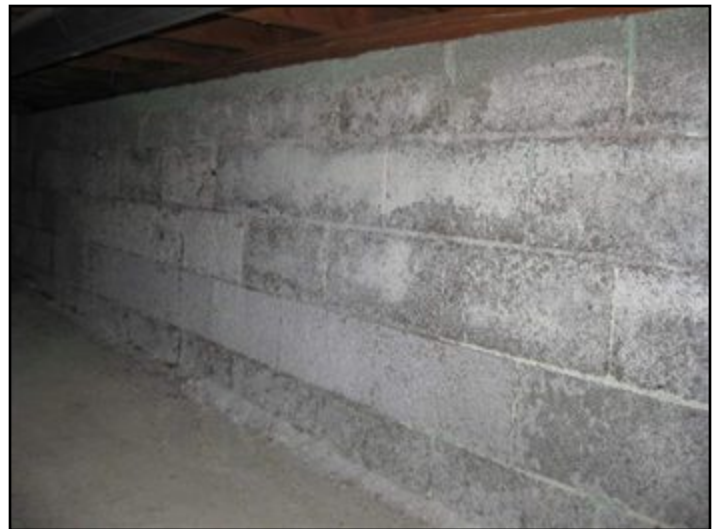
*stains on crawl space walls*
