5ET50 Transmission Part Restriction

Secure Components Properly to Prevent Shipping Damage

The 2016-2017 Volt and Malibu Hybrid use the 5ET50 continuously-variable electric transmission (RPO MKE). As part of GM's process to gather important feedback for engineering improvements, the 5ET50 transmission is currently part of the component restriction program.

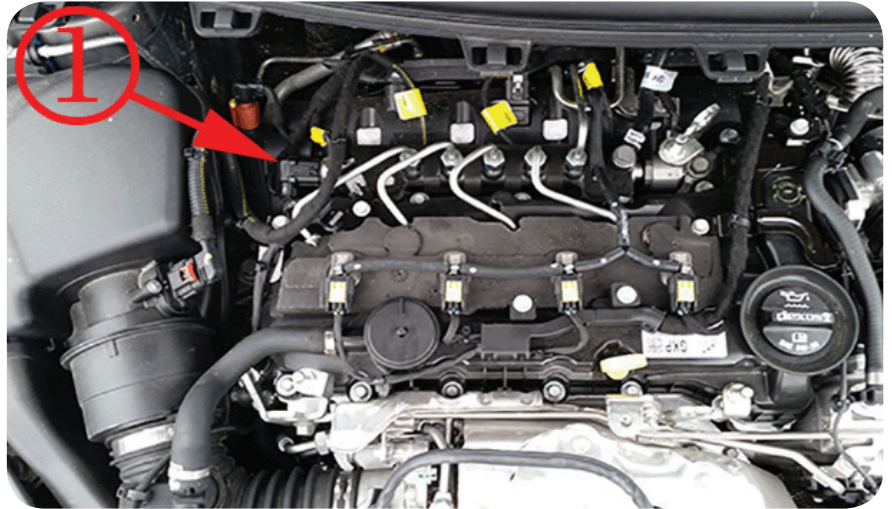
1. Intake manifold runner control valve actuator

Some 2017 Cruze models equipped with the 1.6L turbo diesel engine (RPO LH7) may produce a squeak, chirp or whine sound shortly after the vehicle is turned off. There are several components that may be responsible for these sounds.

The intake manifold runner control valve actuator performs an integrity check to confirm that the mechanical link between the actuator and the intake manifold runner is still connected. This check may be heard cycling under the hood after the engine is turned off.

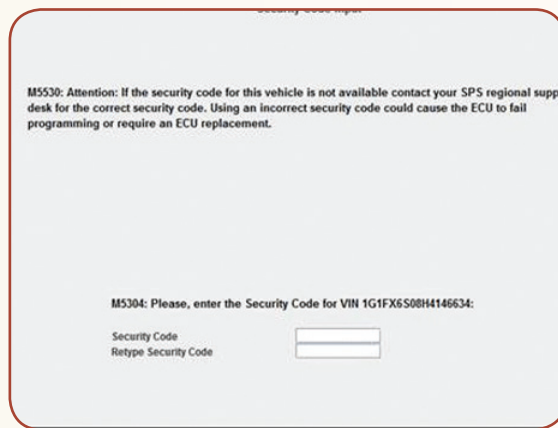
During Service Programming System (SPS) programming on any 2009-2018 Buick, Cadillac, GMC or Chevrolet model, a security code input message with SPS error code E5659, M5304, and/or M5530 may be displayed in TIS2Web. The error codes may appear when programming any module. A related screen will also ask the user to input a security code.

The security code input message and related error codes are flags to identify concerns with released content in the SPS applications. Typically, a security code error message should not appear as the management of security code information is completed prior to release in the SPS application.

Security code input screen with error M5304.

Contact the Techline Customer Support Center (TCSC) for additional information about how to complete the necessary programming procedure.

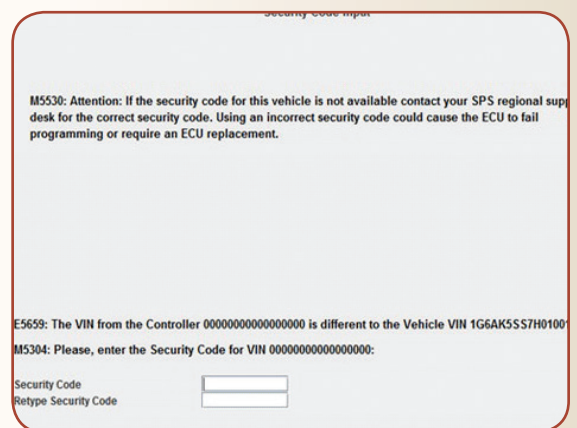
A screen requesting security code input may appear.

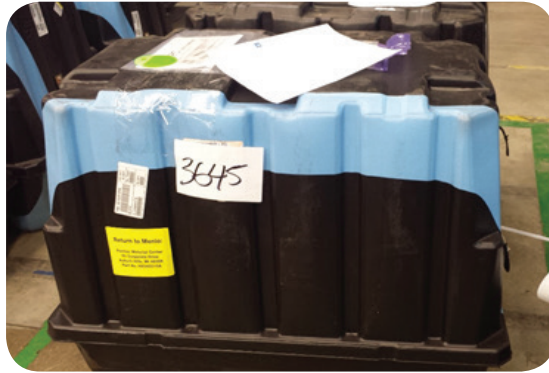
5ET50 cases have a blue stripe

When returning the 5ET50 transmission, it should be shipped back in the same shipping container that the new transmission arrived in. The cases are custom-designed for specific components so it's important to use the correct container.

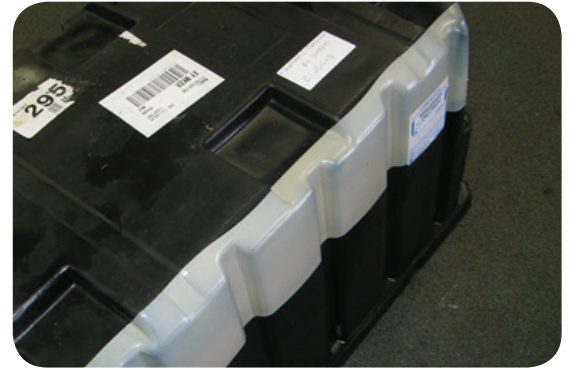
4ET50 cases have a white stripe.

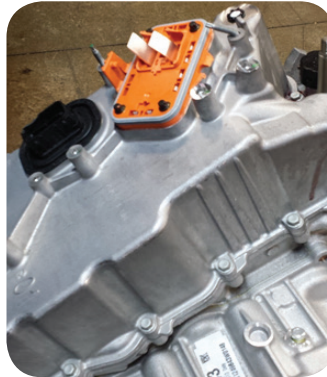
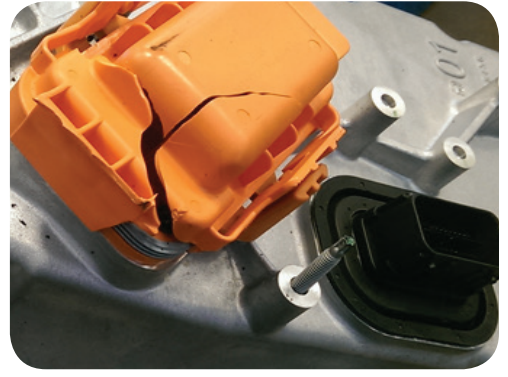
If the transmission is not secured properly in the shipping container, the connectors and other assembly components may be damaged.

Install covers to protect connectors.

Before returning a transmission, ensure that all connectors have protective covers installed to ensure they are protected during shipping.

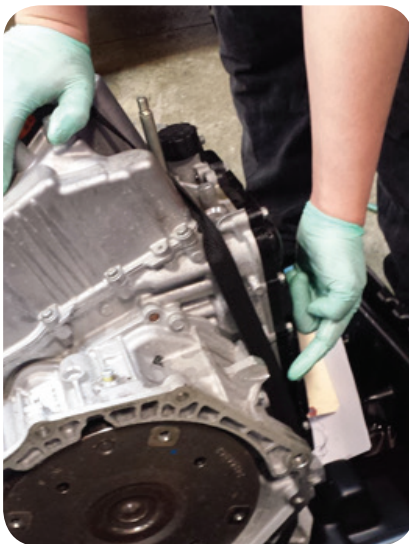
Many returned transmissions have sustained damage during shipping, which hinders the diagnosis that can be performed on the transmission. Damage most often occurs due to the transmission moving in the shipping case.

Place the strap around the side of the bell housing, not over the sharp front edge.

Use the straps in the shipping container to secure the transmission. The straps should be placed over the top of the transmission, around the side of the bell housing.

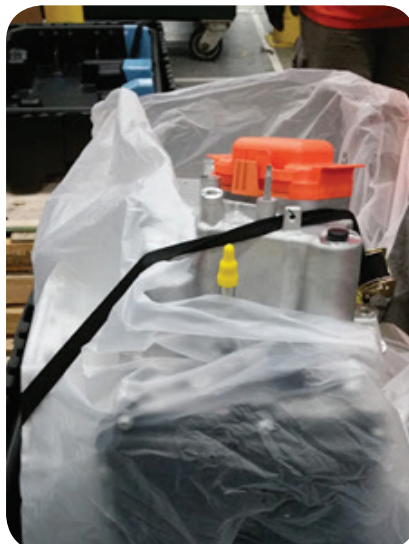
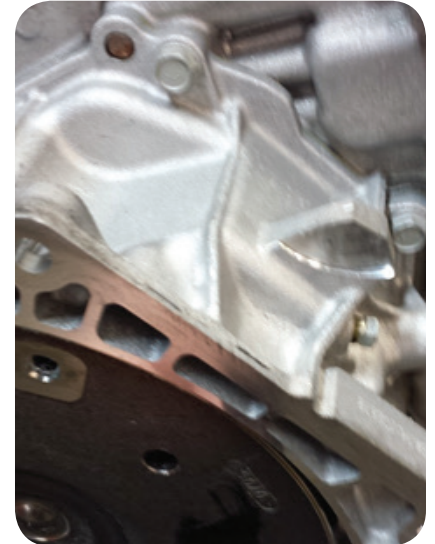
Do not place a strap over the front edge of the bell housing. Routing the strap over the sharp bell housing edge may cause it to be cut and break during shipping.

Do not route the strap over the bell housing edge.

Routing the strap over the sharp bell housing edge may cause it to be cut and break.

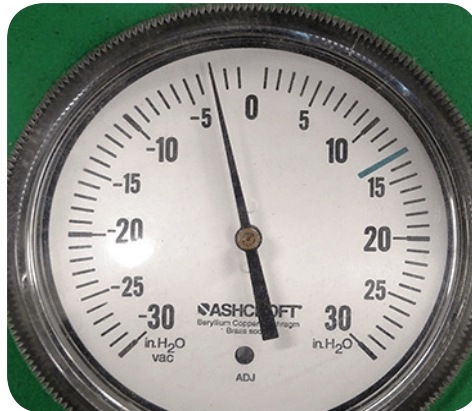
Connect the tester with the engine off, and then start the engine or record the pressure reading. Normal crankcase pressure readings for the 1.4L engine (LE2) and 1.5L engine (LFV, L3A) are between -1 and -5 inches of water in Park at hot idle.

Normal crankcase pressure reading

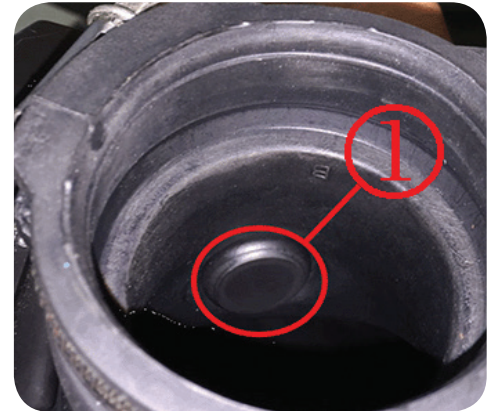
Also inspect the air cleaner outlet duct for a blocked PCV fresh air port. A closed port may cause excessive negative crankcase pressure. If the port is blocked, replace the camshaft cover assembly and retest for proper crankcase pressure.

Blocked PCV fresh air port

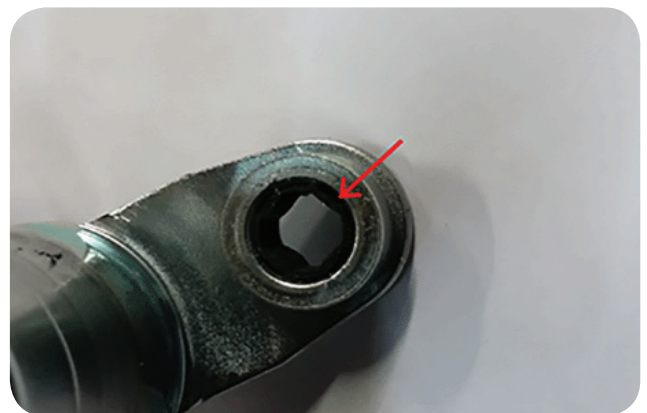
Black plastic bolt retainer in the solenoid hold down ear

If during normal diagnosis for any camshaft oil control actuator solenoid conditions or when replacing the solenoid, it's recommended to remove the black plastic bolt retainer from the solenoid bolt. Push out the black plastic bolt retainer from the top of the solenoid hold down ear and discard it.

Be sure to fully seat the solenoid to the engine before tightening the bolt to the specified torque.

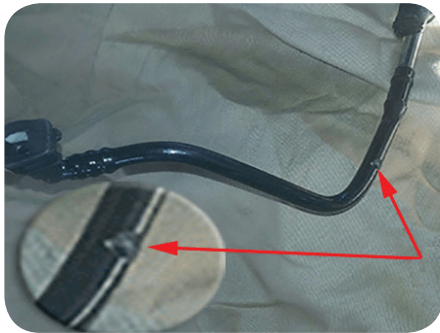
Some 2016-2017 Volt models built prior to October 3, 2016 that are equipped with the 1.5L engine (RPO L3A) may have an illuminated Check Engine light and Diagnostic Trouble Code (DTC) P0442 (EVAP System Small Leak Detected) may be set.

If these conditions are found, inspect the evaporative emissions purge solenoid pipe for damage from contacting the A/C evaporator core hose.

Damaged evaporative emissions purge solenoid pipe

If there is damage to the evaporative emissions purge solenoid pipe, replace the pipe. Position the new pipe to avoid contact with the A/C evaporator core hose.

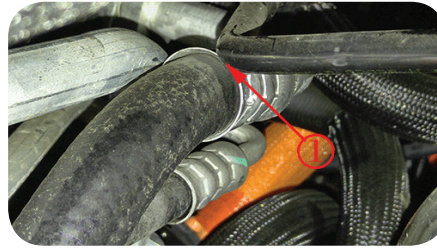
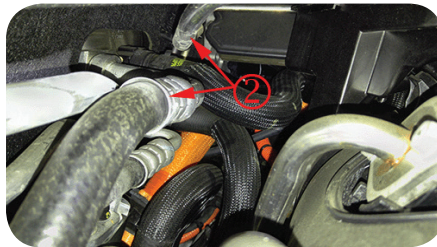
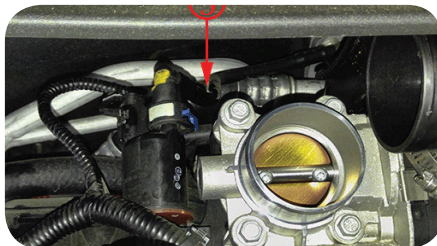
Check the evaporative emissions purge solenoid pipe for contact with the A/C evaporator core hose.
