ATRA WEBINAR

6L50-6L80-6L90 Updates and Product Issues

**Presented by:
Steve Garrett
ATRA Presenter**

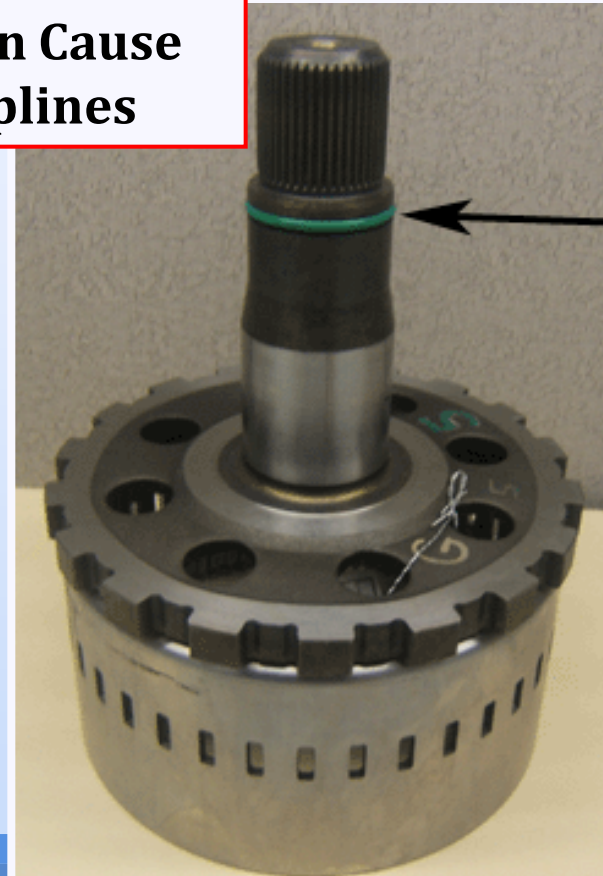
Grinding Noise, No FWD, No REV

The splines of the transmission output shaft or transfer case input shaft may be worn (rusted) or the shaft may have broke. The splines of the transmission output shaft have been updated with a groove for a O-Ring to help maintain the grease located between the transfer case input shaft and the transmission output shaft. Updated shafts require that “both the output shaft and input shaft be replaced as a set”.

**Most Common Cause
Is Rusted Splines**

Note:
If the splines of the
output shaft look ok,
use 2 o-rings GM#
24251228 along with
high temperature wheel
bearing grease during
assembly.

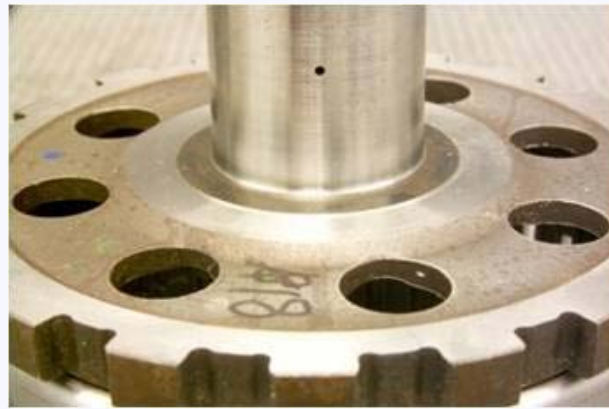
Small Fillet

There were two other updates also made to the transmission output shaft. The hardening process was extended into the fillet radius (where output shaft usually breaks) and the design of the fillet changed to reduce the stress on that area of the shaft.

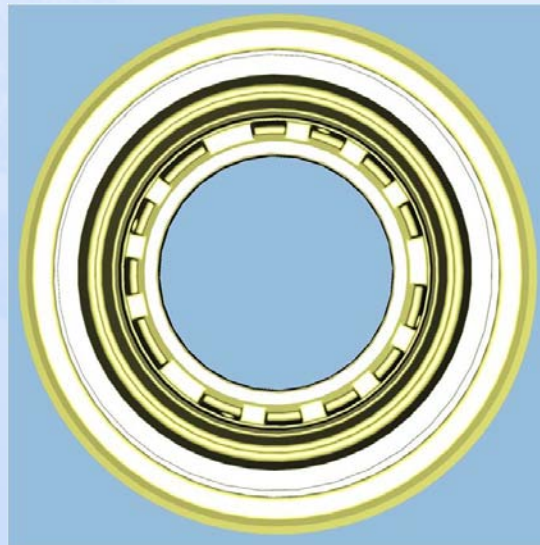
1-2-3-4 Slip Condition, Possible No movement Forward

CONCERN: 6L80/6L90 (RPO MYC, MYD) applications built before June of 2010 may exhibit a slip condition related to the operation of the 1-2-3-4 clutch. This condition may be present in more than one forward gear or if the condition is bad enough, it may result in a no movement forward condition.

CAUSE: The 1-2-3-4 piston may be broken or cracked

CORRECTION: Replace the piston with the new design, The updated piston has 22% more rib area when compared to the previous design piston. The updated piston is sold under part number 24258159

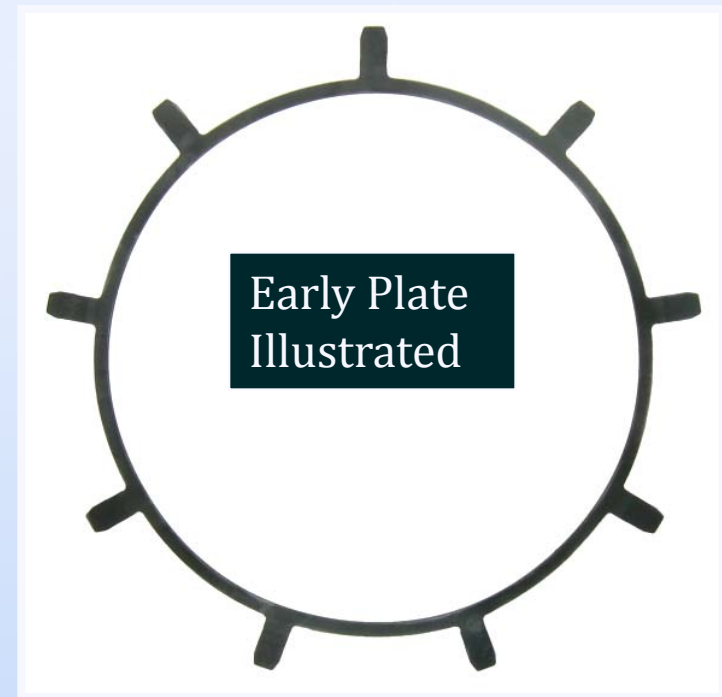
No Forward Movement

1-2-3-4/3-5-R Clutch Housing was updated mid 2007 to address a NO FORWARD condition. The root cause is the snap ring popping out of the housing. The housing has been updated to prevent this. Additionally the 3-5-R waved plate was updated from 12 to 18 teeth and the 1-2-3-4 wave plate was updated from 9 to 18 teeth.

- 24239828 – 3-5-R 18 tooth wave plate
- 24239615 – 1-2-3-4 18 tooth wave plate
- 24240194
- 24240201 – Selective Snap Rings
- 24241232 – Clutch housing Kit
(Includes Housing and Snap Rings)

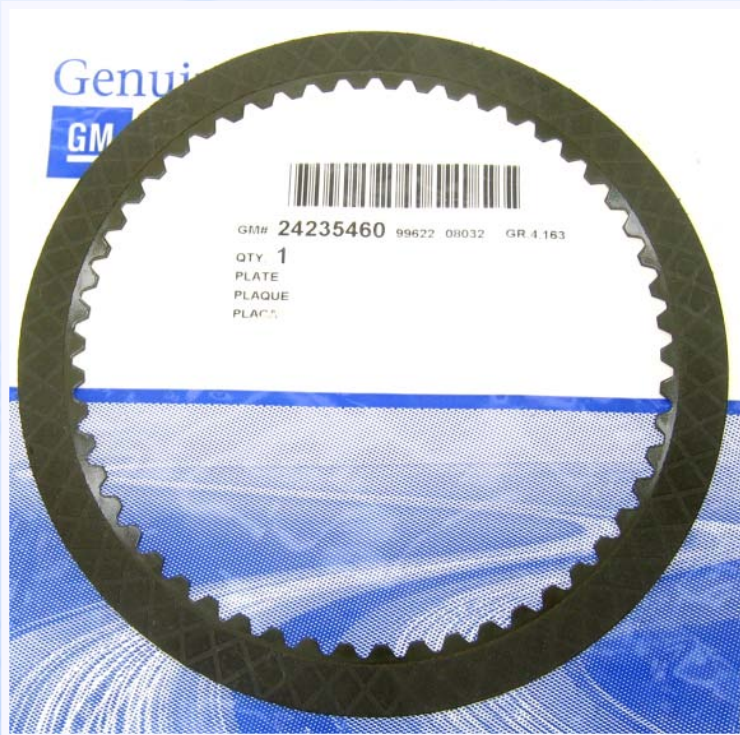
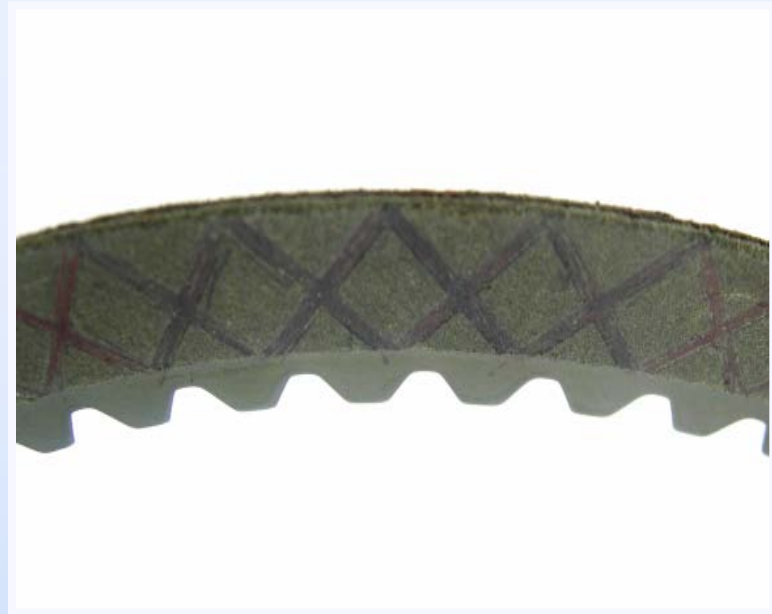
Clutch Shudder Condition

Low/Reverse Clutch Plates – Friction update was done to improve the Low/Reverse clutch apply (Shudder Complaint). Along with the frictions, a calibration update is needed when back servicing units

- 24235460 – Clutch Plate

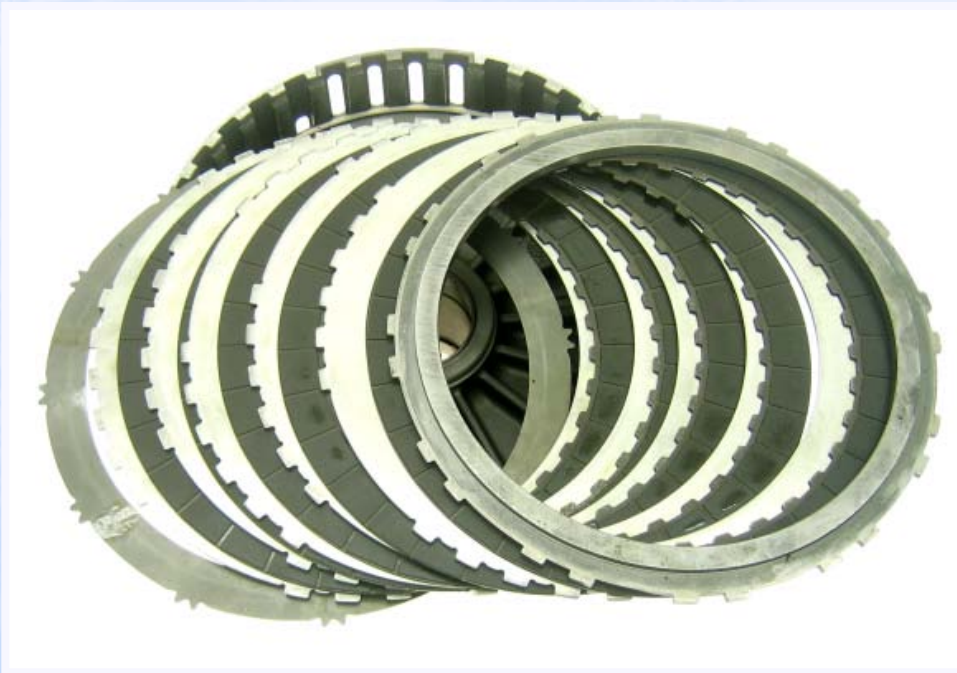
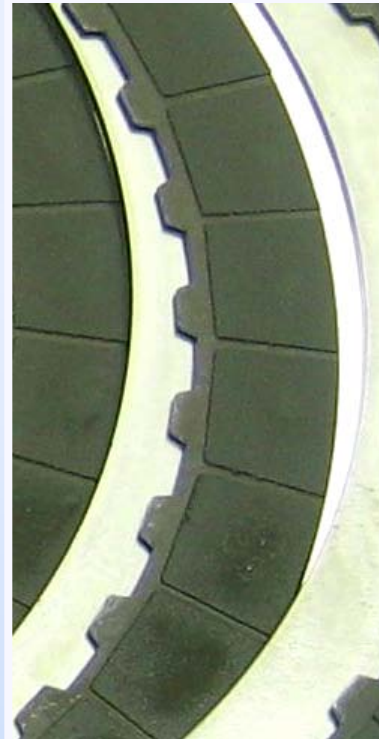
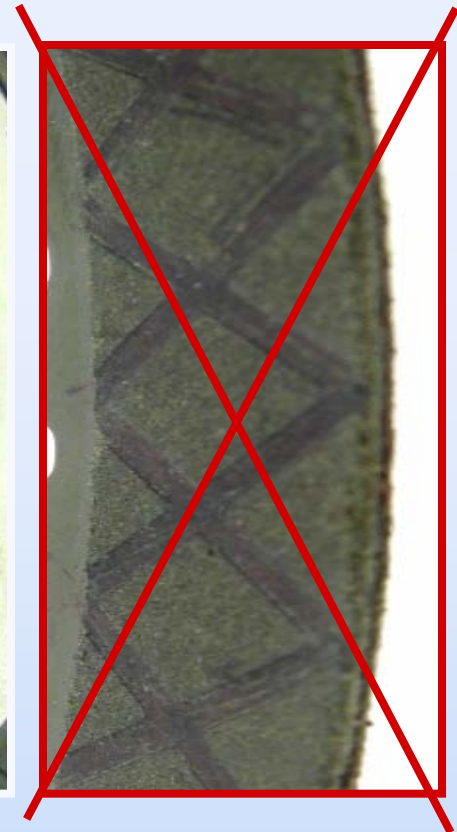
Ticking and/or Rattling Noise

2-6 Clutch Friction Material – Friction design was changed from the X pattern to a radial groove to prevent the plates from rattling.

- 24240221 – Clutch Plate

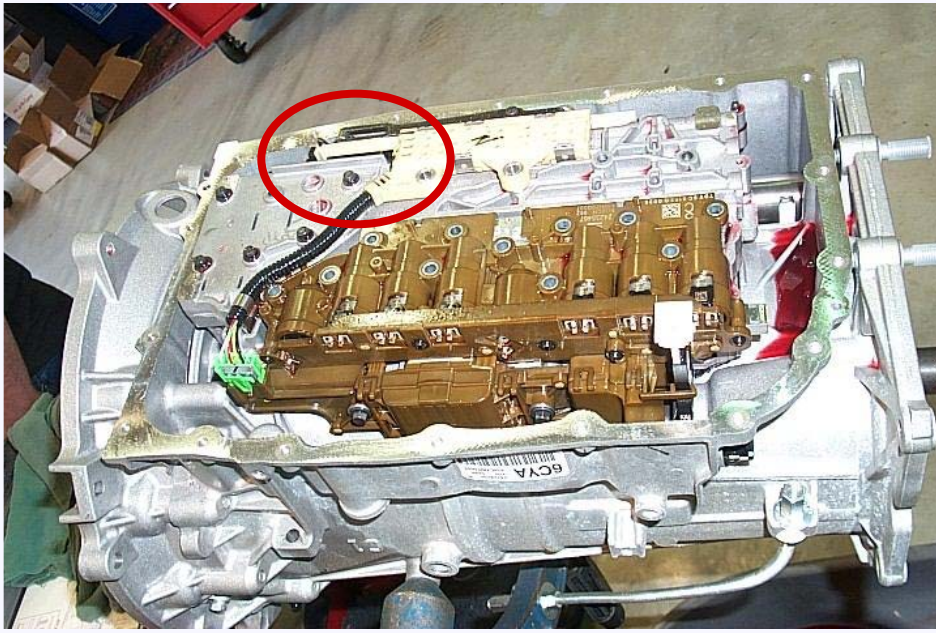
DTC P1875

IMS Out of Range – IMS mid 2007, interim 2007 update. Oxidation was forming on the contacts leading to contact resistance. The updated IMS added additional nickel plating to the contacts and changed the lead frame to stainless steel to reduce the contact resistance.

- 24246427- IMS

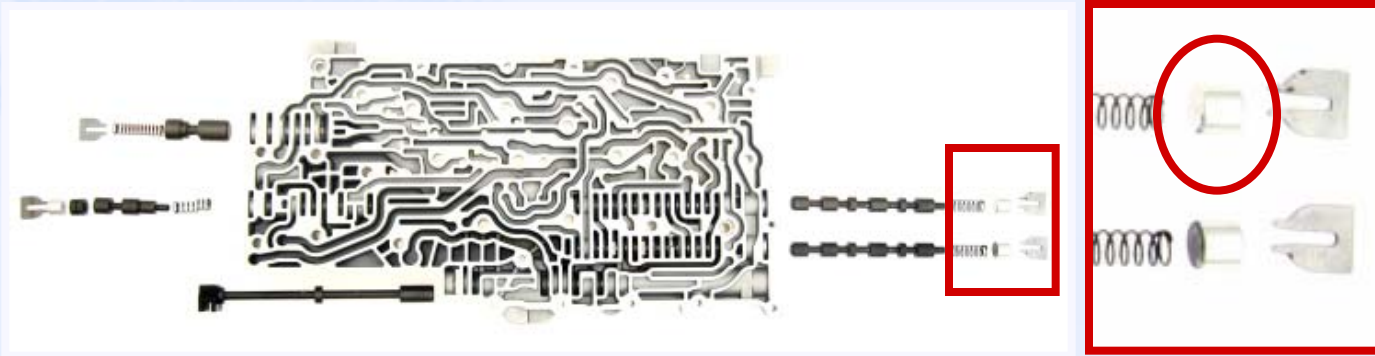
Clutch Select #2 Bore plug must be 11.502mm (0.453") +/- .004mm (0.002")

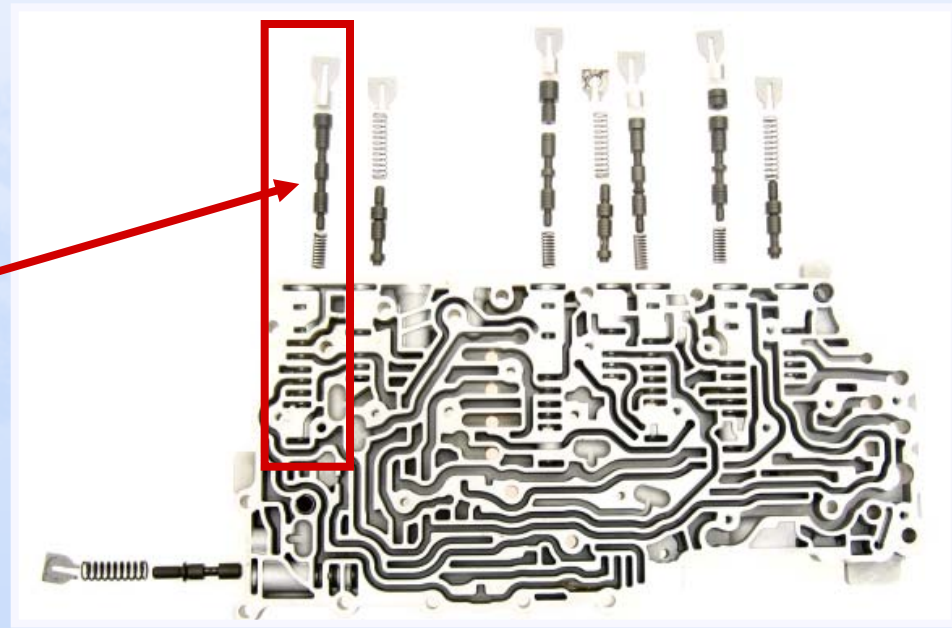
CBR1/C456 Regulator Valve (Sticking/Dragging)

Several Causes for P0751

- Debris in pan
- Cracks in filter
- Debris in Separator plate as well as check ball problems
- Clutch Select valve #2 bore plug improper size
- CBR1/C456 regulator valve sticking
- Calibration updates
- Updated Separator Plate and Valve Body Springs (previously covered)

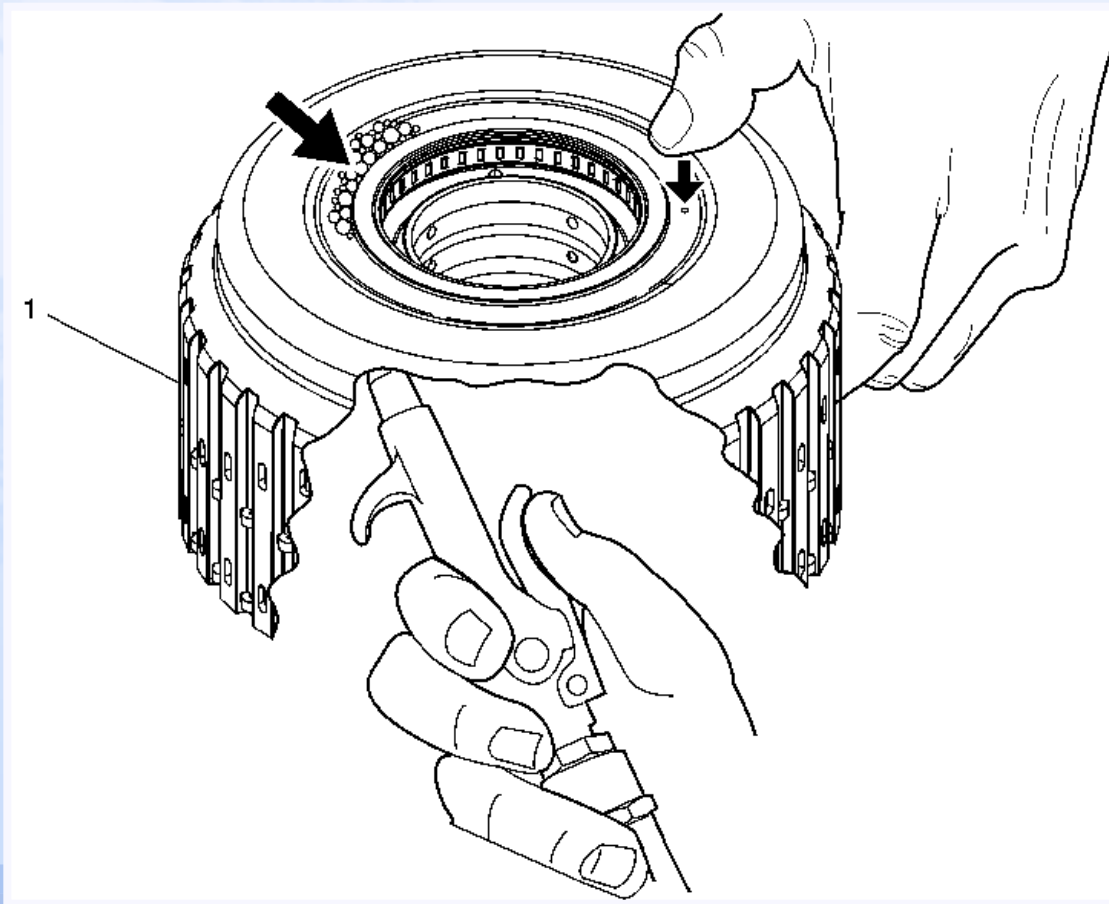
No or Slipping 3rd, 5th, and Reverse Flair on the 2-3 Shift

Common Problem areas for these concerns:

- 3-5 Regulator Valve Sticking. (Upper Valve Body)
- Leak in the 3-5-Rev Drum (air test using soapy water)

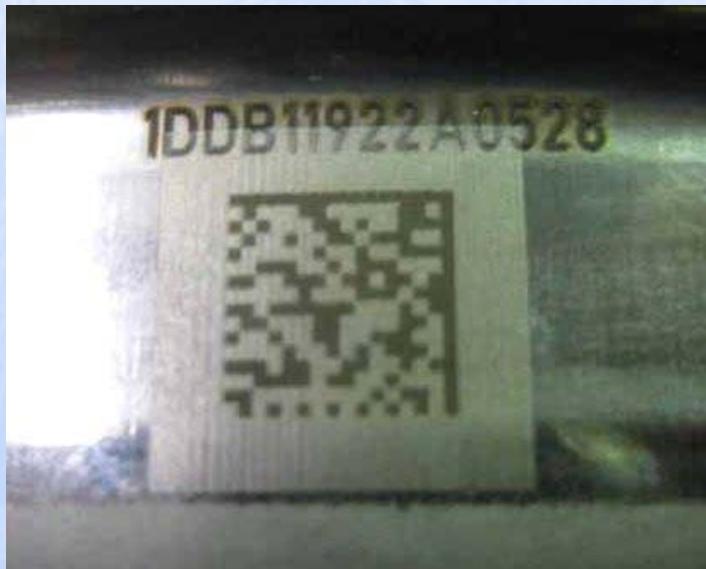
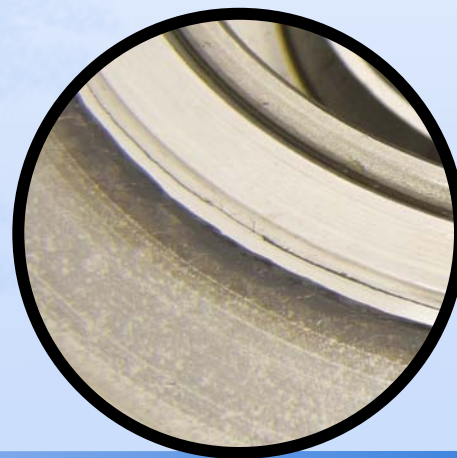
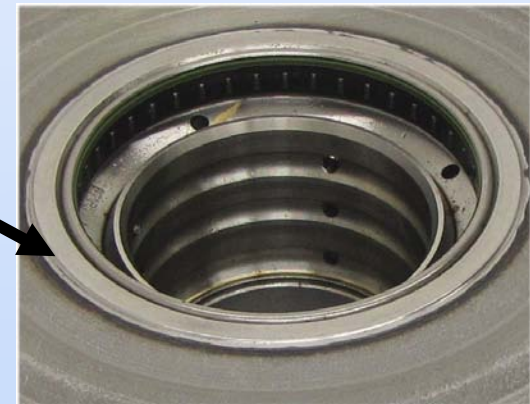
Slips in Reverse, 3rd, 5th P0776 Possibly Set, Cracked Drum

6L80 (RPO MYC) and 6L90 (RPO MYD) transmissions equipped in the GM C/K full size trucks and SUV's, Cadillac D body (STS-V) and the Cadillac/Chevrolet Y body (XLR, Corvette) may experience any or all of the following complaints.

- Slips in Reverse
- Slips in 3rd
- Slips in 5th
- Delayed Reverse Engagement
- Intermittent Hard Shifts into 3rd and/or 5th
- Problems change severity with transmission temp change
- P0776 DTC may set

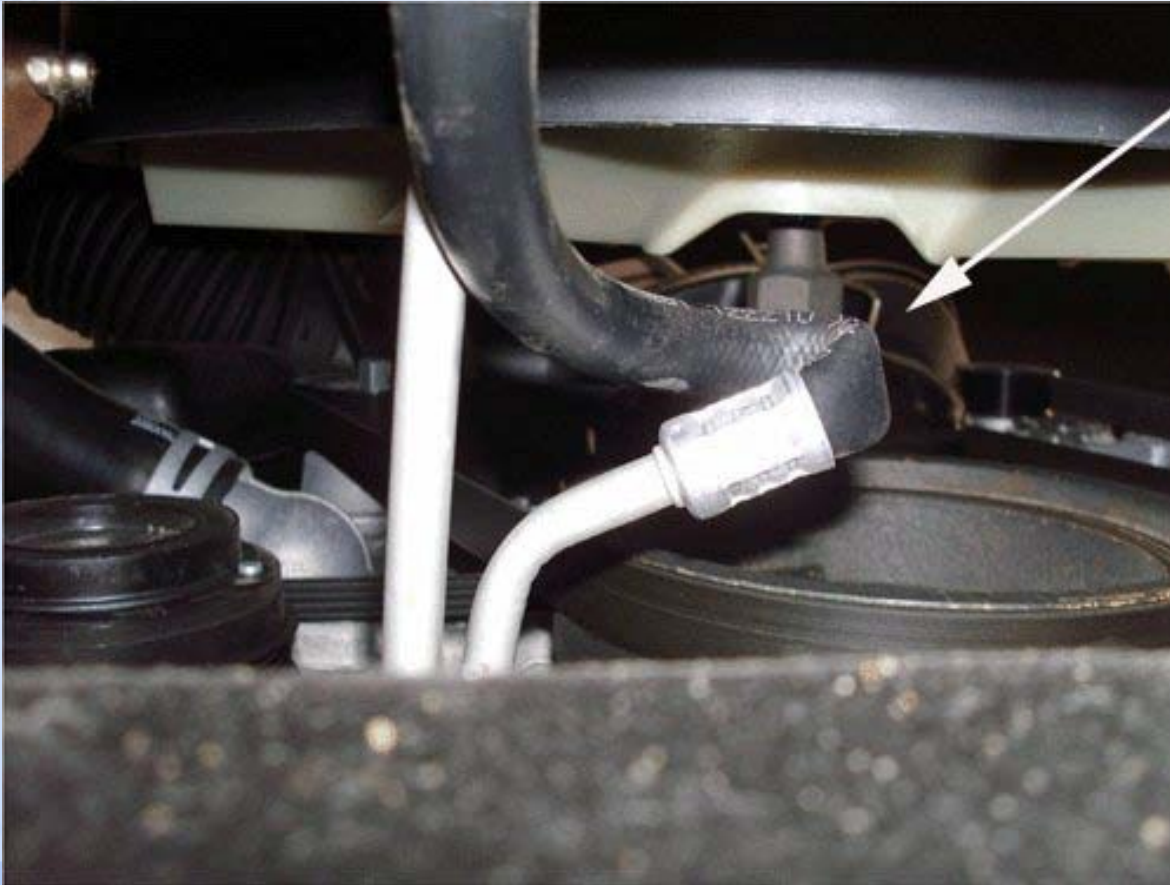
C/K Full Size
Trucks With
6L80 Or
6L90

Transmission Overtemp Indicated. Possible DTC set

Inspect the cooler lines for a restriction. In many instances, the cooler lines are kinked close to the radiator leading to the restriction. If the fluid appears to be distressed you may need to repair damage that may have occurred to the transmission. If the cooler lines are kinked try to straighten them. If the lines have been operating with a kink in them for some time, you may find it necessary to replace them as the restriction from the kink may cause the restriction to “take a set” in the line.

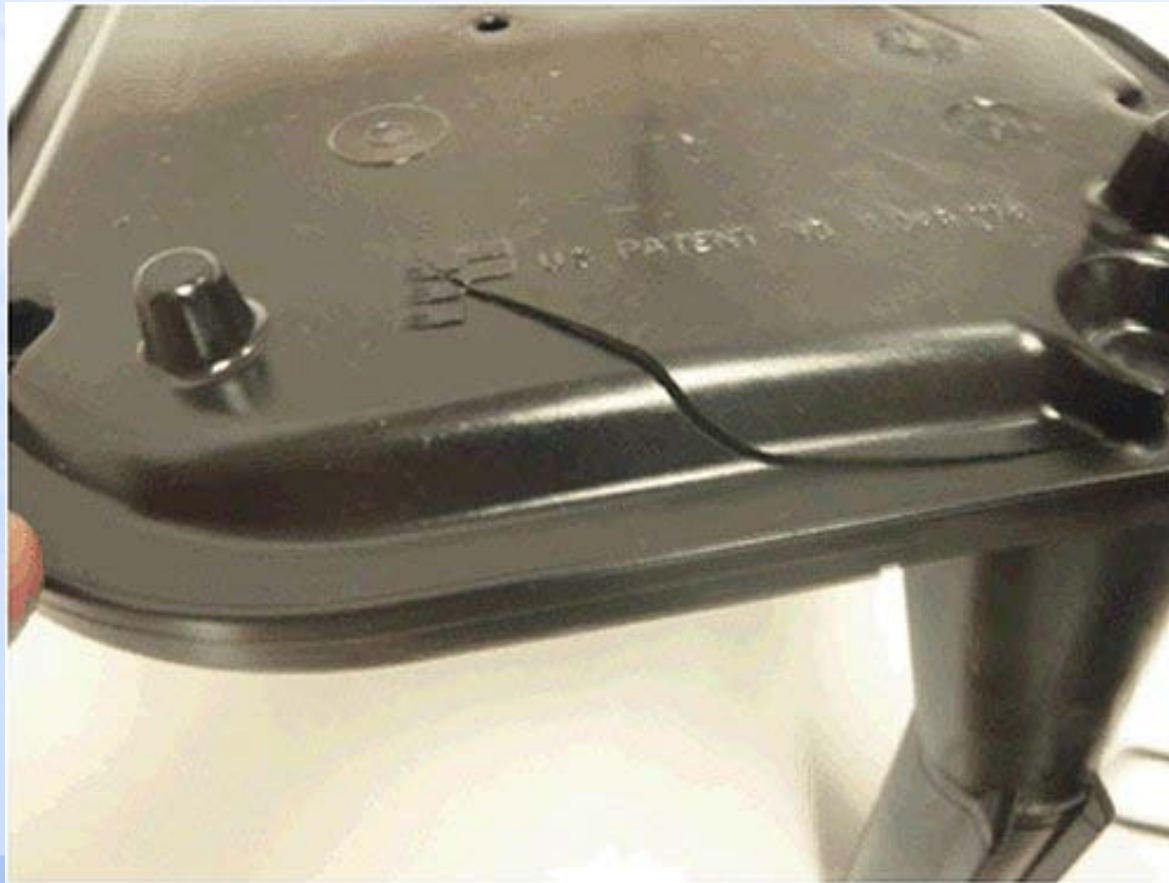
Slipping, No Forward or Reverse

The filter may have developed a crack leading to air ingestion in the hydraulic circuits. This condition has been found on the OE as well as some aftermarket filter designs. Closely inspect the filter for cracks and separation in the seam area of the filter. Upon inspection of the filter, if a crack or damage is found, you may need to disassemble the pump and inspect it for damage. Replace the filter and any damaged pump components.

Some 6L80
(C/K/G
Trucks/Vans, Y,
F and D cars
(RPO MYC)) and
6L90 (C/K/G
Truck/ Vans
(RPO MYD)
transmissions
