ACCIDENT INVESTIGATION REPORT

**Collision Accident near
Moorabbin, Victoria
Beech D50B Aircraft VH-RCN
and
Bell 47G-3B-2 Helicopter VH-BLM
19 October 1970**

Prepared by:
Air Safety Investigation Branch Melbourne

April, 1972

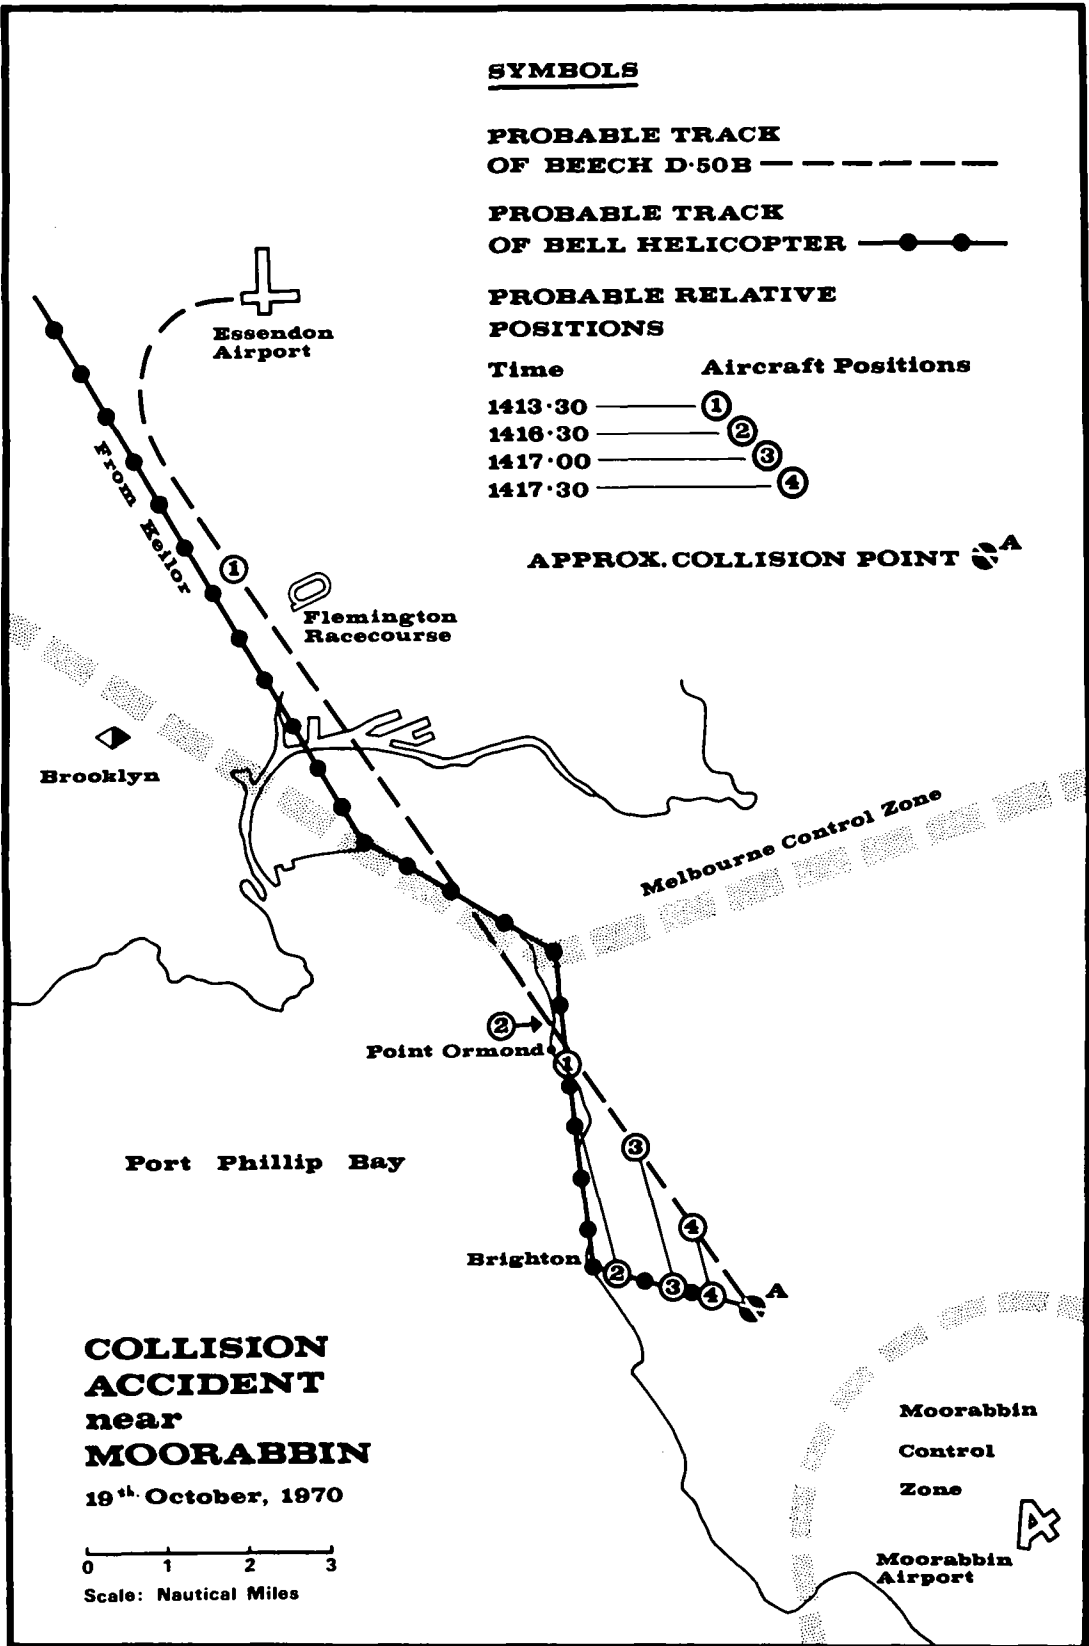
COLLISION ACCIDENT near MOORABBIN

At approximately 1418 hours the two aircraft were observed by witnesses on the ground to be on flight paths which converged at an angle of some 40 degrees, with the Beech aircraft overtaking and on the left of the helicopter. Following the collision of the two aircraft, numerous pieces of wreckage from each fell onto buildings and properties in the area. The main wreckage of the helicopter crashed inverted on to a dividing fence between two houses in the Melbourne suburb of Moorabbin and the Beech aircraft, which had lost a major portion of the starboard mainplane in the

4. The aircraft collided at a position approximately 4.3 miles on a bearing of 295 degrees magnetic from the reference point of Moorabbin Airport. The collision point is not within the boundaries of a controlled airspace.

7. The Beech aircraft, VH-RCN, was the overtaking aircraft. The collision occurred when the flight paths of the two aircraft converged, the helicopter being ahead and to the right of the Beech aircraft.
