Technical Service Bulletin

91 MIB2 High Navigation Software Update Instructions (PR Code 7UG)

91 19 98 2047576/3 October 4, 2019. Supersedes Technical Service Bulletin Group 91 number 18-89 dated April 23, 2018 for reasons listed below.

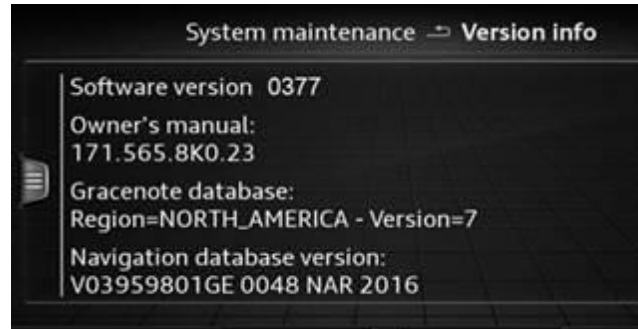
1. To save time, always verify the customer's MMI requires the software update before proceeding. In the MMI, go to *Menu >> Settings >> Left drawer option >> Version Information* (Figure 1). This applies to models using the new MIB2 user interface. The C7 PA uses the old user interface similar to MMI3G+ along with the newer MIB2 hardware. The software version for the older user interface is found under *Menu >> Setup MMI >> Version Information*.

Figure 1. MIB2 Software Version in MMI with a new UI.
