<b>Release Date</b>	05/28/2020	<b>Technical Service Bulletin</b>	
<b>91X4 UPDATE</b>

<b>Audi</b>
<b>MMI Software Update – (NVLW)</b>

This Update has been proactively released to prevent the following condition(s) from occurring in the vehicle:	
Criteria	Technical Background
ALL	<p>The infotainment system privacy setting “Allow data transmission” may, in unfavorable circumstances, change without user intervention. As a result, the vehicle sends data although this function was previously deactivated manually.</p> <p>The software also includes the following technical measures:</p> <ul style="list-style-type: none"> <li>• Performance enhancement for rear view camera display</li> <li>• Increased stability of SMS service</li> <li>• Performance enhancement for eCS route guidance on Audi e-tron (eCS = e-tron Charging Service)</li> <li>• Wi-Fi configuration “GPS detection via navigation unit”</li> <li>• Performance enhancement of external amplifier for multimedia system</li> <li>• Remedy for function impairments of the MMI system</li> <li>• Performance enhancement for multimedia system display units</li> </ul> <p>The following topics for the infotainment system are also addressed:</p> <ul

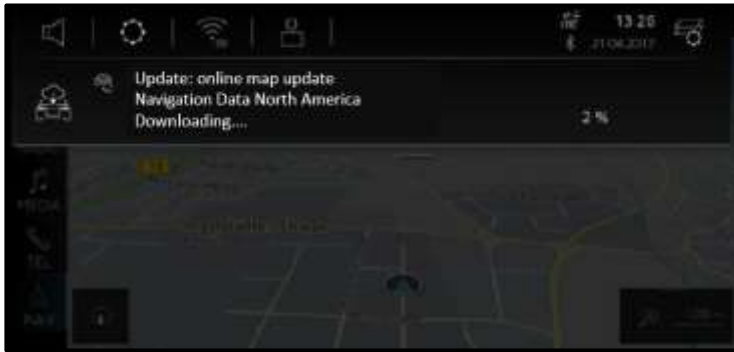
If the infotainment system happens to be in a navigation data download mode (“Downloading...,” as shown), please interrupt this by activating the slider for privacy mode (Home > Settings > Privacy settings > Activate privacy).

Please ensure that you deactivate privacy mode again after the software update is complete.

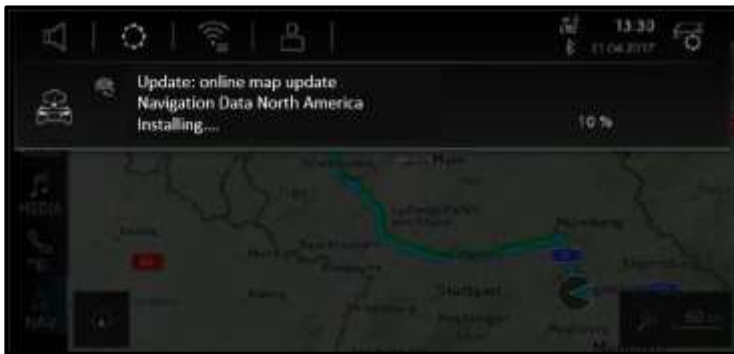
If the navigation database update is already being installed (“Installing...,” as shown), please wait and ensure that the installation is fully complete before continuing with the 91X4 software update.

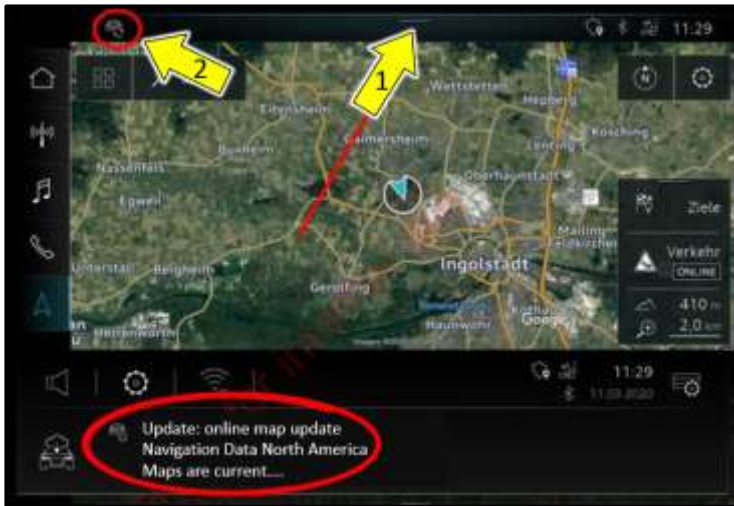
If a navigation database update is already complete, it is very important to confirm this manually in the notifications center of the MMI.

To do so, pull the notification center downwards <arrow 1> and confirm the completion (“Maps are current...,” as shown).

The 91X4 software update can only be started when the icon at the top left <arrow 2> is no longer visible.

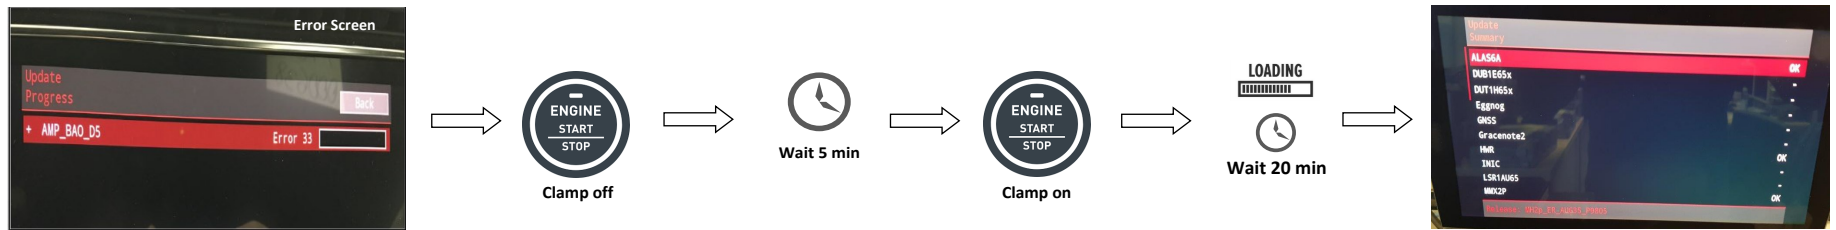
**Error 33: AMP\_BAO\_D5**

Error 33: AMP\_BAO\_D5

remove fuse of the Wireless Charger "recharger 1 for mobile end device" ---

*In case of the A8 it is also necessary to remove the rear Wireless Charger fuse "recharger 2 for mobile end device". The fuse is located at the rear left trunk position --> Repair Instruction --> circuit diagram --> fuse point of installation*

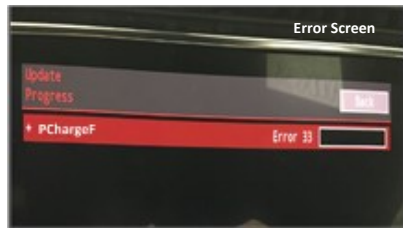
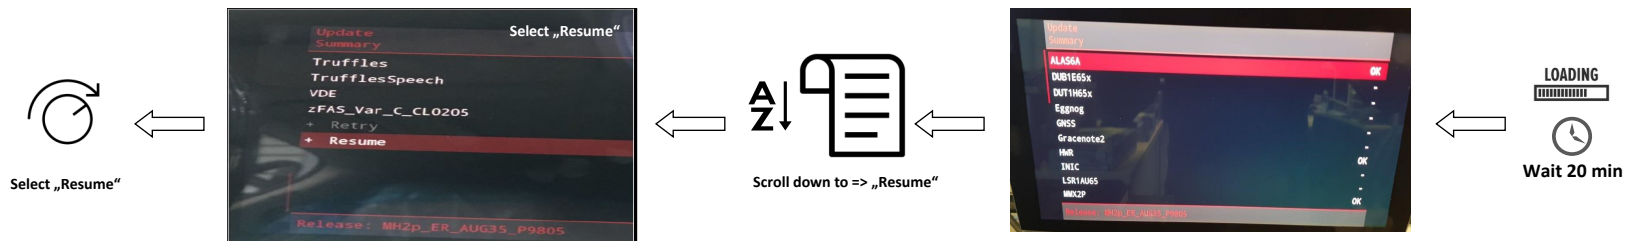
**Error 33: PChargeF or PChargeR**

Error 33: PChargeF or PChargeR

Error Case 33 "PChargeF" = wireless charger front  
 Error Case 33 "PChargeR" = wireless charger rear

remove fuse of the Wireless Charger "recharger 1 for mobile end device" ---

In case of the A8 it is also necessary to remove the rear Wireless Charger fuse "recharger 2 for mobile end device". The fuse is located at the rear left trunk position --> Repair Instruction --> circuit diagram --> fuse point of installation

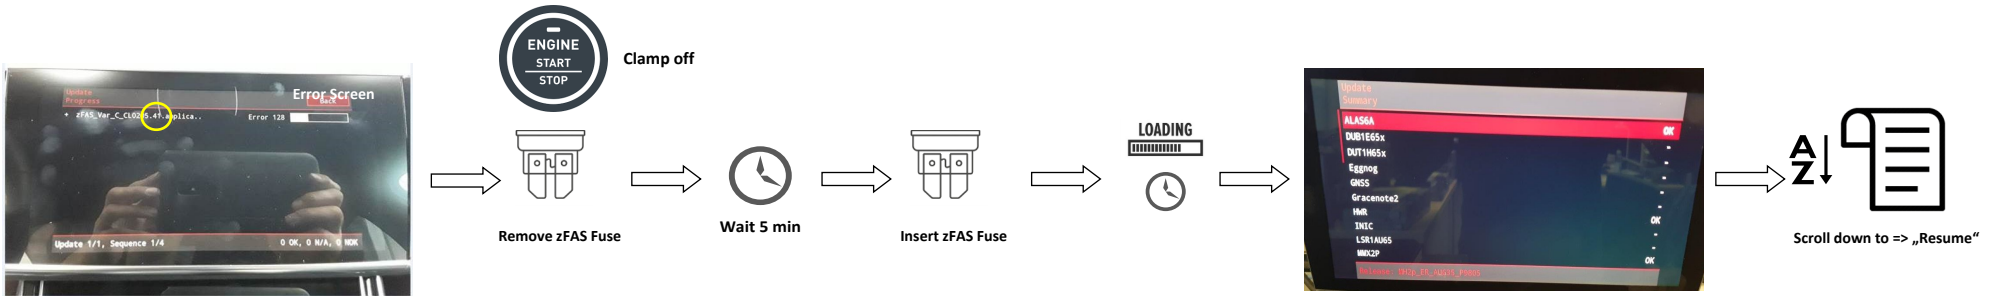
Error Case 128: zFAS\_Var\_C\_CL0205...  
Step by Step Description

Note: This step is only necessary if Error 128 on Block 41 occurs!

Error 128: zFAS\_Var\_C\_CL0205...

remove fuse of the Wireless Charger "recharger 1 for mobile end device" ---

In case of the A8 it is also necessary to remove the rear Wireless Charger fuse "recharger 2 for mobile end device". The fuse is located at the rear left trunk position --> Repair Instruction --> circuit diagram --> fuse point of installation
