A CRITICAL FUEL IMBALANCE !

From London to Athens : how a fuel imbalance lead to control difficulty !

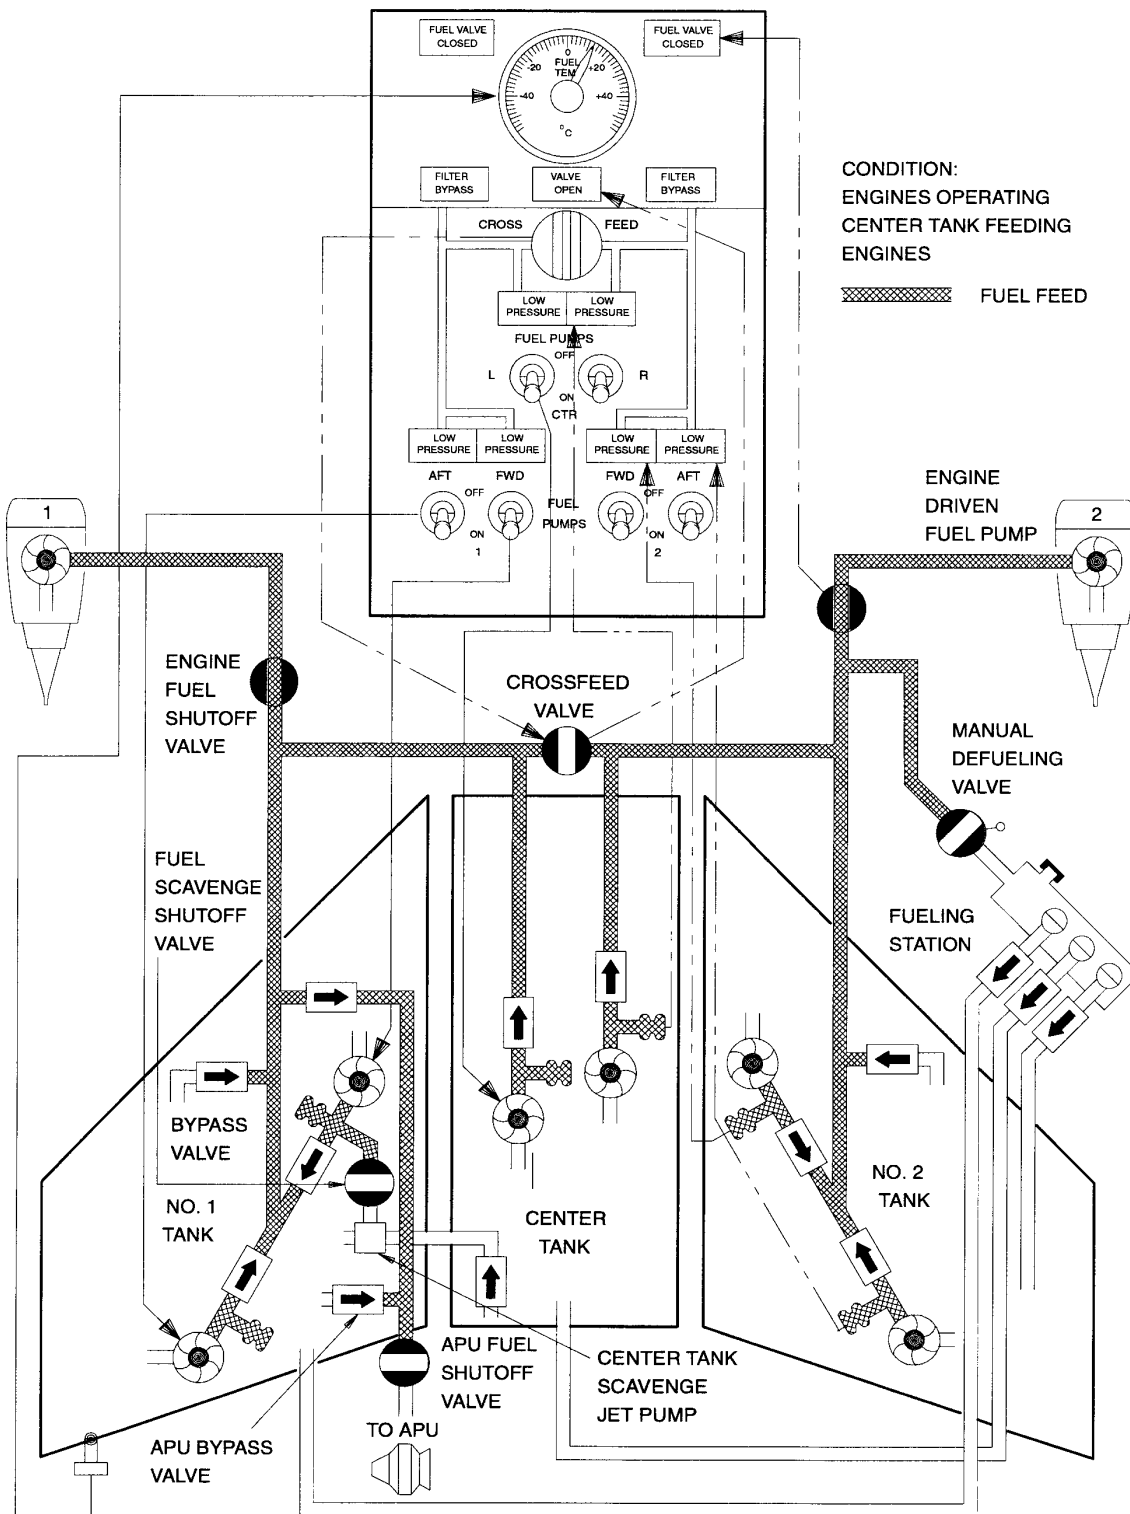
FUEL - SCHEMATIC (737-300/-400)

The B737-400 departed from London Gatwick for a scheduled flight to Athens with the first officer as Pilot Flying (PF). A fuel load of 13,200 kg had been selected by the captain and this resulted in full wing tanks and 4000 kg in the center tank. In accordance with standard operating procedures, all six booster pumps (two in each of the three fuel tanks) were selected on prior to start. With these switch positions, pressure differentials within the fuel system would mean that the center tank fuel would be used before the fuel in the two wing tanks. A fuel schematic diagram is shown in Figure 1.
