A Review of Common Metallurgical Defects in Ductile Cast Iron

Causes and Cures

C.M.Ecob

Customer Services Manager, Elkem AS, Foundry Products Division

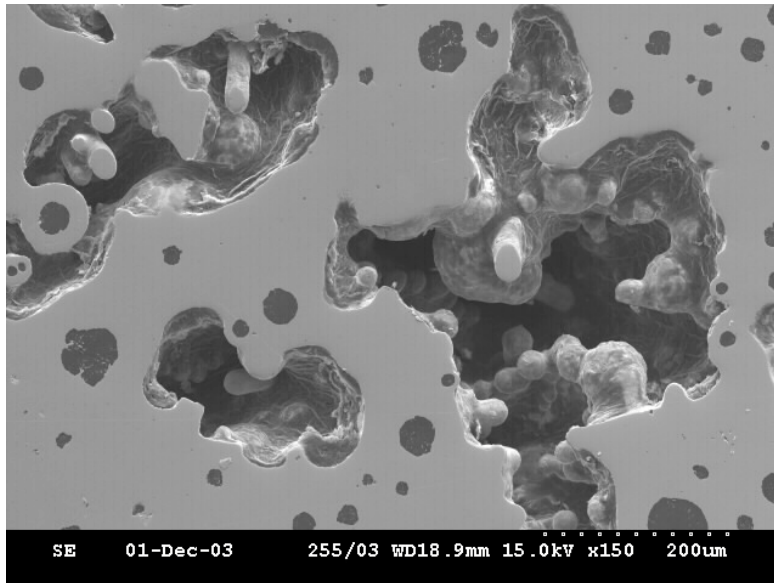
Figure 1 shows a typical sub-surface shrinkage defect. There are many causes of shrinkage in ductile iron, experience globally has shown that about 50% of shrinkage defects are related to sand systems, feeding and gating. The other 50% may be attributed to metallurgical factors such as carbon equivalent, temperature, inoculation or high magnesium residuals.

Figure 1: Typical sub-surface shrinkage defect with dendrite arms partly covered with graphite sticking out.

When a shrink or porosity is detected in a casting, there are several immediate and simple steps that can be taken to identify the cause of the problem. Firstly, the geometry of the casting should be examined to determine whether the location of the defect is close to a sharp radius or a potential hot spot. At the same time, the sand in the region of the shrink should be examined to look for any soft spots. Sand integrity accounts for a high proportion of shrinkage defects and a worn seal on the moulding machine, for example, resulting in a lower sand compaction can often be the cause of an unexplained sudden outbreak of shrinkage.

The second avenue of investigation should be the gating / runner designs and the feeding of the casting. Whilst many foundries have computer aided design systems, patterns are often altered slightly over the years at shop floor level and can be significantly different from the original design. Also, changes to the feeder specification can lead to different burn characteristics and metal solidification patterns. This can affect the amounts of feed metal available to different parts of the casting.

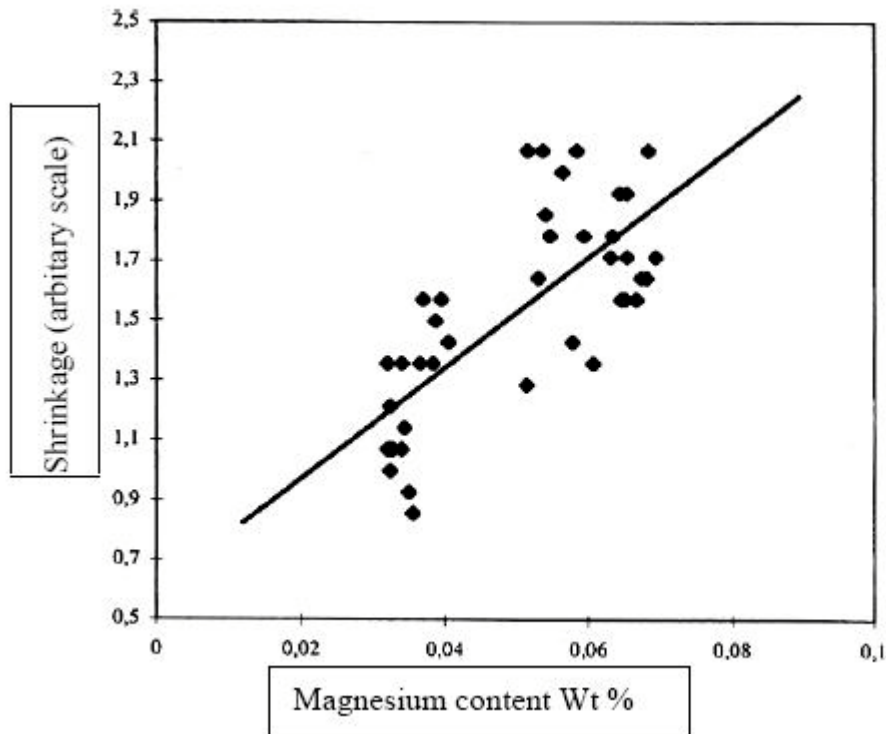
Figure 2: Effect of magnesium content on shrinkage

Magnesium, apart from being one of the most powerful carbide stabilisers, has a marked effect on the shrinkage tendency of ductile irons. Foundries operating at the higher end of the magnesium range, 0.05% or above, will find that the iron is more prone to shrink than foundries operating at lower, but very acceptable, levels, say 0.035-0.04%.

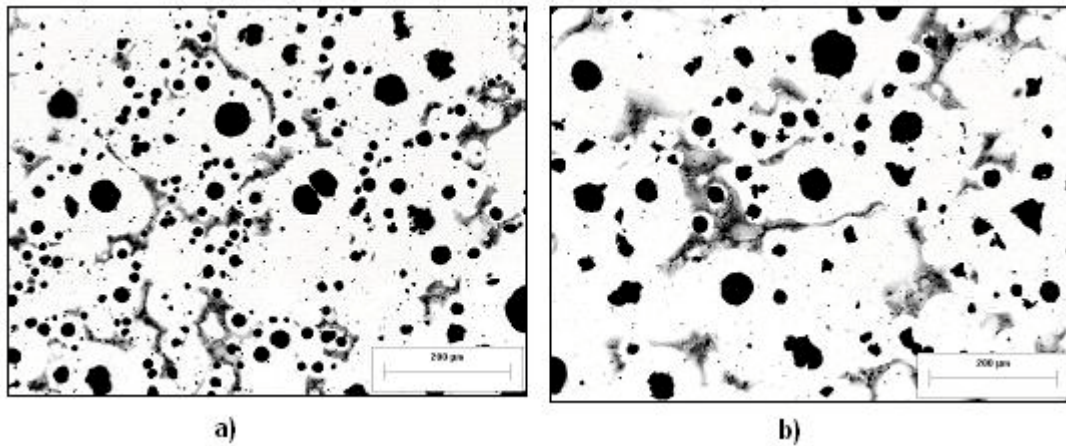
In many foundries, the microstructure shows even sized nodules (accounting for the fact that the section cuts through nodules in 2-dimensions). Many foundrymen still consider this to be a good structure, even though the iron is prone to shrinkage. Nodularisers and specialist inoculants are available these days, which help to counter shrinkage by giving a skewed nodule distribution. These structures are shown in figure 3.

Figure 3: The same base iron treated with two different nodularisers resulting in a) Skewed nodule distribution b) Unskewed nodule distribution

A skewed nodule distribution indicates that some nodules are being created late in the solidification process and the drawing of graphite from solution at this stage is a very effective way to counter shrink. Most inoculants act almost instantaneously and this gives the even nodule size effect. Once the potency of the inoculant has gone, then there is no driver to create nodules late in the solidification and shrinkage can be the result. More recently, nodularisers have been developed by Elkem that have the same effect of producing the skewed and shrink reducing nodule distribution curve.

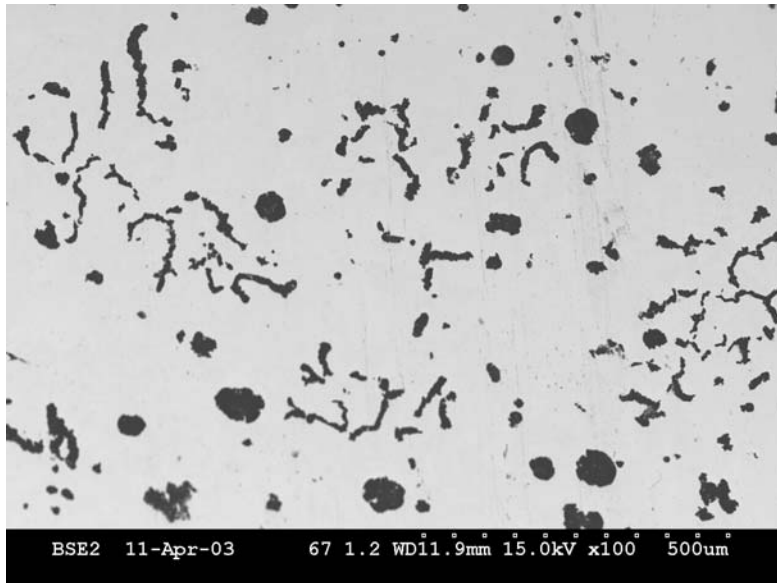
Figure 4 shows a good example of compacted graphite in the structure. There are several causes of this, the most common being that the nodularisation process has partly failed. Incorrect weighing of the nodulariser or the use of the wrong nodulariser are possible reasons for the failure, although a long holding time in the ladle or excessive temperatures can be contributory factors.

Figure 4: Sample with compacted graphite present in the matrix due to partly failed nodularisation process.

Another cause of CG particles in the matrix is an incorrect sulphur level in the base iron. Many foundries melt both grey and ductile charges and segregation of returns is essential. During the nodularisation process, the first reactions that take place are a desulphurisation and deoxidation, these elements combining preferentially with the magnesium. The base sulphur level must be accounted for in the calculation of MgFeSi charge weight.

A note of caution here with regard to the addition of the MgFeSi to the ladle or treatment vessel. To add the MgFeSi early to a hot ladle and then hold the ladle for several minutes until the moulding line calls for metal is bad practise as the alloy will be burning or oxidising in the bottom of the ladle during this time. Higher and more consistent recoveries can easily be achieved by adding the alloy just before tap from the furnace.

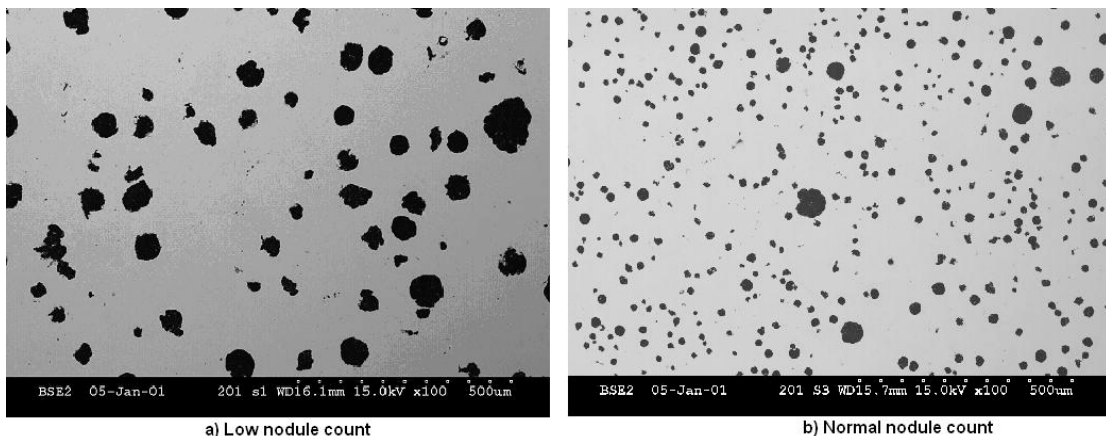
As the compacted graphite mentioned above may commonly be attributed to the nodulariser, then low nodule counts tend to be a function of the inoculant. Figure 5 shows a low count compared to the foundry's normal practise. Avoiding long holding times in the furnace and prolonged pouring time post-inoculation will help to achieve consistent nodule counts, as will improving the responsiveness of the iron via preconditioning. The use of a specialist powerful inoculant will give the most consistent results.

a) Low nodule count

b) Normal nodule count

Figure 5: Two casting with the same metal treatment resulting in a) low nodule count due to long pouring time and b) normal nodule count with normal practise.

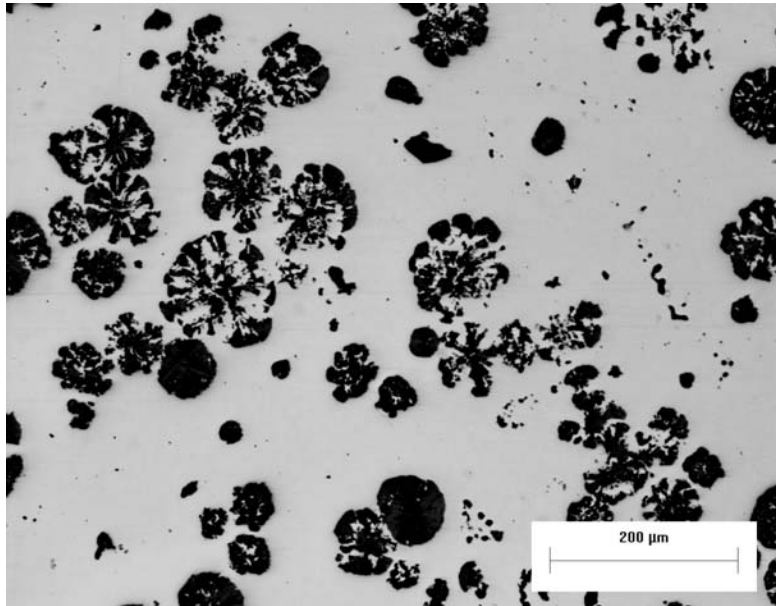
Figure 6 shows exploded graphite within the structure. Characteristically, exploded graphite looks exactly as the name might suggest that the graphite has been blown apart. Most MgFeSi alloys contain some rare earth metals, cerium, lanthanum, neodymium, praeosodium etc and these are beneficial in that they neutralise the effects of some detrimental tramp elements such as lead, bismuth, antimony, titanium etc.. Rare earth elements are also nodularisers and aid the effects of the magnesium. In excess, however, rare earths can cause exploded graphite. This is more especially when high purity charges are used which are low in tramp elements. Exploded graphite is normally found in thicker section castings with slow cooling rates or at very high carbon equivalent levels.

Figure 6: Sample with exploded graphite present due to excess concentration of rare earth metals.

Care should be taken when using induction melting as rare earths can be cumulative in the iron. They tend to have very high melting points and do not volatilise, although some will be oxidised and come out in the slag. This is important to note if a low/zero RE containing nodulariser is substituted to eliminate the problem as it may take time to dilute the residual RE out of the system.

Should exploded graphite occur, then examination of the rare earth sources should be made – normally the MgFeSi. Melting a virgin charge with steel scrap, pig iron and no returns will quickly show if the returns and/or the MgFeSi are the problem. Latin America and countries in the Far East tend to use high levels of rare earth in the nodulariser. Reductions in the carbon equivalent may help to reduce exploded graphite.

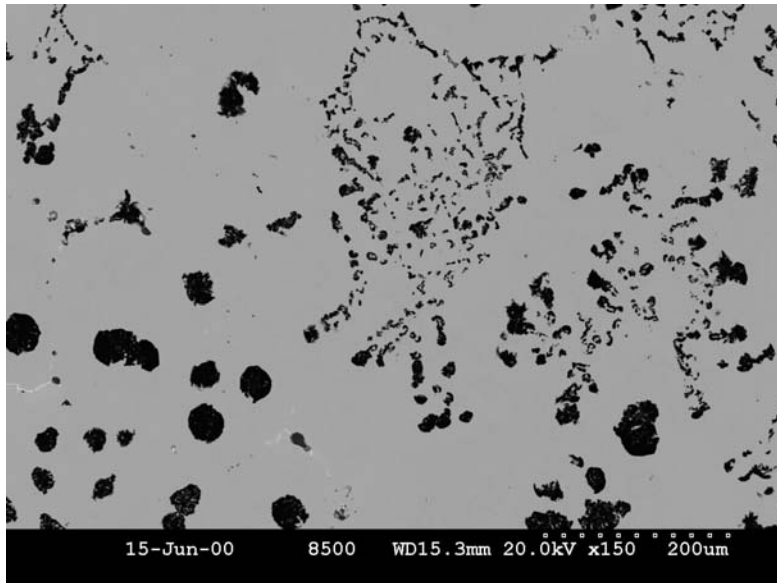
This is shown in Figure 7. The causes of chunky graphite are exactly the same as for exploded graphite with the addition that the defect is also found in thinner casting sections and is not as sensitive to the carbon equivalent as exploded graphite.

Figure 7: Sample with chunky graphite present due to excess concentration of rare earth metals.

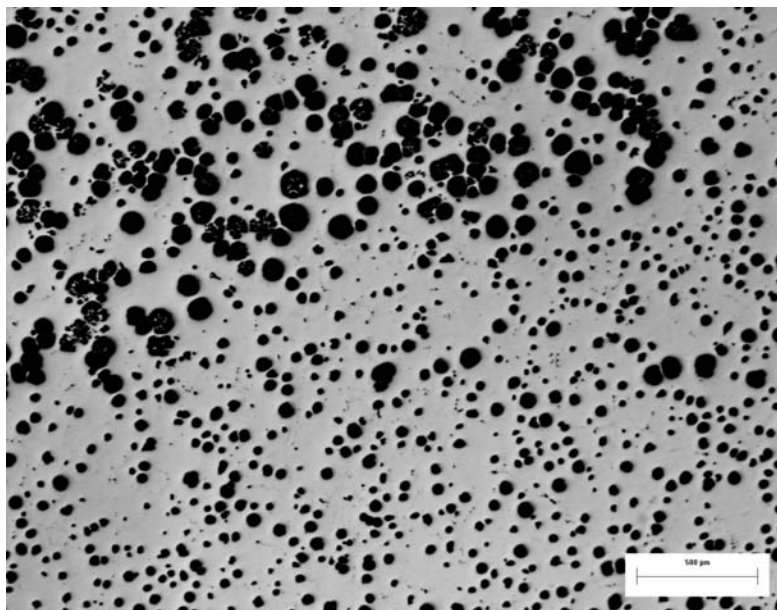
This is caused when large, low density graphite nodules are formed during the solidification of thick section or otherwise slow cooling castings. The nodules, being of a lower density than the matrix, tend to float towards the surface of the casting and thus can have a negative effect on the mechanical properties (and surface finish) in that region.

Figure 8: Sample with graphite floatation present due to high carbon equivalent.

A reduction in the carbon equivalent will help to control this, as will a reduction in the pouring temperature or increasing the cooling rate of the casting by the use of chills. The inoculation system should also be examined, as it is likely that the large graphite nodules have been formed very early during the solidification process and an inoculant, which will generate more, smaller nodules, could be an advantage. An example of graphite floatation is shown in Figure 8.

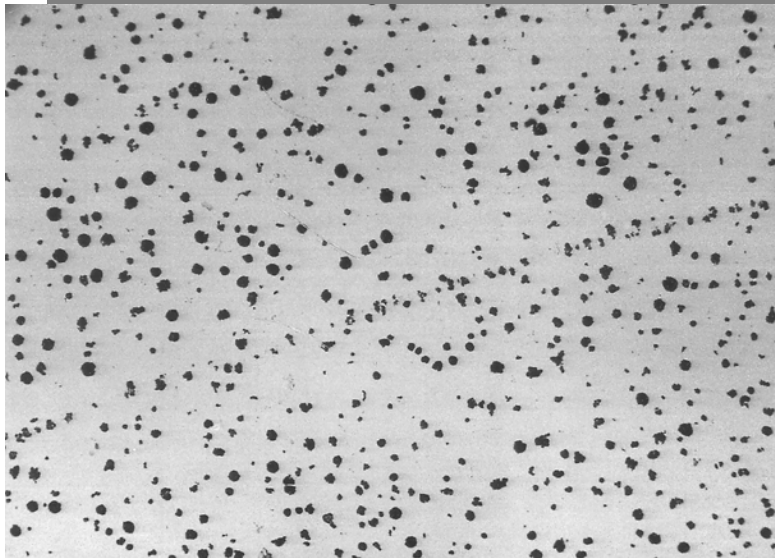
Figure 9 shows a classic case of nodule alignment, not too many examples as clear as this have been seen coming through our laboratory. This is caused by large dendrites growing during the solidification with the nodules being precipitated between the dendrite arms. Thus the nodules appear to be aligned. Whilst not normally a serious problem, this can have detrimental effects on such properties as tensile strength or impact resistance.

The normal causes are low carbon equivalent where not enough graphite is precipitated during the cooling, under inoculation or too high a pouring temperature.

Figure 9: Sample with nodule alignment caused by large dendrites growing during the solidification with the nodules being precipitated between the dendrite arms.

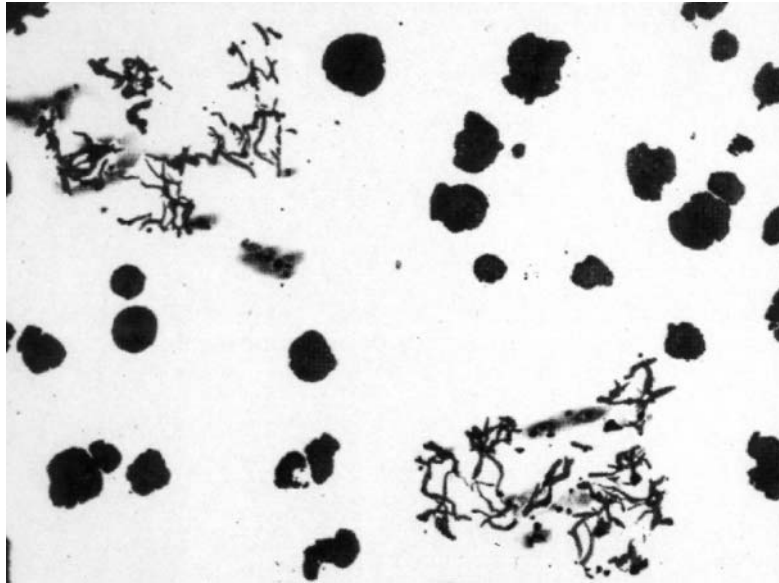
The occurrence of spiky graphite in ductile iron is rare provided that the nodulariser used contains a small amount of rare earths. Normally, the rare earth metals neutralise such elements as lead, bismuth, titanium and antimony, as discussed in the section on exploded graphite, however the use of a rare earth-free nodulariser where traces of the deleterious elements are present results in spiky graphite. This is most commonly found in converter iron where the separate additions of RE have been left out by human error.

The effect of spiky graphite is a dramatic reduction in the mechanical properties of the iron, the spikes provide points of weakness in the structure. Figure 10 shows a typical example of spiky graphite. The only cure for this type of defect is the addition of rare earths with the nodulariser.

Figure 10 Sample with spiky graphite present in the matrix due to too elevated level of Pb.

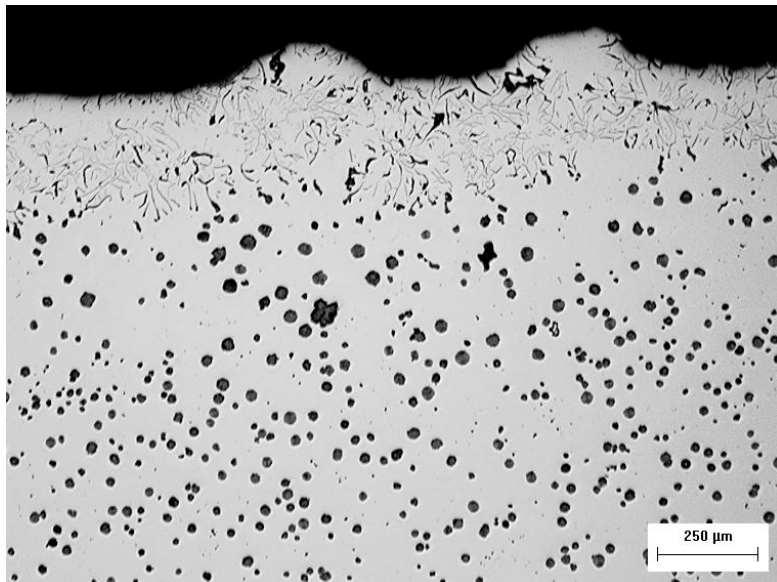
This is commonly seen in foundries, however many ignore the flake graphite on the surface as it forms part of the machining allowance. The defect is illustrated in Figure 11 and clearly shows the thin layer of flake graphite adjacent to the mould. This is found mainly in greensand systems and is caused by a build up of sulphur in the sand, which reacts with the magnesium in the iron to form magnesium sulphides and effectively de-nodularise the iron. A higher Mg or Re in the nodulariser can overcome this, subject to shrinkage restrictions discussed earlier, but the most common remedy is to use an inoculant containing cerium. This has the effect of re-nodularising the iron locally.

Figure 11 Sample with flake graphite on the surface of the casting due to high sulphur content in the moulding sand.

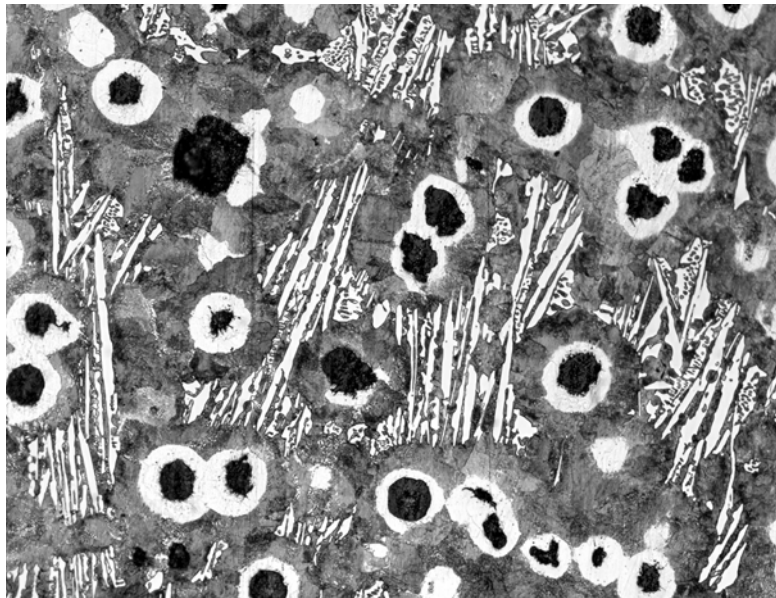
In the production of ductile iron, it must be remembered that magnesium is one of the most powerful carbide promoters. Coupled with this, the violence of the magnesium reaction during the nodularisation process tends to destroy nuclei. For these reasons, inoculation requirements are heavier than for grey irons and under-inoculation or the use of the wrong inoculant are amongst the most common causes of chill or carbides in ductile iron.

Figure 12 shows typical carbides in a ductile iron structure. Poor inoculation is not the only cause of carbides, however, and all the potential reasons need to be explored to determine the reason behind carbide formation.

Figure 12 Sample with carbide present in the matrix due to poor inoculation

Steel scrap qualities have already been mentioned in this paper and increasing concentrations of carbide promoting elements, such as molybdenum, chromium, vanadium etc can lead to the promotion of carbides. These can be found particularly in the centre of castings or at grain boundaries, where the eutectic solidification front tends to concentrate the elements to the point where carbides form. Apart from steel scrap, use of molybdenum containing returns can be a source of undesirable carbide promoting materials.

Low carbon equivalent and high pouring temperatures may also promote carbides, particularly in thin section castings.

The cures for carbide problems usually revolve around the use of a more powerful proprietary inoculant, although nodularisers have been developed which have lower carbide promoting properties.
