A Study of Bank Erosion Rates within Selected Reaches of the Housatonic River

Prepared by

**Stantec Consulting
30 Park Drive
Topsham, ME 04086**

August 27, 2009

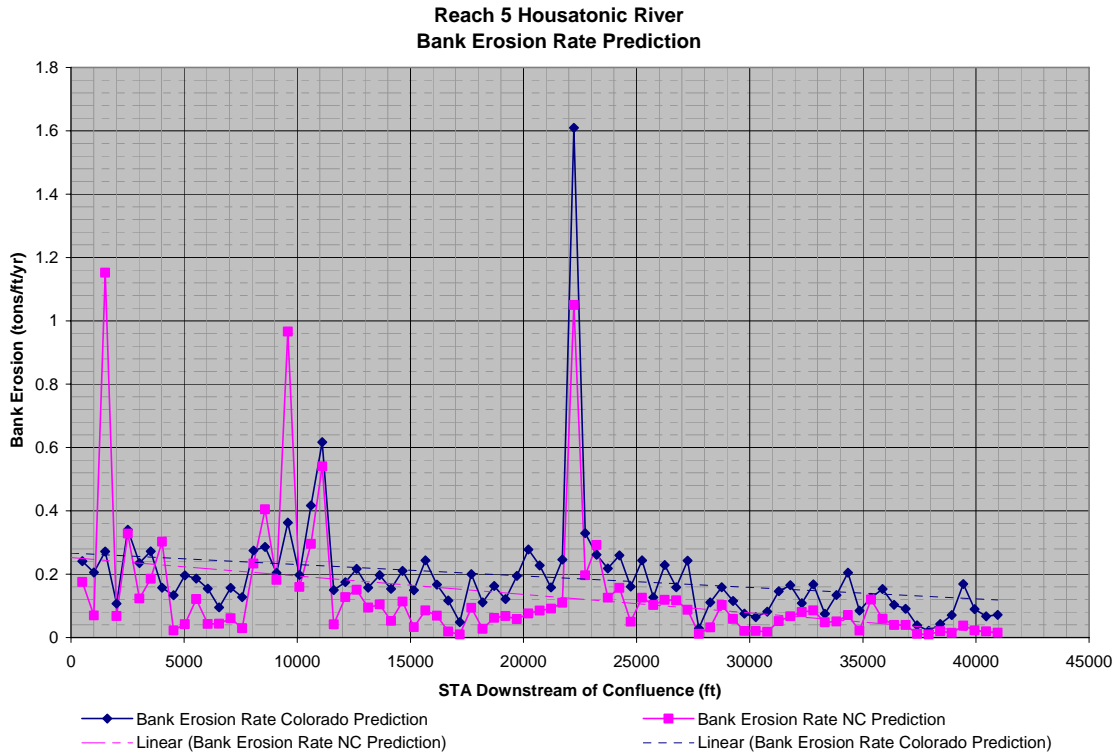
Figure 6. Bank Erosion Rate Predictions for Locations along Reaches 5A and 5B

Figure 6 shows the bank erosion in tons/foot/year for Reaches 5A and 5B, which varies from almost 0 to 1.6 tons/foot/year with an average rate of about 0.2 tons/foot/year.

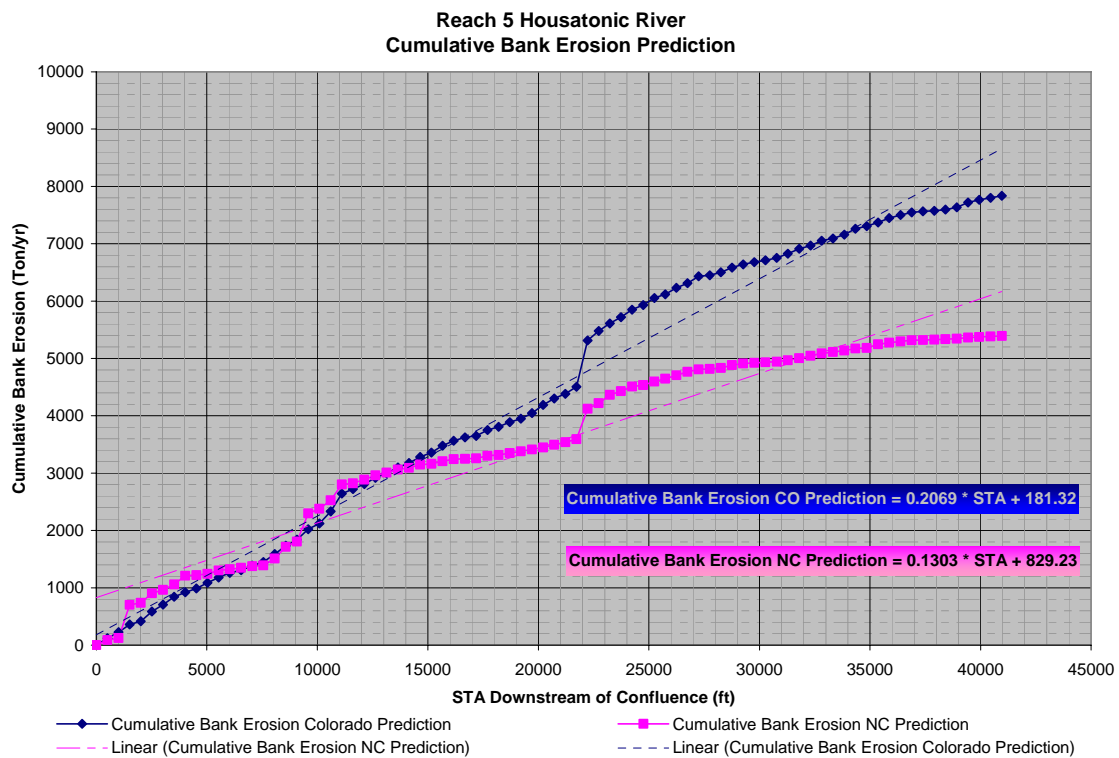
Figure 7. Cumulative Bank Erosion for Reaches 5A and 5B

The total bank erosion predicted from the 82,000 linear feet of streambank (41,000 feet of stream channel) surveyed was estimated to be about 8,500 tons/year using the South Central Colorado Region curve and 6,200 tons/year using the North Carolina Piedmont Region curve (Figure 7). The actual rate is likely between these two rates. The rates are based on a number of conditions, such as soil cohesion and vegetation, which are different depending on location. The conditions in Colorado lead to higher rates of erosion compared to the conditions in North Carolina. The conditions found along the Housatonic River are somewhere between the conditions found in North Carolina and Colorado, leading to the conclusion that erosion rates would be between those calculated.

Note: The straight, dashed “linear” lines represent the linear cumulative trend for total bank erosion. The slopes of each of these lines are the average bank erosion rates per unit length for each bank erosion prediction. These lines show that the two different predictions have two separate average bank erosion rates and the areas that graphically have a higher than average bank erosion rate (i.e., slope of the cumulative curve).

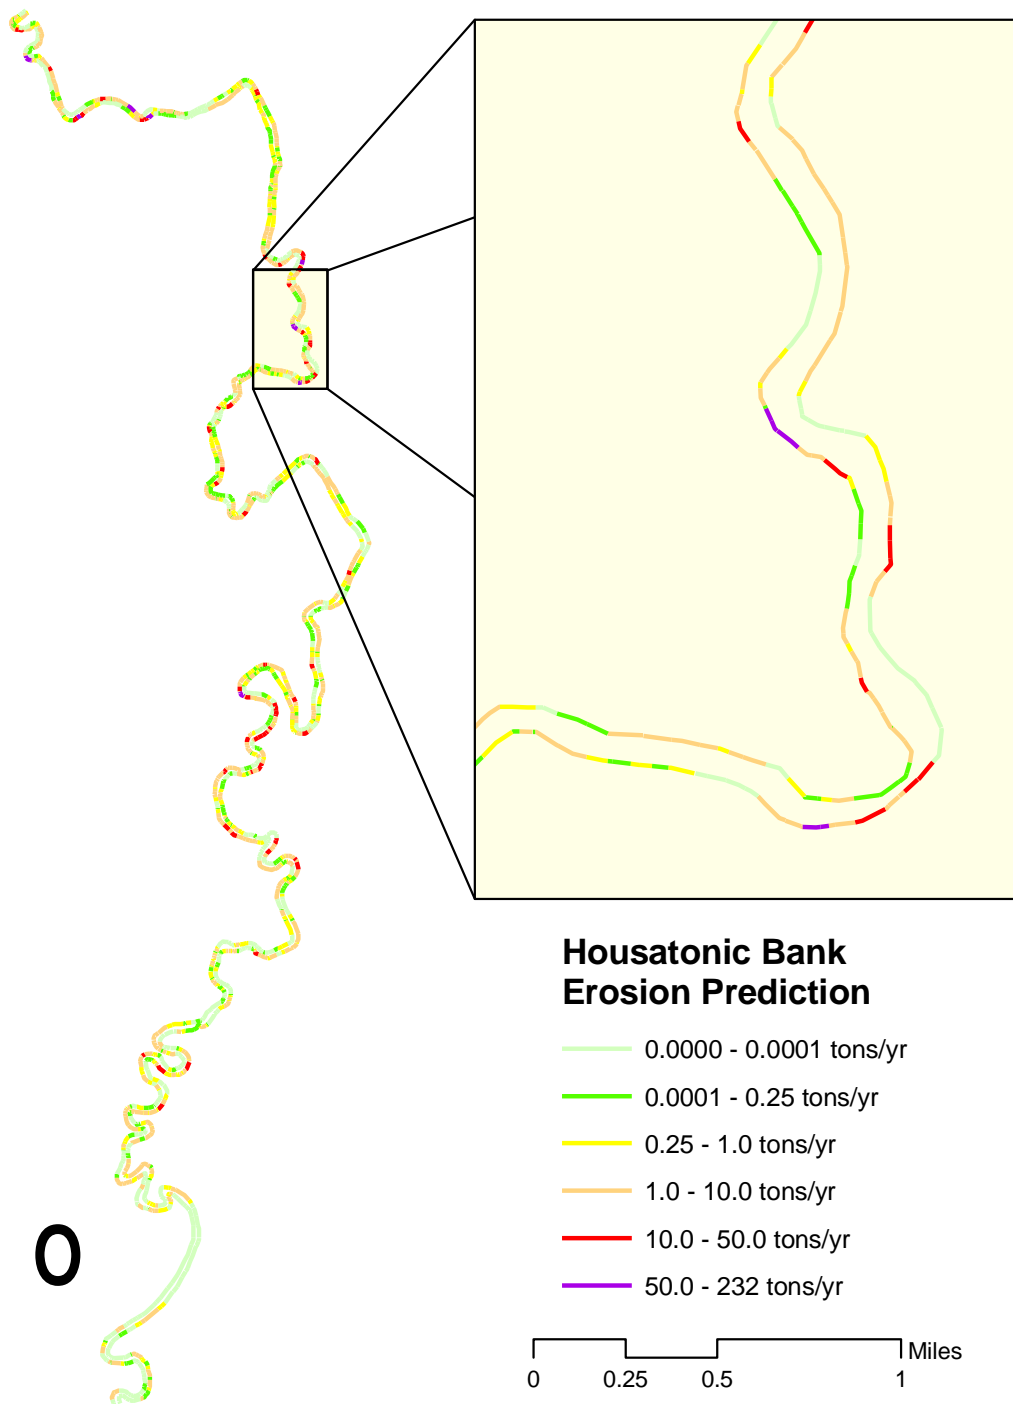
Figure 8. Reaches 5A and 5B Bank Erosion Prediction:
Example GIS Shapefile Showing Bank Segments

The geographic information system (GIS) analysis supports the field data and observations. Reaches 5A and 5B have areas of very low bank erosion and areas of extreme accelerated bank erosion. The GIS analysis, however, shows that the areas of high bank erosion are generally out of phase with the plan form of the river. In alluvial systems, the areas of highest erosion are expected to occur in the lateral scour pools on the outside of the meander bends and in the lower third of the meander bend. On the reaches studied here, many of the extreme and very high bank erosion rates are located upstream of point bars on the inside banks. This is a sign of active channel migration and horizontal instability. The shapefile created for the GIS analysis can be mapped or displayed over aerial photography or other base map information (Figure 8). The shapefile has an associated database file containing data on the 1,910 segments.

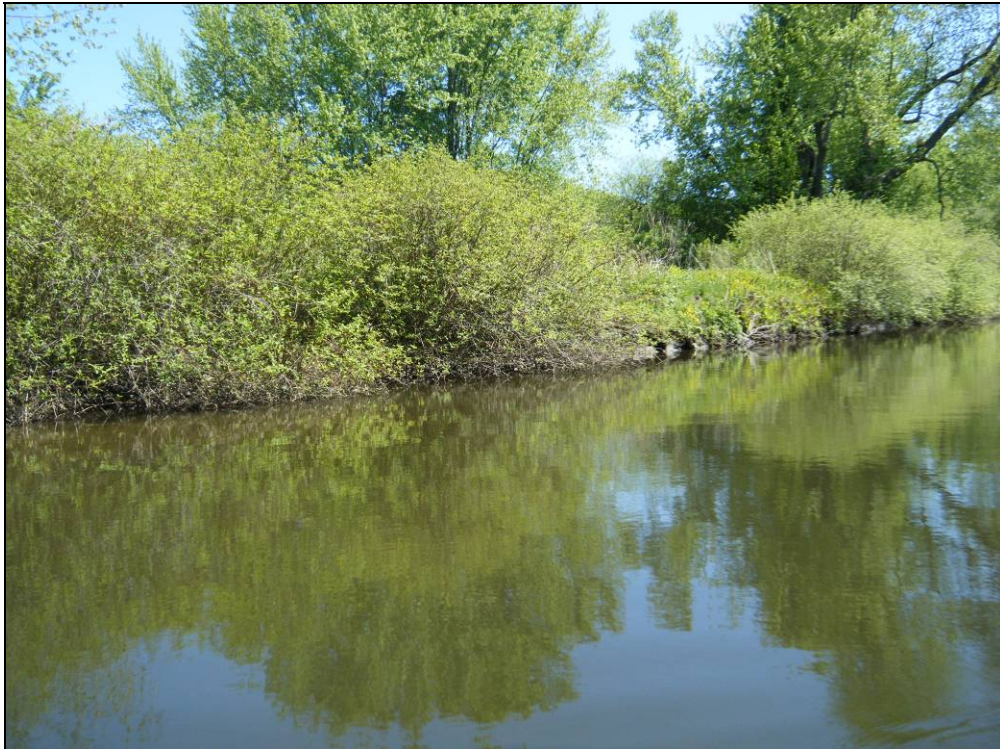
Example of bank conditions with a Bank Erosion Hazard Index (BEHI) rating of very low

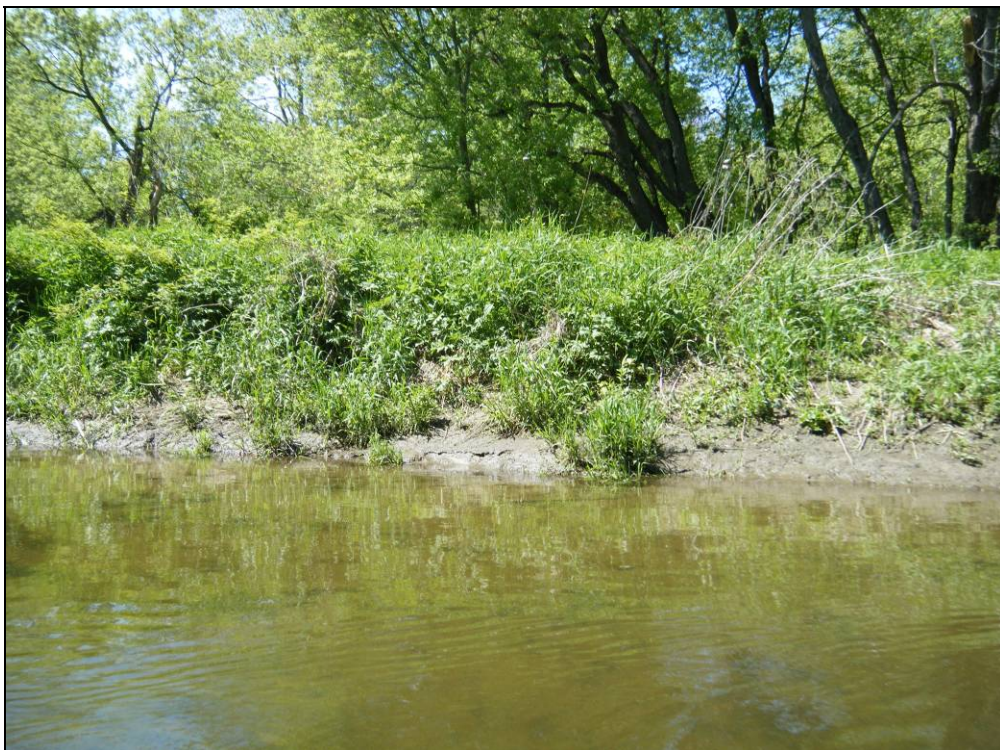
Example of bank conditions with a BEHI rating of low

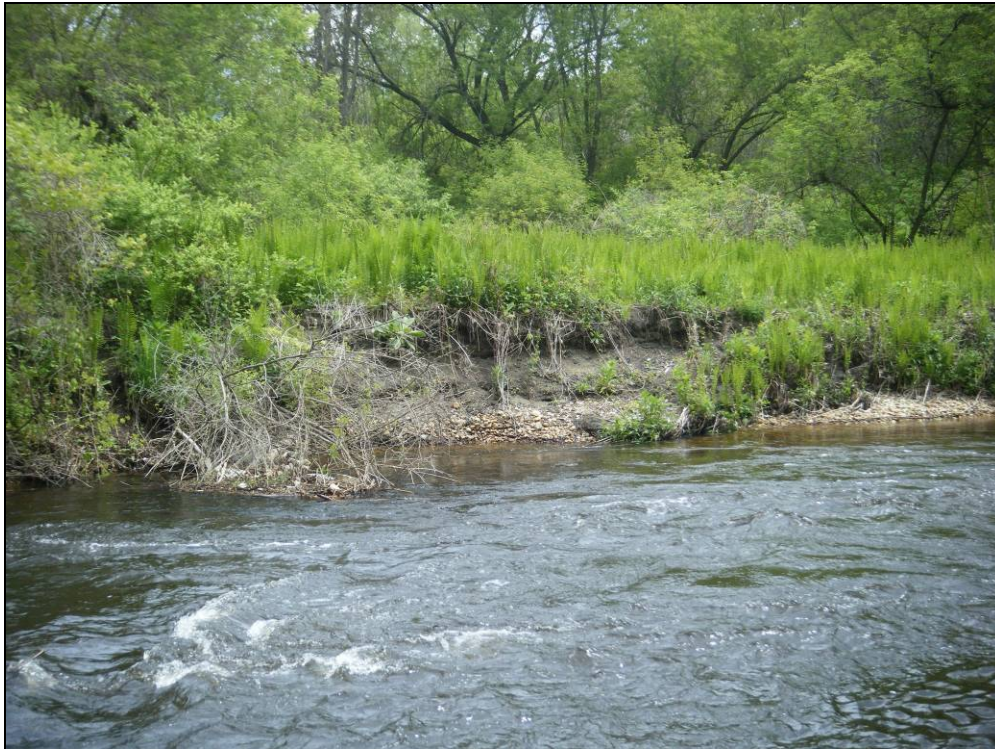
Example of bank conditions with a BEHI rating of moderate

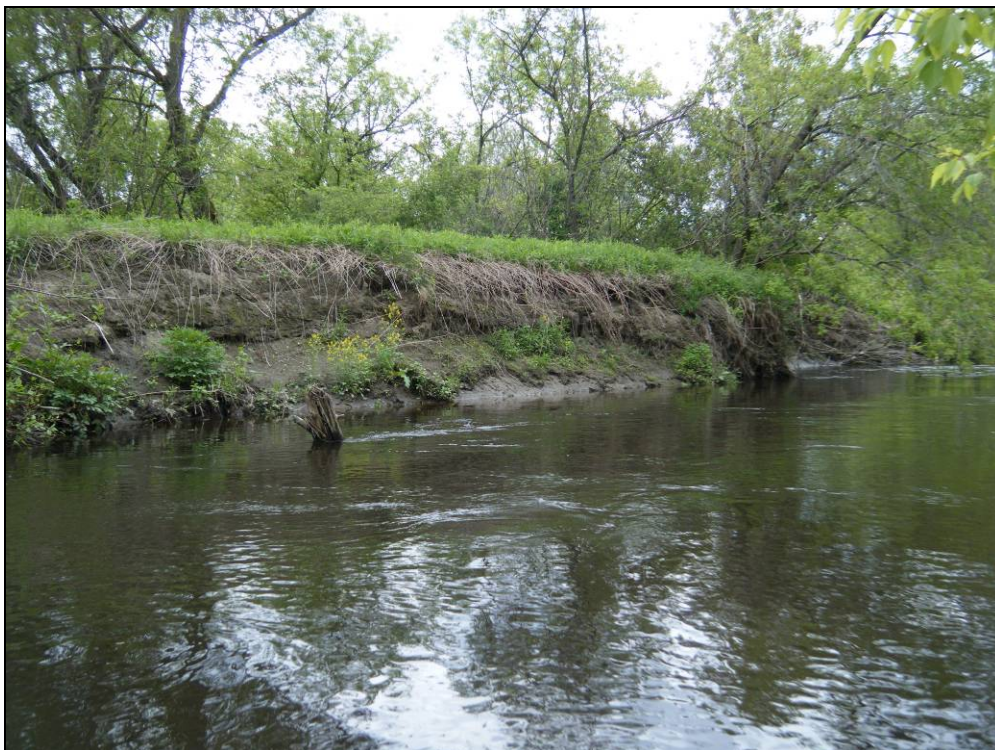
Example of bank conditions with a BEHI rating of high

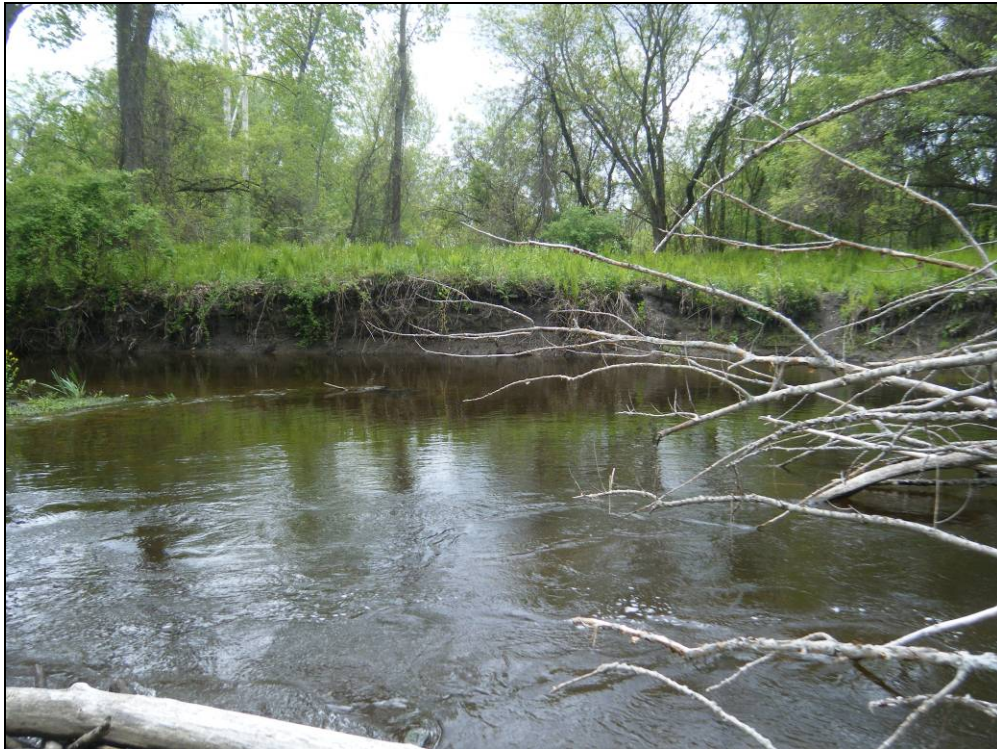
Example of bank conditions with a BEHI rating of very high

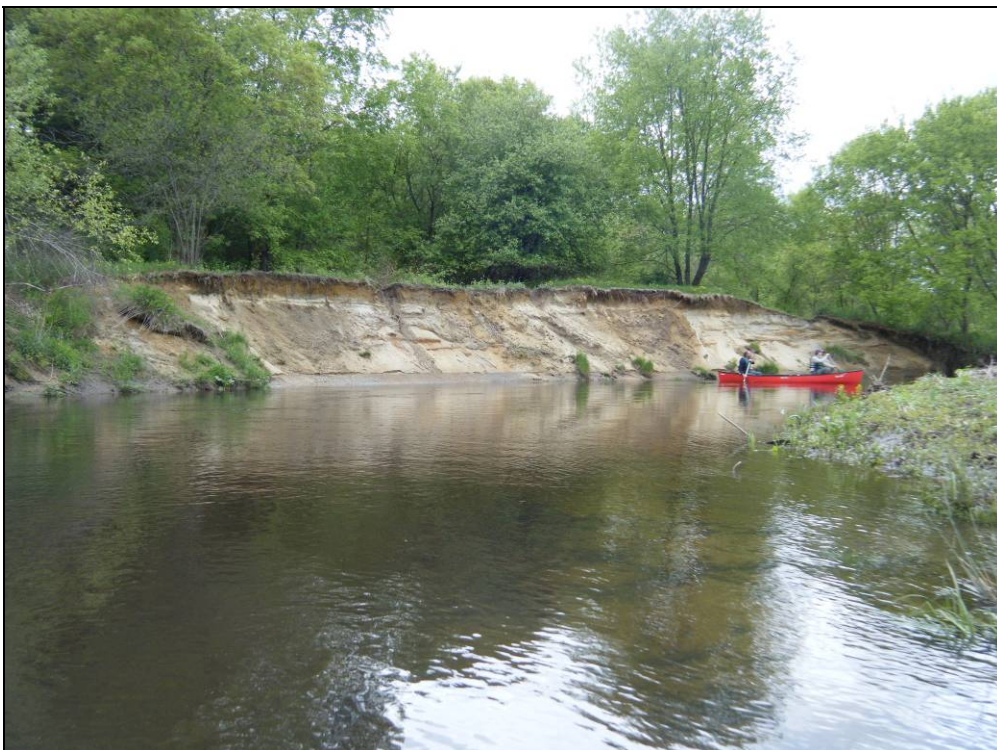
Example of bank conditions with a BEHI rating of extreme
