# ***AAIB Bulletin***

***1/2016***

1/2016 - Airworthiness of Aircraft Registered Overseas and Resident in the UK 3

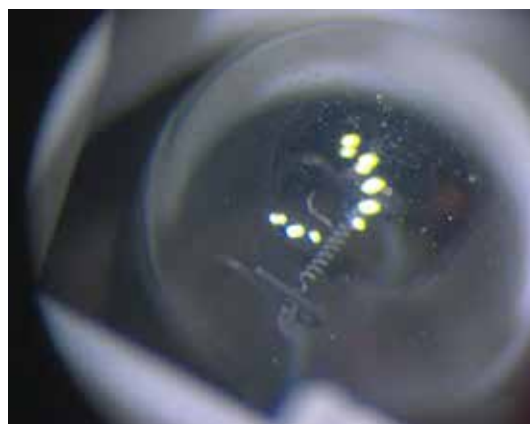
Figure 5

The navigation and radio equipment was severely damaged by the impact forces and it was not possible to determine their settings. However, examination of the HSI source annunciator bulb filaments under a microscope showed that the GPS filament had characteristic plastic deformation, indicating that it was illuminated at the time of impact (Figure 5). This indicated that GPS-derived navigation data was being displayed on the HSI at the time of the accident.

HSI source annunciator lightbulbs,  
showing plastic deformation of the GPS bulb filament

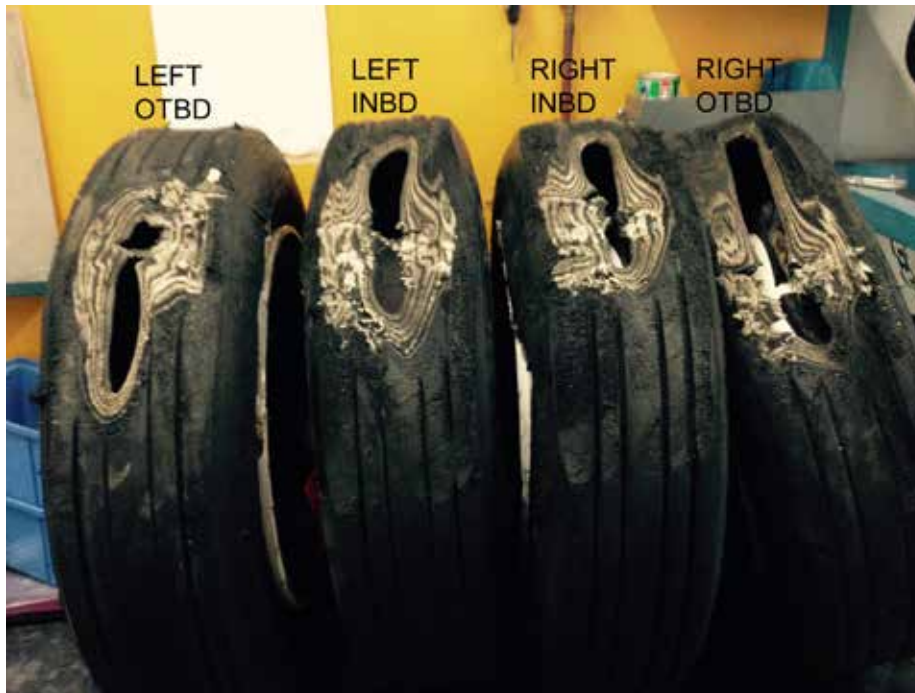
**Figure 2**  
Damage to tyres

Within a second of touchdown, a tyre, probably the right outboard, burst. The flight crew were aware of the burst tyre and perceived that a second tyre had also burst on the right side. They experienced directional control and braking difficulties which resulted in them selecting the emergency braking system. The crew brought the aircraft to a stop on the runway, after which it was found that all four mainwheel tyres had burst.

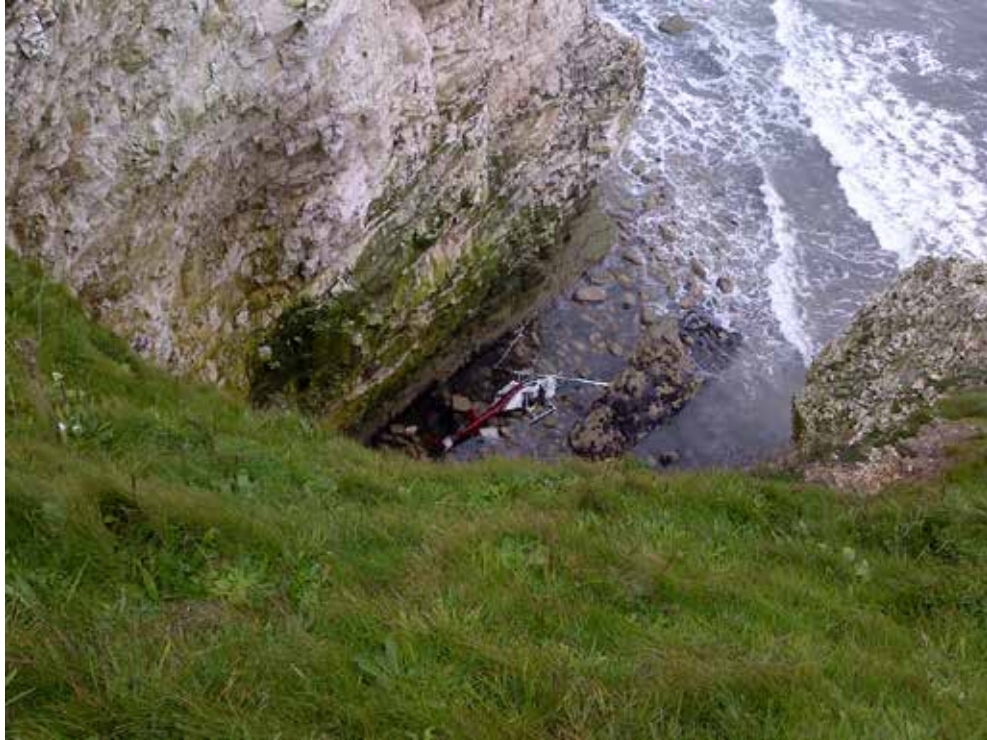
**Figure 6**

The accident site was located in the inter-tidal zone at the base of a gully in the cliffs at Flamborough Head. A photograph taken shortly after the accident showed the helicopter lying on its left side, partly submerged in the sea (Figure 6). It had sustained damage from the impact but appeared whole. The tide was ebbing and the emergency services were able to recover the deceased occupants at low tide. A significant quantity of jet fuel was reported in the sea around the wreckage.

Showing helicopter lying at the base of the cliffs shortly after the accident  
(Courtesy Trevor Norton)

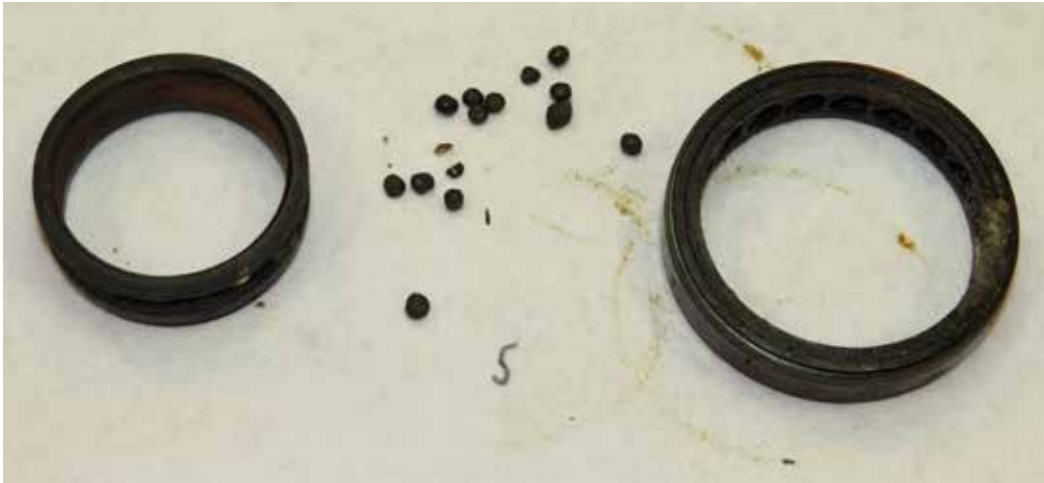
**Figure 10**

Example of bearing damage, in this case No 5 bearing

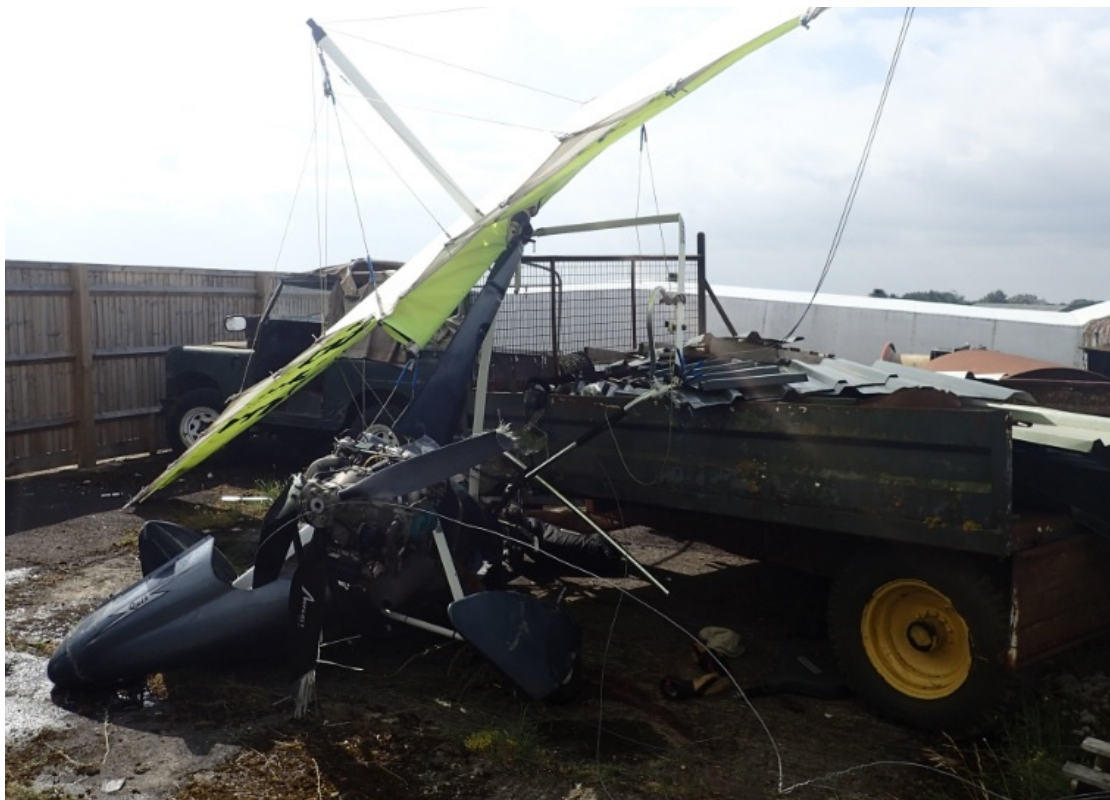
**Figure 4**

After touchdown the aircraft passed through a wire fence at the eastern end of the runway and collided with a vehicle trailer that was parked beside other equipment (Figure 4) before coming to rest. The aircraft remained upright with the nose embedded under the trailer but the wing showed little sign of obvious external damage. Ground marks showed that the trailer and a large grass roller adjacent to it had been displaced sideways when the aircraft struck the trailer.

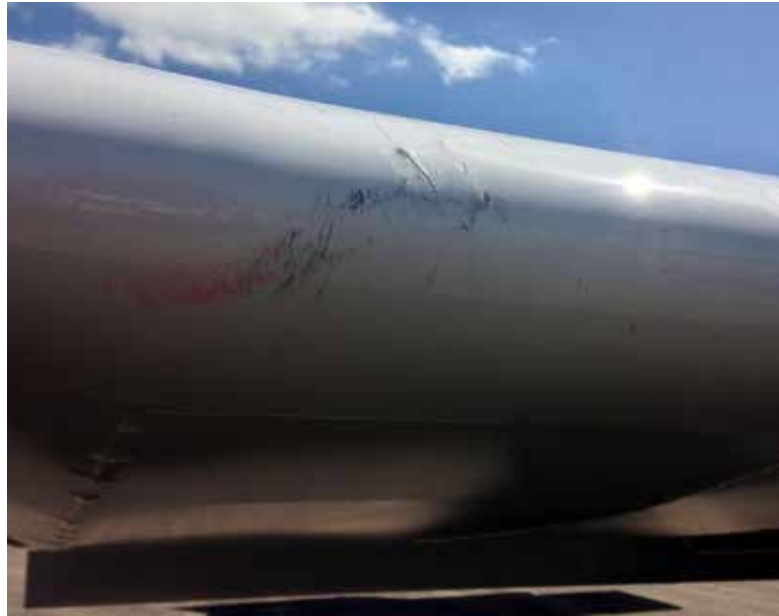
**Figure 3**

While on the base leg, at an estimated altitude of 600 to 800 ft amsl, the aircraft's right wing struck a model glider. The pilot initially thought he had been hit by a large bird, but the collision was caught on a passenger's video camera which revealed that it was a model glider (Figure 1). The aircraft continued to handle normally and the pilot turned final and landed uneventfully. He had not been aware that there was a model glider flying site on the base leg to Runway 20.

Damage to right wing leading edge of F-GSBM
