This paper describes protection systems proposed and introduced on components in the Tornado aircraft structure subjected to adhesive and erosive wear. Particular attention will be addressed to the flap tracks and to the leading edges of both taileron and air intake ducts.

Paper presented at the RTO AVT Specialists' Meeting on "The Control and Reduction of Wear in Military Platforms", held in Williamsburg, USA, 7-9 June 2003, and published in RTO-MP-AVT-109.

1. REPORT DATE		2. REPORT TYPE		3. DATES COVE	RED	
01 JUN 2004		N/A -				
4. TITLE AND SUBTITLE				5a. CONTRACT NUMBER		
Adequate Protection Systems for Reduction of Wear on Tornado Aircraft 5b. GRANT NUMBER 5c. PROGRAM ELEMENT NUMBER 5c. PROGRAM ELEMENT NUMBER			1BER			
			5c. PROGRAM ELEMENT NUMBER

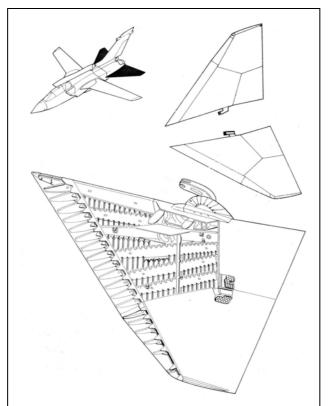
Figure 2: The taileron

The taileron are attached to the rear fuselage by pivot pins and consist of twist panel, leading and trailing edge, Figure 2. As consequence of the AIM-9L Sidewinder firing missile the leading edge, consisting of aluminium alloy, is subjected to heavy damage due to thermal erosion. To overcome the problem investigations with different anti erosion coatings on behalf of nations using Tornado were performed during the years. One solution proposed from IAF concerned the use on the leading edge of silicone rubber against the thermal stress covered with polyurethane anti erosion adhesive. Nevertheless the results of this experience were not significant for damages caused for aerodynamic friction on the protection within less 40 FH and with only two firing missile.

The use of an acrylic primer [7] proposed from GAF improved the thermal resistance of the leading edge but caused problems by age hardening of the resin which could be by cured by re-painting. Therefore, the RAF thought necessary to use new taileron with leading edge made in nickel alloy as Inconel 600, which showed good properties in terms of both thermal resistance and erosion. On this experience IAF and GAF replaced the taileron as well: in particular, in the case of the IAF, the introduction of new taileron has become executive from May 2002 and will be completed in 2012.

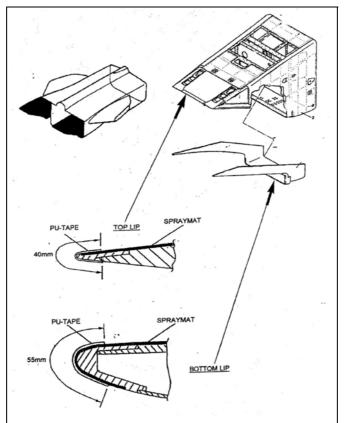
Figure 3: The air intake ducts

2.3 Air intake duct

The erosion of the top coat permits the water permeation between the resin and the surface of the air intake which causes superficial corrosion detectable only after the coating raising or with the short circuit of the heating elements. Methods of protecting the coating were proposed during the years. RAF intended to spray tungsten carbide [8] to retard erosion, whereas GAF used a polyurethane tape and a Thermovision trial as method of inspection for corrosion with good results, suggesting the regularization from Panavia. Nevertheless further tests are still ongoing to solve problems due to overheating of the heating elements for insulating effect and aerodynamic erosion of the tape.
