Service Letter

PRODUCT SUPPORT PROGRAM FOR UPDATING THE CALIBRATION FILE ON THE ENGINE ELECTRONIC CONTROL MODULE (ECM) AND AFTERTREATMENT CONTROL MODULE (ACM), AND QUALITY LEVEL SENSOR (QLS) ON CERTAIN CT660, CT680, AND CT681 ON HIGHWAY TRUCKS EQUIPPED WITH A CT13 ENGINE

Media Number -TEBE5856-00

Publication Date -2017/06/29

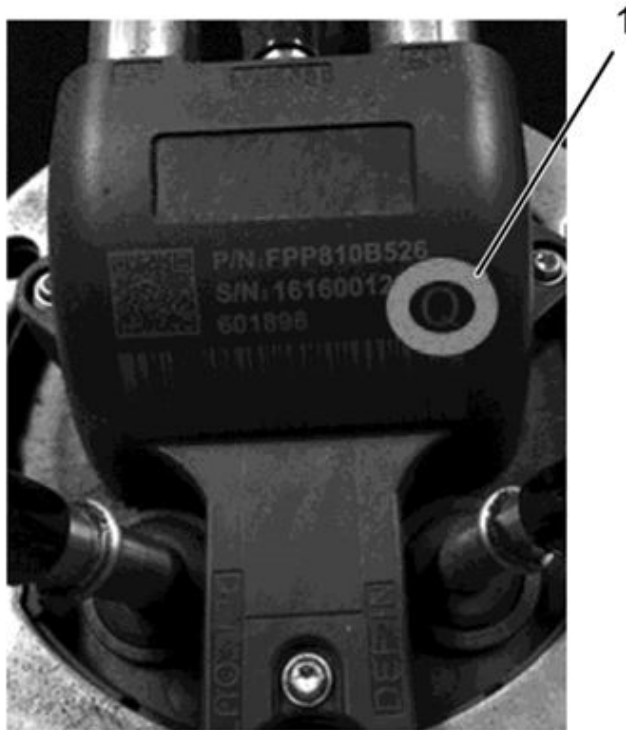
Image1.1.1

Image 1.1.1 Marked Sensor

1. Paint mark

6. Access and inspect Diesel Exhaust Fluid Quality Sensor (DQS) / Quality Level Sensor (QLS). If QLS has been previously replaced, a paint mark (Image 1.1.1, Item 1) will be present on sensor:

- a) If paint mark is present, proceed to Step 23.
- b) If paint mark is not present, proceed to Step 7.

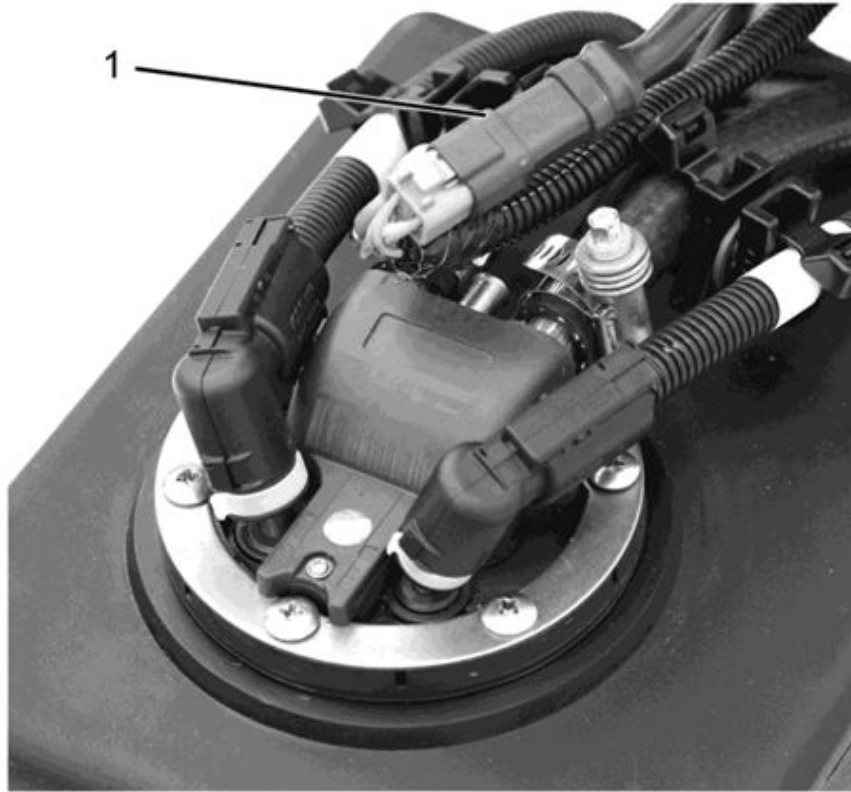
Image1.2.1

Image 1.2.1 QLS Sensor Harness - Tank Location
1. Harness

7. Remove cable wire tie securing DQS / QLS harness. Disconnect DQS QLS harness (Image 1.2.1, Item 1) from vehicle harness.

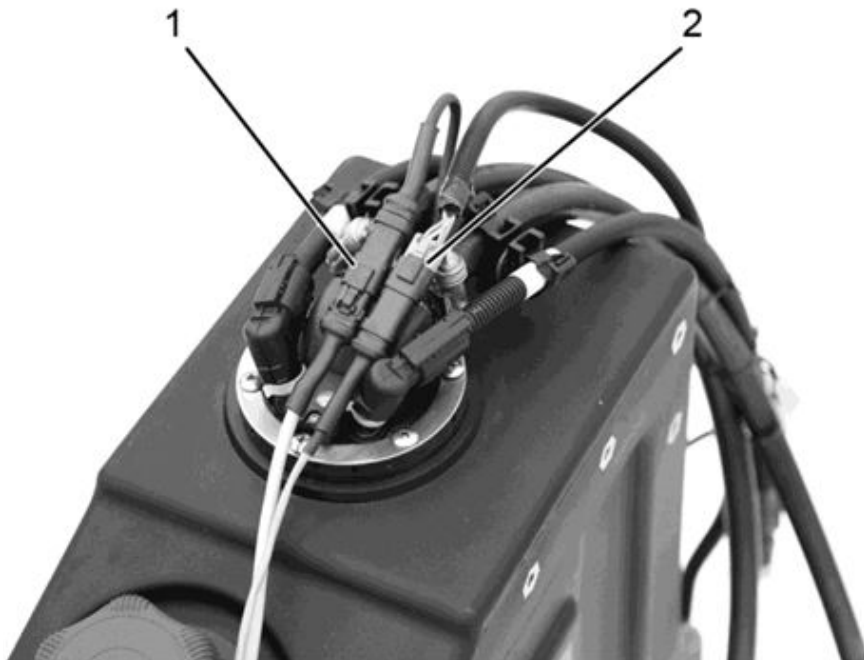
Image1.3.1

Image 1.3.1 QLS-CABLE Quality Level Sensor Reflash
Cable - Vehicle Connection

1. Sensor harness
2. Vehicle harness

8. Connect reflash cable between DQS / QLS harness (Image 1.3.1, Item 1) and vehicle harness (Image 1.3.1, Item 2).

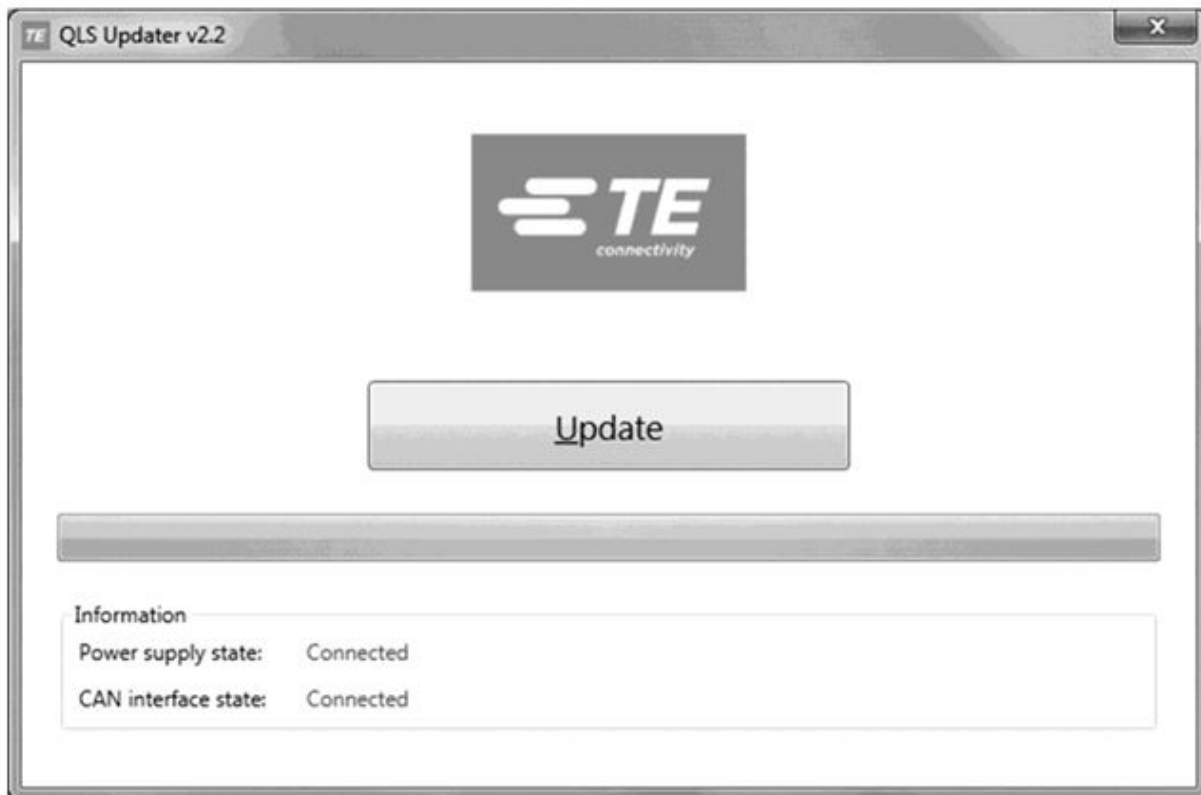
Image1.5.1

Image 1.5.1 QLS Updater - Connected Status

13. Verify on screen that QLS is properly connected (Image 1.5.1). If necessary, check harness connections to vehicle and service tool.

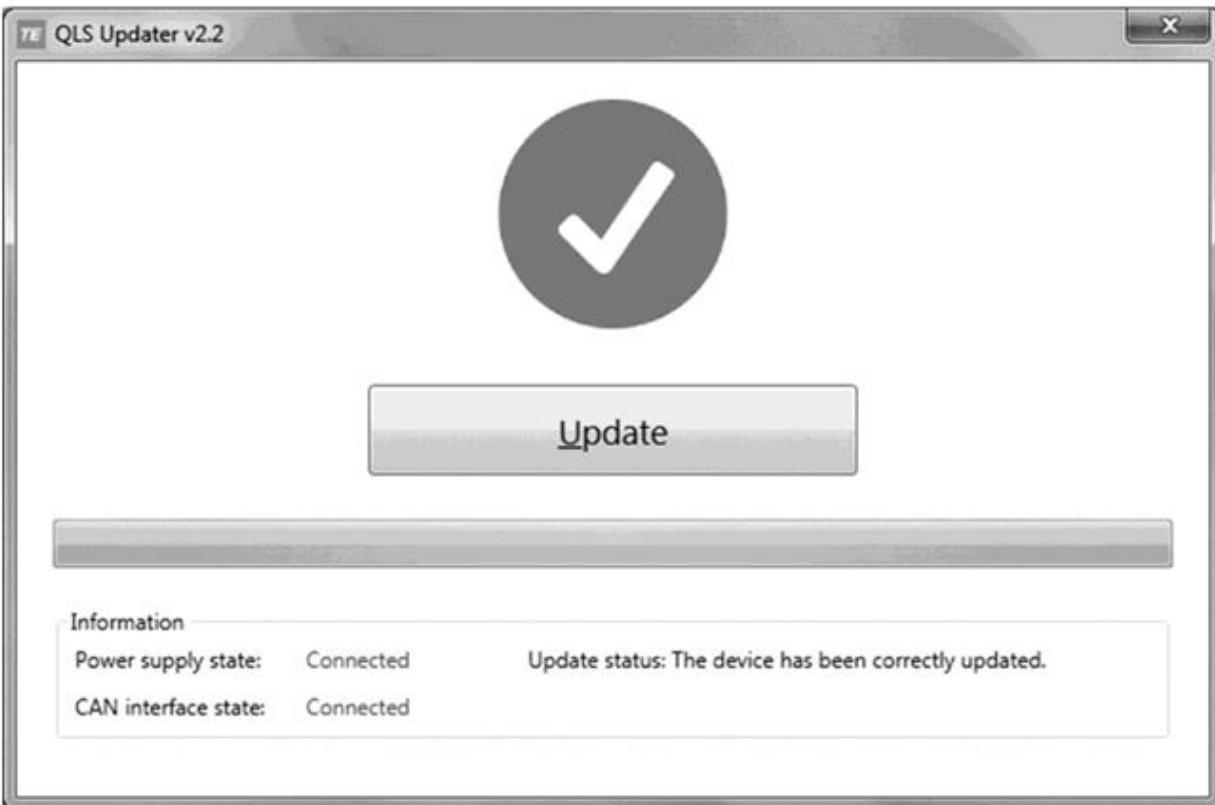
Image1.6.1

Image 1.6.1 QLS Updater - Successful Update

- a) If successful, a green checkmark will be shown (Image 1.6.1).
- b) If unsuccessful, an error message will display (Image 1.7.1). Verify all cable / harness connections are properly connected and click YES to try again.

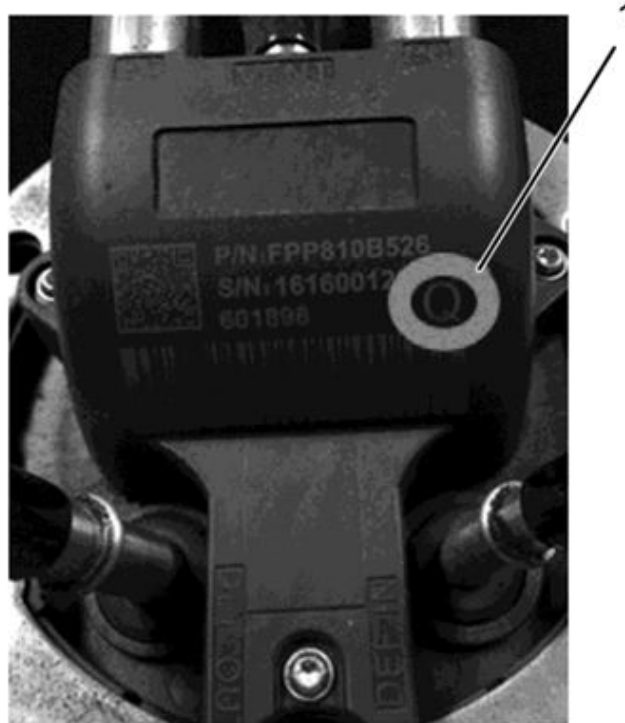
Image1.9.1

Figure 1.9.1 Marked Sensor

1. Paint mark

22. Using a yellow paint marker, mark successfully updated sensor with a paint mark (Figure 1.9.1, Item 1).
23. Connect ED (Engine Diagnostics) to vehicle.
24. Turn ignition to key ON, engine OFF position.
25. Verify that ECM has latest software.
