AAIPU# A14-005111

AIRCRAFT ACCIDENT REPORT

**CONTROLLED FLIGHT INTO TERRAIN (OBSTACLE)
DIPLOMAT AVIATION (BAHAMAS) LTD.
GATES LEARJET MODEL 35A**

**GRAND BAHAMA SHIPYARD
FREEPORT, GRAND BAHAMA, BAHAMAS
NOVEMBER 9, 2014**

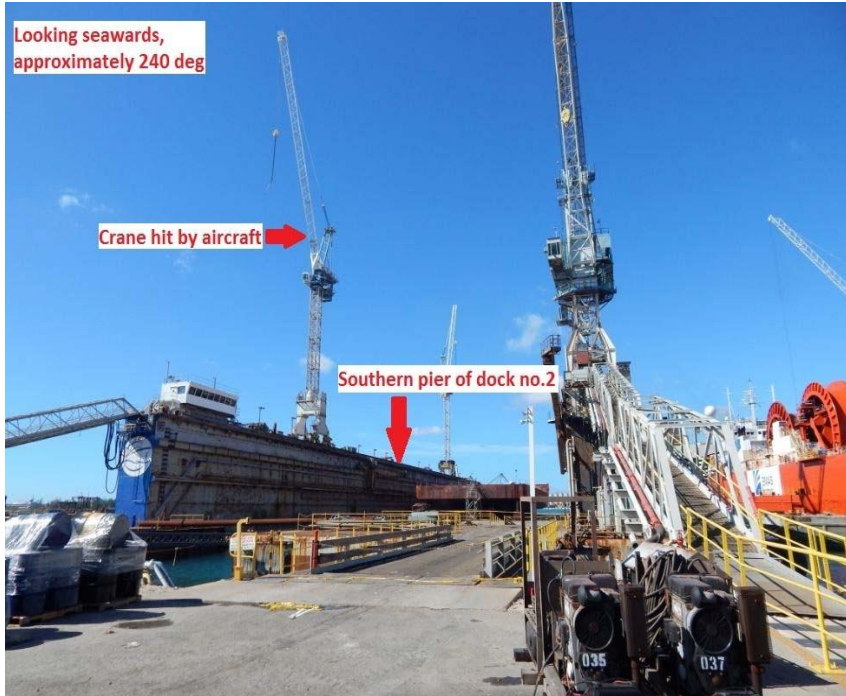
Wreckage at Site 1

At site 1, various small pieces of aircraft wreckage consistent with wing and wing tip tank structure were found on the southern pier of dock number 2, starting around pier frame 21. The wreckage on the pier appeared to extend inland to pier frame 11. A crane, identified as the point of impact, was located at pier frame 18. A GPS measurement at the north side of the pier at frame 18 was taken: N 26 deg 31.617 min, W 078 deg 45.363 min, elevation 89.9 feet.

Pieces of wreckage consistent with wing and wing tip tank structure were found at various points on the ladder platforms accessing the crane.

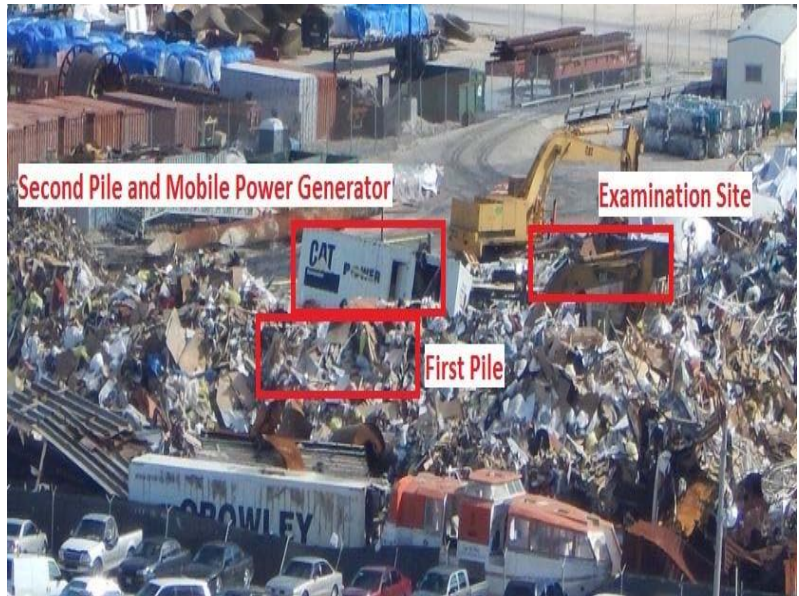
The forward fuselage of the aircraft had come to rest after impacting the side of the mobile power generator. The mobile power generator appeared to show some evidence of fire damage on the top. It was not determined whether this fire damage was as a result of the impact with the aircraft or whether this fire evidence was previously on the generator unit.

The fuselage, wings, cockpit and left-hand engine had been moved from their final resting place to an examination site to facilitate removal of human remains; the right-hand engine, horizontal stabilizer and vertical stabilizer had not been moved from the final resting point. The examination site was on the far side of the mobile power generator along the direction of travel of the aircraft.

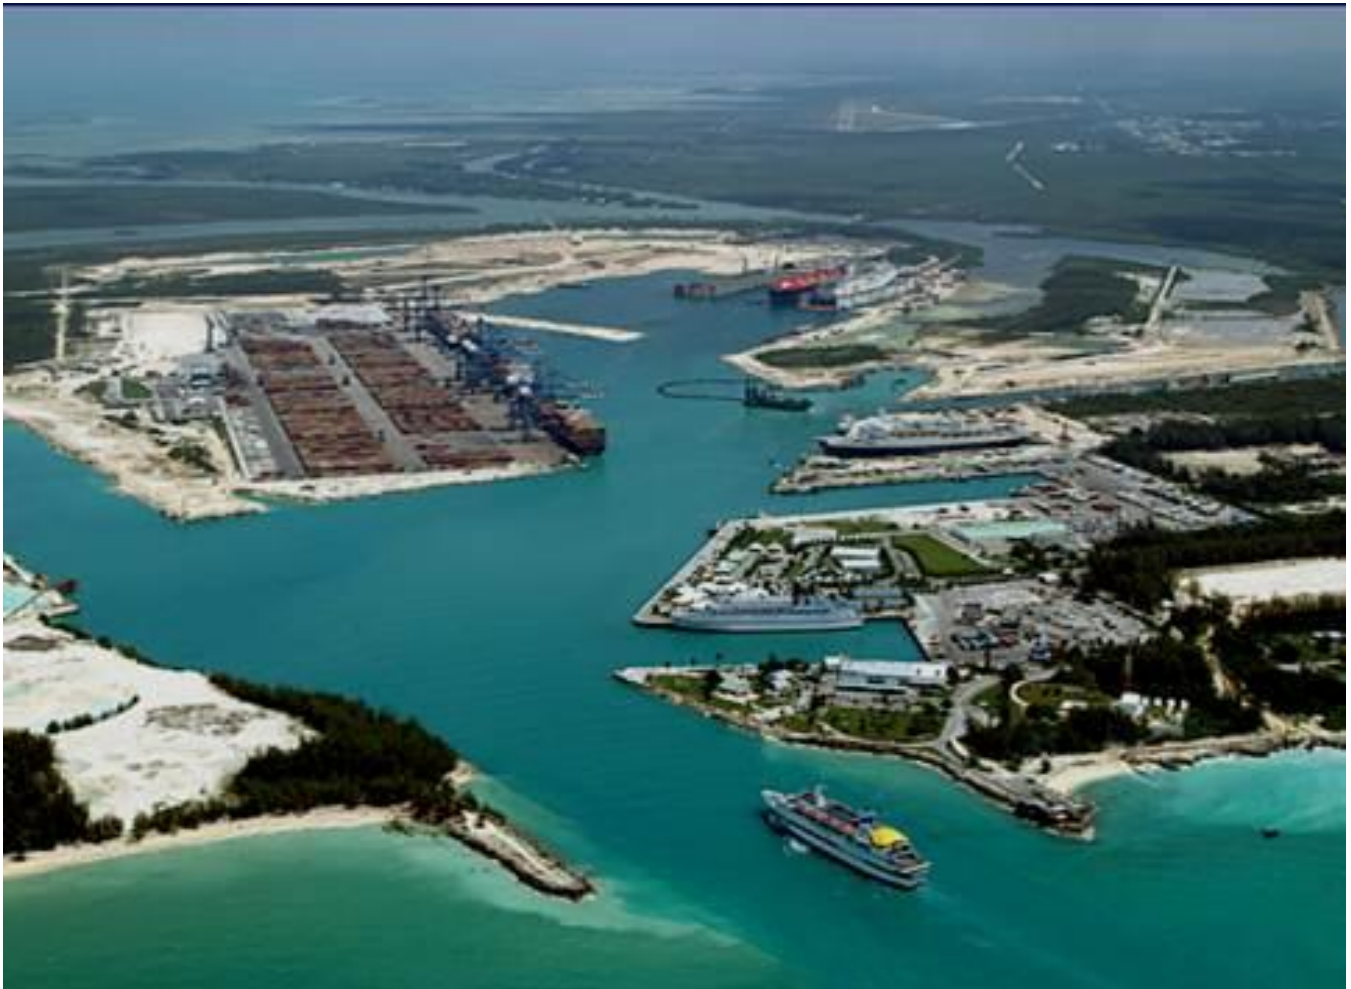
APPENDIX 2 Overview of Approach to Runway 06

View of the airport and runway as you approach runway 06 over the Harbour. Note that the shipyard lies directly under the path of operations to runway 06 on approach and under the path of departures on runway 24.

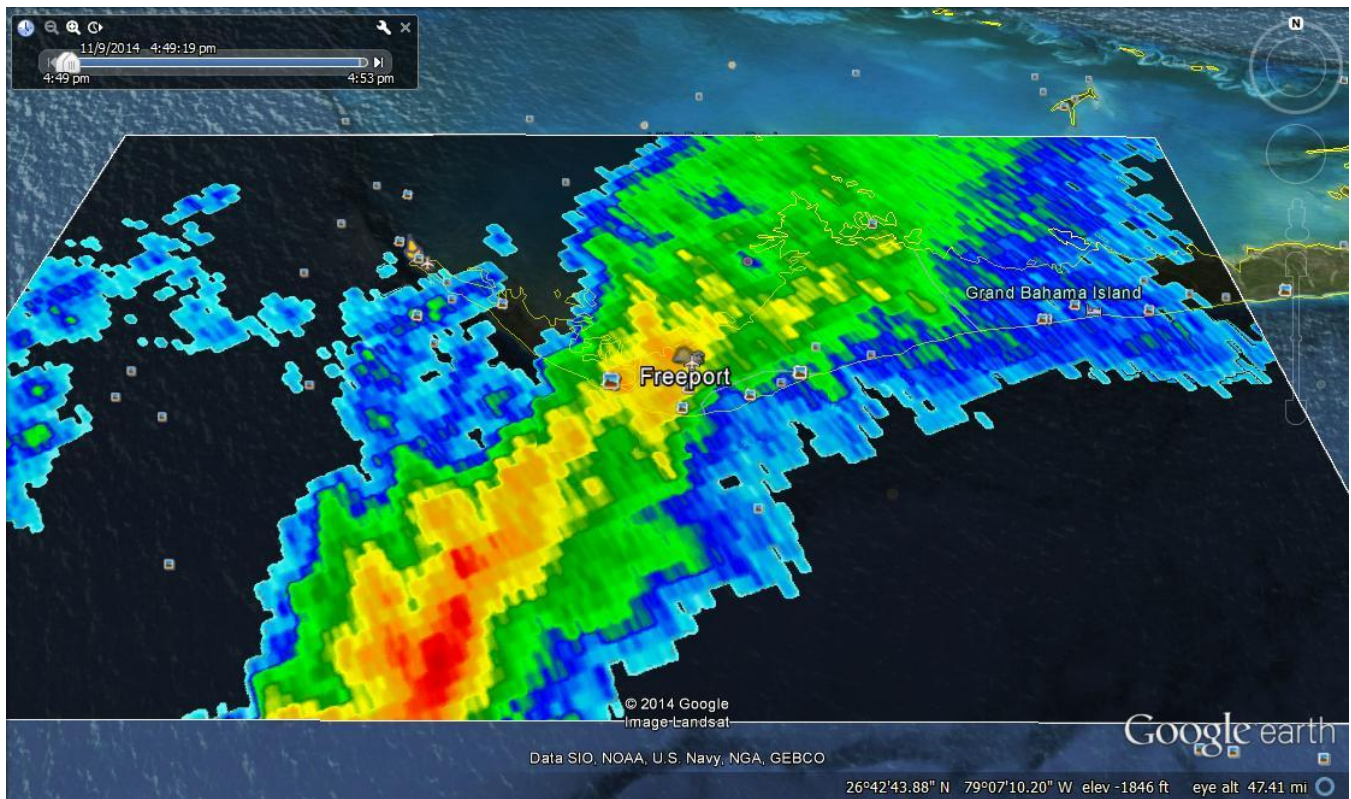
APPENDIX 3 Overlay of Weather conditions over Freeport before and after the accident

Overview of the weather overlay over Freeport Grand Bahama, as shown on Google Earth during the period 4:49pm to 4:53pm (3minutes prior and 1 minute after the accident)

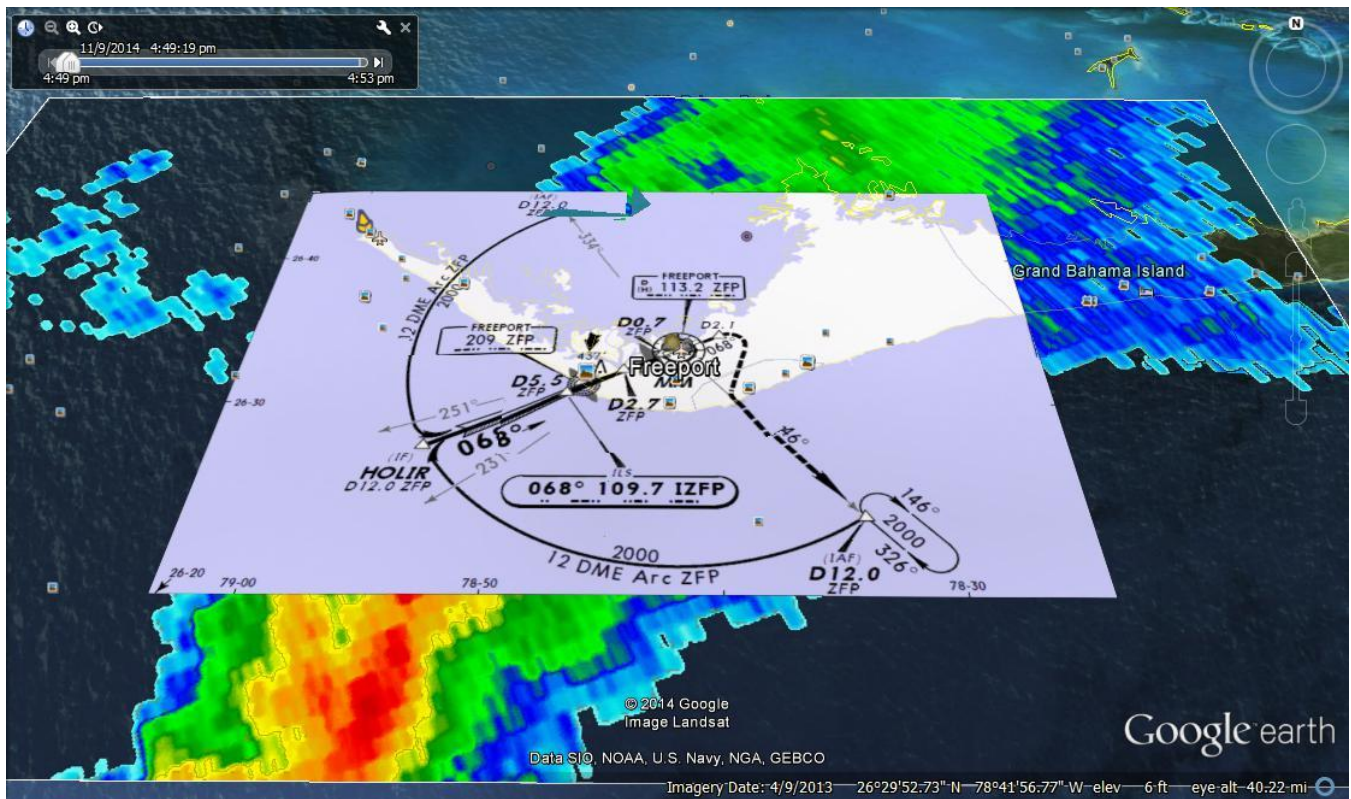
APPENDIX 4 Overlay of Weather Conditions Approach Chart over weather

Overlay of the Instrument Approach Chart for ILS z RWY 06 over the weather conditions at Freeport. This chart also overlaid during the period 4:49pm to 4:53pm the time during which the accident occurred.

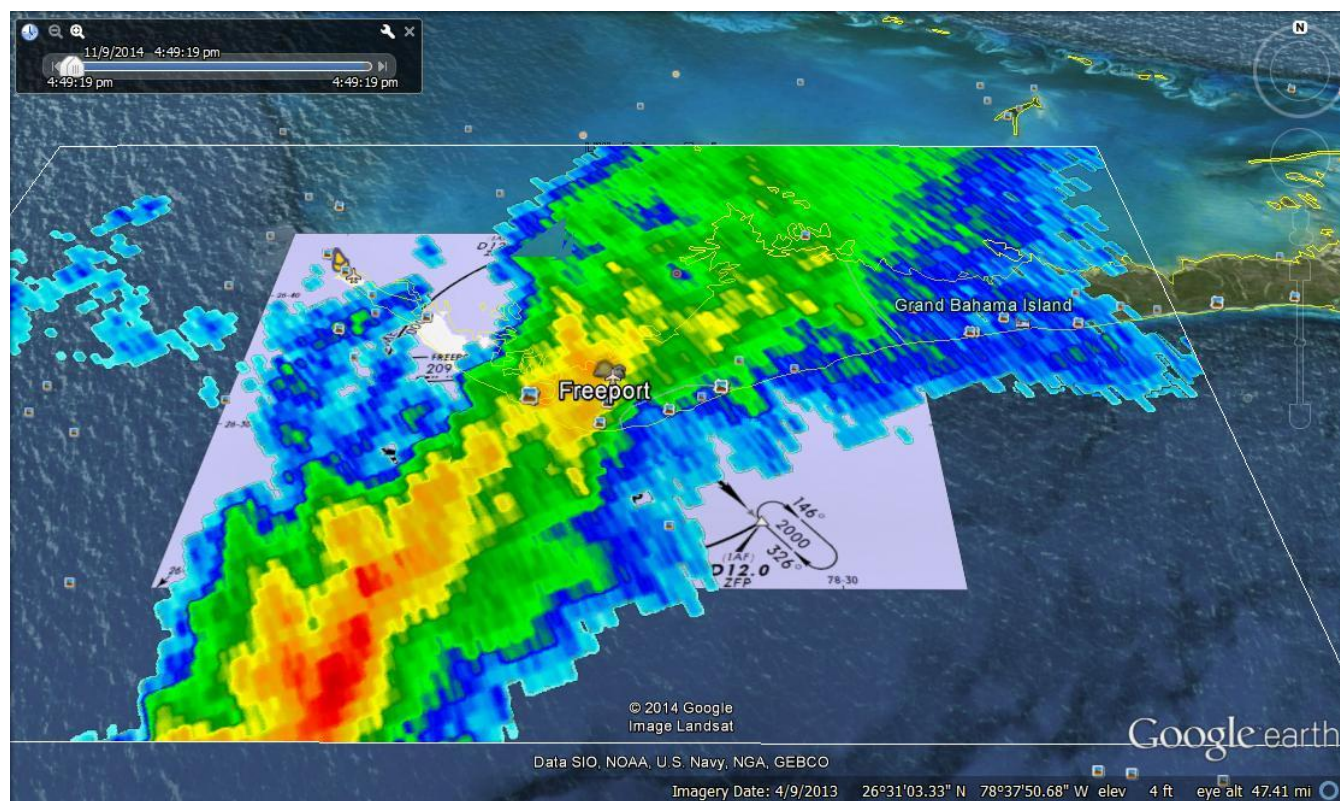
APPENDIX 5 Overlay of Weather Conditions Approach Chart under weather

Overlay of the Instrument Approach Chart for ILS z RWY 06 under the weather conditions at Freeport. This chart also displayed during the period 4:49pm to 4:53pm the time during which the accident occurred.

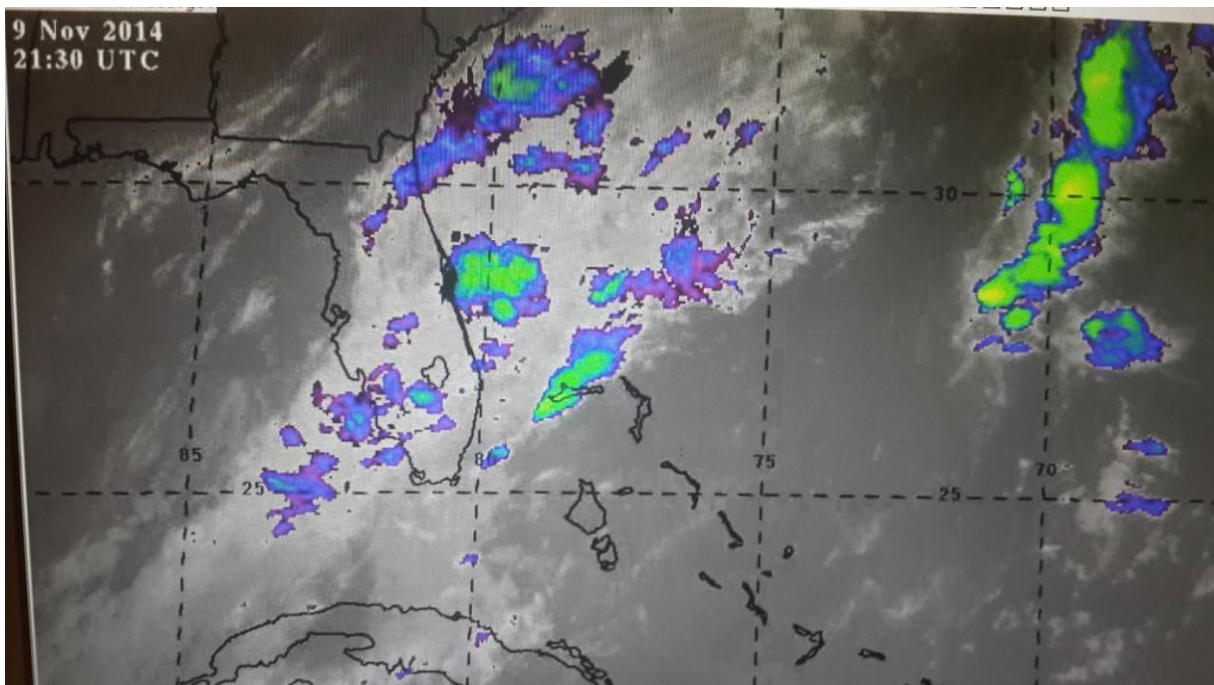
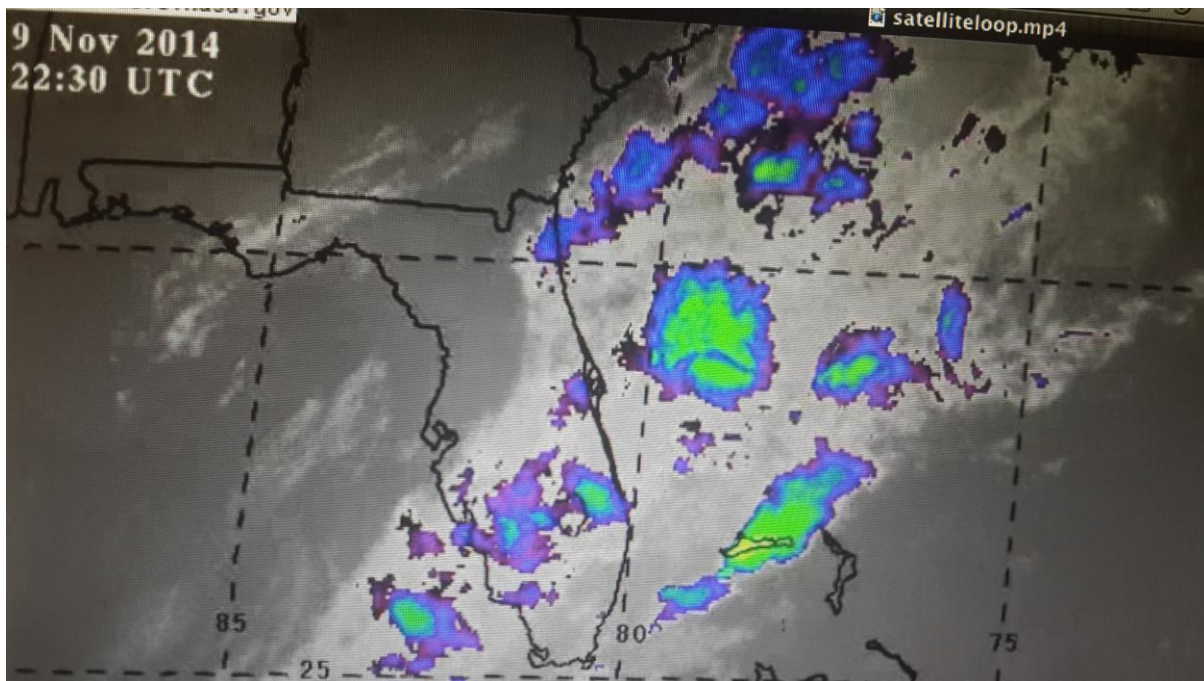
Above both Satellite loops show a period between 4:30 pm and 5:30pm where weather was present over the Freeport area. Weather intensity varied significantly during the period.

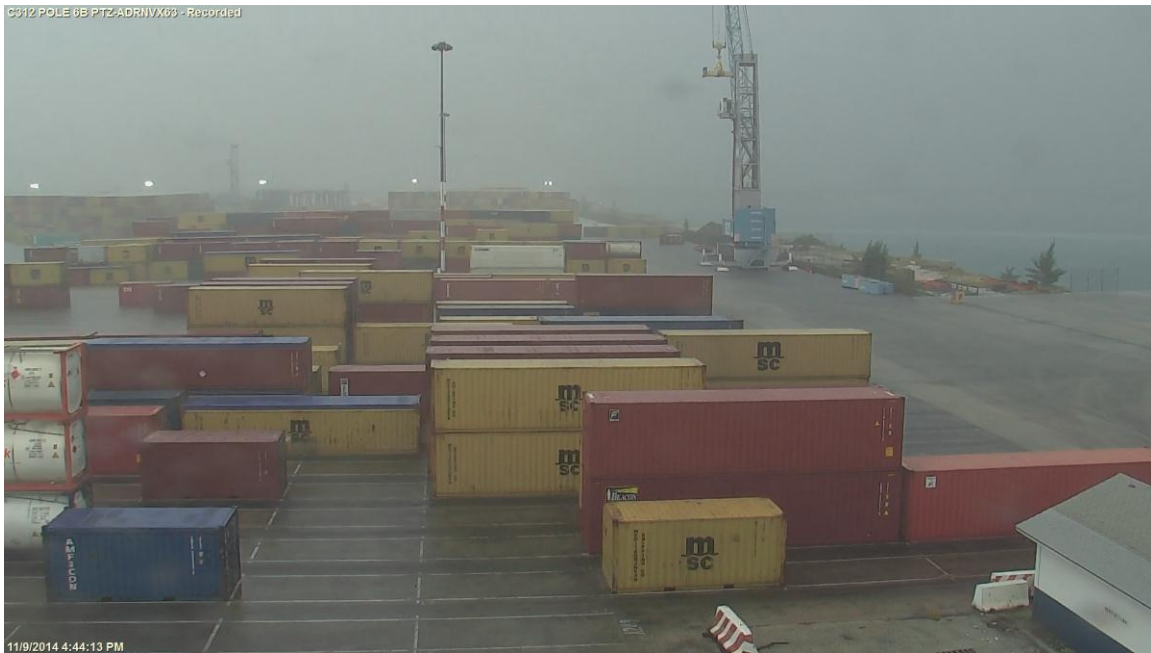
Weather conditions looking toward the airport taken from Camera located at an industry partner camera system at 4:44pm (8 minutes before the accident)

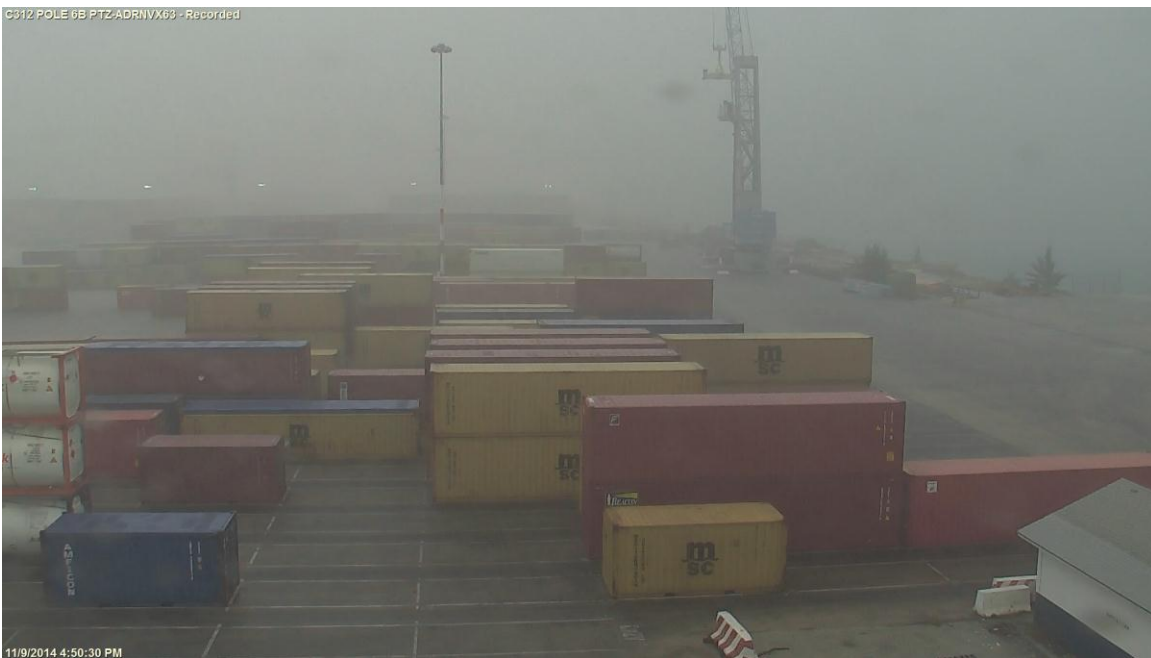
Weather conditions looking toward the airport taken from Camera located at an industry partner camera system at 4:50pm (2 minutes before the accident)

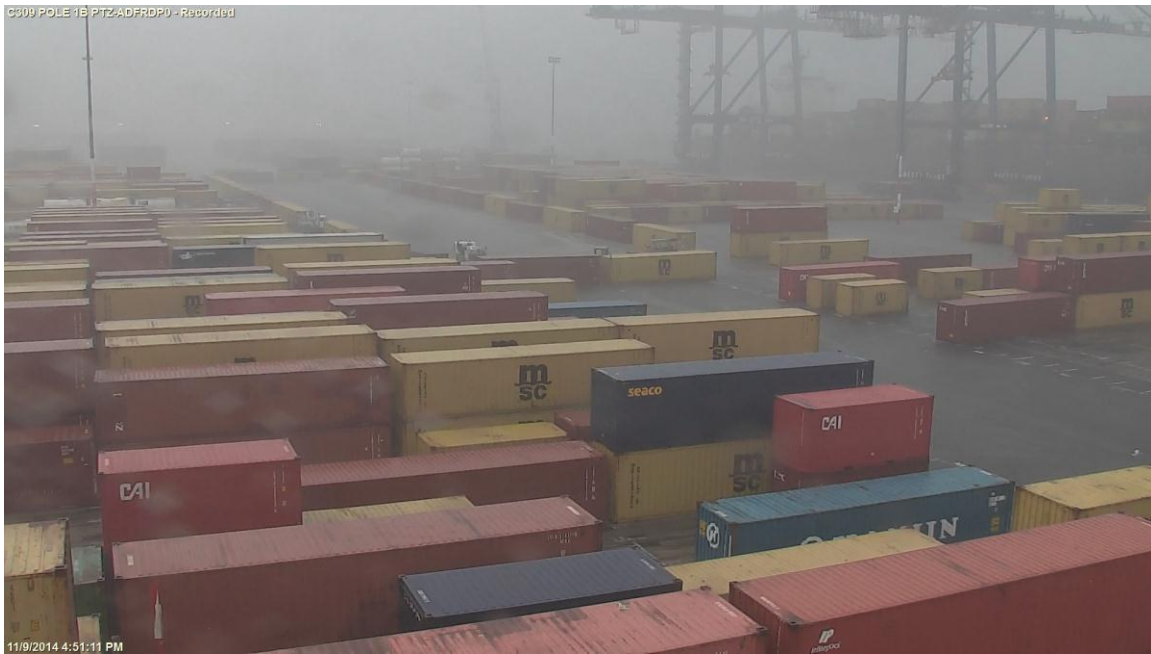
Weather conditions looking toward the airport taken from Camera located at an industry partner camera system at 4:51pm (less than 1 minute before the accident). This camera also captured the footage of the actual impact of the aircraft with the crane. (Footage not displayed or presented in this report).

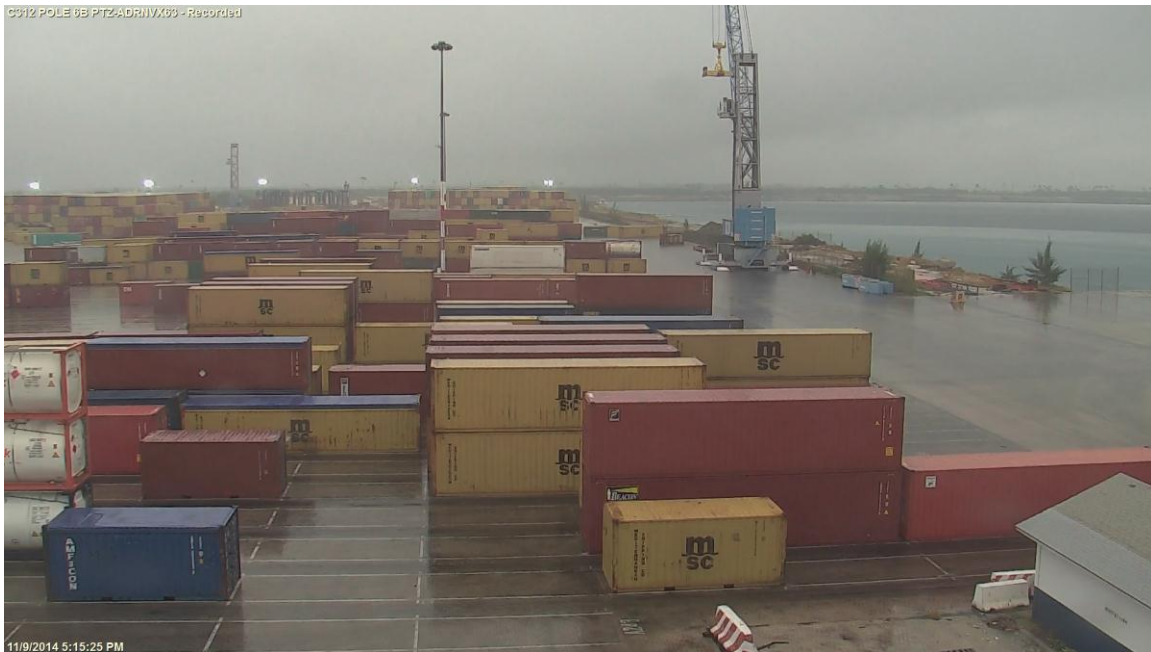
Weather conditions looking toward the airport taken from Camera located at an industry partner camera system at 5:15pm (22 minutes after the accident)

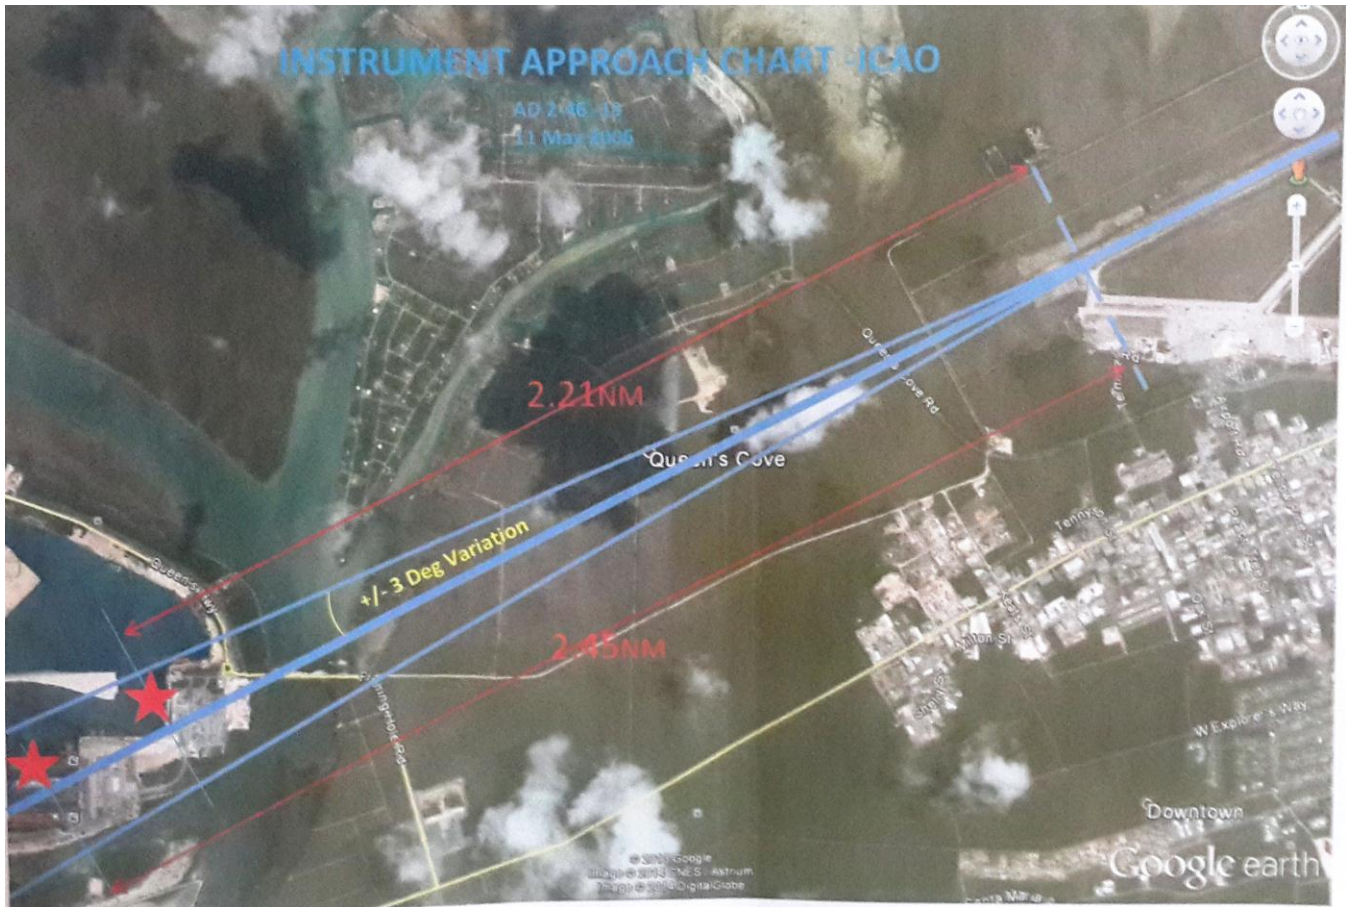
APPENDIX 9 Instrument Approach Chart Rwy 06 Google Earth View

Approach plate-showing path of flight in relation to GB Shipyard and airport.

Note 1: Stars on chart shows location of GB Shipyard (site 1) and location of City Services (site 2) where the aircraft ended up.
