Subject: - Interim Investigation Report of accident 737-8 MAX ET-AVJ, ET-302

**Aircraft Accident Investigation Bureau
Interim Investigation Report on
Accident to the B737-8 (MAX) Registered ET-AVJ operated by
Ethiopian Airlines
On 10 March 2019**

09 March, 2020

Report No. AI-01/19

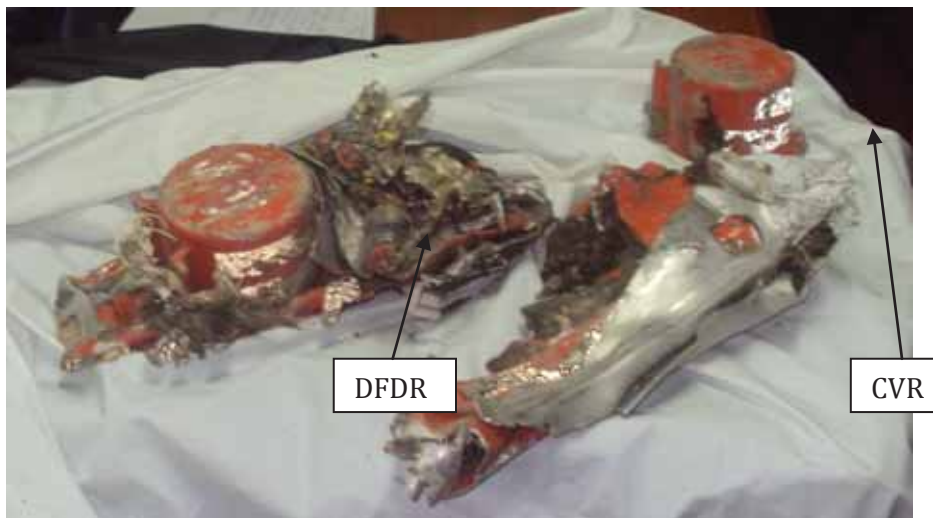
The Aircraft was equipped with a Digital Flight Data Recorder (DFDR) and Cockpit Voice Recorder (CVR), which were located in the aft cabin and aft cargo hold (respectively) section of the aircraft.

FIGURE 24: DFDR AND CVR AS DISCOVERED ON THE ACCIDENT SITE.

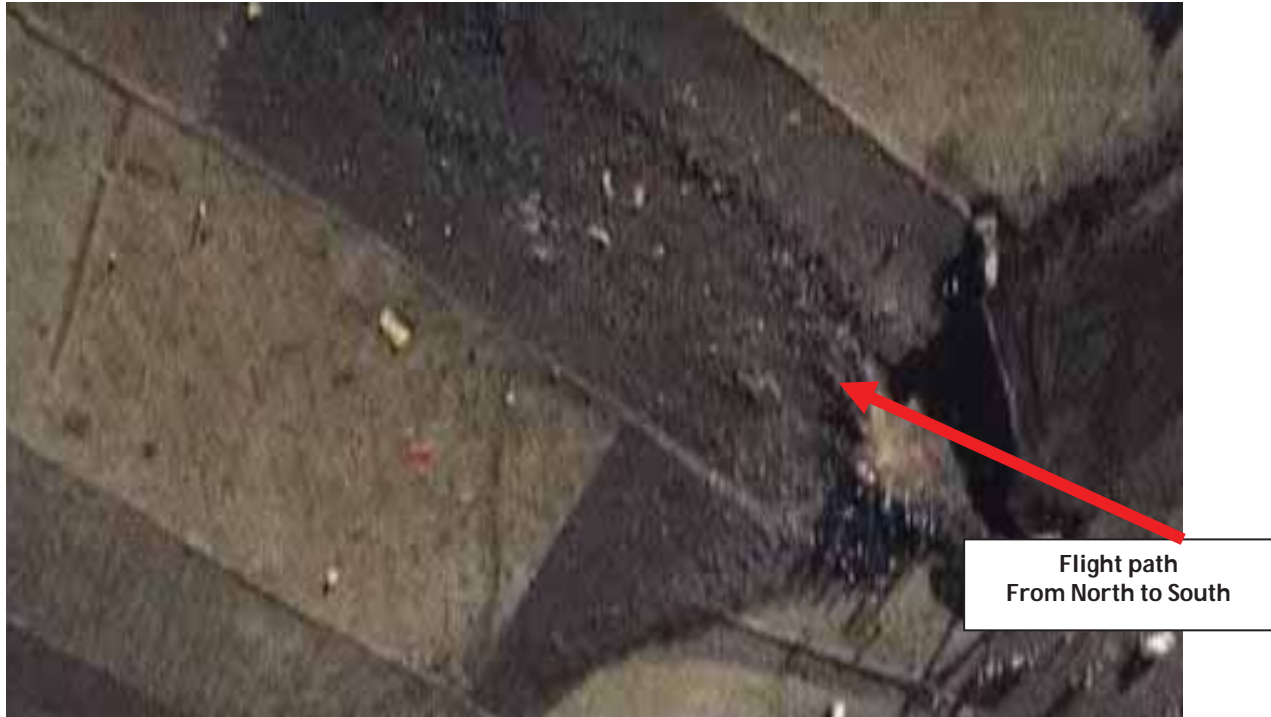
scattered around the site in an area by about 200 meters width and 300 meters long. The damages to the aircraft are consistent with a high energy impact.

FIGURE 32: TOP VIEW OF THE CRATER

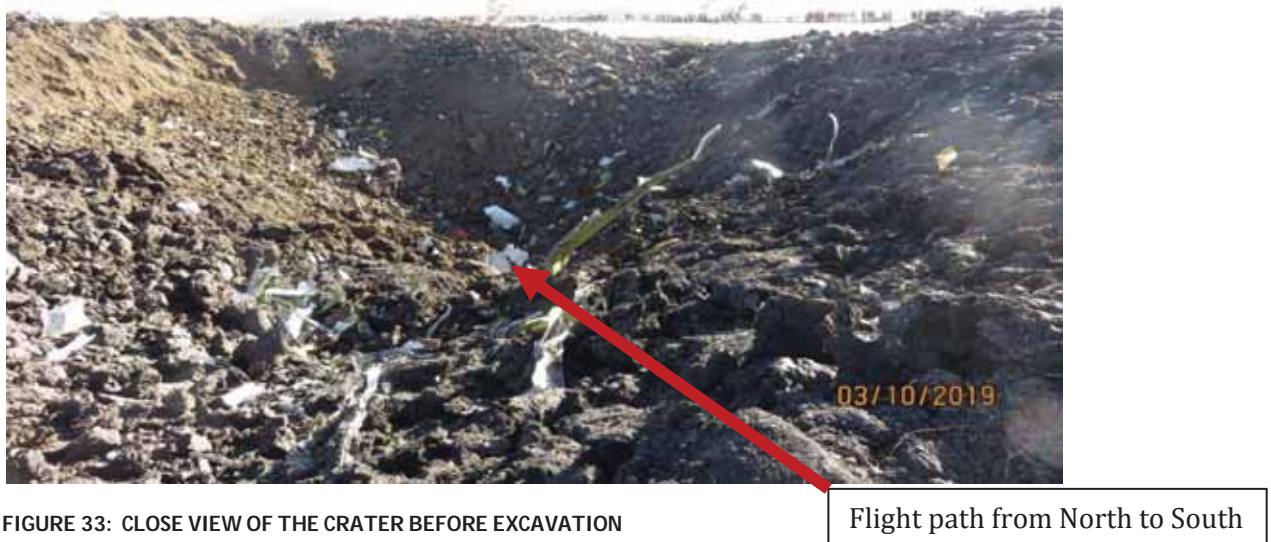
FIGURE 33: CLOSE VIEW OF THE CRATER BEFORE EXCAVATION

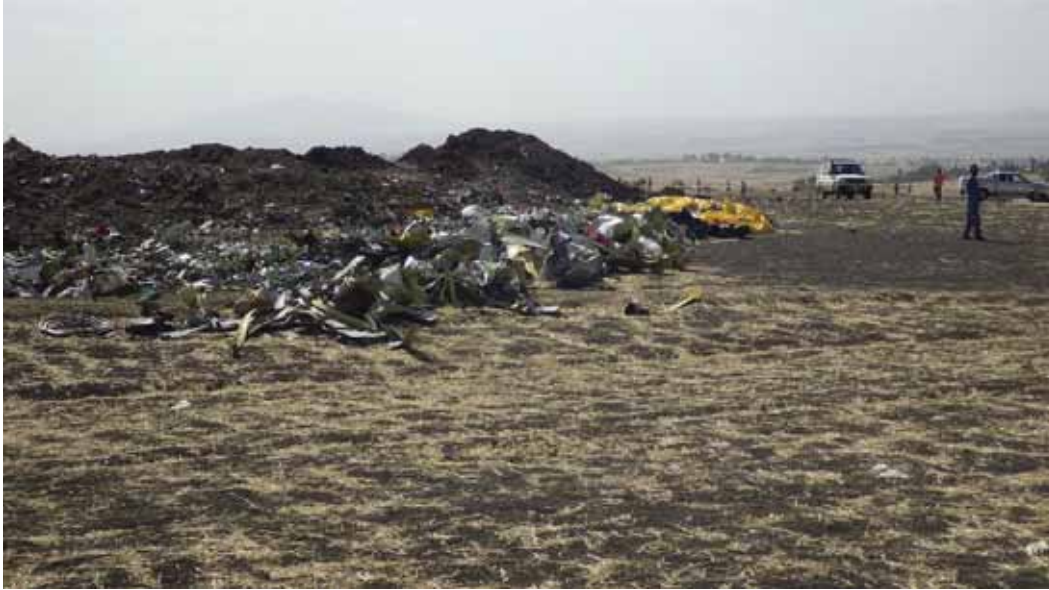
FIGURE 34: ACCIDENT SITE

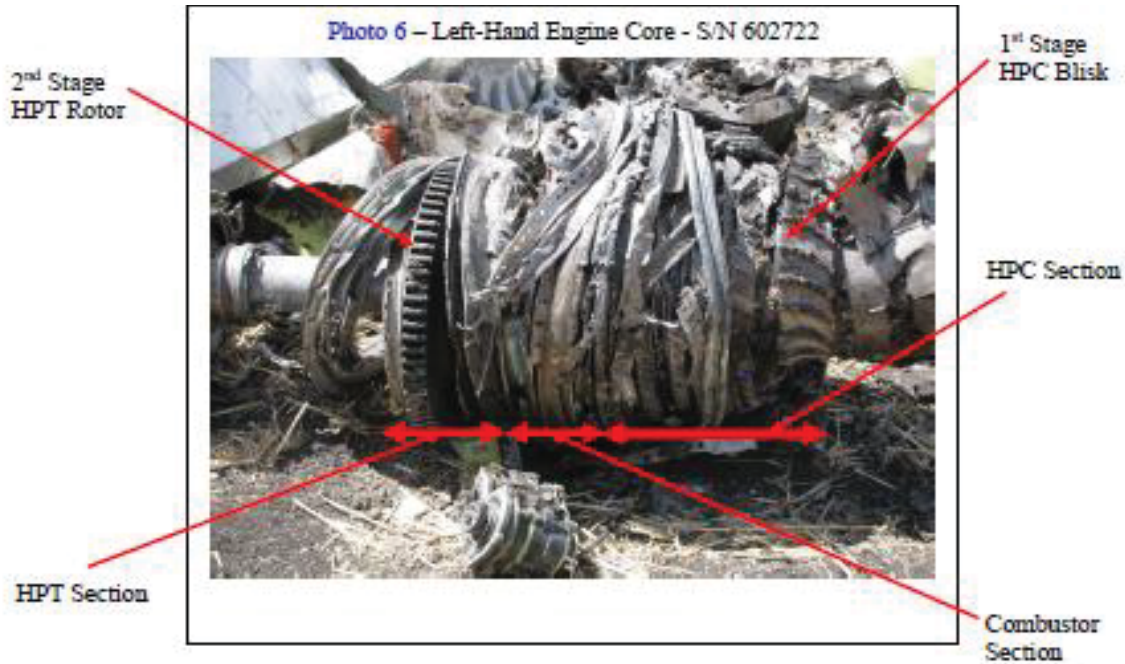
The left engine core was recovered from the site and examined by the group. The engine was reportedly recovered at a depth of approximately 10 to 15 meters depth on the left side of the excavation site. The predominant feature of the deformation of the entire remaining core was axial deformation.

FIGURE 35 : LEFT HAND ENGINE SECTION

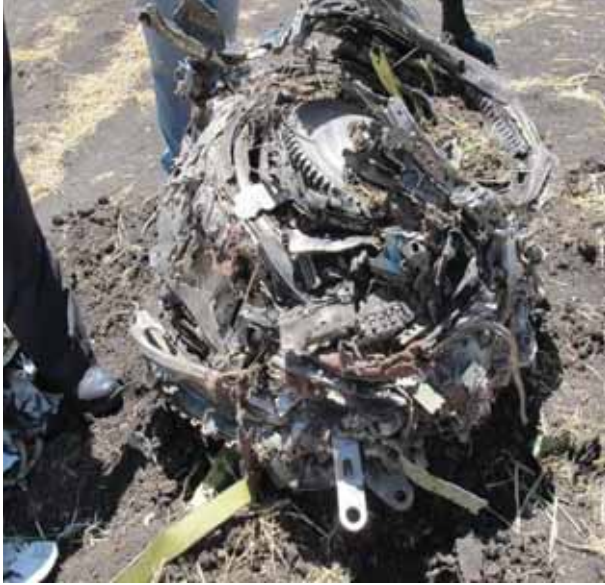
The predominant feature of the deformation of the entire remaining core was axial deformation.

FIGURE 36: R/H ENGINE - S/N 602695 – CORE

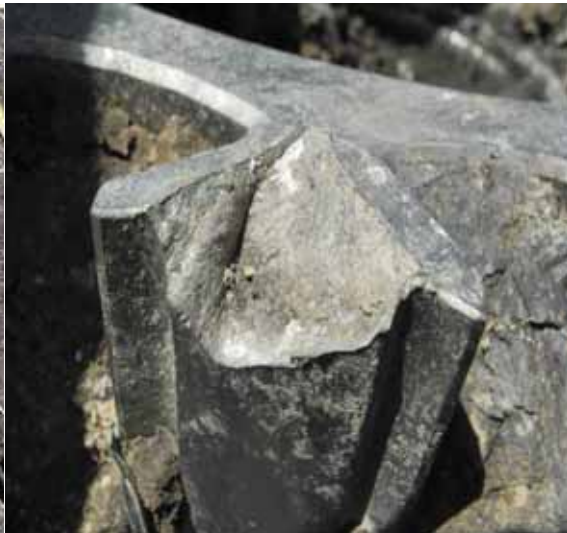
FIGURE 39: R/H ENGINE - S/N 602695 - RETENTION LUGS - FRACTURED

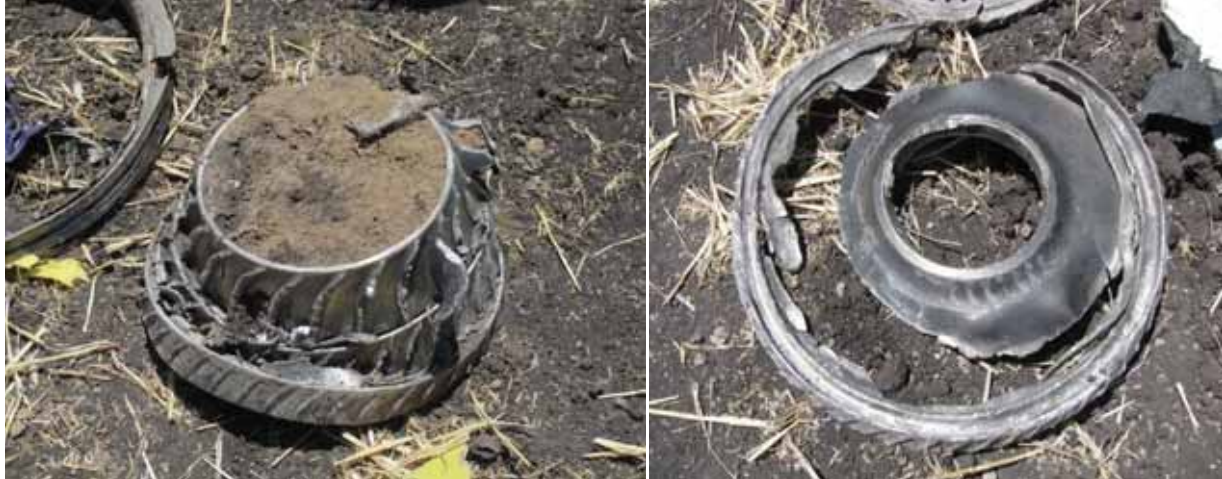
The HPC case was fractured and a portion of it remained with the core and the HPC stages were separated from the core. The 1st, 2nd and 3rd stage blisks were found together and were missing their airfoils. The 4th, 6th, and the 8th to 10th stages were not found. The 5th stage was found separately, and it was also missing its airfoils. The 7th stage web was fractured circumferentially. The stator sections could not be identified.

FIGURE 40: - R/H ENGINE - S/N 602695 – HPC STAGES 1 TO 3 FIGURES 41:- R/H ENGINE - S/N 602695 – HPC STAGE 7

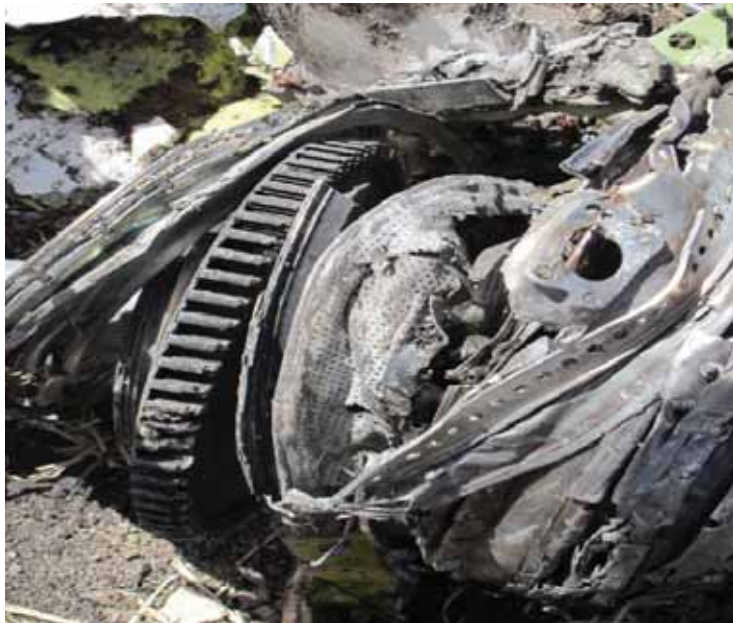
The combustor was severely crushed and most of it was missing into pieces.

FIGURE 42 : COMBUSTOR CRASHED

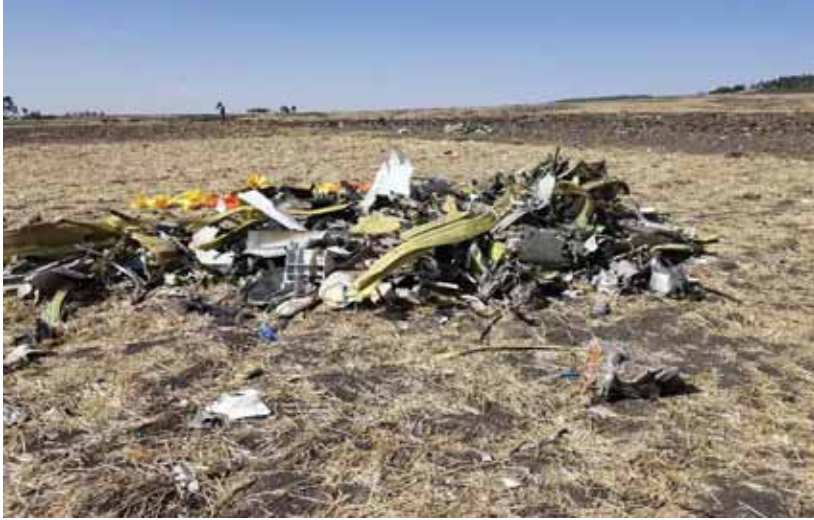
FIGURE 43: RECOVERED WRECKAGE PILE ON THE SITE

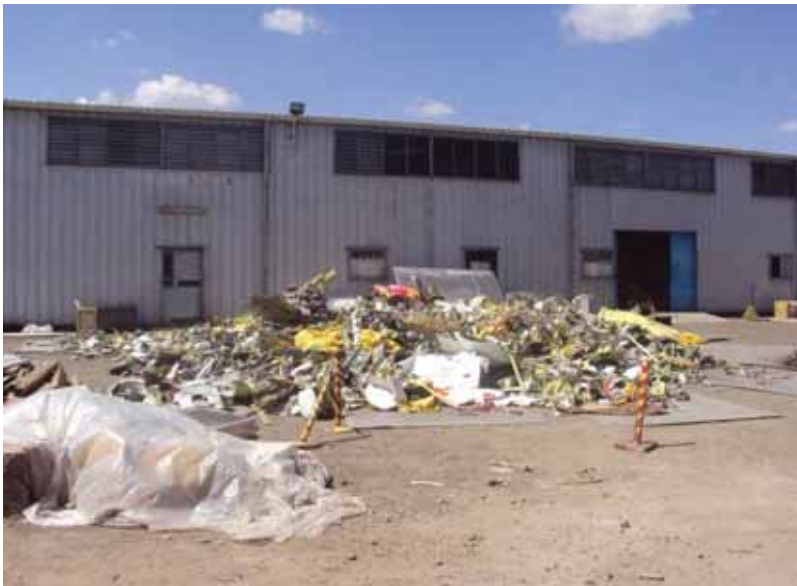
The investigation team had much of the wreckage moved from the impact site to a secured location on Addis Ababa AIB store. The wreckage pile measures approximately 5' high and about 30' in diameter. Assistance from Ethiopian Airlines recovered a number of flight control components – some are documented above during the on-site examination. Below is a detailed exam of each of the identified components.

FIGURE 44: RECOVERED WRECKAGE PILE

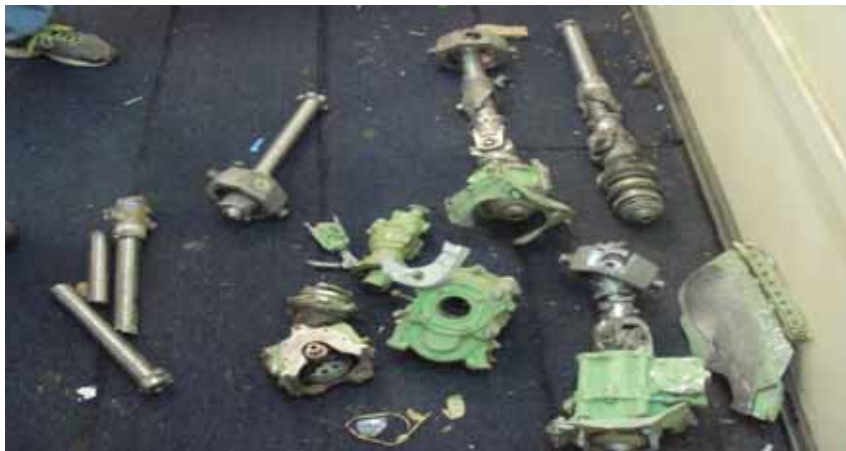
During the examination of the wreckage pile located at the Addis Ababa airport AIB store, the Airworthiness group identified a total of 4 (including the ones identified at the impact site) trailing edge flap transmissions (there are 8 total); three of these had the ball nut and gimbal still attached.

FIGURE47: TRAILING EDGE FLAP TRANSMISSIONS AND BALL SCREWS

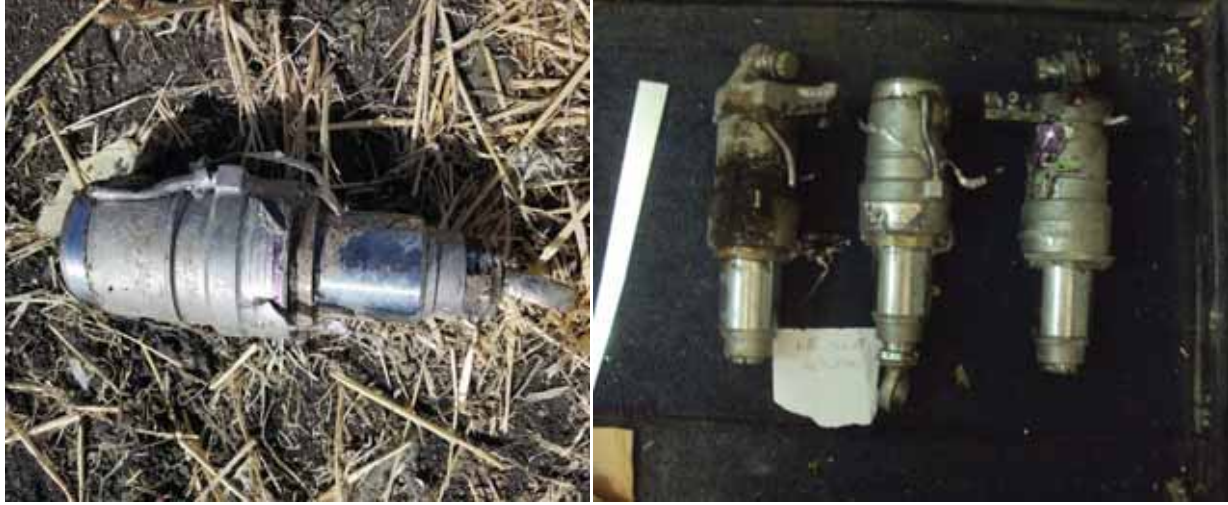
During the examination of the wreckage pile located at the Addis Ababa airport AIB store the Airworthiness group identified a total of three leading edge slat actuators at the impact site. The actuator position, as photographed, are in the fully retracted position,

FIGURE 48: SLAT ACTUATOR (POSITION UNKNOWN)

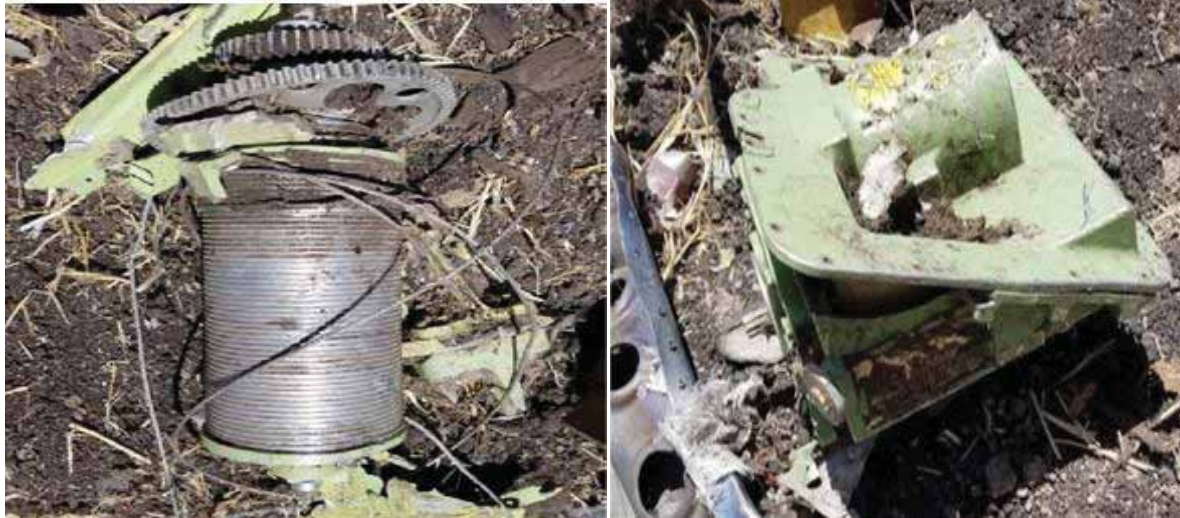
Two parts of the control system were located and examined at the impact site. One consists of aft cable drum; the other consists of the stab trim actuator (see Figures below respectively). These components do not provide any evidence of what position the horizontal stabilizer may have been at the time of impact.

FIGURE 50:AFT CABLE DRUM

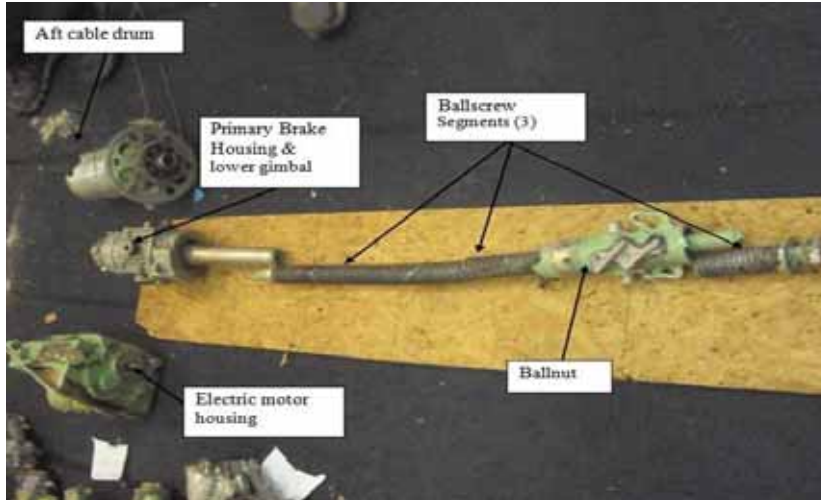
The figure below shows the relationship of the ballnut position along the ball screw. There is a safety rod which acts as a secondary load path should the ball screw fracture in service for any reason. It is attached to a separate set of secondary gimbals below the primary support gimbals on the primary brake housing and to the top of the ball screw. Figure 54 shows the safety rod and that it protrudes out from the ball nut. However, the fracture faces on the 5" long upper screw portion (note the measurement in Figure 53) match those found near the ballnut upper stop. This is consistent with the safety rod being pulled out several inches prior to final fracture.

Figure52 : recovered Stabilizer Trim components

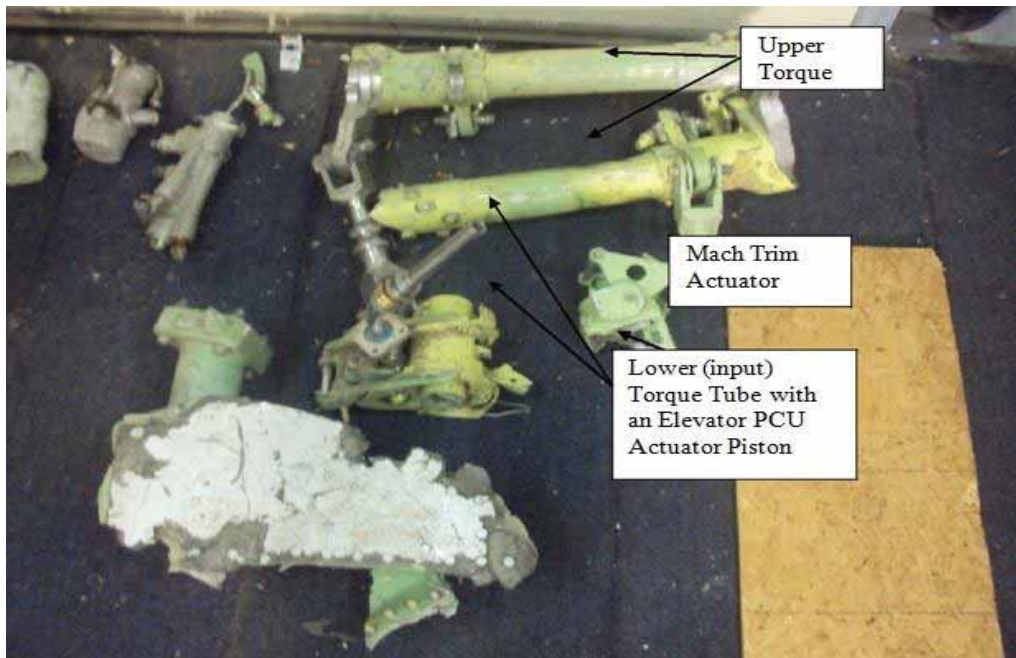
FIGURE55: ELEVATOR PCU ACTUATOR PISTON
