Aircraft Accident Investigation Report

**NATIONAL
TRANSPORTATION
SAFETY
COMMITTEE**

BOEING 737-4Q8

**MAKASSAR STRAIT, SULAWESI
REPUBLIC OF INDONESIA**

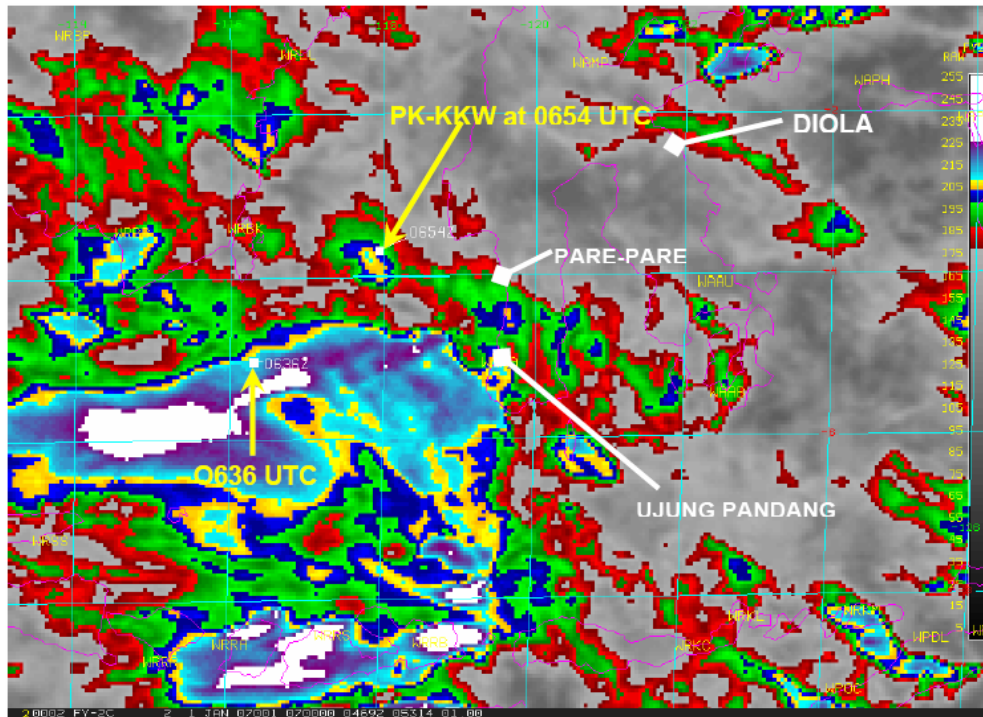
Figure 3: Convective activity weather map of 07:00 UTC showing location of PK-KKW near severe weather cell at 06:54 UTC

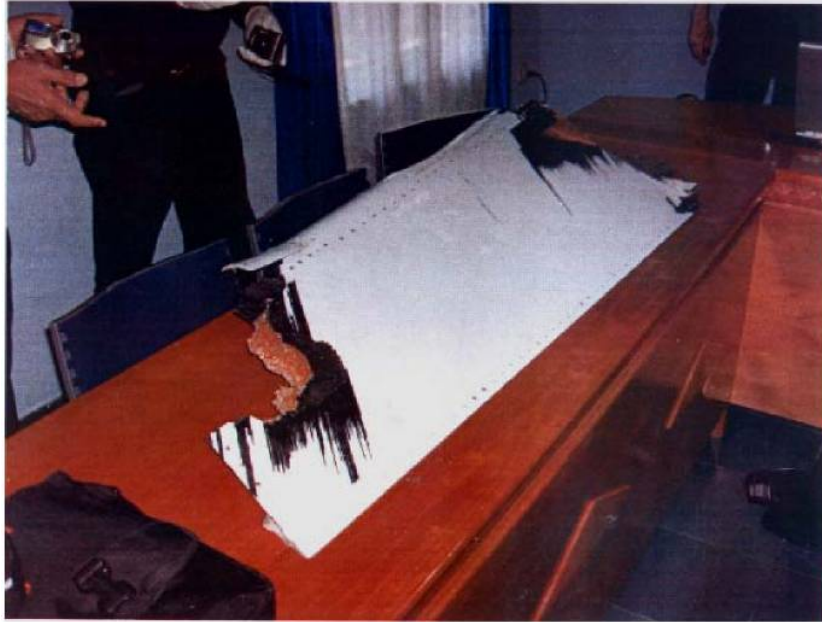
- The outboard section of the right elevator, left elevator, and two pieces of elevator tabs.
- One spoiler panel.
- Several fragmented composite panels probably from a horizontal stabilizer, one cabin floor panel.
- One passenger seat cushion with a fabric pattern that matched the passenger seat on other AdamAir aircraft, and several additional seat cushions without fabric covers.
- Several mangled and crushed seat trays from the backs of passenger seats.
- A small amount of personal effects; an empty briefcase and a passenger's personal identity card.

Figure 12: Outboard section of right elevator

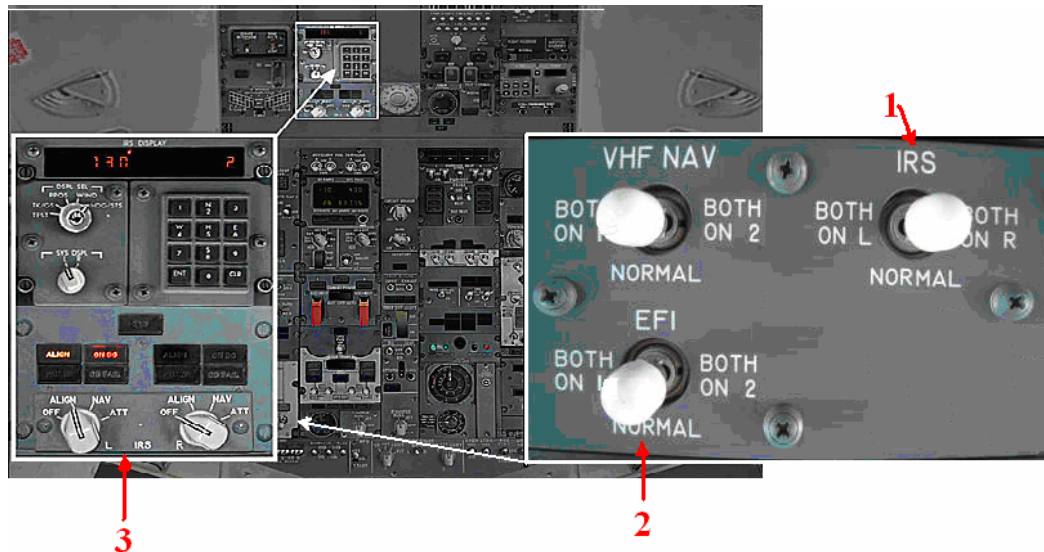
An assessment of the DFDR data indicates that the IRS Transfer switch was either in the *Normal* or *Both ON L* position. Based on this data, the PIC's EADI and EHSI would have received IRS data from the Left IRU and copilot's EADI and EHSI could have received IRS data from either the Left or Right IRU.

The IRS transfer switch is wired to the DFDR system to switch the DFDR to record data from the same IRU source that is feeding the PIC's EFIS displays. The state of the IRS transfer switch is also a one "bit" parameter that is recorded on the DFDR. This parameter is "0" when the switch is in the *Normal* or *Both ON L* positions. The state of this bit is a "1" when the switch is in the "Both ON R" (copilot) position. The DFDR recording shows that this parameter never changes state from "0" to "1", but remained "0" throughout the flight indicating that the IRS transfer switch remained in the *Normal* or *Both ON L* position.

Figure 14: Boeing 737-400 overhead instrument panel

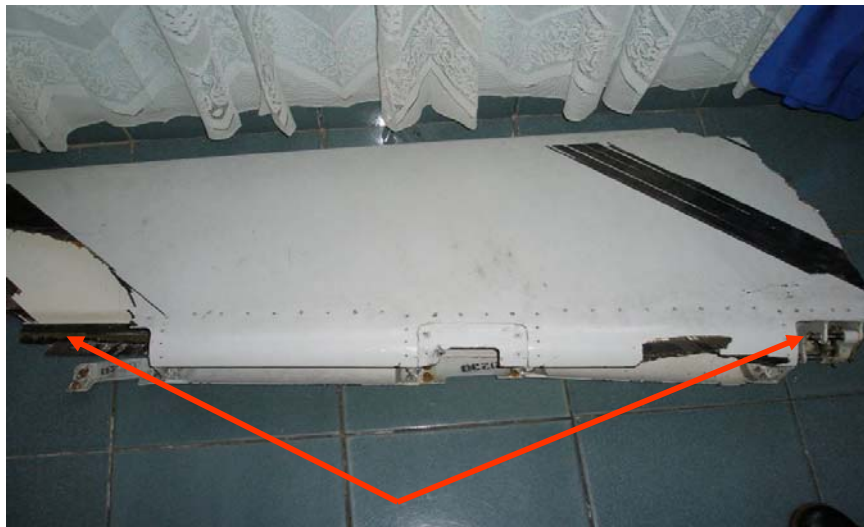
Figure A2 : Part of right elevator showing upper surface (Red arrows point to hinges). Found floating in the sea close to Sulawesi island (between Pare-pare and Baru, South Sulawesi) Makassar Strait

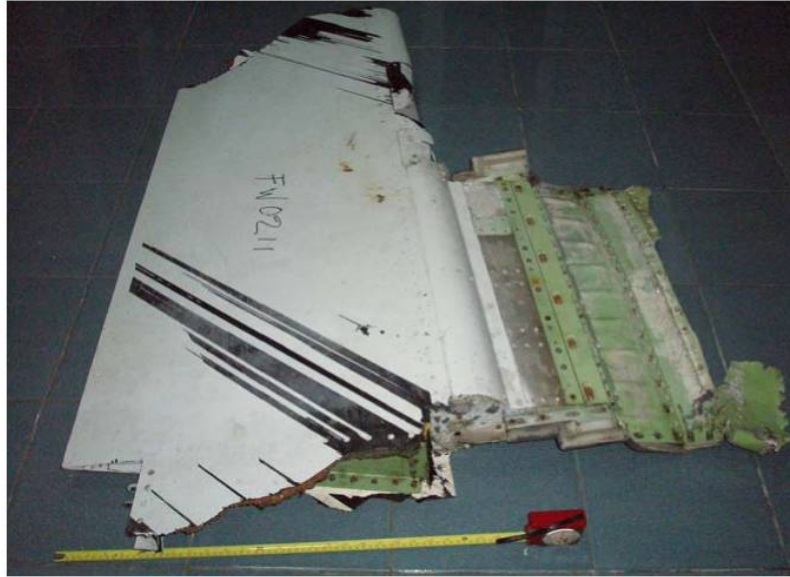
Figure A3: Part of Left Elevator showing upper surface. Found floating in the sea off the coast near Pare-Pare

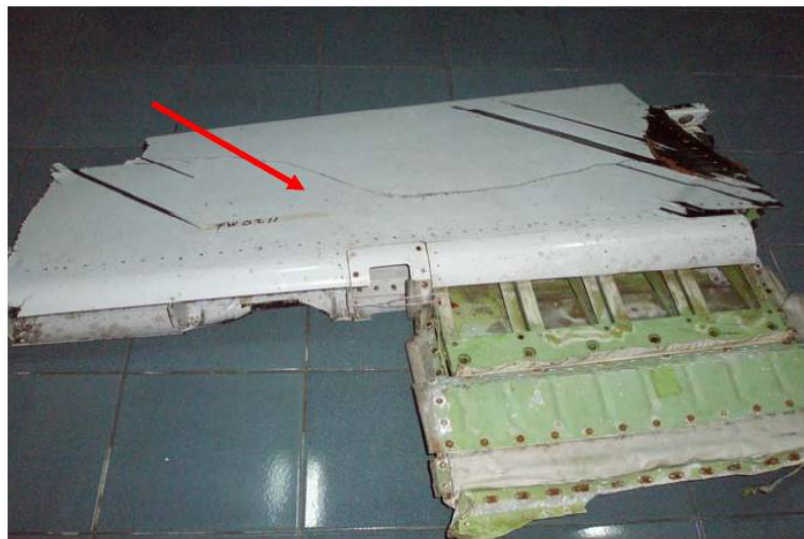
Figure A4 : Part of left elevator showing lower surface. Found floating in the sea off the coast near Pare-Pare

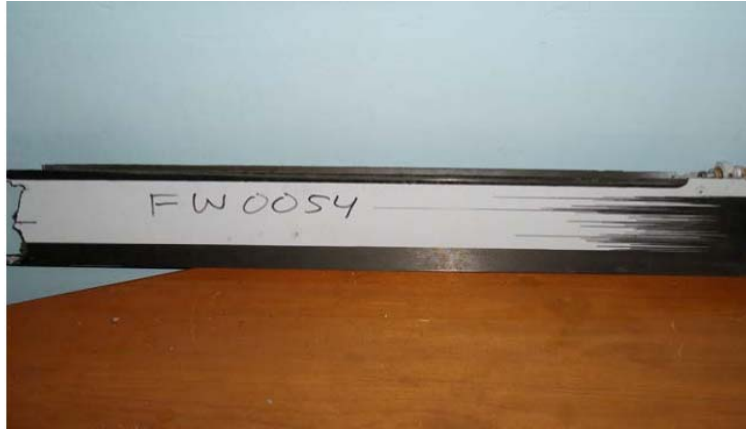
Figure A5 : Part of elevator tab. Found floating in the sea off the coast near Pare-Pare

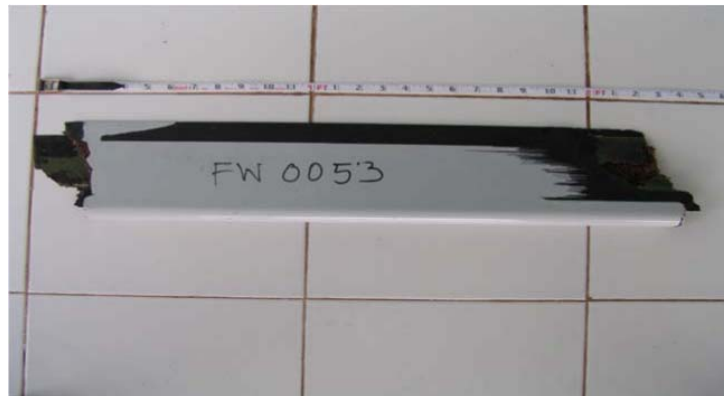
Figure A6 : Part of elevator tab. Found floating in the sea around Pare-pare

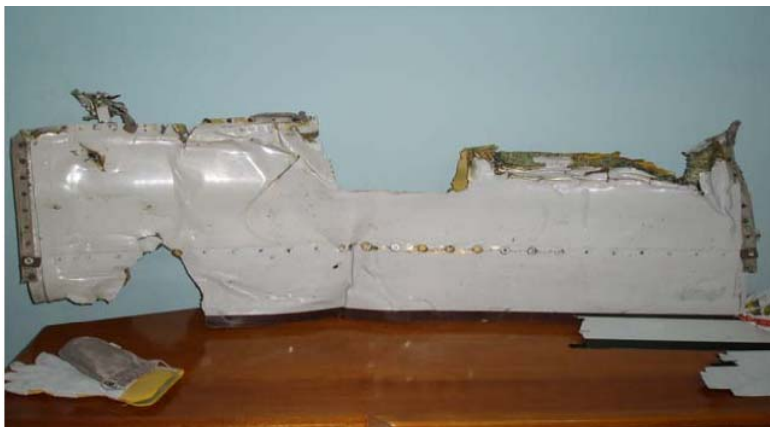
Figure A7 : Flight spoiler (showing lower surface) found floating in the sea off the coast of Pare-pare

Figure A8 : Flight spoiler as in figure A7

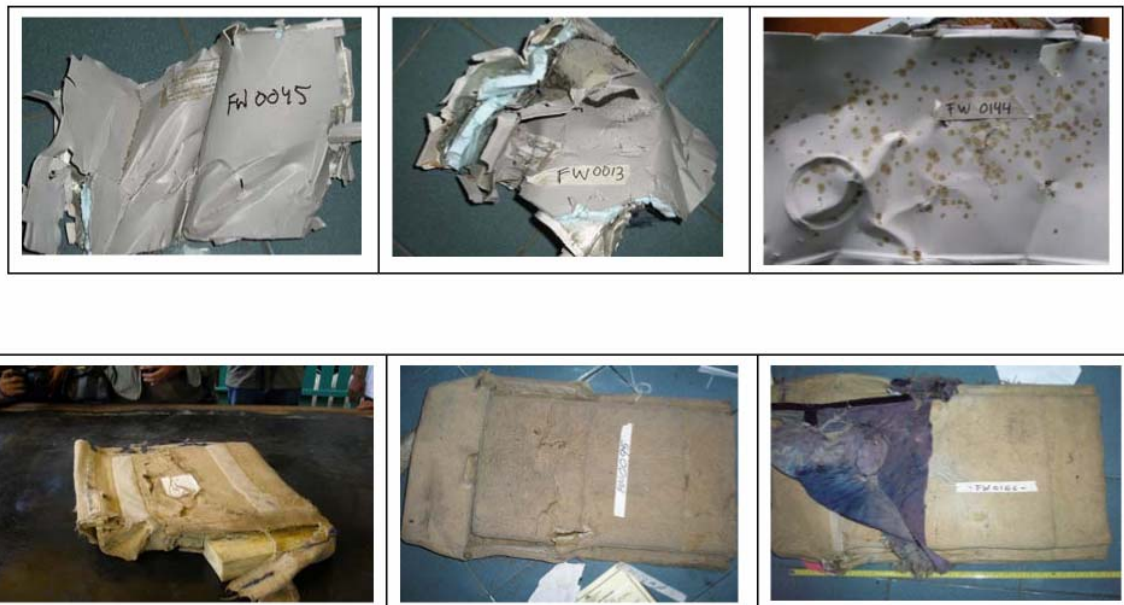
Figure A9 : Seatback tray tables (top row) and seat cushions (lower row)
