**AIRCRAFT INVESTIGATION
PROCESS AND ANALYSIS**

10 TECHNICAL INVESTIGATION

The Aircraft and Its Systems

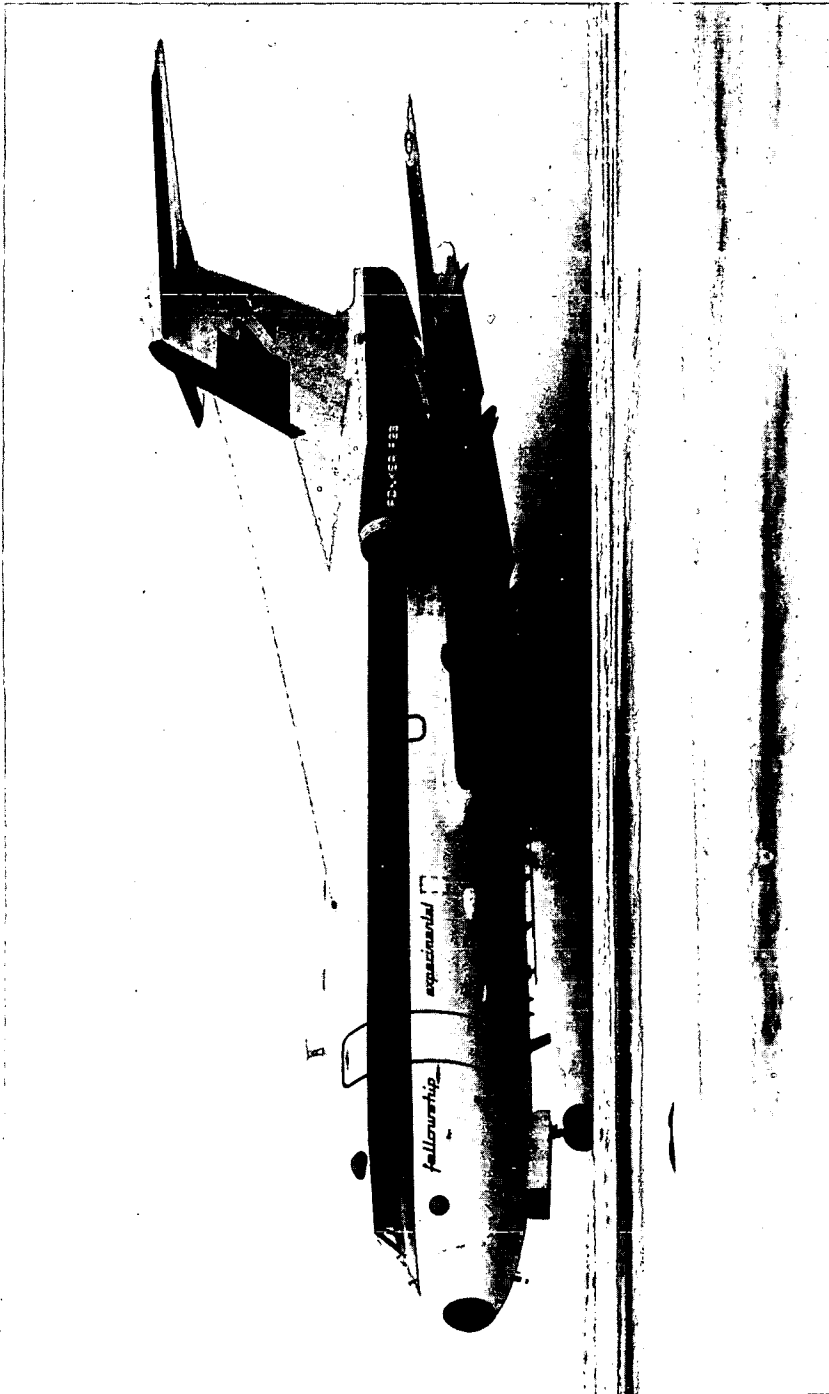
Figure 12-1 F-28 during Slush Test, February 5, 1968

There is some possibility that snow, slush, or ice that left the wing upper surface during the takeoff run was ingested into the engines. The Piedmont operations manual, in the section on adverse weather, contains information regarding ice that may form on the upper surface of the wings while the aircraft is on the ground. The ice forms either because of warm fuel, which can cause snow to melt, with the water subsequently refreezing; or because of extremely cold fuel, as may be the case after long flights at very low ambient temperatures, which causes water condensation or rain to freeze. It is stated in the manual that "[d]uring take-off this ice may break away and at the moment of rotation enter the engine causing compressor stall and/or engine damage" (p. 3A-24-1). During testimony, however, no one described seeing anything that could be taken to be unusually large amounts of ice or snow separating from the wing of C-FONF during the takeoff roll. Moreover, there was no damage found during examination of the engines that showed they had ingested slush or ice. (For details, see the section on engine investigation in chapter 10 of this Report, Technical Investigation.) During manufacturer's certification tests of the F-28 Rolls-

Royce engines, as described in chapter 10, it was demonstrated that the engines were able to ingest great quantities of water with no apparent difficulty. Bearing this point in mind along with the fact that most witnesses testified that the engines were operating normally throughout the takeoff run, it is probable that if the engines ingested snow, slush, or ice from the wings during takeoff, the ingestion could have caused only a fleeting abnormality and perhaps an uncommon noise.

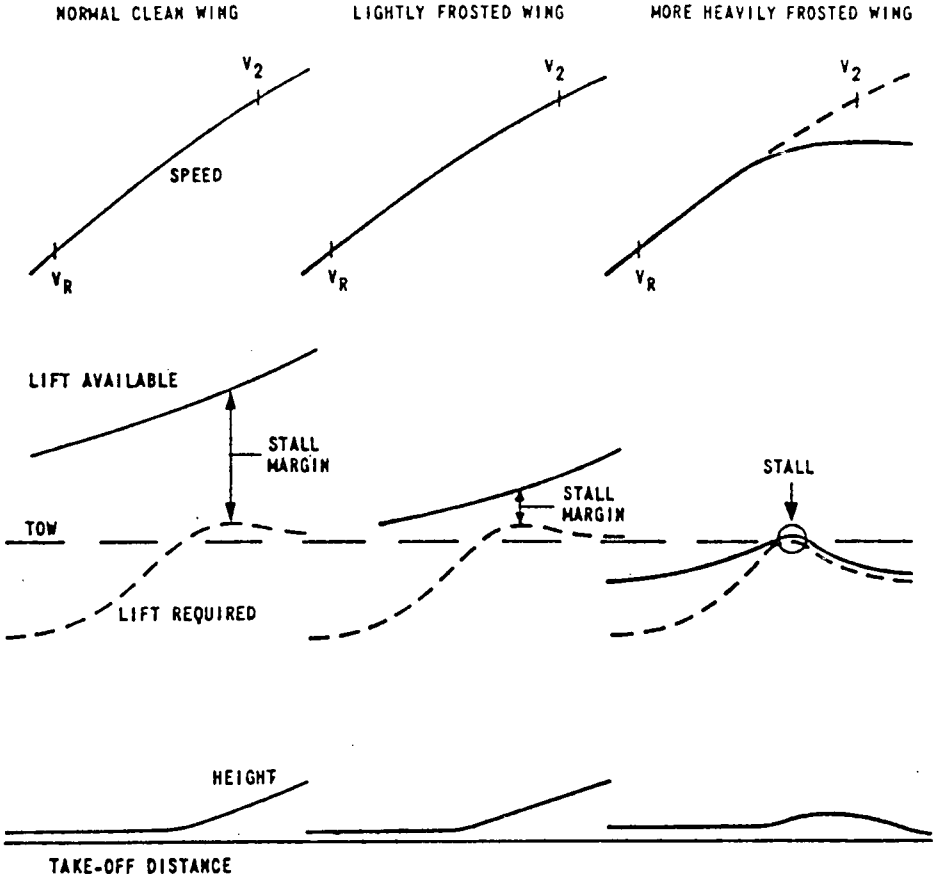
Figure 12-4 Comparative Stall Margins¹

¹ Illustrates differently the comparative stall margins for the same (figure 12-3) two arbitrarily chosen frost-contaminated wings and the normal clean wing.

with more heavily frosted wings is unable to sustain flight because the wing is in a stall condition at rotation.

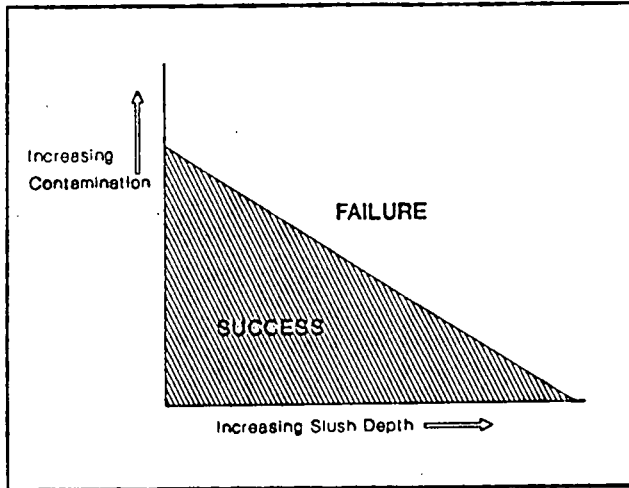
Figure 12-8 A Boundary Condition Plot for Successful Takeoff

Figures 8a-10b of the "Flight Dynamics" report illustrate in detail the various test runs. A review of the figures reveals that there are well-defined boundaries of slush depth and contamination level that either allow or prevent the aircraft from flying successfully. For example, with a rotation speed (V_R) of 122.5 knots, a slush depth of 0.25 inches, and a wing-contamination level of 0.65, the aircraft flies away. At 0.68 wing contamination, the aircraft gets airborne, but, 500 feet beyond the end of the runway, it is only at 10 feet. At 0.69 contamination, the aircraft returns to the runway and runs off the end. In another example, with a rotation speed of 127.5 knots, a slush depth of 0.10 inches, and a wing-contamination level of 0.823, the aircraft flies away despite two bursts of stick-shaker. At 0.824 wing contamination, the aircraft height never exceeds 5 feet, and it eventually returns to the surface 1100 feet beyond

the end of the runway. The figures also demonstrate that pilot technique can have a marked effect on the success or failure of a takeoff.
