Airworthiness Directive Schedule

Engines

Continental IO-470 Series and O-470 Series

24 February 2022

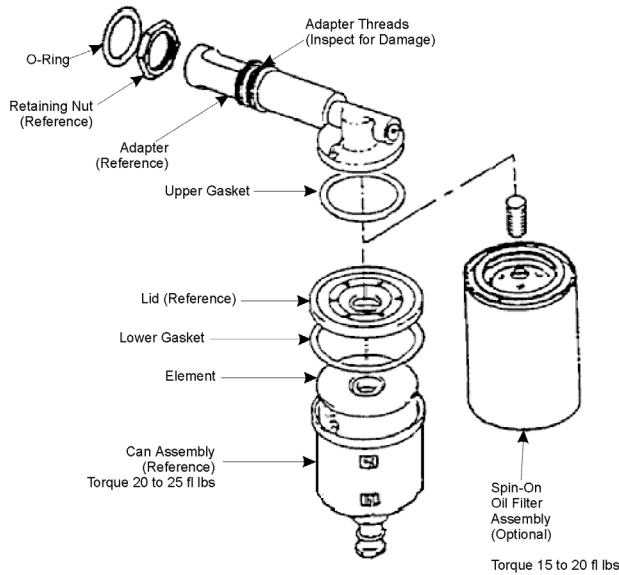
DETAIL A

Requirement: To prevent loss of engine oil caused by loose or separated oil filter adapters, which could result in engine stoppage, accomplish the following:-

2. For oil filter adapter assemblies that do have torque putty between the engine filter adapter assembly, nut, and oil pump housing, inspect the torque putty for misalignment, evidence of oil leakage, or cracks.

(d) Apply torque putty between the engine filter adapter assembly, nut, and oil pump housing as specified in the diagram.
