Erik Serrano

**An overview of failures in
large-span timber structures**

SP AR 2006:14
Bygg och Mekanik
Borås 2006

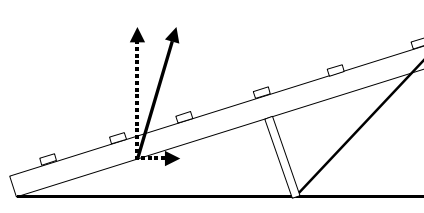
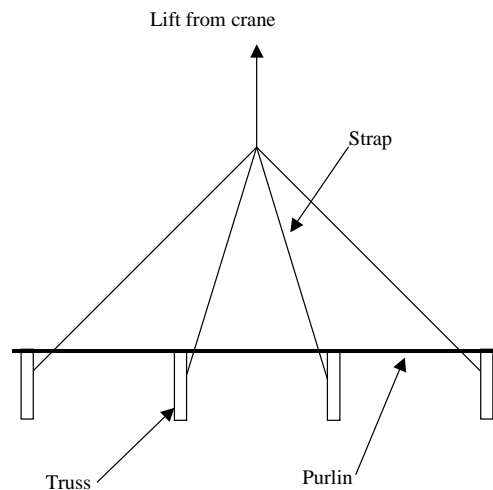
After finalising the roof structure with four trusses and purlins, a crane was used to raise it in place on top of supporting columns. The straps used during rising of the structure were placed according to Figure 8. The forces in the straps lead to a compressive force in the glulam parts, as indicated below. In addition, the purlins are also subjected to compressive forces, see Figure 9. Just before putting the roof structure down on its supports, the structure collapsed. According to witnesses, one of the outermost trusses tilted and the structure failed.

Figure 8. Strap placement.

Figure 9. Strap placement.

The conclusion from the original investigation was that buckling of the purlins caused the failure, due to an excessive compressive force being applied. A simple hand calculation of the forces was made showing that the normal force in the mostly stressed purlin exceeded the design value by a factor of 3. The positions of the straps during the raise were possible to determine due to local compressive failure of the wood.

The conclusions from the original investigation seem adequate. The failure can be classified as being due to poor handling during erection. The roof structure should have been further stabilised during the raising. The local crushing of the wood at the straps should alone be a reason for stopping the raise.

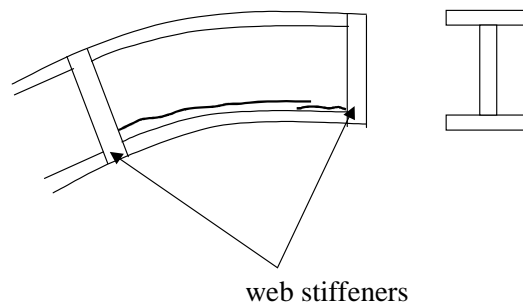
Figure 10. Schematic of arch apex with cracks. The crack length was about 4 m.

In addition to the cracks it was also noticed that the bolts holding the flanges together had loose fittings. Distances of about 5 mm were measured between the nuts and washers.

The original investigation concluded that the failure was due to the changing climate conditions after insulation was added to the roof. By placing the insulation in between the arches instead of on top of the existing roof, a temperature and thus a moisture gradient built up. The drying of the wood induced the perpendicular to grain failure. Calculations showed that the loading by self-weight resulted in approximately 0.2 MPa perpendicular to grain stresses, which is about the allowable stress. The moisture gradient induced stresses were estimated to be also about 0.2 MPa, and thus the strength of the material was reached. The moisture variation was assumed to be linear over the beam depth, with a difference of 6% MC between the inner and outer parts of the arch.

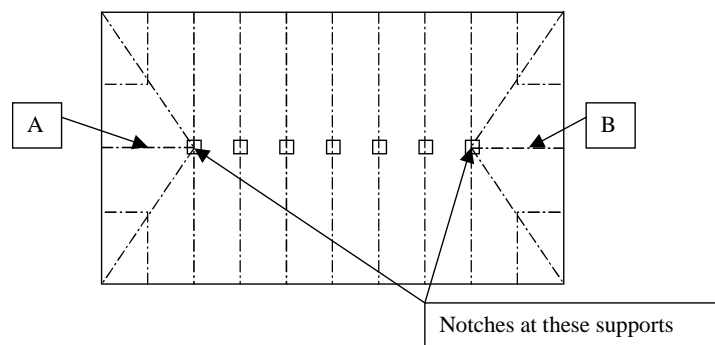
Figure 11. Schematic of roof structure

During winter beam A failed in shear, with a crack originating from the support where a notch had been cut. The crack originated from the mid-depth of the beam. The beam was lifted, a new steel support put in place and the beam was then reinforced with steel holders.

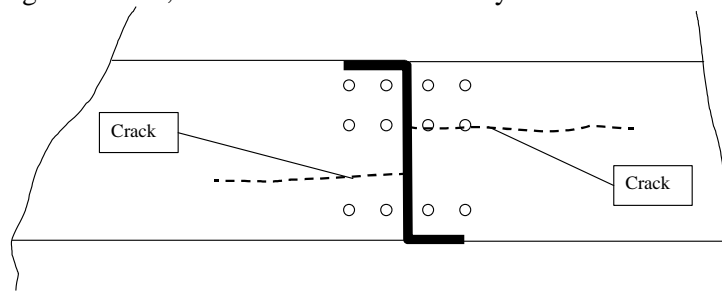
Approximately six months after the completion of the roof structure, severe cracking occurred in the connections. Another four months after this, in February, a shear failure in one of the beams occurred. The failed beam had been monitored prior to the shear failure, and it was concluded that its deflection had increased from 37 mm to 121 mm under constant loading conditions, from December to February.

Figure 13. Schematic of beam connection and cracks found.

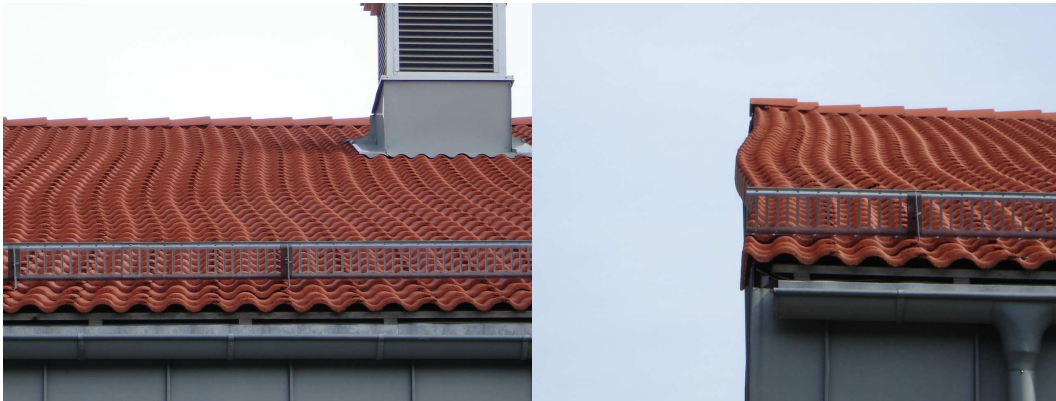
The failure led to the battens falling down in between the roof trusses in several cases. The battens were often joined at the same truss, leading to a more flexible structure with larger deformations. It is noticeable that there was no snow on the roof when failure occurred.

The risk of total collapse of the buildings was estimated as being very high in some of the cases.

Figure 19. Example of deformations at failure.

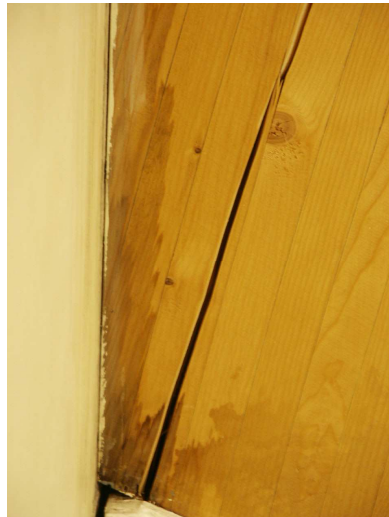
One of the columns showed a large crack, which stopped at a length of 2-2,5 m. The crack started from the steel part, where a notch had been made. The hall was closed pending an investigation and proper actions to be taken.

Figure 21. Crack at column fitting to the steel part..

- The amount of snow on the roof was less than 200 mm.
- No deformations nor misalignments were visible.
- The crack was approximately 10 mm wide and 2-2,5 m long. The crack had gone through the complete beam width. The crack path crosses three laminations.
- The crack starts at a notch made for the steel part added to transfer horizontal loads.
- The steel part is not according to the original drawings. The steel part was placed about 100 mm from its original position, and a notch making this possible has been cut.
- There is evidence of leakage from the roof (miscoloring of the glulam). Thus, a possible moistening of the timber followed by drying could be the reason for crack formation.

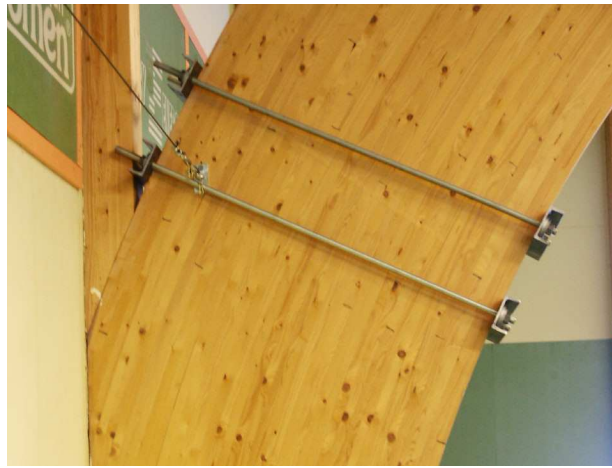
Figure 22. Temporary steel fixings attached to the column.

To assure that no further cracking would occur, and as a temporary remedy, steel fixings were placed on the column, at the crack end.
