CERN
CH1211 Geneva 23
Switzerland

EDMS NO.
1724436

Metallurgy Report

Analysis of ITER Axial Insulation Break (IBDH251)

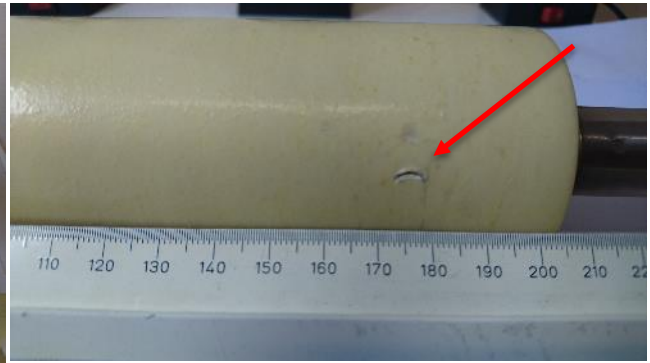
Figure 4: Imperfection in the outer surface of the IB.

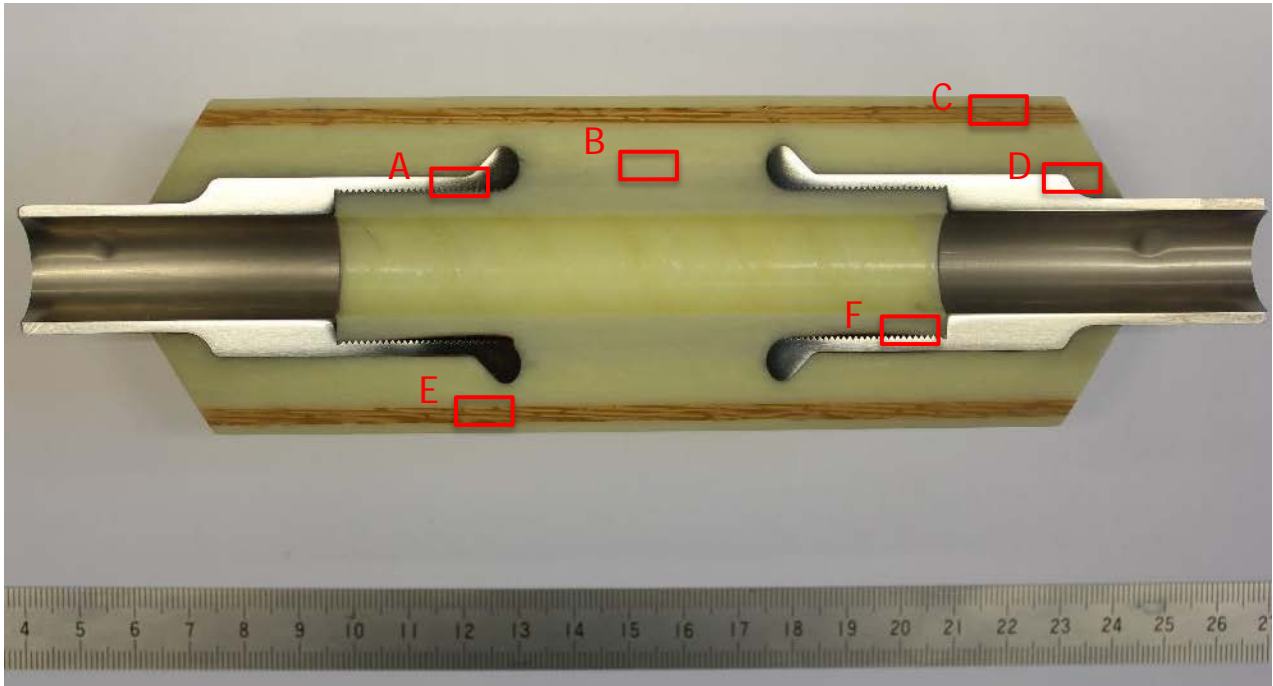
Figure 7 shows the location of the micrographs which were analysed in the insulation break (magnification: 50x). The two composites show good continuity between them (Field B, Figure 8). No big porosities are visible in any of the two composites. However, in some regions around the stainless steel fitting, some voids and cracks are observed (Field A, Figure 10; Field D, Figure 11; Field F, Figure 12). Moreover, The GKG insulation layers show some voids particularly concentrated towards the outer layer (Field C, Figure 12; Field E, Figure 13).

Figure 7: Half of the insulation break after manual polishing, indicating the fields of view used for showing specific features and their location.

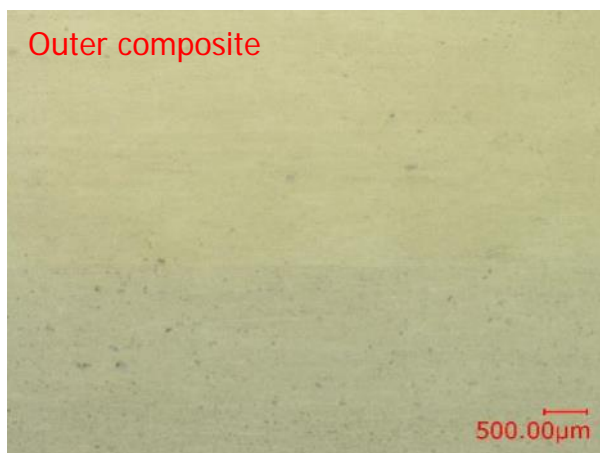
Figure 8: Interface between both composites (field of view B in Figure 7).

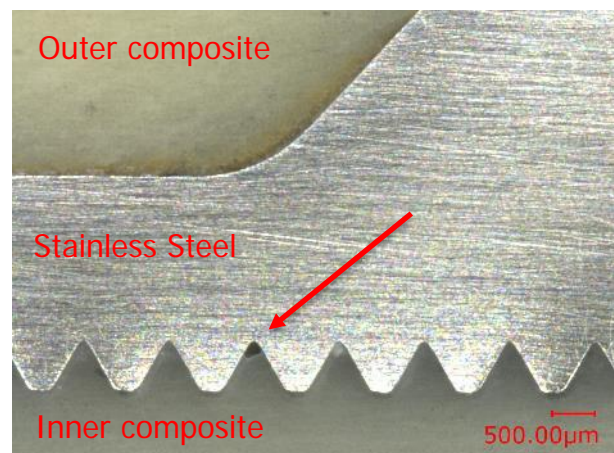
Figure 9: Void close to the stainless steel fitting region (field of view A in Figure 7).

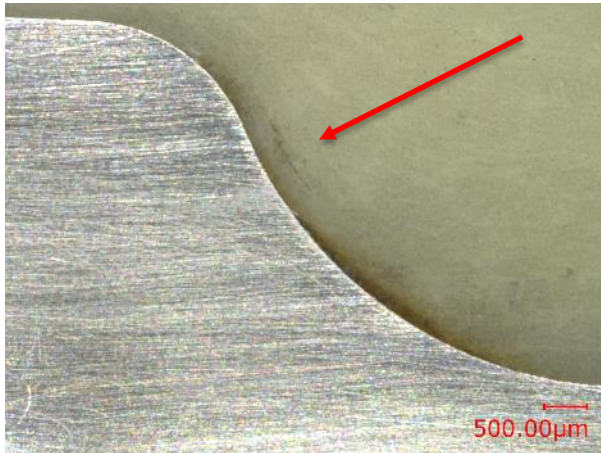
Figure 10: Cracks close to the stainless steel fitting region (field of view D in Figure 7).

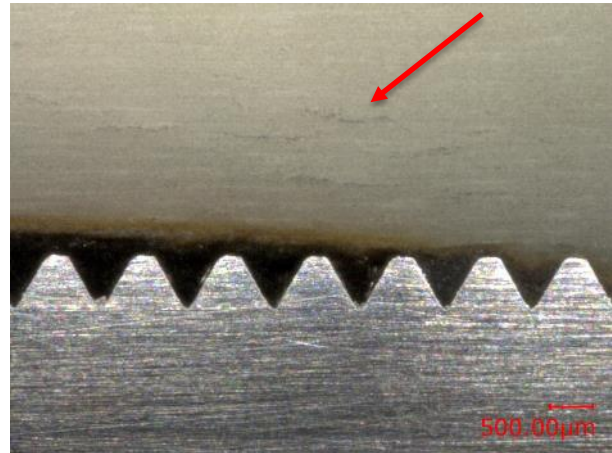
Figure 11: Cracks close to the stainless steel fitting region (field of view F in Figure 7).

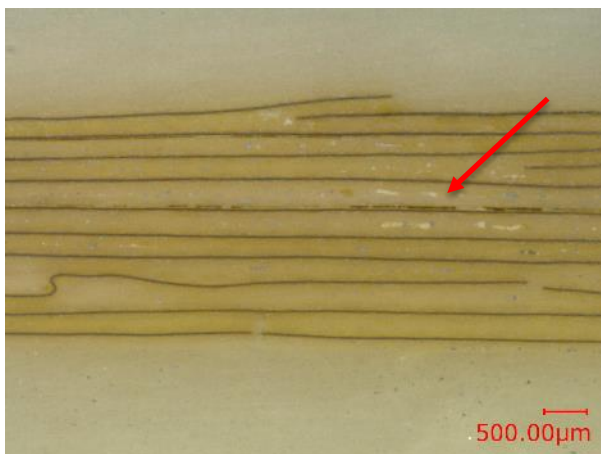
Figure 12: Voids in the GKG insulation layers (field of view C in Figure 7).

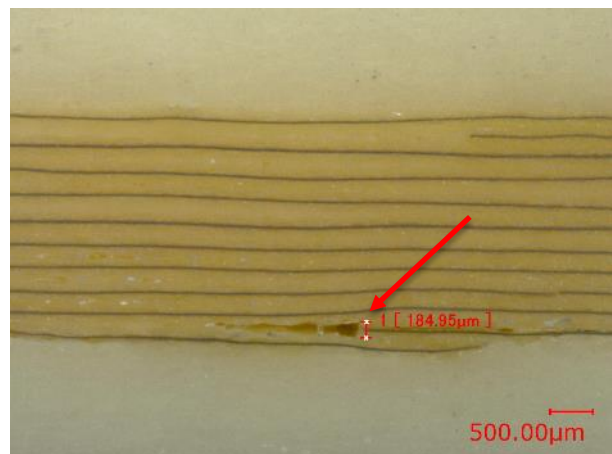
Figure 13: Voids in the GKG insulation layers (field of view E in Figure 7).

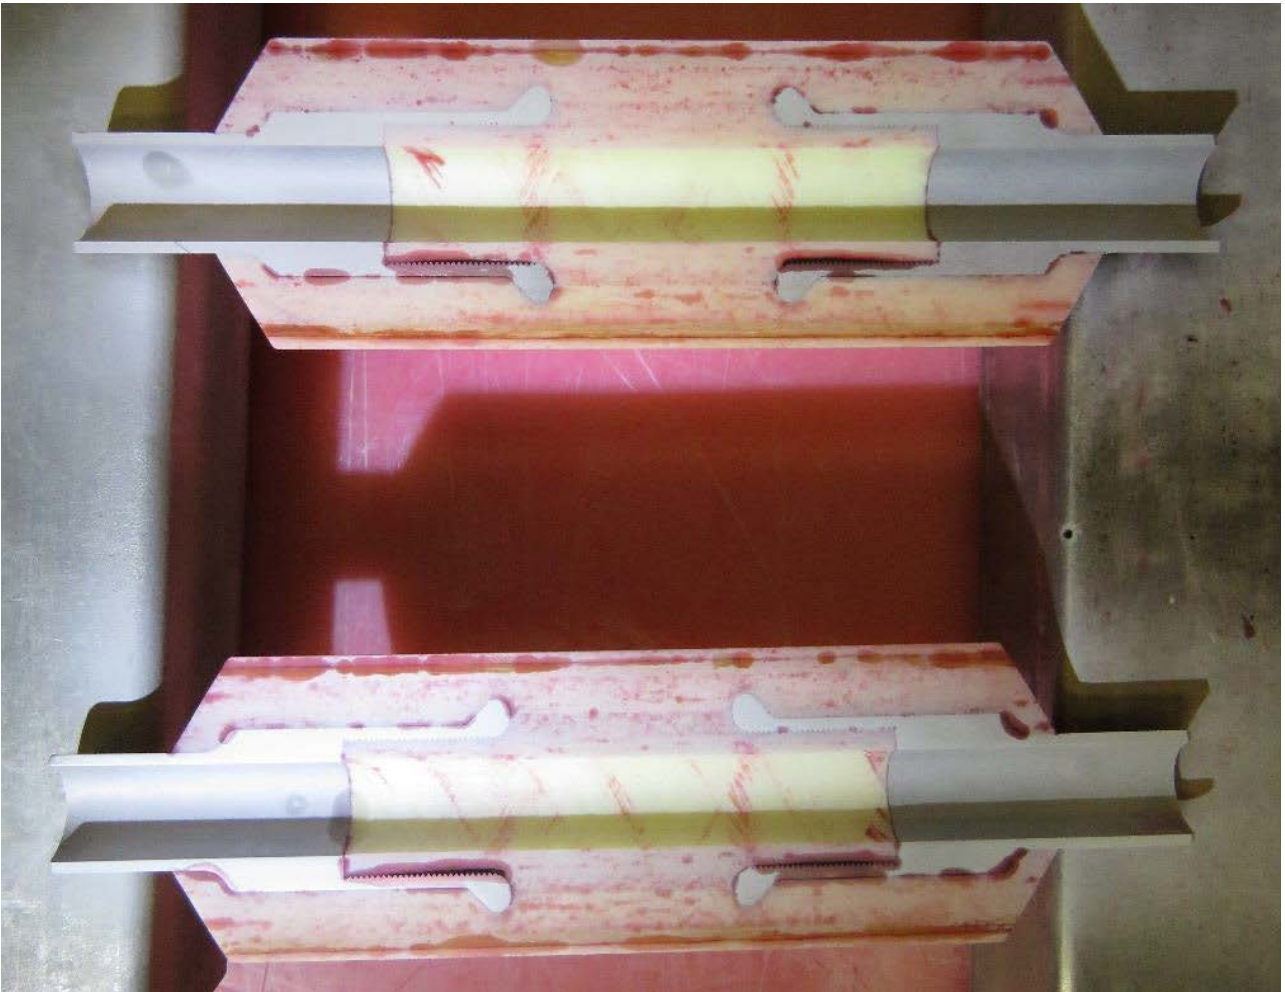
As it can be seen in Figure 14 and Figure 15, respectively, 5 minutes after the developer is applied, very pronounced linear indications are mainly observed in the stainless steel – to – composite interfaces and in the GKG insulation layers (also in the imperfection localized in the outer surface shown in Figure 4). The big amount of dye penetrant observed in some regions is a sign of a deep discontinuity associated to the respective indications.

Figure 14: Internal surface of the insulation break after application of developer. Dwell time: 5 minutes.

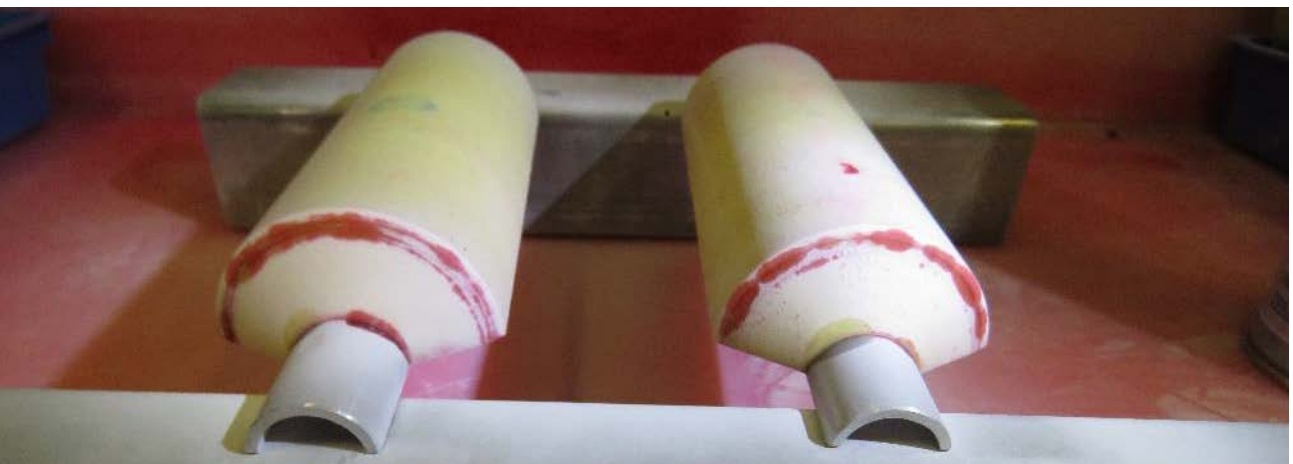
Figure 15: Outer surface of the insulation break after application of developer. Dwell time: 5 minutes.

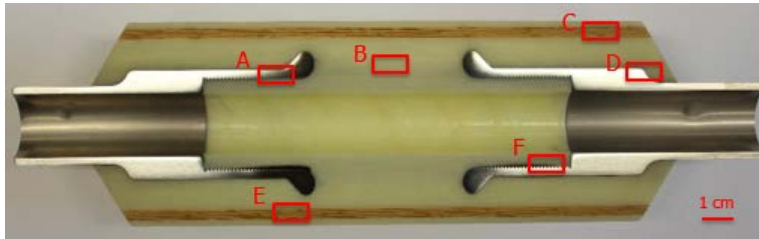
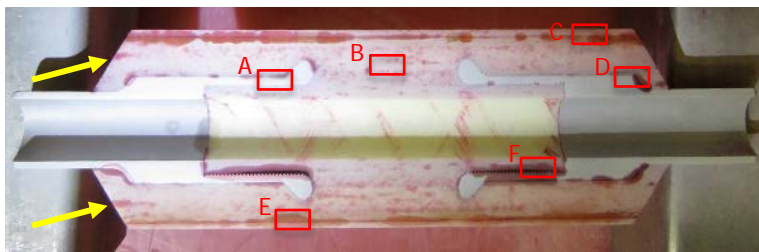
Figure 16: Comparison between the results obtained by the micro-optical analysis and the dye penetrant testing.

It is noteworthy that two longitudinal indications revealed by dye penetrant testing were not noticed during the micro-optical inspection (indications shown by arrows in Figure 16). It seems like the indications are deep but the exposed surface in the IB axial cross-section is small. In spite of that, the indications found by dye penetrant testing agree fairly well with the micro-optical observations (see Figure 16).

Field	Description
A	Void surrounding the metal area
B	Interface with good quality
C	GKG insulation layers with some voids.
D	Crack surrounding the metal area.
E	GKG insulation layers with some voids.
F	Cracks surrounding the metal area.

As indicated before, the cutting operation might have locally affected the external surfaces of the insulation breaks. Nevertheless, the intense indications observed after PT suggest deep discontinuities in the material that could not be induced by the cutting operation.

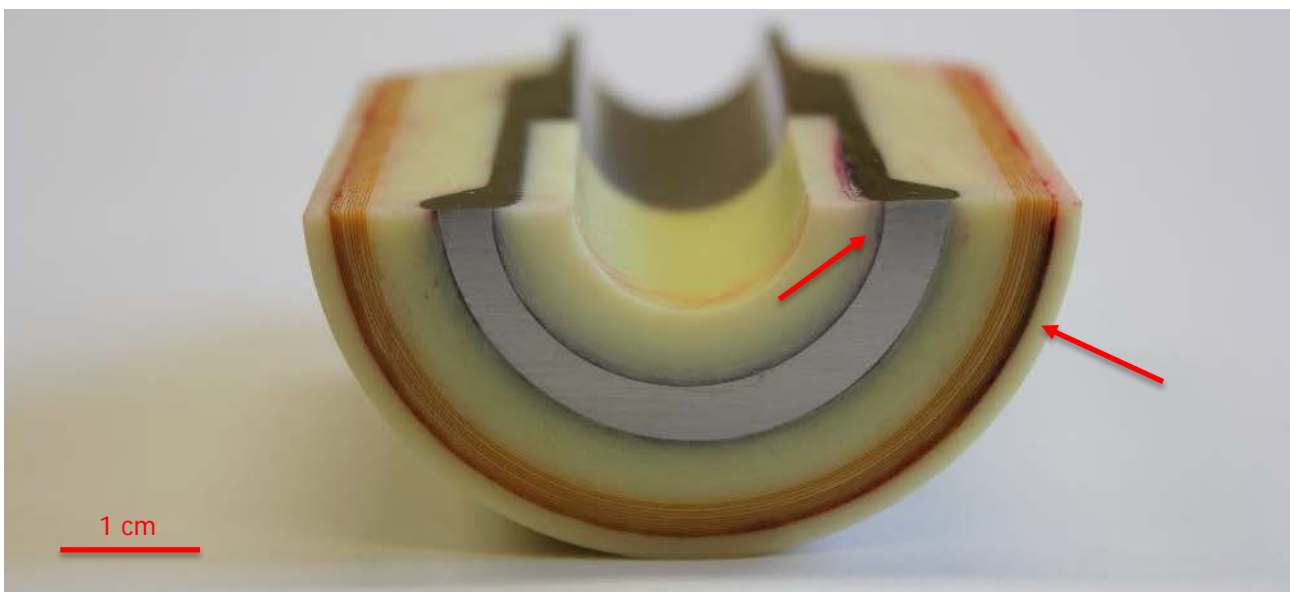
As it can be seen in Figure 23, small linear indications are observed in the stainless steel – composite interface, and a long indication is observed in the last layer of the outer GKG insulation. Both cross sections were obtained in correspondence of major indications from PT performed in the axial plane (no additional PT has been performed for the cross sectional inspection). Consistently, in these positions, the cross sectional micro optical observations have confirmed indications present in the bulk.

Figure 23: Cross sectional inspection of the insulation break. The arrows show the indications from PT located in: the stainless steel-composite interface and in the last layer of the GKG insulation layers.

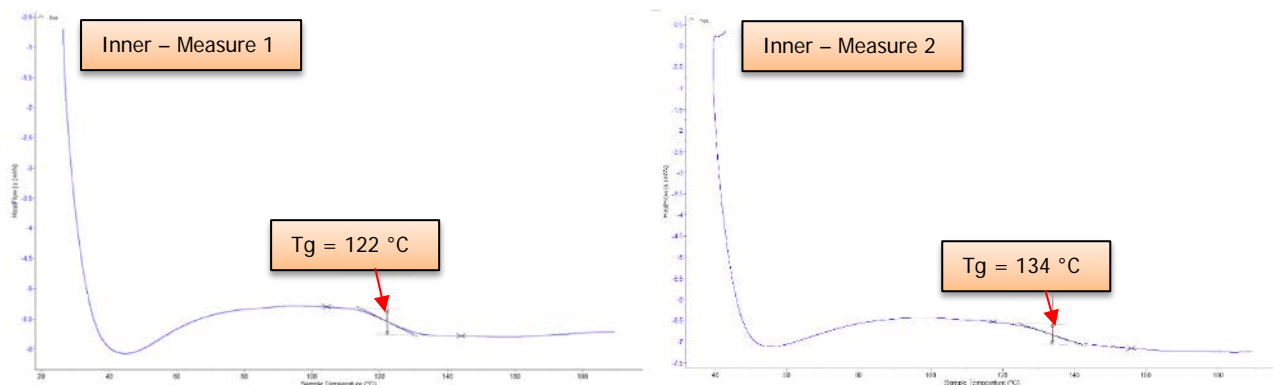
Figure 27: Thermograms for the inner composite for the calculation of T_g . On the left the first measure is observed and on the right, the second one.

The first DSC scans show that for the first temperature ramp up, both composites display the same glass transition temperature (T_{g1}). For the second temperature ramp up, a rise in T_g for both composites is observed, which is suspected to be due to an incomplete polymerization.

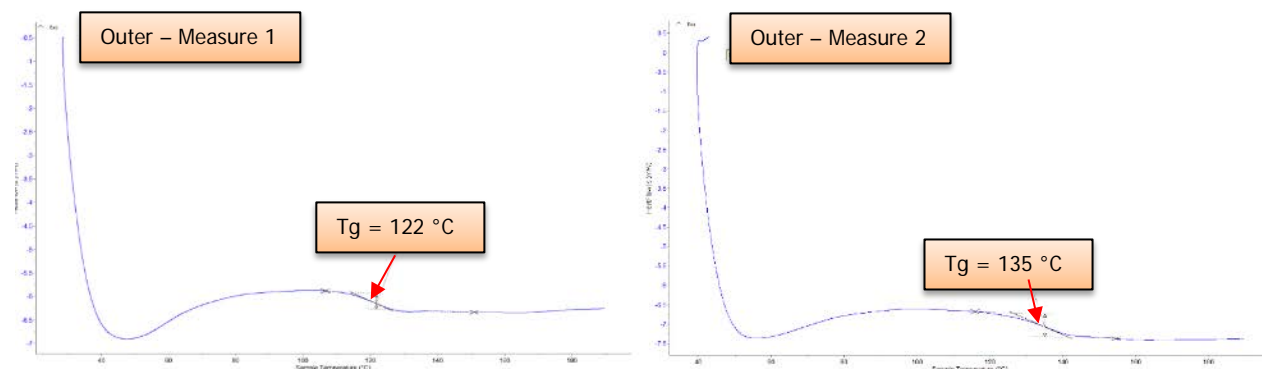
Figure 28: Thermograms for the outer composite for the calculation of T_g . On the left the first measure is observed and on the right, the second one.
