ANNUAL REPORT FOR 2016

Unnamed Tributary to Little River Wayne County
TIP No. R-2554A – Site 7
USACE Action ID: SAW-2008-00252

NCDWR Project # 20080570

Prepared By:
Roadside Environmental Unit & Natural Environment Section
North Carolina Department of Transportation
December 2016

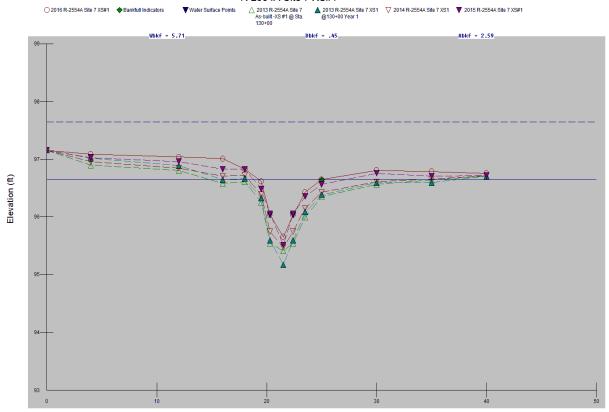
Cross-Section #1 (Riffle) Abbreviated Morphological Summary							
	2013	2014	2015	2016	2017		
Bankfull Width (ft.)	5.76	5.68	5.85	5.71			
Bankfull Mean Depth (ft.)	0.58	0.49	0.42	0.45			
Width/Depth Ratio	9.93	11.59	13.93	12.69			
Bankfull Cross Sectional Area (ft²)	3.32	2.77	2.47	2.59			
Maximum Bankfull Depth (ft.)	1.22	0.96	1.06	1			
Width of the Floodprone Area (ft.)	40	40	40	40			
Entrenchment Ratio	6.94	7.05	6.83	7

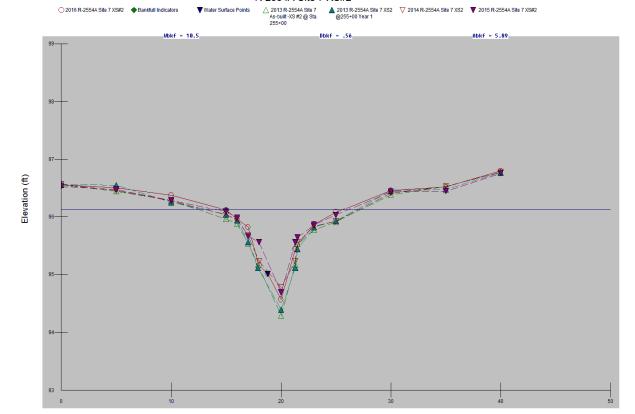
R-2554A Site 7 XS#2

Cross-Section #2 (Pool) Abbreviated Morphological Summary*						
2013 2014 2015 2016 2017						
Bankfull Cross Sectional Area (ft²)	5.49	4.49	4.91	5.89		
Maximum Bankfull Depth (ft.)	1.55	1.18	1.4	1.55		
Bankfull Mean Depth (ft.)	0.6	0.48	0.46	0.56		
Bankfull Width (ft.)	9.09	9.4	10.73	10.53

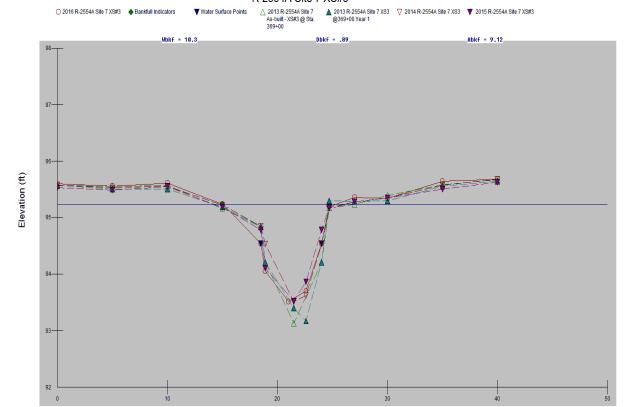
R-2554A Site 7 XS#3

Cross-Section #3 (Pool) Abbreviated Morphological Summary*						
	2013	2014	2015	2016	2017	
Bankfull Cross Sectional Area (ft²)	6.26	4.72	7.54	11.37		
Maximum Bankfull Depth (ft.)	1.67	1.33	1.66	1.73		
Bankfull Mean Depth (ft.)	1.06	0.81	0.78	0.97		
Bankfull Width (ft.)	5.9	5.84	9.7	11.69

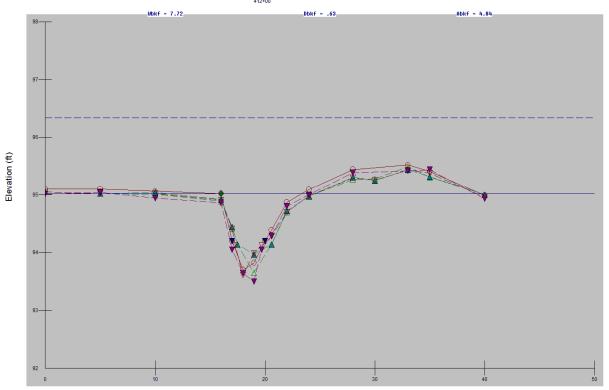
R-2554A Site 7 XS#4

Cross-Section #4 (Riffle) Abbreviated Morphological Summary							
	2013	2014	2015	2016	2017		
Bankfull Width (ft.)	7.6	7.5	6.6	7.72			
Bankfull Mean Depth (ft.)	0.54	0.57	0.69	0.63			
Width/Depth Ratio	14.07	13.16	9.57	12.25			
Bankfull Cross Sectional Area (ft²)	4.08	4.27	4.55	4.84			
Maximum Bankfull Depth (ft.)	0.95	1.3	1.36	1.32			
Width of the Floodprone Area (ft.)	40	40	40	40			
Entrenchment Ratio	5.26	5.33	6.06	5.18

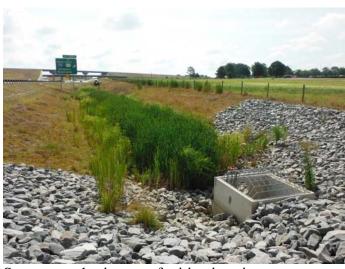
Stormwater basin east of mitigation site

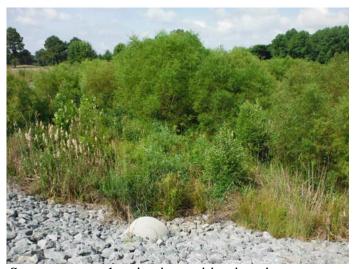
Stormwater outlet pipe into mitigation site

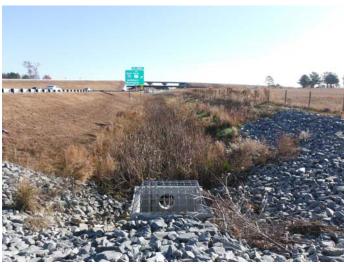
Stormwater basin east of mitigation site

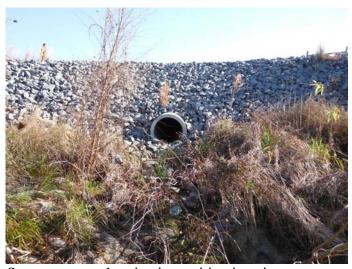
Stormwater outlet pipe into mitigation site

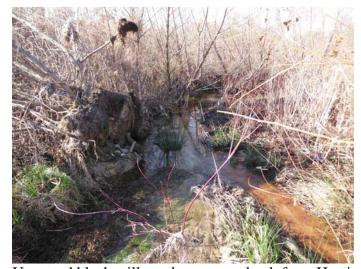
Site Notes: The black willow and silky dogwood live stakes were surviving along the streambank. Some of the planted black willows along the streambank had fell or were leaning over due to Hurricane Matthew. Other vegetation noted included briars, soft rush, pine cattail, woolgrass, lespedeza, wax myrtle, sweetgum, and various grasses.

Uprooted black willow along streambank from Hurricane Matthew
