Appendix A—Topographic Maps

409 E. Armour Blvd.
Kansas City, MO 64109

Appendix B – Site Photographs & Drawings

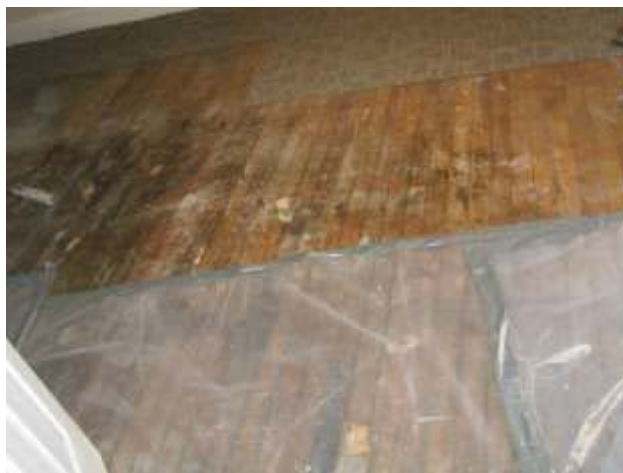
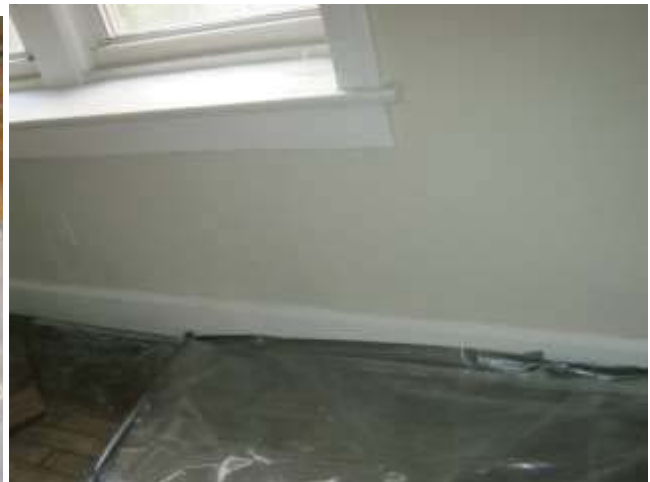
Typical Unit Flooring Under Carpet (moisture/water stains visible)

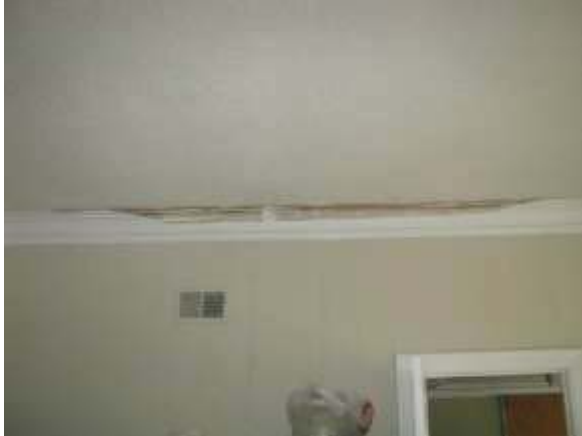
Water Stained Ceiling, 2nd Floor Unit

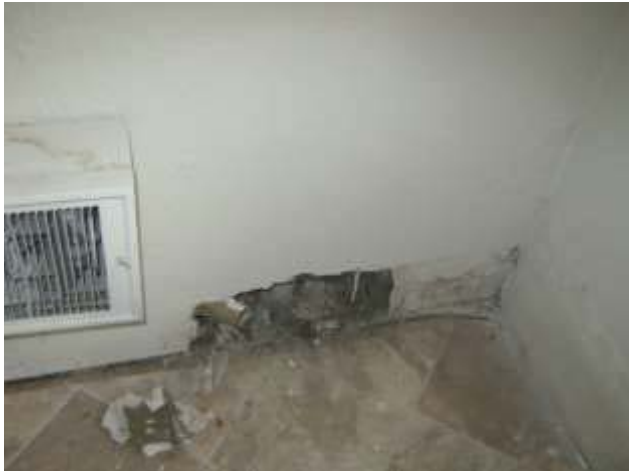
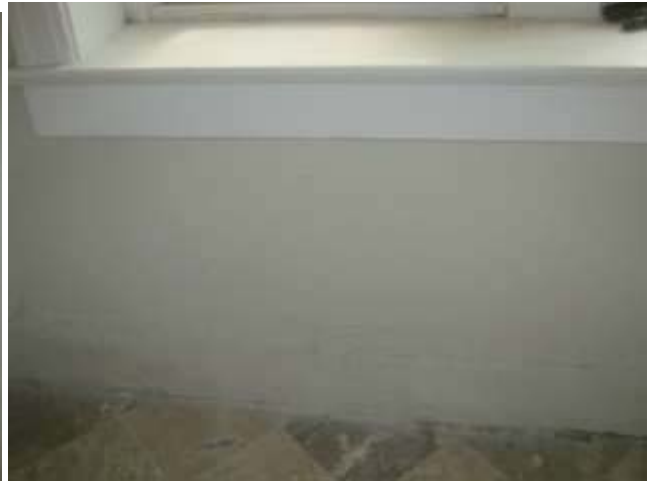
Water Stained Wall near Floor, 2nd Floor Unit 1

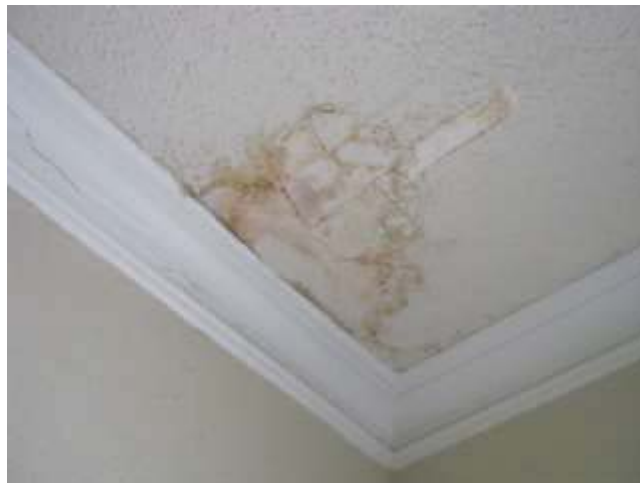
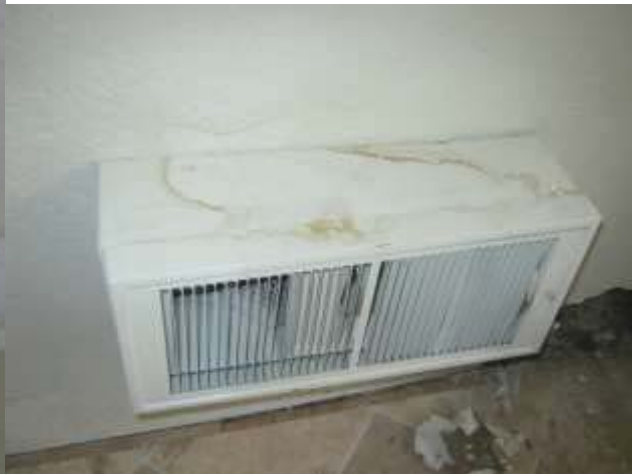
Water Stained Wall near Floor, 2nd Floor Unit 2

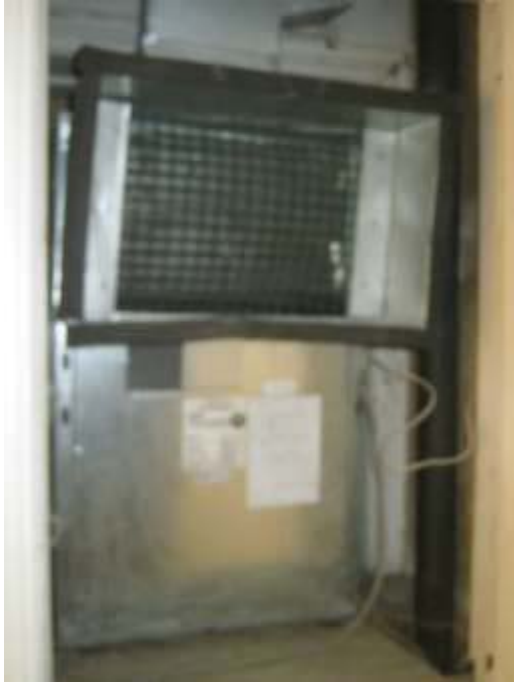
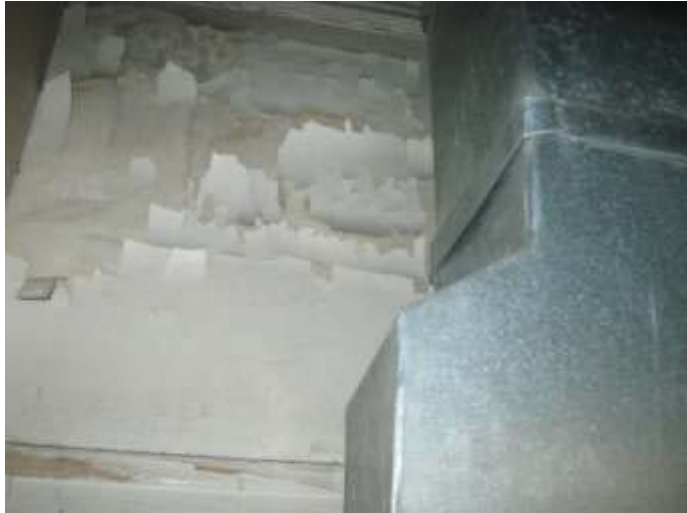
Water Stains on Ceiling & Vent Register, 2nd Floor Unit

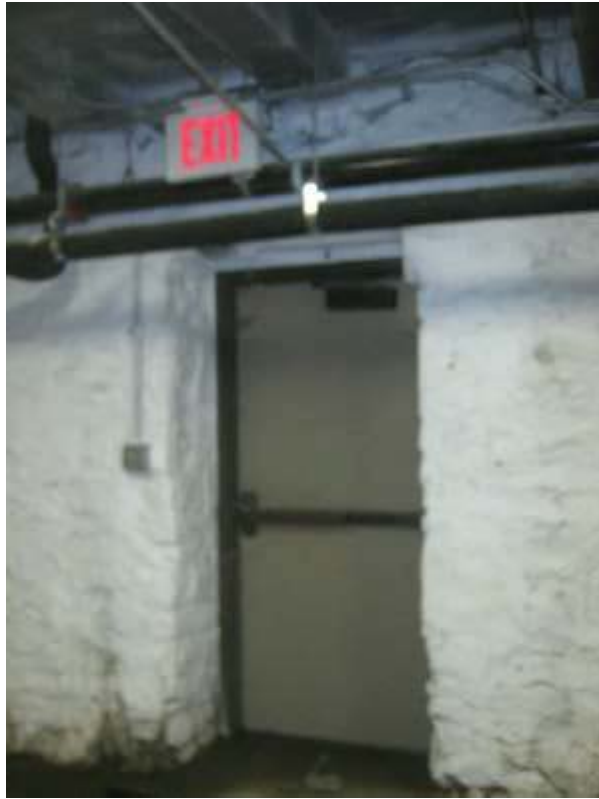
Visible Mold on Wall, NW Basement 2

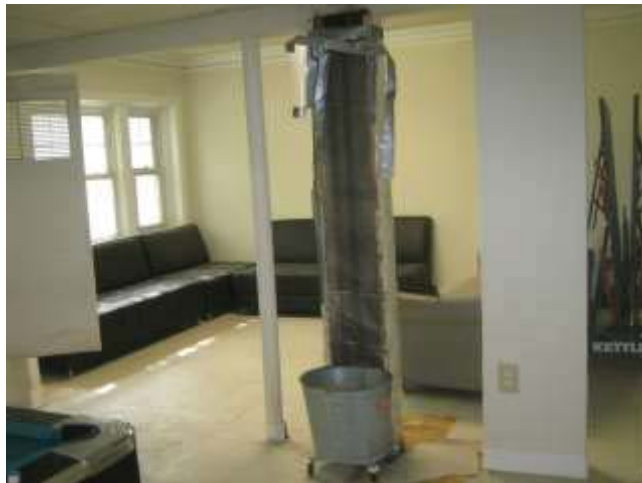
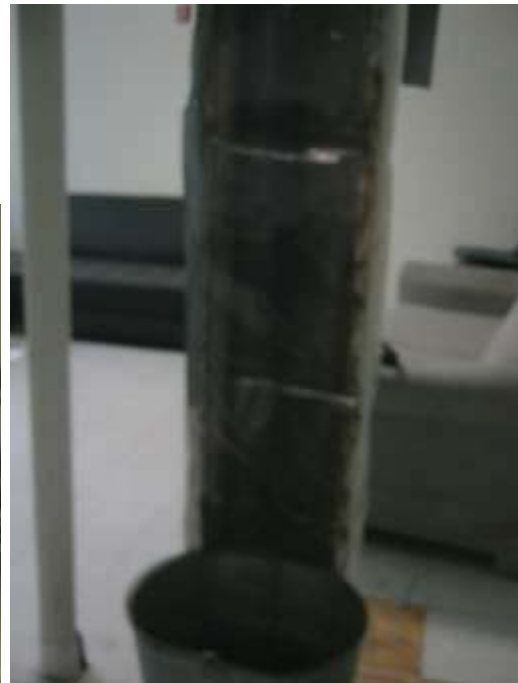
Water Damage in 2nd Floor Game Room

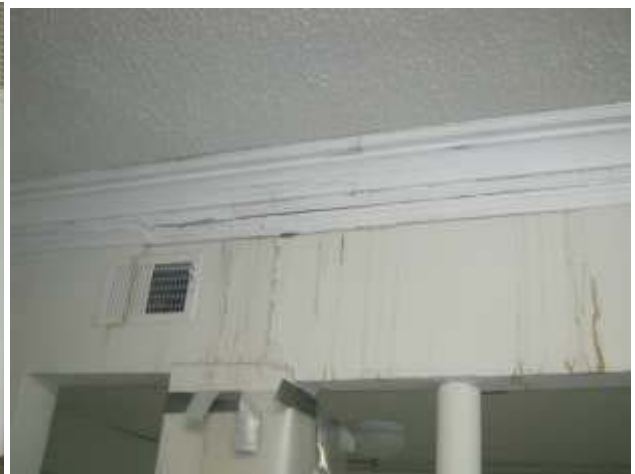
Water Stains Above Central Column, 2nd Fl. Game Room

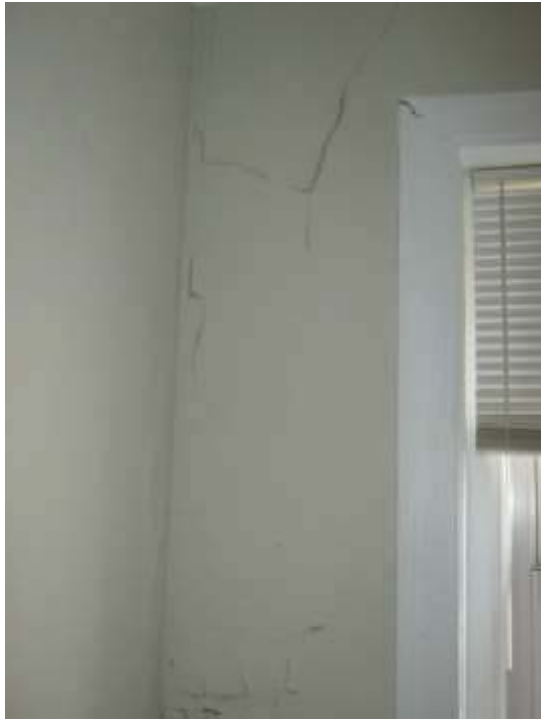
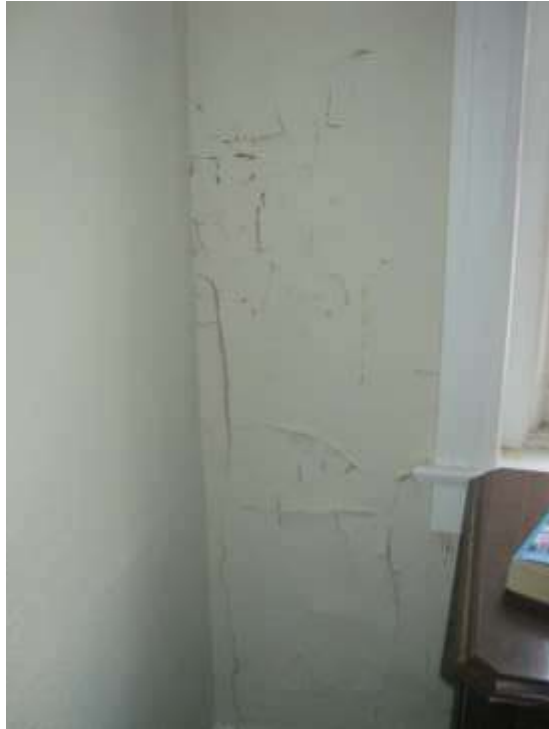
Cracked Plaster Walls, Unit 205 Living Room/Bedroom

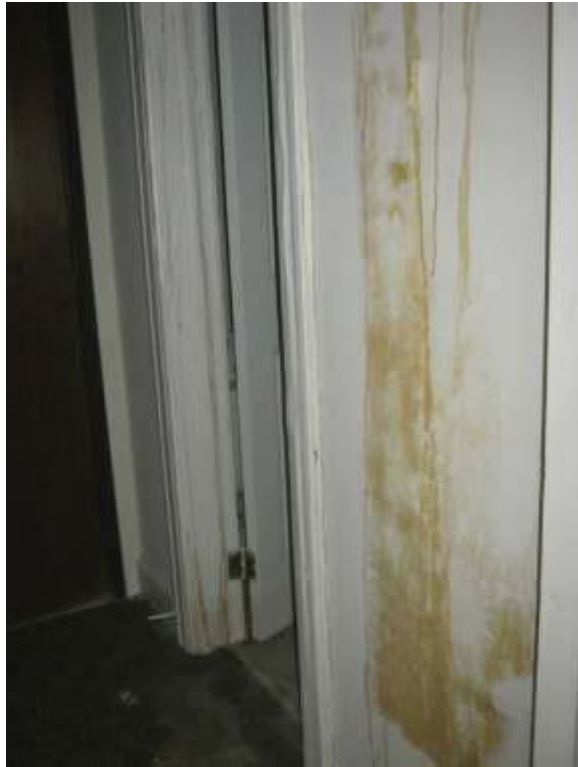
Water Stains, Unit 203 Main Hallway

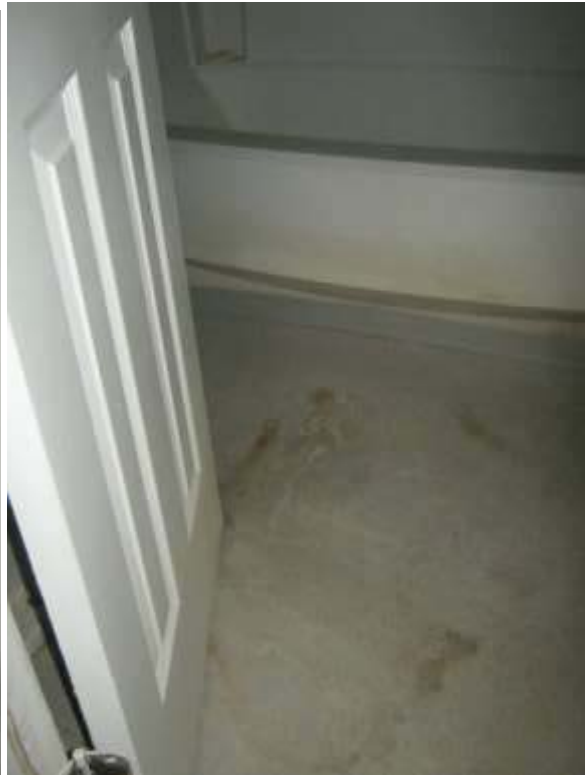
Water Stains, Unit 203 Bathroom Floor

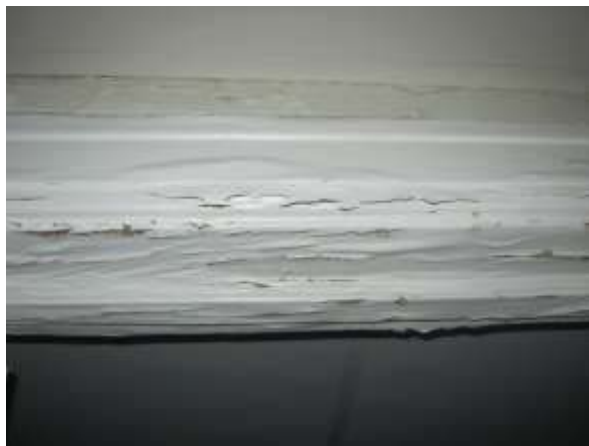
Water Stained Door Header, Unit 203 Bathroom

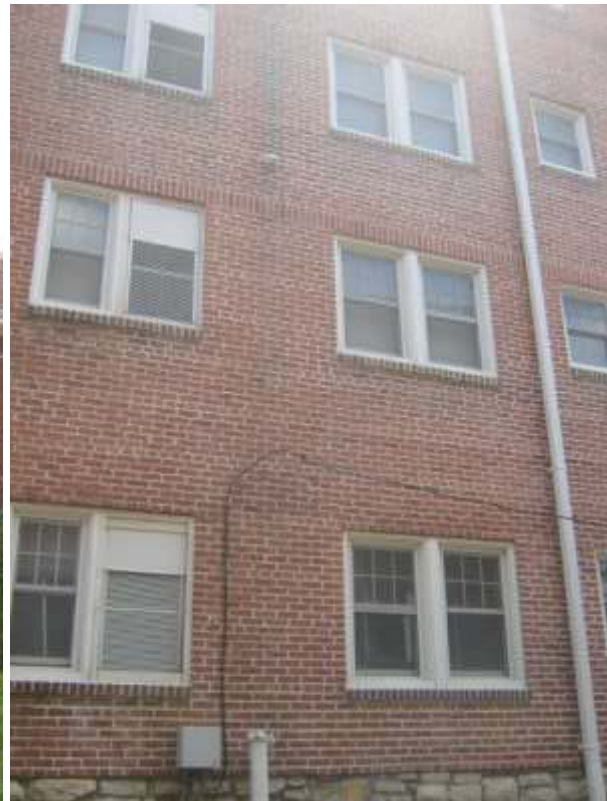
West Side Water Stain, Likely from Roof
