# Appendix: Physical Assessment

**Del Valle Sports & Fitness Clubhouse**

**2015-0123**

April 10, 2015

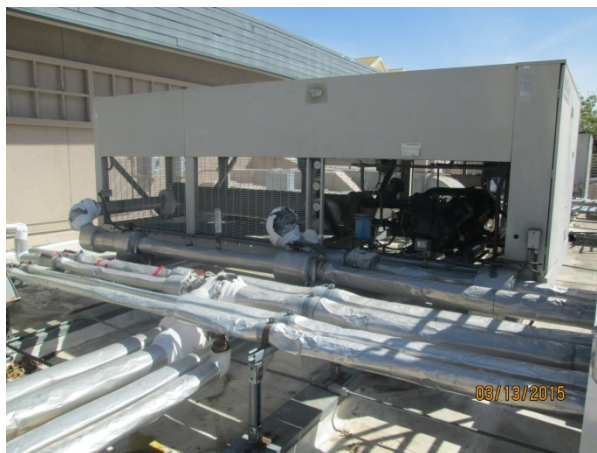
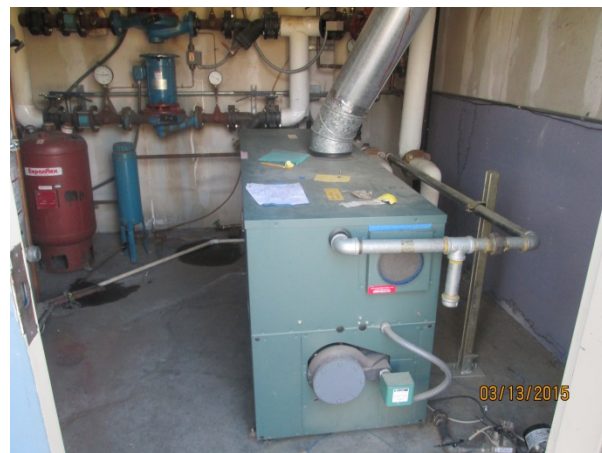
The building mechanical system consists of an existing central plant, installed during the 1993 clubhouse renovation with the exception of the boiler replacement in 2009, which provides chilled water and heating hot water to air handling units. The existing chilled water system consists of (2) air-cooled chillers (CH-1 & CH-2) located on the roof, with (2) constant volume chilled water distribution pumps (CWP-1 & CWP-2). Chilled water piping is routed along the rooftop to serve the existing rooftop air handling units, and along a pipe chase north of the gymnasium to serve air handling units AHU 14, AHU 15, & AHU 16, located in a mechanical room adjacent to the gymnasium. The heating hot water system consists of (1) gas-fired boiler (B-1) located in the boiler room that is east of the women's shower, with (2) heating hot water distribution pumps (HWP-3 & HWP-4). Heating hot water is distributed up to the roof to serve the existing rooftop air handling units, and along a pipe chase adjacent to the gymnasium to serve air handling units AHU 14, AHU 15, & AHU 16. By visual inspection the existing chilled water and hot water exposed piping is in poor condition. In some cases the insulation is missing and the pipe damaged and rusting.

A majority of the existing equipment installed during the 1993 renovation has exceeded its expected service life, or within the next three years will be at or near the end of its service life. Although the new air handlers installed during the 2001 renovation are also nearing their estimated service life, based on ASHRAE, facilities personnel noted there have not been any major problems and they are operating consistently. We would recommend that a service professional perform an inspection of the units for preventative maintenance if they are to be used for an extended period.

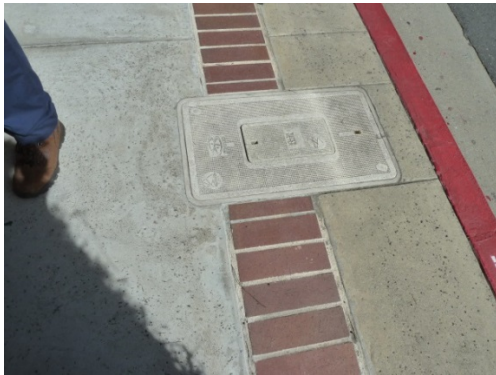
Domestic Water Meter in Vault

The existing capacity of the domestic cold water system is adequate at this time. The capacity should be reevaluated for future remodels.

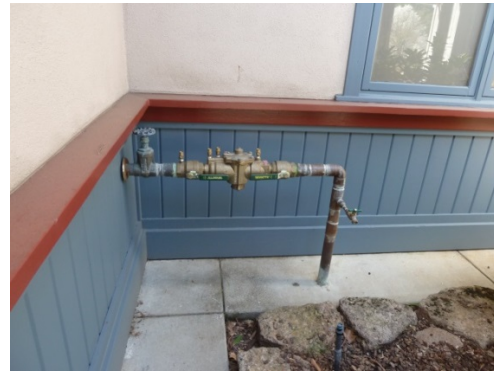
Irrigation Backflow Preventer

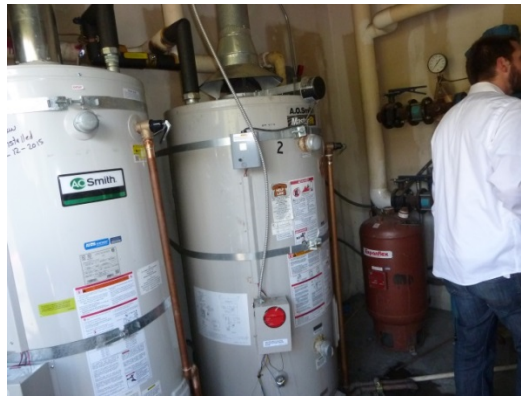
Domestic hot water is provided by two 100 gallon gas fired storage type commercial water heaters. Water heater WH-1 has an input rating of 275,000 BTUS per hour. It was recently installed on February 2, 2015. WH-2 has an input rating of 250,000 BTUS and was installed in April 1, 2002. Hot water circulation is provided by an inline circulating pump. Supply and return lines are insulated. Thermostatic mixing valves are provided to each shower room to provide tempered water. The heaters share the mechanical room with the boiler on the north side of the Fitness Center.

Existing Domestic Hot Water Heaters

The existing domestic hot water system is adequate and in good condition especially with the recently replaced heater. The second water heater is 13 years in service and would be good for a few more years but the facility should plan for its replacement. Future remodels would require reevaluation of capacity.

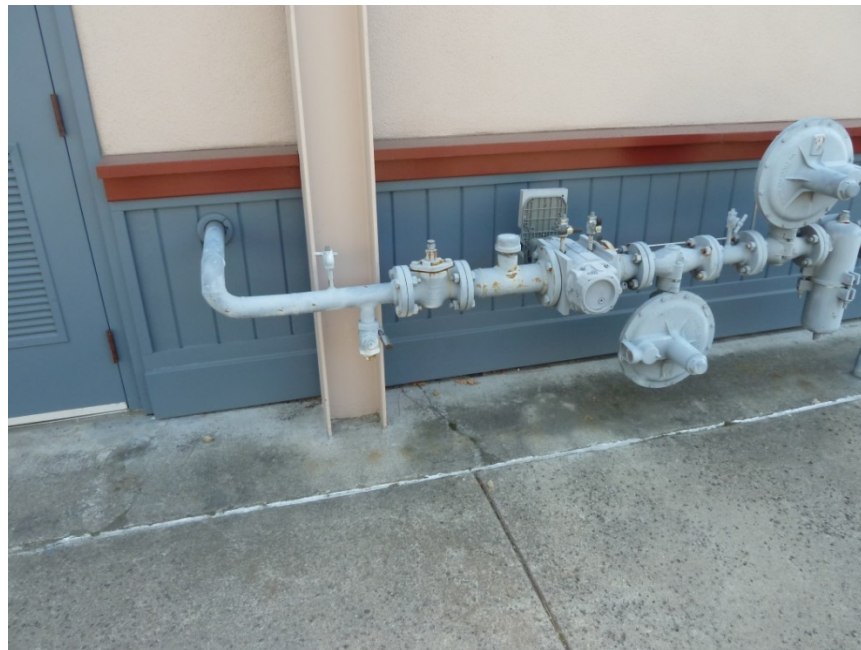
Natural gas is served from a rotary meter at the back of the Fitness Center (north) just outside the mechanical room and has a capacity of 5,000,000 BTUS. Gas is delivered at standard pressure by a 5" main. No earthquake gas valve was observed. Pipe material is steel with galvanized steel for exterior locations and black steel inside the building. Gas is supplied to the water heaters, boiler, three pool heaters, make-up air unit and kitchen equipment. The existing gas load is approximately 4,500,000 BTUS.

Existing Gas Meter

The existing natural gas supply has a spare capacity of 500,000 BTUS and with the planned re-use for the kitchen area, the spare capacity would increase to 1,250,000 BTUS. For added safety it is recommended to add an earthquake gas valve at the main line.

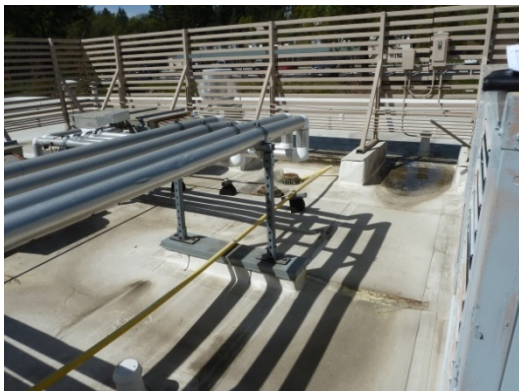
Corrosion at drain domes

Except for maintenance on the rusting domes, no additional work is needed at this point.

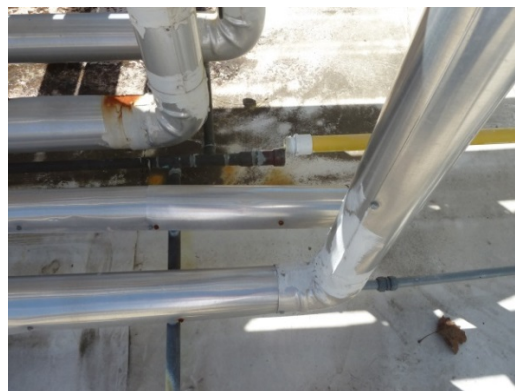
Condensate drain disconnected

The condensate drain lines serving the rooftop air handling units at the Fitness Center were intended to discharge to a roof drain. However, the main pipe was disconnected halfway through the run and pipes are not properly supported.

Condensate drain line on the Fitness Center roof should be repaired and properly supported.

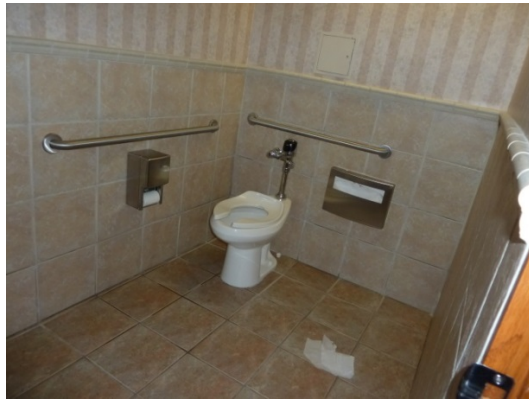
Floor Mount Public Toilet

The existing fixtures still function but for water conservation, it is recommended to replace fixtures or faucets with high water efficiency models with either manual or sensor controls. Control selection shall be made by the Owner.

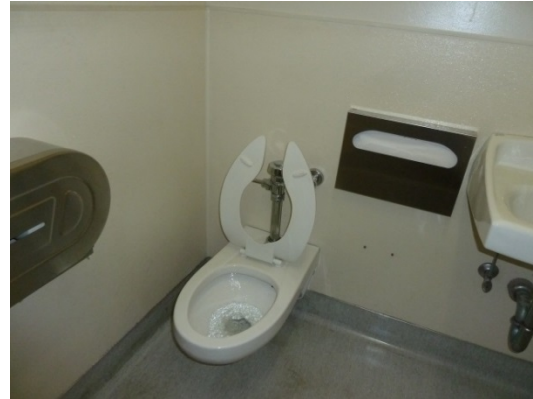
Wall Mount Staff Toilet

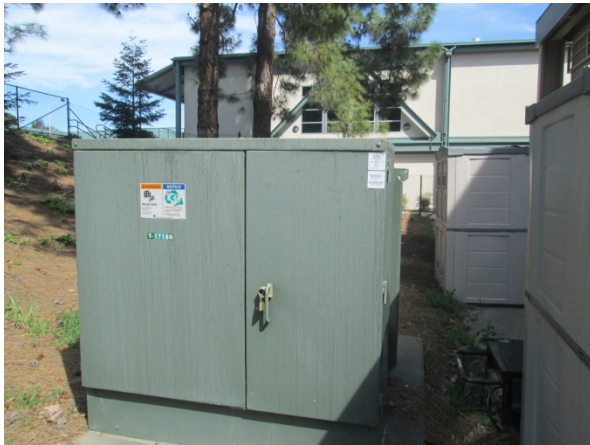
Existing PG&E transformer

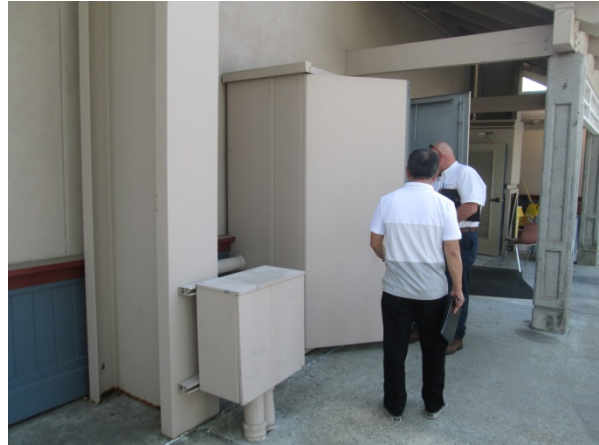
Existing Main Switchboard closet and distribution board closets.

Based on the age and conditions of the existing switchboards, no further work is required on the power distribution system. All existing lighting is installed on 120/208V panel boards and new lighting will be selected to be compatible to this voltage. The majority of the panel boards were installed during the 1991 modification and have another 20 years of life.

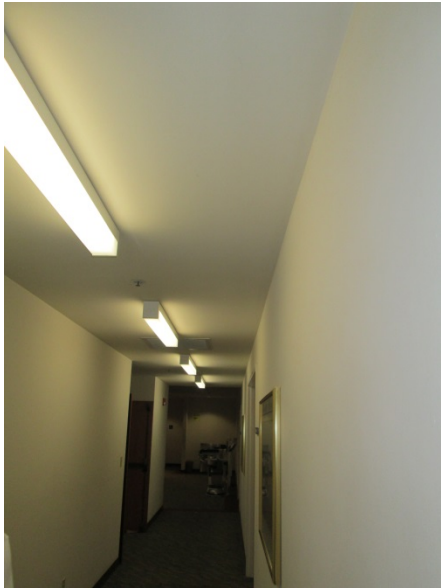
- Multi-use gym rooms consists of downlights, recessed 2'x4' troffers with motion sensor control. Troffers appear to have high glare and are not comfortable especially for elderly viewers.
- Corridor lighting consists of surface mounted strip lights and recessed downlights. It was observed that there was scalloping on the walls where downlights were installed. The surface mounted strip lights did not provide adequate lighting for the corridor.
- Main equipment gym room consists of recessed parabolic louver 2'x4' T-bar lighting. There are existing skylights in this room.
- Auditorium area consists of recessed florescent 2'x4'high output T-bar fixtures, recessed MH lamps and stage lighting.
- Pool enclosure has MH lamp rod mounted pendants. Powder coating is peeling and there is rusting in some fixtures.

Existing corridor lighting

The existing lighting within the clubhouse is not optimal for senior occupants according to IESNA (The Illuminating Engineering Society of North America) standards. The recommended lighting levels for seniors are higher than those of other observers and should be sufficient in lighting quantity, direction of light, and good contrast without causing glare. Good lighting maintains an environment that promotes wellness, personal independence and reduces accidents. It was observed that many spaces were dark, not lit uniformly, and caused scalloping on walls. In addition, many of the fixtures create glare and contain non-energy saving globes. Energy improvements can be made from using LED sources and low glare fixtures. Higher lighting levels can be achieved from new lighting with higher lumen outputs and better color rendering. Task lighting can also be provided to specific task areas.

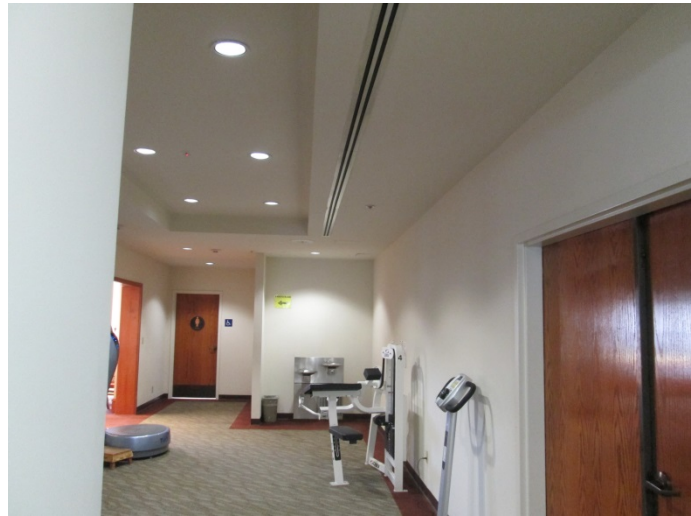
Existing lighting showing scalloping on walls

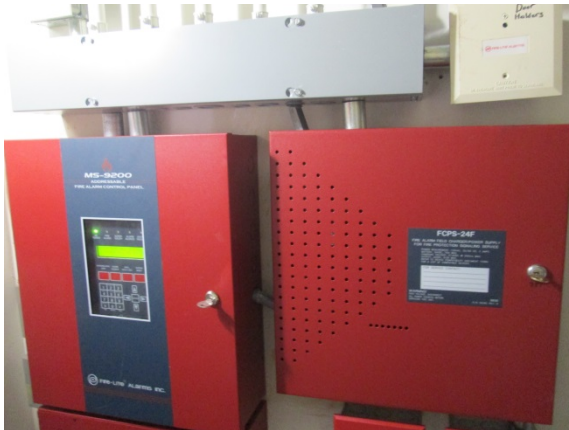
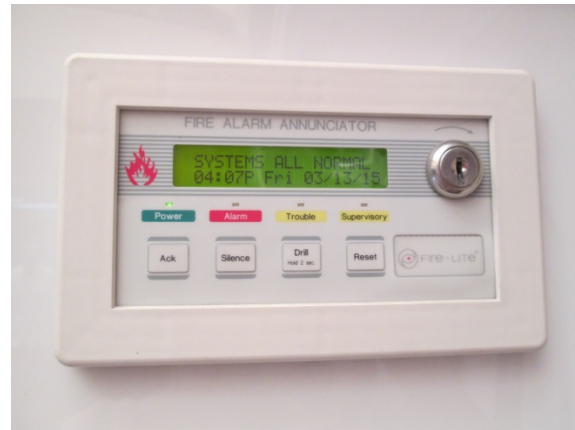
Existing Fire-Lite fire alarm annunciator is located at the existing main entry to the gym foyer. Fire Control panel is in a Fire-Lite MS-9200 system. It is located with fire power supply panels in the storage room next to the multi-use rooms. Manual pull stations are provided throughout the building. All devices are in good condition.

The existing strobes and horn type speakers are in locations that are required by code. Should modifications be required to the entries, exits, and paths of egress, fire alarm equipment will need to be either relocated or new. The existing fire alarm panels in the storage room should be retained if possible. If the main door is relocated, the main annunciator will need to be relocated to the new location.
