Prepared for: Angus Johnson | Design Director Victoria | Delfin Lend Lease

Prepared by: James Martens-Mullaly | Director | Tree Logic Pty Ltd

Arboricultural Assessment

Richmond Property, Bulban Road, West Werribee

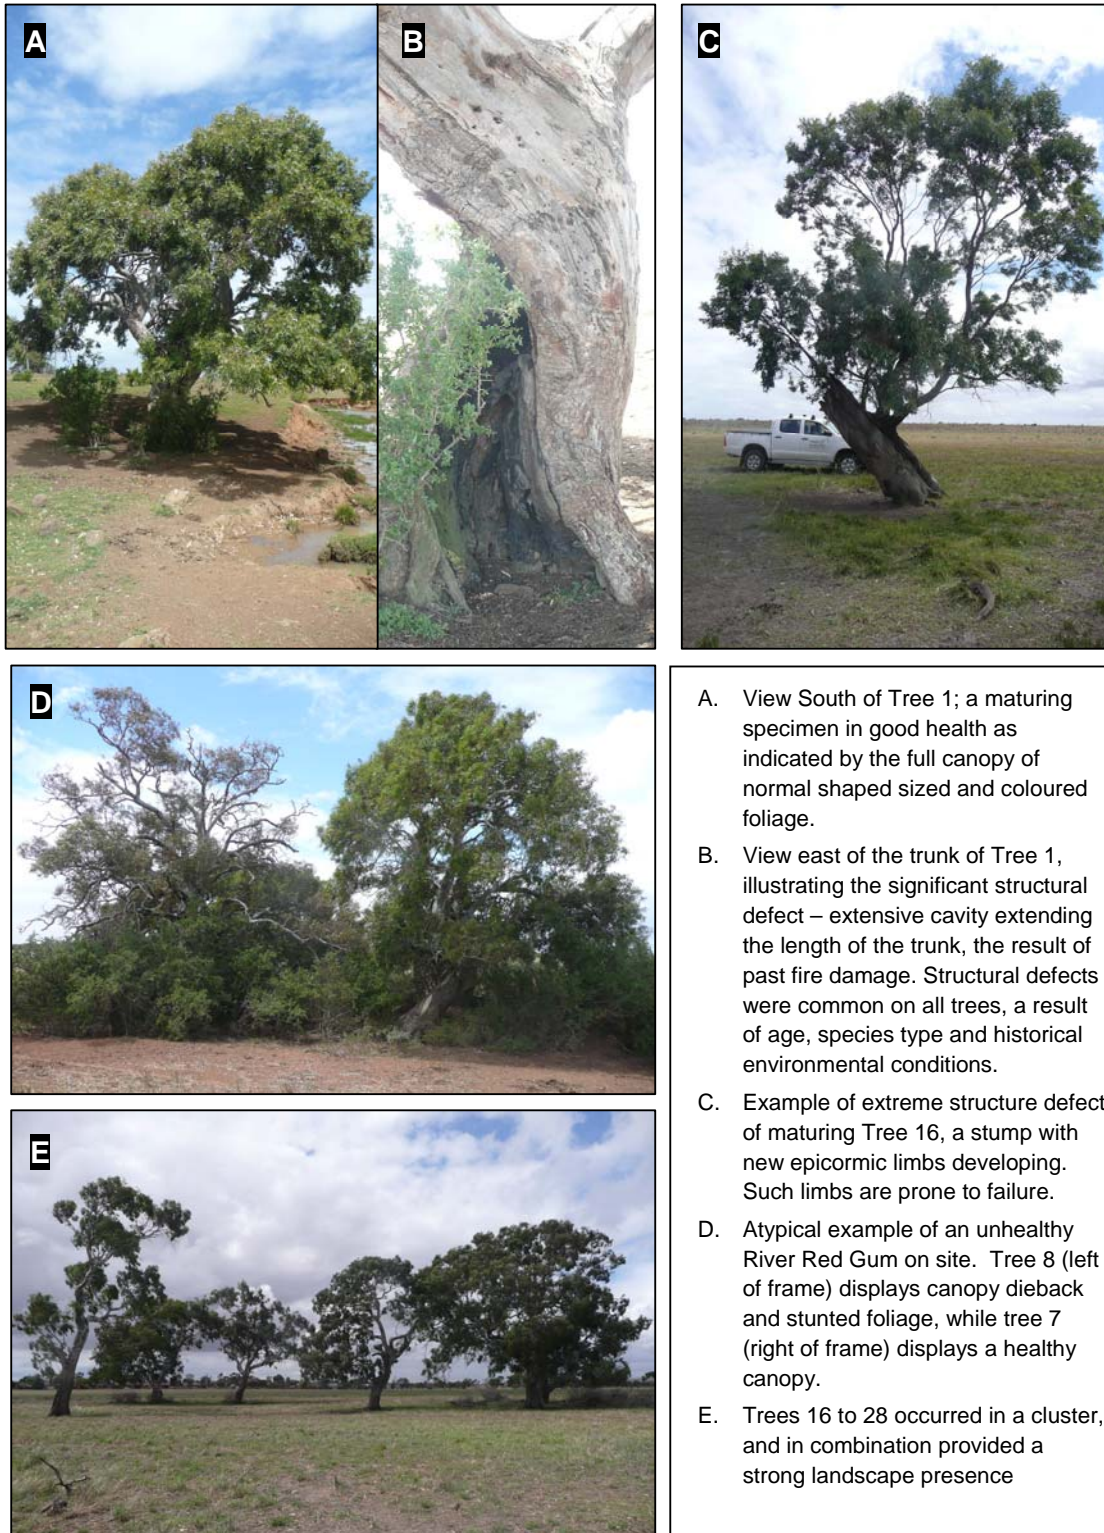
5 Photographic Catalogue

- A. View South of Tree 1; a maturing specimen in good health as indicated by the full canopy of normal shaped sized and coloured foliage.
- B. View east of the trunk of Tree 1, illustrating the significant structural defect – extensive cavity extending the length of the trunk, the result of past fire damage. Structural defects were common on all trees, a result of age, species type and historical environmental conditions.
- C. Example of extreme structure defect of maturing Tree 16, a stump with new epicormic limbs developing. Such limbs are prone to failure.
- D. Atypical example of an unhealthy River Red Gum on site. Tree 8 (left of frame) displays canopy dieback and stunted foliage, while tree 7 (right of frame) displays a healthy canopy.
- E. Trees 16 to 28 occurred in a cluster, and in combination provided a strong landscape presence

- 7.5 Trees attracting a Moderate Arboricultural rating included specimens of a generally unremarkable nature, though in this instance displaying minor health and/or structural defects. Trees attracting Low arboricultural ratings included specimens with more advanced health and/ or structural defects.
- 7.6 Trees attracting No arboricultural ratings included Tree 16, a specimen that had previously experienced failure of the trunk; the remaining tree was a stump with epicormic limbs developing (Plate C, Section 5).
