**Assessment of
Civil, Architectural, Mechanical, Electrical, Plumbing and Fire Protection Systems**

**Belk and Graham-Hewlett Residence Halls
University of North Carolina Wilmington**

October 1, 2012
(DRAFT)

Sud Associates, P.A.

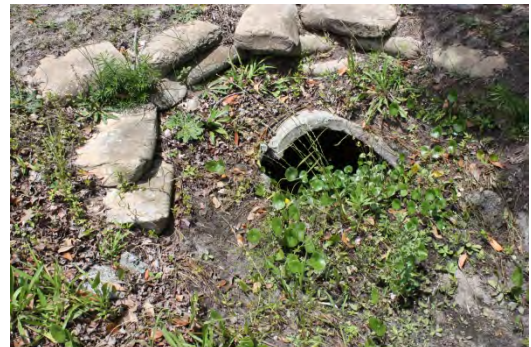
Discharge from parking area to ditch

The surrounding grade of the storm water drop inlet located at the east end of Belk Hall is holding water in the adjacent parking area. An attempt has been made with hand tools to limit this issue however a more permanent solution is required.

- Reestablish the ditch profile to create positive drainage. Permanent vegetative ground cover should be established within 14 days of any work.
- Install flared end sections at the pipes serving the ditch.
- Grade the surrounding area around the drop inlet to provide positive drainage from the parking area to the inlet.
- Clean storm water piping.

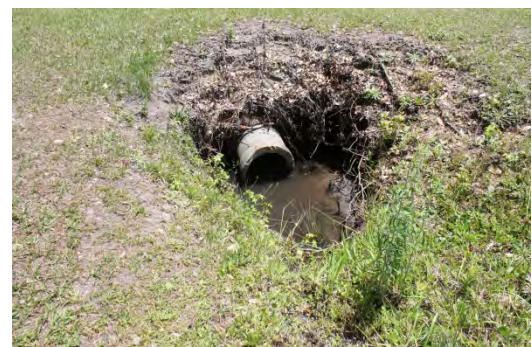
Inlet pipe at ditch

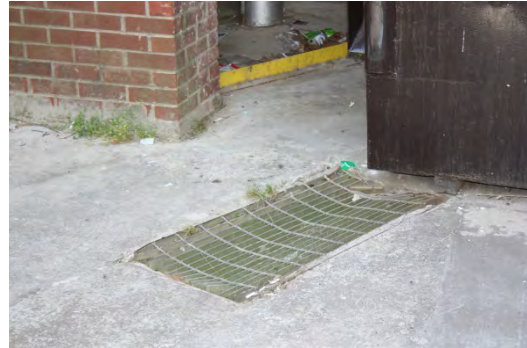
A drain has been installed at the rear of the building to serve the area behind the dumpster. This drain has been filled with sediment and is no longer functional. This drain line and the storm water piping system as a whole should be cleaned and all sediment removed.

Drain at dumpster

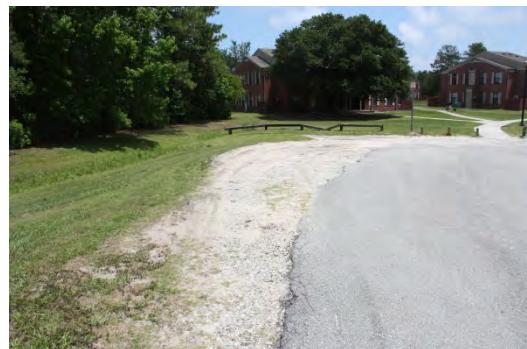
The asphalt pavement has signs of deterioration along the edges where vehicle traffic is present. The rear access road along the north side of the building has significant rutting and erosion due to vehicles turning in this area.

Rear Access Road

- Construct a cul-de-sac at the rear of Belk Hall to accommodate vehicle traffic in that area.
- Remove the damaged asphalt and replace the asphalt area around the sewer manhole.

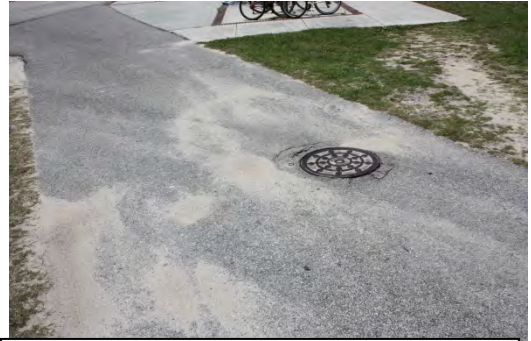
Vehicle activity along the south side of building has created pavement settling around sewer manhole. Pavement is thin and cracked in this area.

Cracking around Manhole

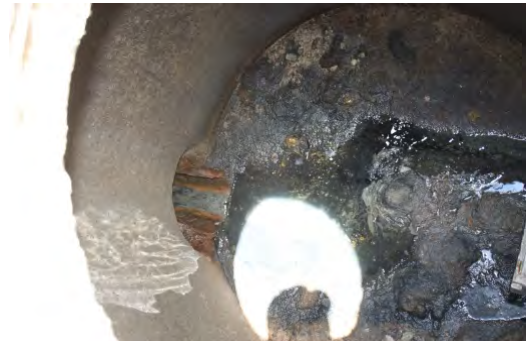
The manhole in the access road along the south side of Belk Hall appears to be in good condition. The manhole provides access to an eight (8) inch ductile iron pipe (DIP) gravity sewer main. Debris and other material were observed in the manhole indicating low flow conditions. The DIP shows signs of deterioration. The sewer flow in this system likely experiences periods of high and low flow directly related to the occupancy of the resident facilities on campus. As a result of non-continuous flow, the sewer in the system can generate high levels of sulfuric acid and damage piping and manholes.

Sewer Manhole at Belk Hall

- The sewer system as a whole should be cleaned and inspected with cameras to determine the overall condition of the system .

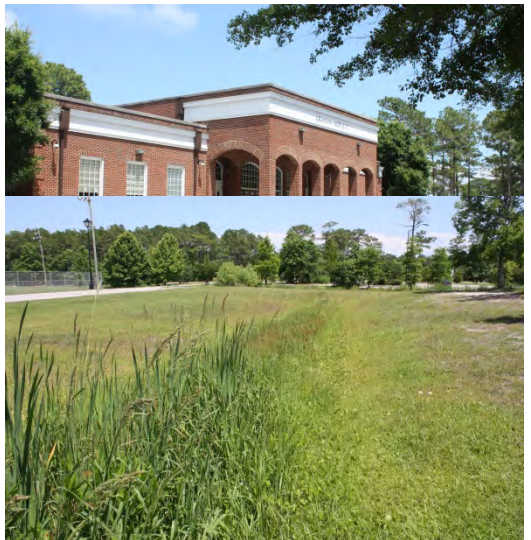
Overgrowth of vegetation in drainage ditch

The ditches at the east side of the building, north of the parking lot, requires maintenance. The ditch is overgrown which is limiting flow and capacity and cannot be maintained. The pipes at each end of the ditch require a flared end section to be installed to maintain stability of the ditch cross section. The areas immediately in front of the discharge piping to the ditch is severely overgrown.

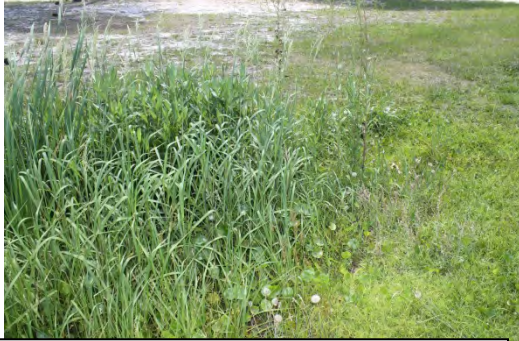
Overgrowth at discharge to ditch

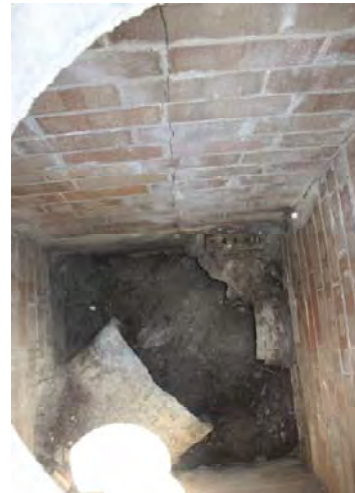
The Stormwater Manhole at the north end of the building is cracked and should be repaired.

Cracking inside stormwater manhole

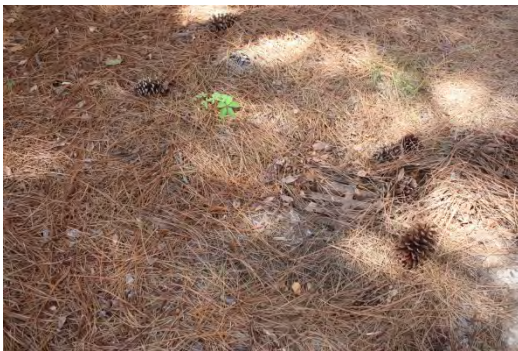
Drop Inlets around the building show evidence of sediment and debris buildup in the system. This will reduce the system's ability to convey storm water a reduce capacity. Drop inlets located in natural areas lacked appropriate vegetative aprons.

Drop inlets in Natural Areas

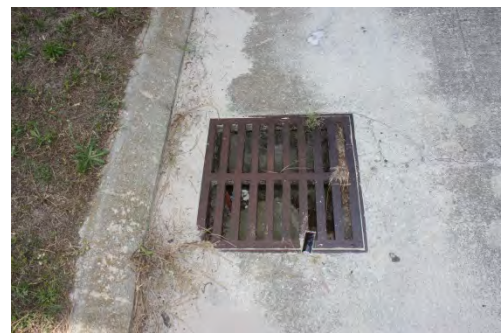
Debris in drop inlets

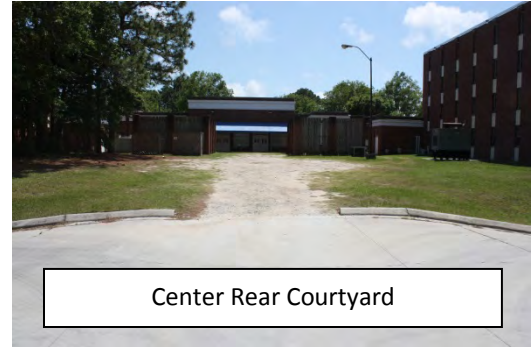
All but two of the gravity sewer service cleanouts were covered. One of the two cleanouts found had no cap and was open. The manhole at the front of the building was not accessible for inspection.

- Find all sewer cleanouts and confirm they are sealed and in good condition.
- Perform a system wide sewer cleaning and video inspection of sewer system to confirm system integrity.

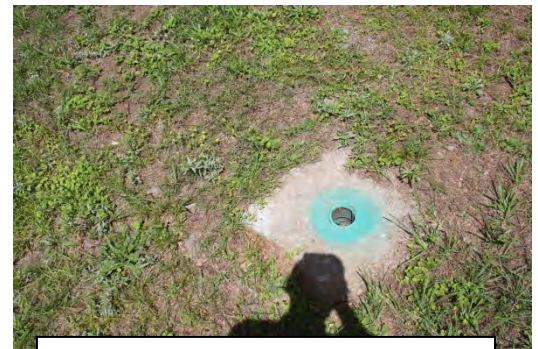
Water Valve at North end of building could not be found. Valves along the front of the building appear to be in good condition. All valves should be located and protected with concrete collar

- Water valves should be located and concrete collars should be installed to provide protection.

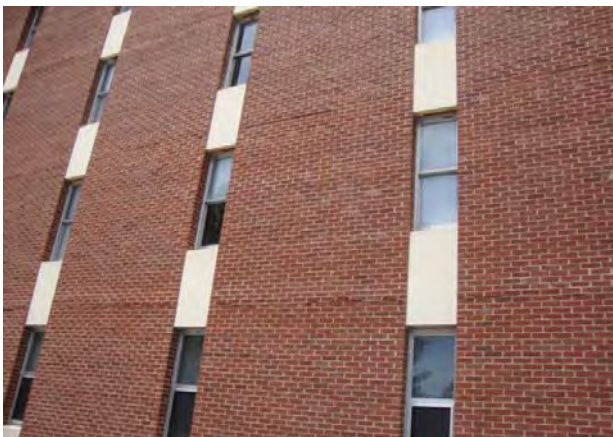
Figure 3.1: Hewlett Hall Exterior Face Brick

- b. Residence Hall which is now showing areas of additional masonry problems. The cost estimate includes replacement of the brick veneer on all three residence halls which includes wall insulation, weep holes and flashing, control joints, shelf angles, veneer anchors, etc.
- b. Steam clean all pre-cast concrete panels and stone copings and re-caulk.
- c. Replace fourth floor window projections with cement fiber board over metal framing and scrape and paint lintels.
- d. Scrape and paint all lintels.
- e. Re-caulk exterior door frames.

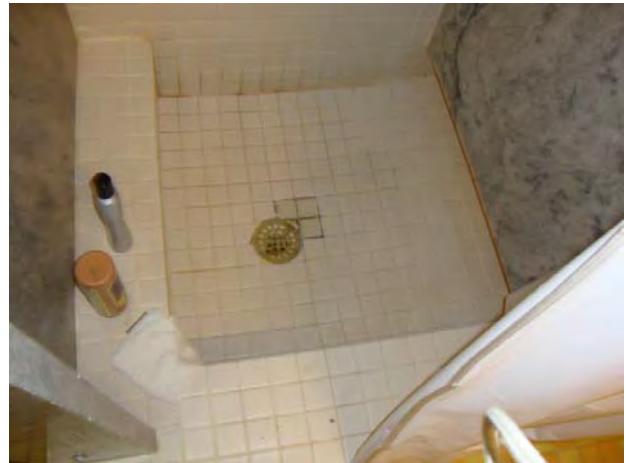
Figure 3.2: Shower to be upgraded.

- b. Membrane Waterproofing
 - c. New ceramic tile floor & base
 - d. New floor drain flush with new work
 - e. New lavatory counters
4. Magnetic Hold Open devices will be added to stair doors in all three residence halls (Reference FCAP Report).
 5. Graham Residence Hall will have proper signage at Fire Pump and AHU Room No.1 door openings (Reference FCAP Report).
 6. Maintenance items at the Graham-Hewlett Connector:
 - a. Repair rubber base in Lobby LB1/W
 - b. Men MR1E/G: Repair drywall, secure lavatory, adjust door hardware.
 - c. Repair drywall in Men MR1W/H
 7. Provide dumpster protection at Graham & Hewlett.

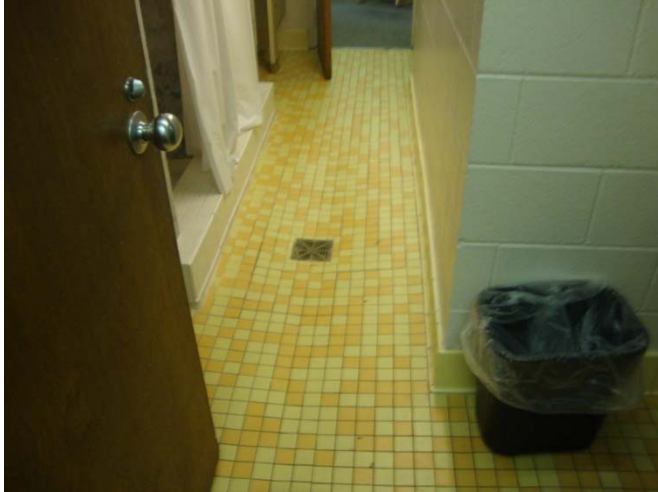
1. The 2009 NCBC requires each dormitory to have five accessible bath rooms, one of which will have a roll-in shower. All other rooms shall have access to baths complying with Type 'B' Sleeping Rooms. The study design team visited recently constructed UNCW dormitories (International and Cornerstone Halls) to visualize currently constructed and understand floor plans desired by the University.

Figure 3.4: Typical Nonconforming Bathroom Hall

The study architect prepared and reviewed alternative floor plans to comply with the present building code. After considerable effort, a proposed layout was developed to comply with the code requirements. The layout removes the Study Rooms and Baths and substitutes the Men's and Women's gang bath rooms in the center of the remaining space. Reference NCBC Section 1107.6.2.2. Proposed layout is provided as figure 3.5.

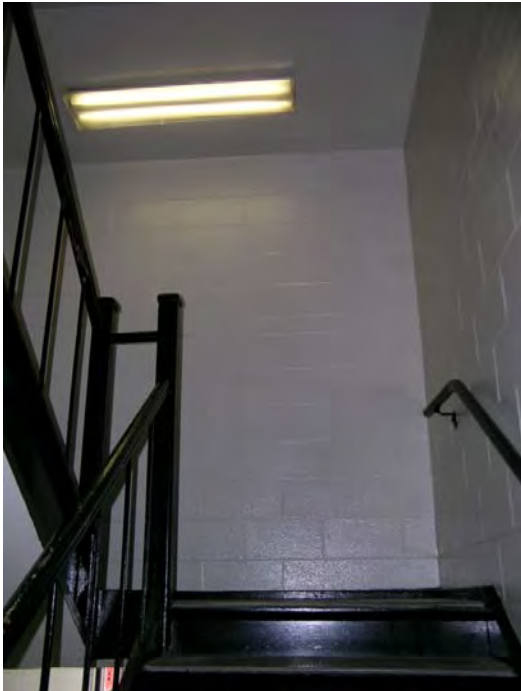
5. The original railings remain in use at the three dormitories. All Stairwells include new code compliant railings, contrasting color of risers, level identification, soffit repairs, and

Figure 3.6: Railings in Stairwells.

replacement of doors and frames with magnetic hold open devices. *Reference NCBC, Handrails Sections 1009.12, 1012, 1607.7; Guardrails Sections 1013.1, 1013.2, 1607.7. Railings shall be replaced with the following elements:*

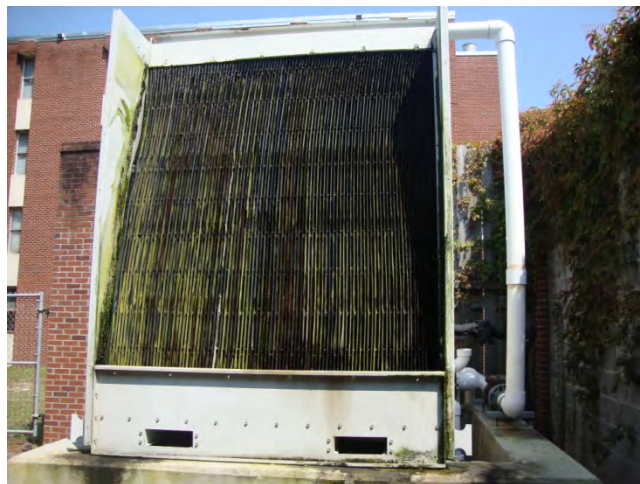
years of remaining service life. On both units the wetted surfaces of the tower packing was covered with algae; so, it is recommended to check on the chemical feed system. The ASHARE estimated service life for cooling towers constructed of

Figure 4.1: Cooling Tower with Algae Formation.

galvanized metal is 20 years. However, this does not include the effect of a coastal environment (See figure 4.1).

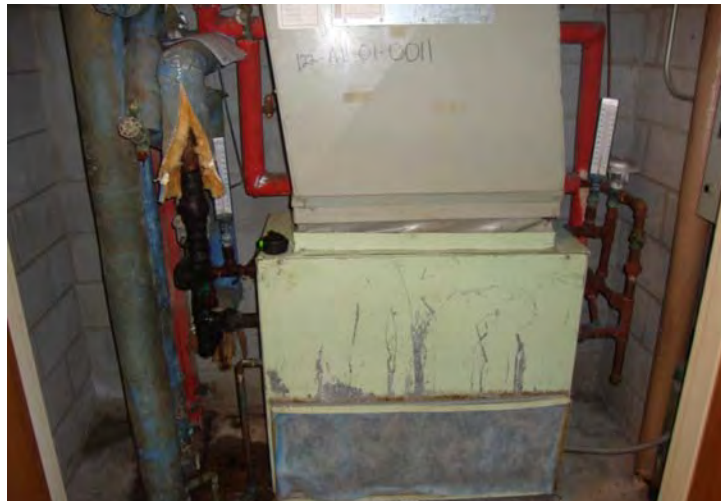
Figure 4.2: Belk Hall – Air Handler for Suites, in Mechanical Closets

found un-insulated which is indicative of repetitive repair and replacement at the unit controls. At Graham and Hewlett there are no space thermostats. The hot and chilled water distribution piping (risers) is steel and galvanized steel at the connections at the units. Mr. Batts stated that these risers have been subject to rust and through wall failure and need to be replaced. Replacement of the first floor HHW and CHW mains is not as an immediate concern and could be held until coordinated with other work. Failures in these mains would be indicated by frequency of water damage on the ceiling tile.

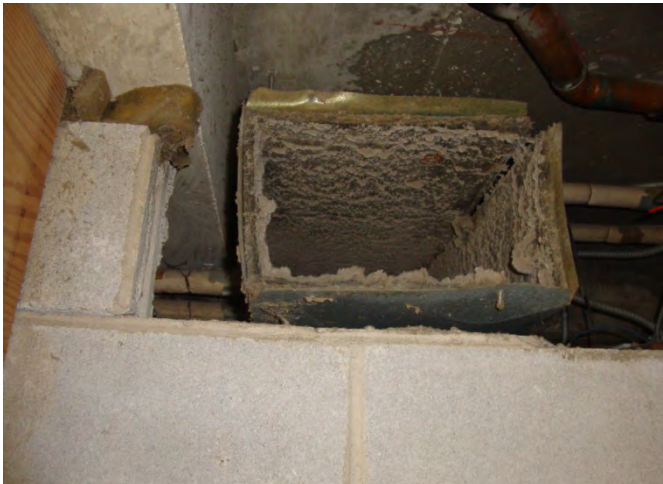
At all three buildings, the supply and return ducting for the suites units is located above the bath and toilet area plaster ceiling and within the soffit at the inside wall of the bedrooms. The ducting is lined and is expected to be of original construction. The lining in return ducts in the two study rooms in each suite is very dirty (see Figure 4.3) and the ducts should be replaced with the units. At Belk Hall, the returns and outdoor air supply stub into the mechanical closet, with this closet serving as a plenum. Ducted outdoor air and returns provide greater assurance that smoke would not be transported from the mechanical room to living areas (NCSBC Mechanical 602.2.1) and ducting is

Figure 4.3: Return duct with liner, recommended to be replaced

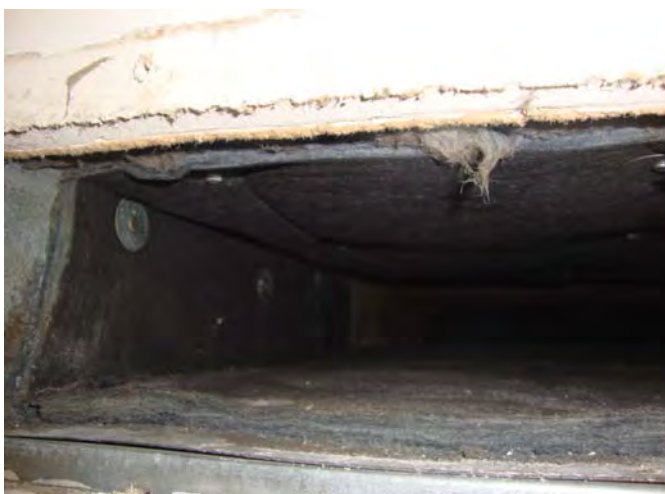
required by the State Construction Office. The returns and outdoor air are ducted to the unit at Graham and Hewlett Halls. The lining within the supply duct above the bathroom and in the soffits is in reasonable condition (see Figure 4.4). Duct from the original construction is beyond the 30 year service life estimated by ASHRAE.

Figure 4.4: Supply duct with liner, Can be Cleaned and Encapsulated

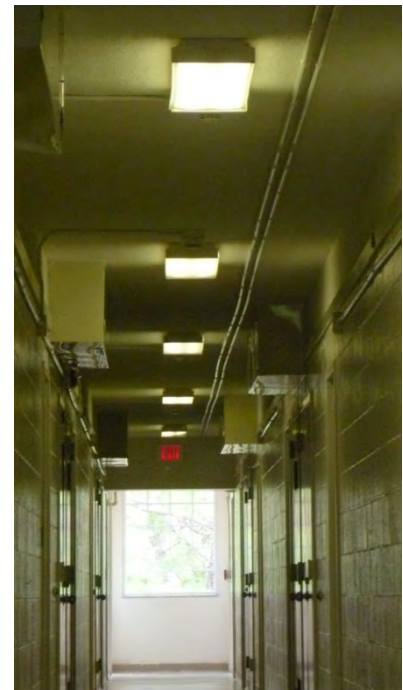
A reconfiguration of the space per Figure 3.5 would require the replacement of the emergency lighting system to meet Accessibility code.

Figure 5.3 Hewlett Corridor Emergency Lighting

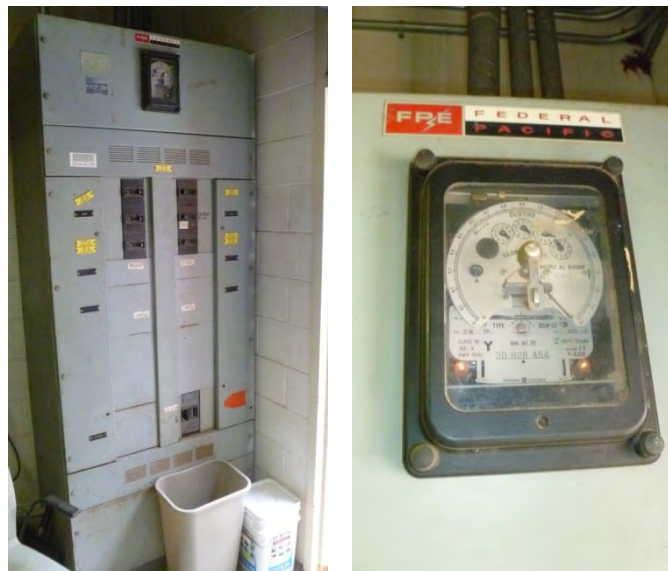
The original riser configuration was driven by cost and has the draw-back that panel replacements or work on the feeder requires a power outage on all floors of the dorm.

Figure 5.5 Graham Hall Main Service Panel and Meter

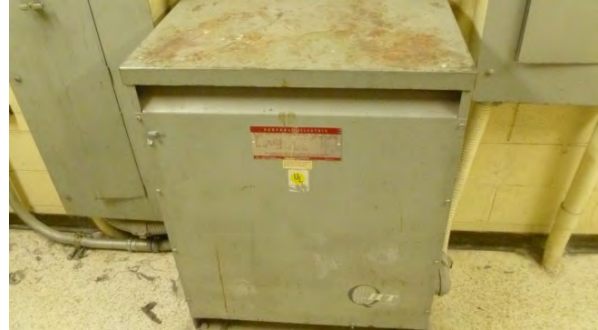
The original dry-type step-down transformers and their replacement models are low efficiency 112.5 kVA and 45kVA transformers with 150°C temperature rise. The considerable amount of rejected heat is indicative of the losses. The ambient temperature appears to be high in the Hewlett and Graham electrical rooms, which would negatively affect the electronic equipment such as transfer switches and fire alarm panels.

Figure 5.7 Typical 112.5 kVA Step-Down Transformer

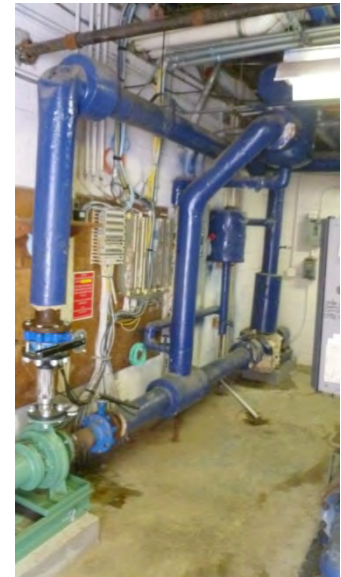
The original design combined the telecommunications and mechanical systems into the same spaces. The environmental conditions of the mechanical and boiler rooms are not suitable for active or passive telecom equipment or terminations. The original telephone services were replaced with new underground trunclines to the mechanical spaces in the early 2000s. The protector and punch-down blocks are mounted on a sheet of plywood in the mechanical/boiler rooms. The plywood appears to have no fire resistance markings and the access to the telecom boards are restricted by mechanical equipment and piping. The telephone drops are fed from the Mechanical Room via original in-slab conduits to 12x12 pull boxes in the dorm's ceilings, from which individual ½" conduits serve the individual telephone outlets in the bedrooms. The telephone wiring in the buildings appears to be original cat3 cables. The telephone system is reported to be functional without any major drawbacks. The usage of these landlines in the dorms has declined over the years. However, the front desks, the vending machines and fire alarm systems depend on this system.

Figure 5.9 Telephone Backboard behind Mechanical Equipment

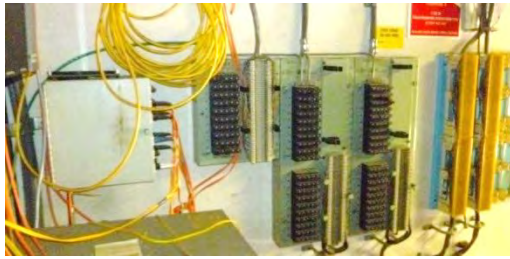
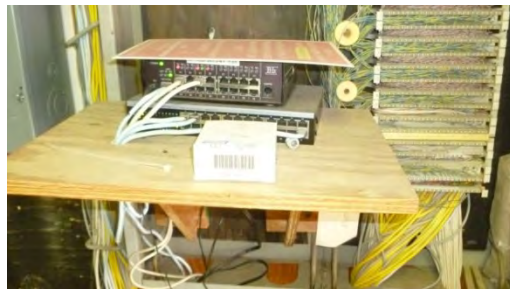
Figure 5.10 Telephone and Data Equipment in Mechanical Space

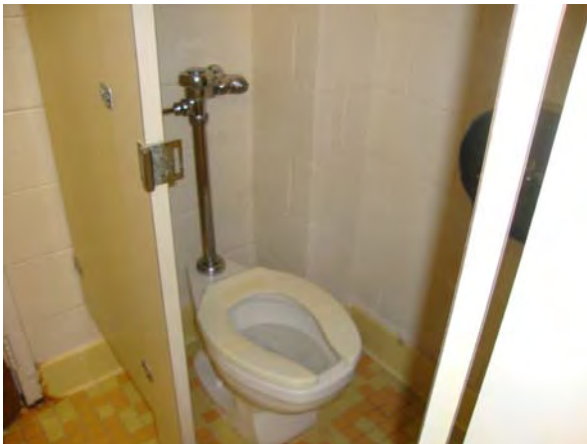
4. There are repeated failures of the shower pans (5-6 per year) as documented in maintenance reports. Often these failures occur at the joint between the shower drain and the drain pan. Particular attention and detail is required for the design at this joint. The same applies to floor drains within bathrooms (or wet) floors.

Figure 6.2: Typical Water Closet in Suite Bathrooms

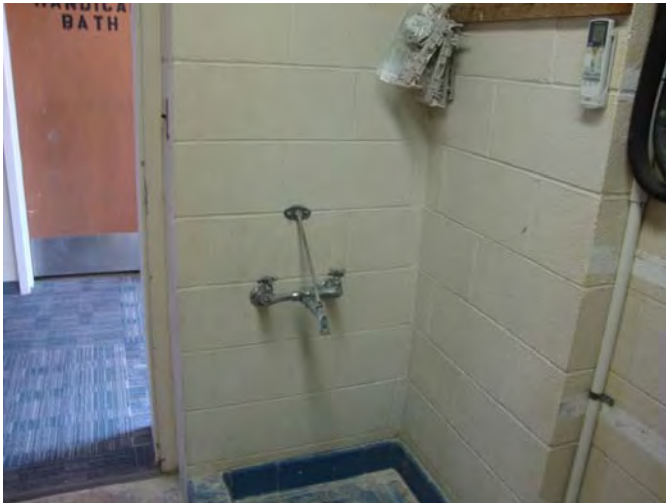
Figure 6.3: Mop Sink can siphon from contaminated source.

to be replaced. Drains and tailpieces and supplies should be fitted with insulation. Fixtures should be replaced or modified to make cross connection impossible.
