Transmission: AS68RC

Subject: Shift Issues, P0796 After Overhaul

Application: *Chrysler*

Issue Date: October, 2016

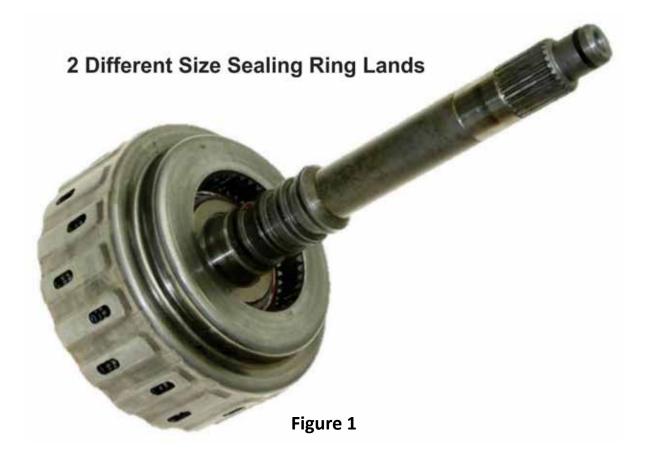
One area that is over looked is the sealing rings on input shaft. There are two size sealing ring lands and stator support bores built sometime between 2010 and 2011. The input shaft size is the same just the ring land size is different (figure 1).

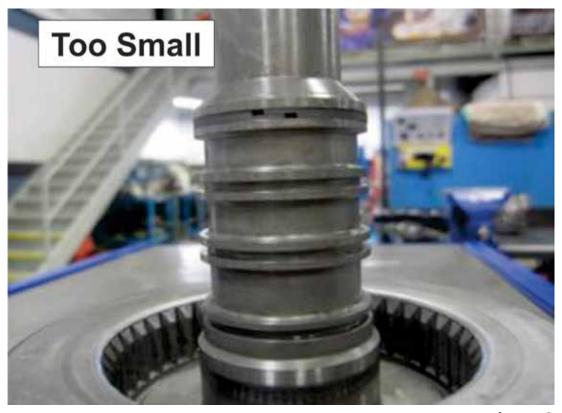
Figure 2

A sealing ring that is too small will cause code P0796. Be sure to check the rings for proper fit (figure 2).

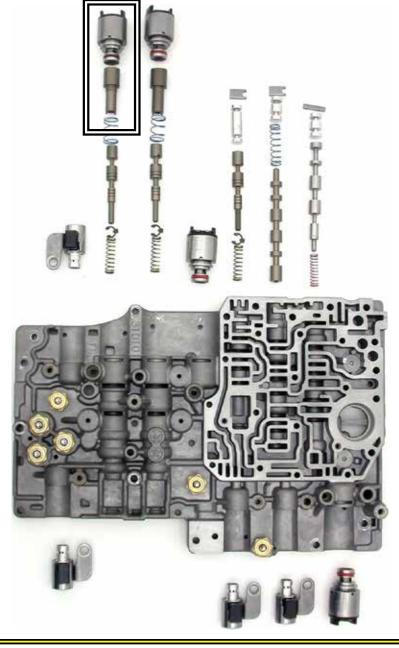
This condition can be caused by the linear solenoid B failure. Allison trim solenoid B (\$120) works well in place of linear solenoid B. Dodge sells the linear solenoids with the valve body only (\$3500)/pressure switches and on/off solenoids (\$200 for either) sold separately. Your costs may vary.

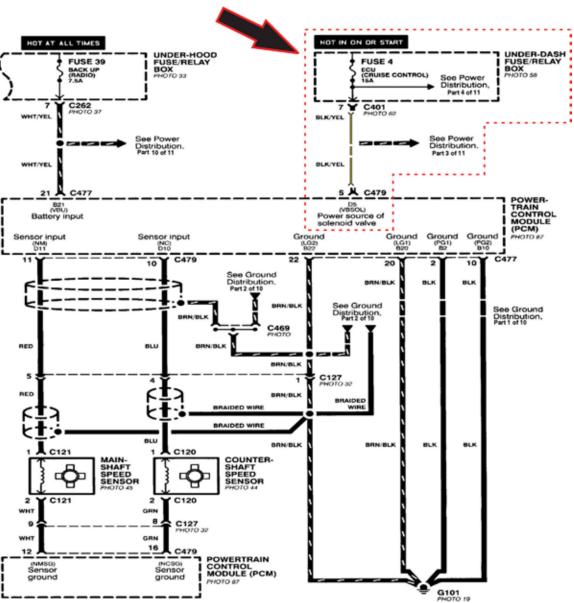
Figure 1

Look at the wiring diagram in Figure 1. We have pointed out and drawn a dotted outline that shows fuse number 4 from the driver's under-dash fuse panel. The fuse in this diagram is the solenoid power circuit. If there is no power from the fuse to terminal 5 of the C479 connector at the PCM there will be no power for the solenoid to be controlled by the PCM. The default action of this is to store DTC P1768 in the computer memory.

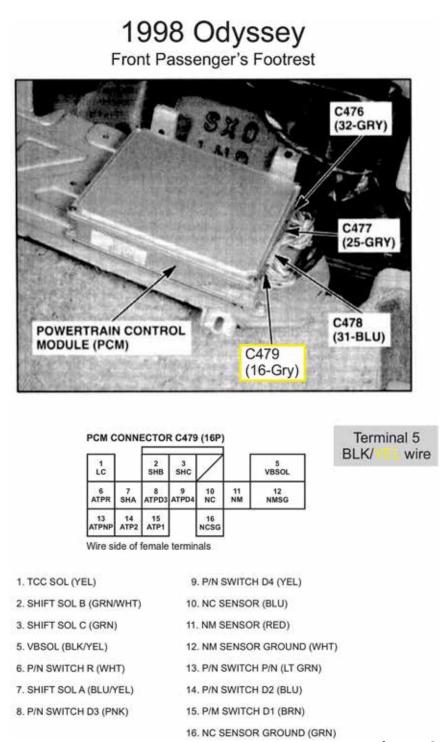
See Figure 2 for the location of the PCM with connector C479, and the connector C479 pin lay out showing terminal number 5. If there is no power at terminal number 5, check the fuse and or repair the open or shorted circuit as necessary.

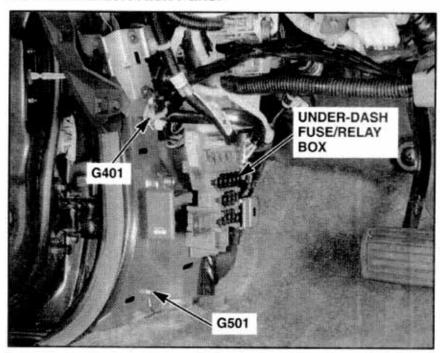
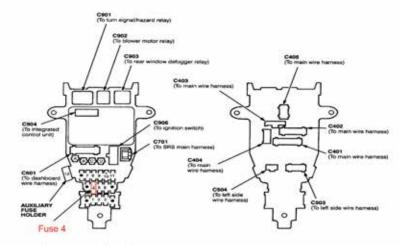
See Figure 3 for driver's side under-dash fuse panel location and location of fuse number 4.

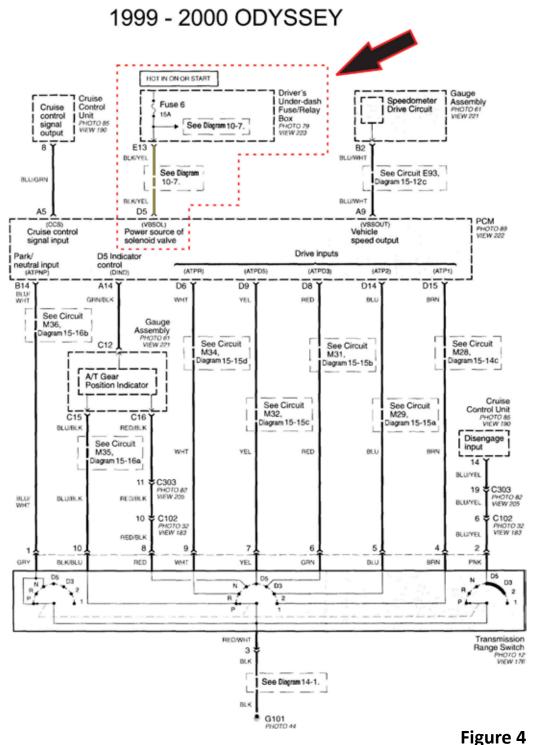
Look at the wiring diagram in Figure 4. We have pointed out and drawn a dotted outline that shows fuse number 6 from the driver's side, under-dash fuse panel. The fuse in this diagram is the solenoid power circuit. If there is no power from the fuse to terminal D5 of the PCM connector there will be no power for the solenoid to be controlled by the PCM. The default action of this is to store DTC P1768 in the computer memory.

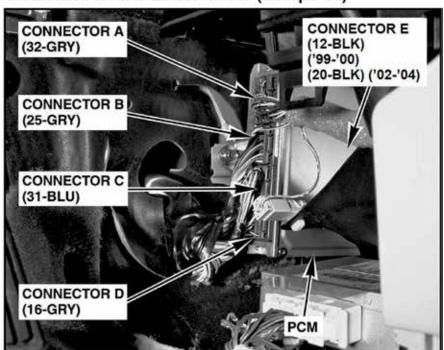
See Figure 5 for the location of the PCM with connector D and the connector D pin layout showing terminal number 5. If there is no power at terminal number 5, check the fuse and or repair the open or shorted circuit as necessary.

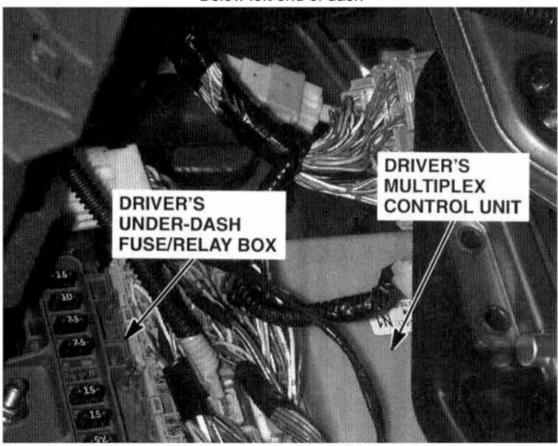
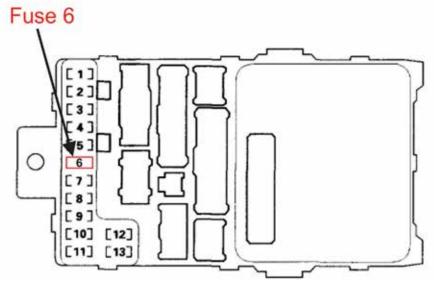
See Figure 6 for driver's under-dash fuse panel and location of fuse number 6.

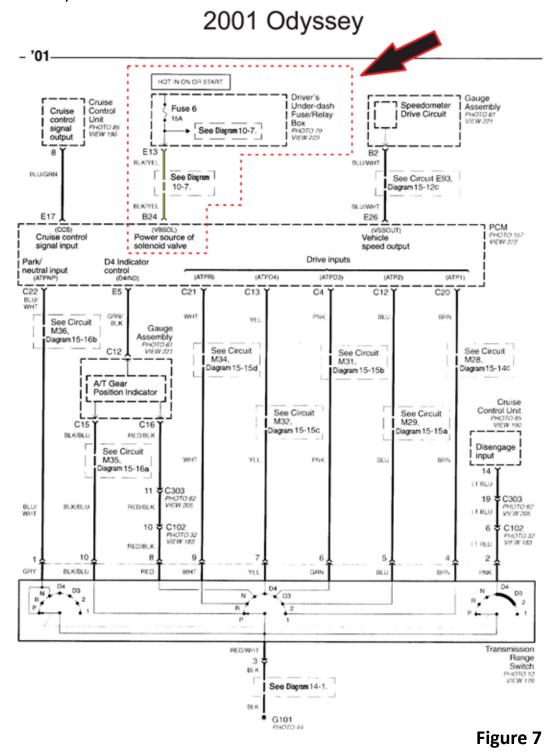
Look at the wiring diagram in Figure 7. We have pointed out and drawn a dotted outline that shows fuse number 6 from the driver's under-dash fuse panel. The fuse in this diagram is the solenoid power circuit. If there is no power from the fuse to terminal B24 of the PCM connector, there will be no power for the solenoid to be controlled by the PCM. The default action of this is to store DTC P1768 in the computer memory.

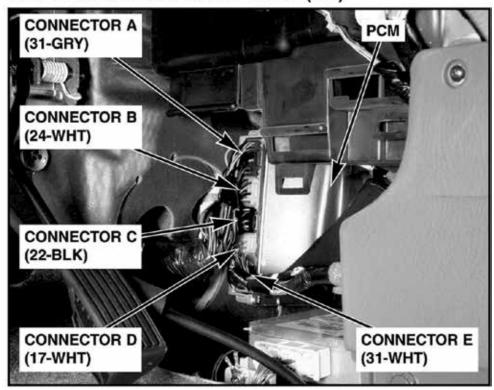
See Figure 8 for the location of the PCM with connector B and the connector B pin layout showing terminal number 24. If there is no power at terminal number 24, check the fuse and or repair the open or shorted circuit as necessary.

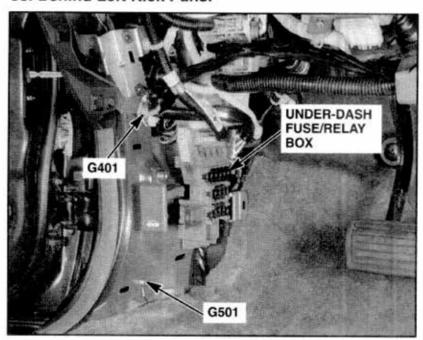
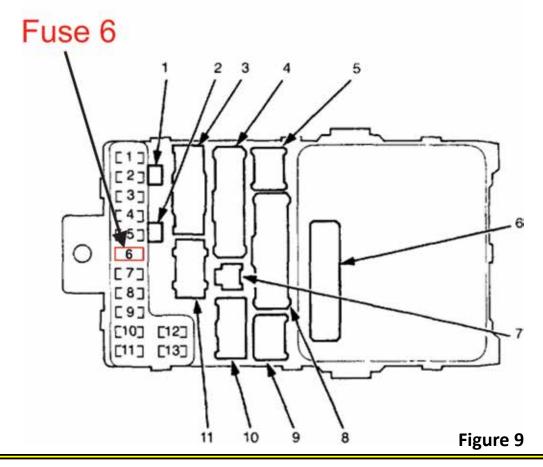
See Figure 9 for driver's under-dash fuse panel and location of fuse number 6.
