SERVICE BULLETIN

APPLICABILITY: 2020-22MY Legacy and Outback Models **NUMBER:** 15-261-20R
SUBJECT: Reprogramming File Availability for Optimization of Gen 4 Denso CP1 Infotainment Systems **DATE:** 03/10/20
REVISED: 01/28/22

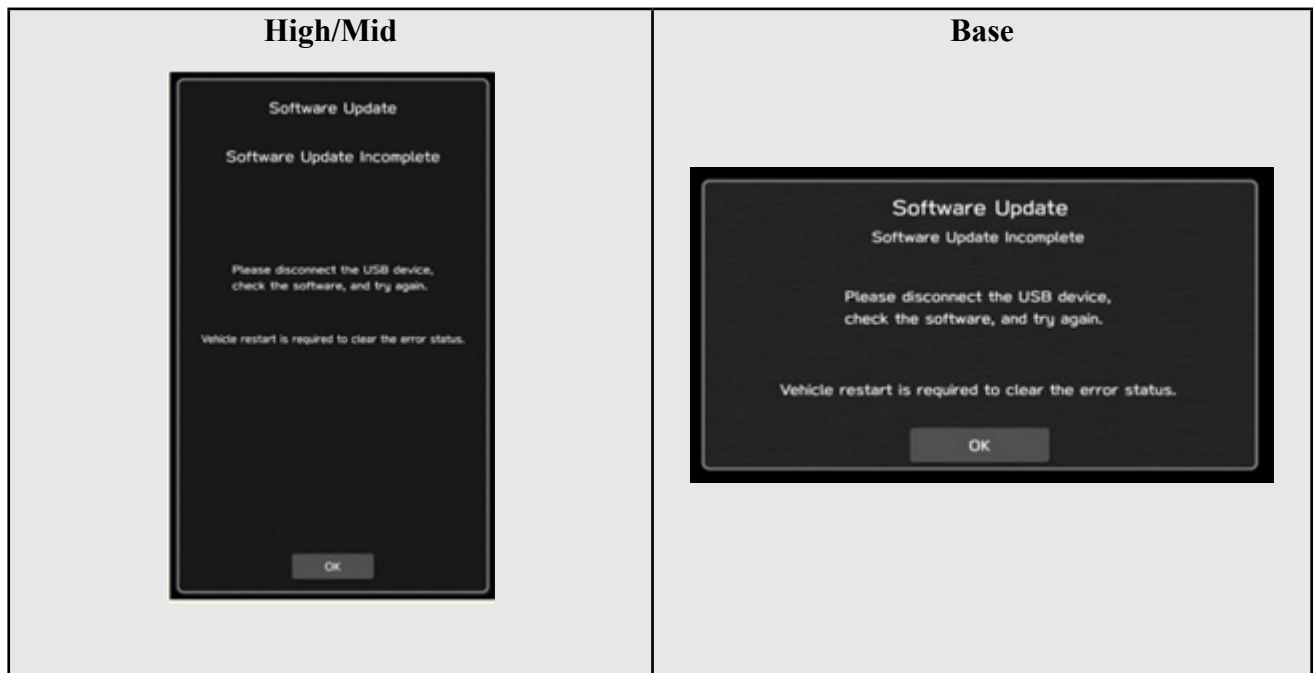
If you get the message Software Update Incomplete as shown below, please don't replace the hardware but retry updating the software according to the instructions in "Appendix B" on pg. 21.

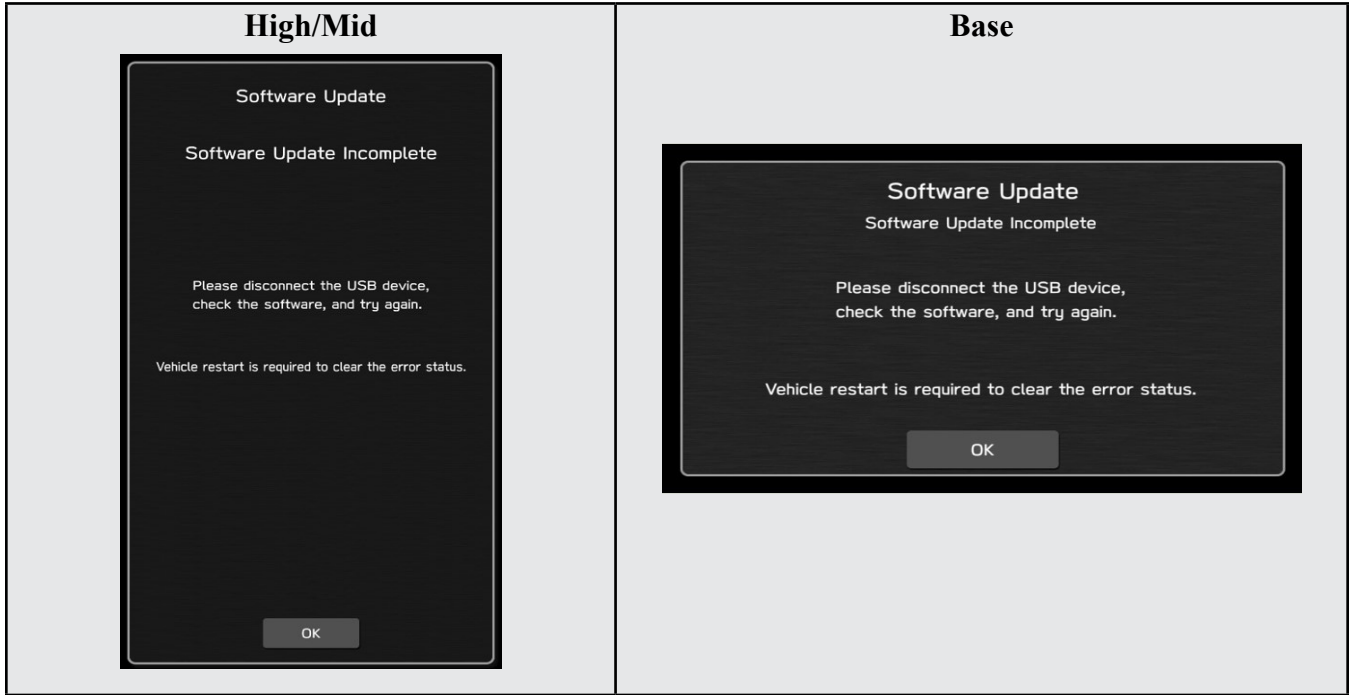
- If the first attempt of update fails with the message below, follow the steps described below 1-2 to 1-8 before retrying the software update.

1-1. Select OK in the screen below

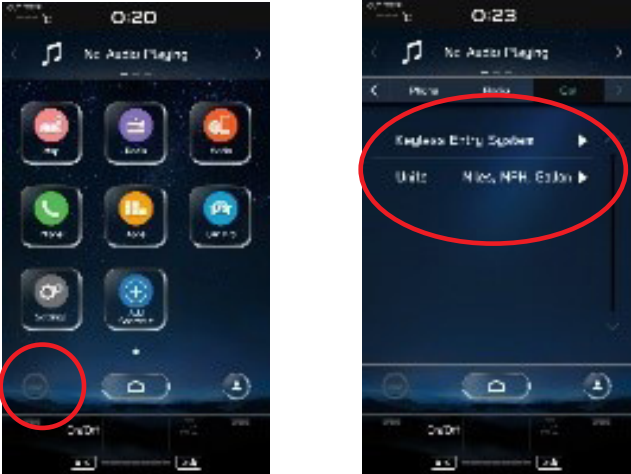
Number	Symptoms to be Improved:
4	<p>Vehicle Setting Icon in <Home> menu is grayed out. Menu list in the “Car” tab in the Setting Menu is not displayed.</p>

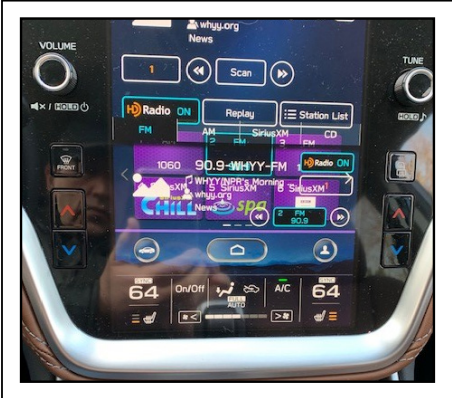
5	CarPlay stopped working after hanging up a hands-free phone call.
6	<p>CID shows multiple images simultaneously.</p>

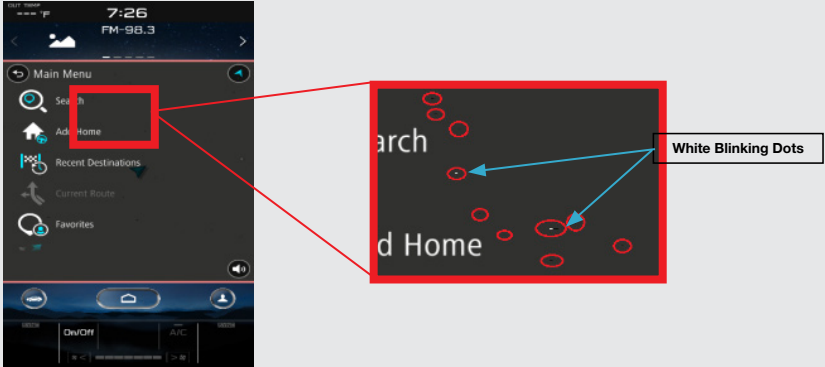
Symptom #	Description of Symptom:
1	Several minutes after Engine start, the Center Information Display (CID) reboots.
2	<p>After an extended period of usage, some white blinking dots appear on the display.</p>

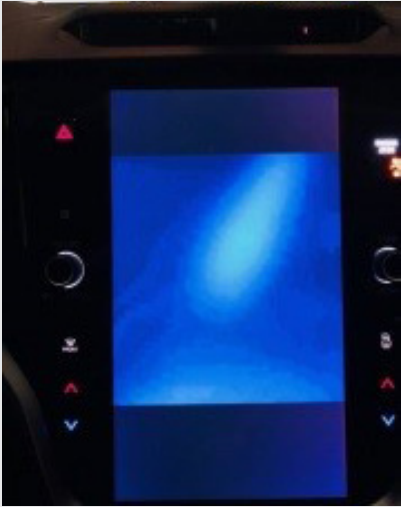
Symptom #	Description of Symptom:
14	<p>The HOME screen goes blank. When the screen is switched from Camera mode to HOME, no icons are displayed as shown below.</p>

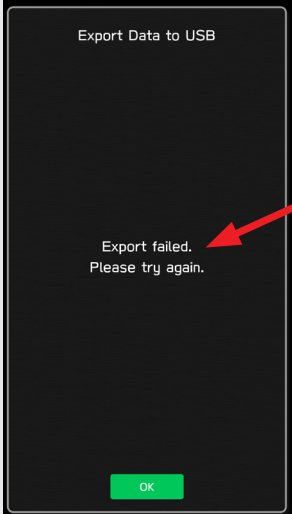
4	<p>Diagnostics Recorder Data cannot be exported to the USB memory device. When the diagnostic log data is being downloaded (by selecting: Dealership Menu > Diagnostics Recorder > Export Data to USB), it fails after the progress bar reaches almost 90% with an error message of Export failed. Please try again.</p>
