Audio Restoration Repair Bose Wave Music System AWRCC1 AWRCC2 AWRCC7

This applies to the Wave Music System, Wave Music System II, Wave Music System III, in all AC voltage variations.

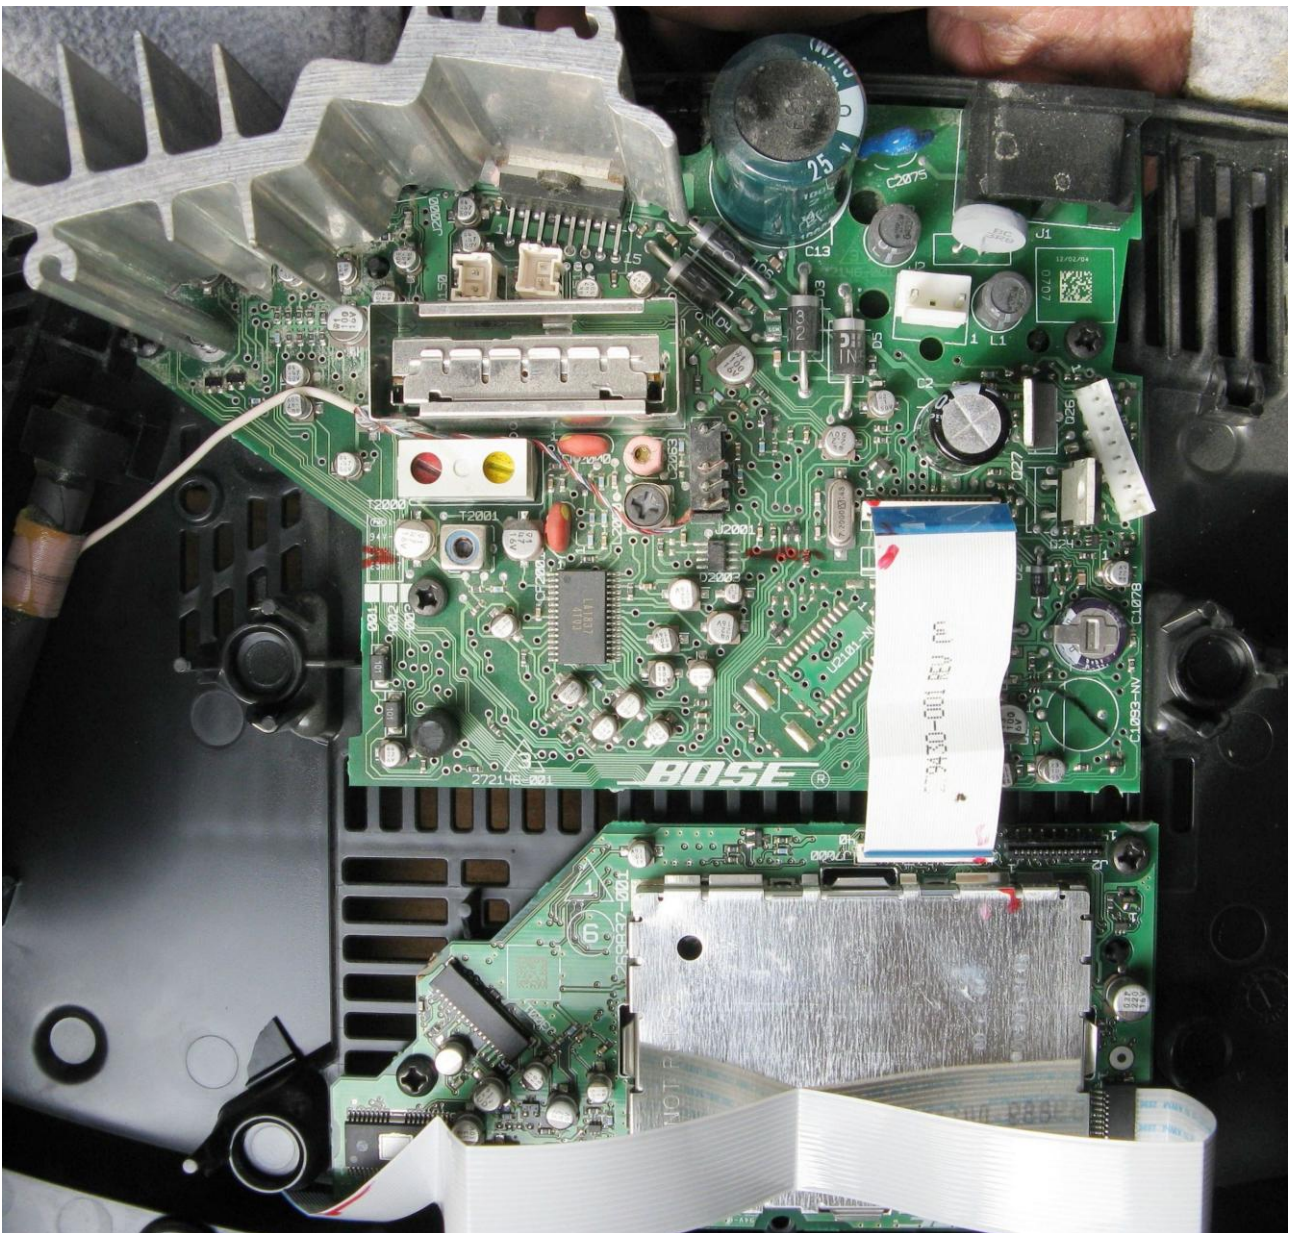
This is the early version BEFORE starting work - the CD mechanism and speaker cabinet have been removed.

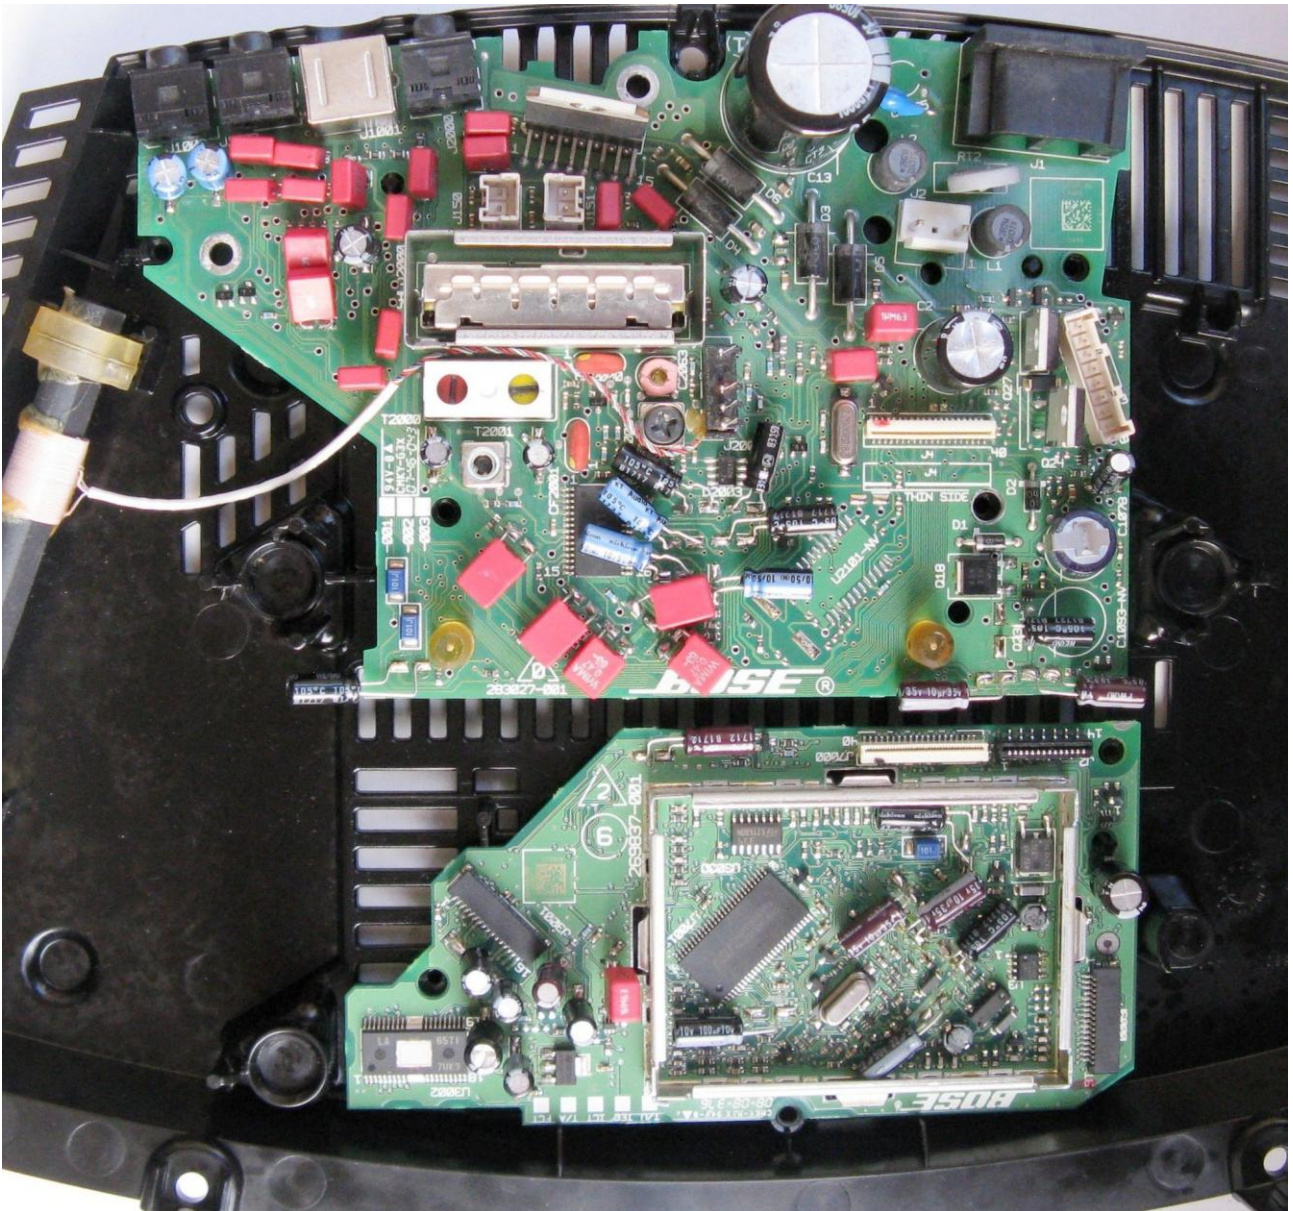
This is the early version AFTER completing work – the CD mechanism and speaker cabinet have not yet been reinstalled.

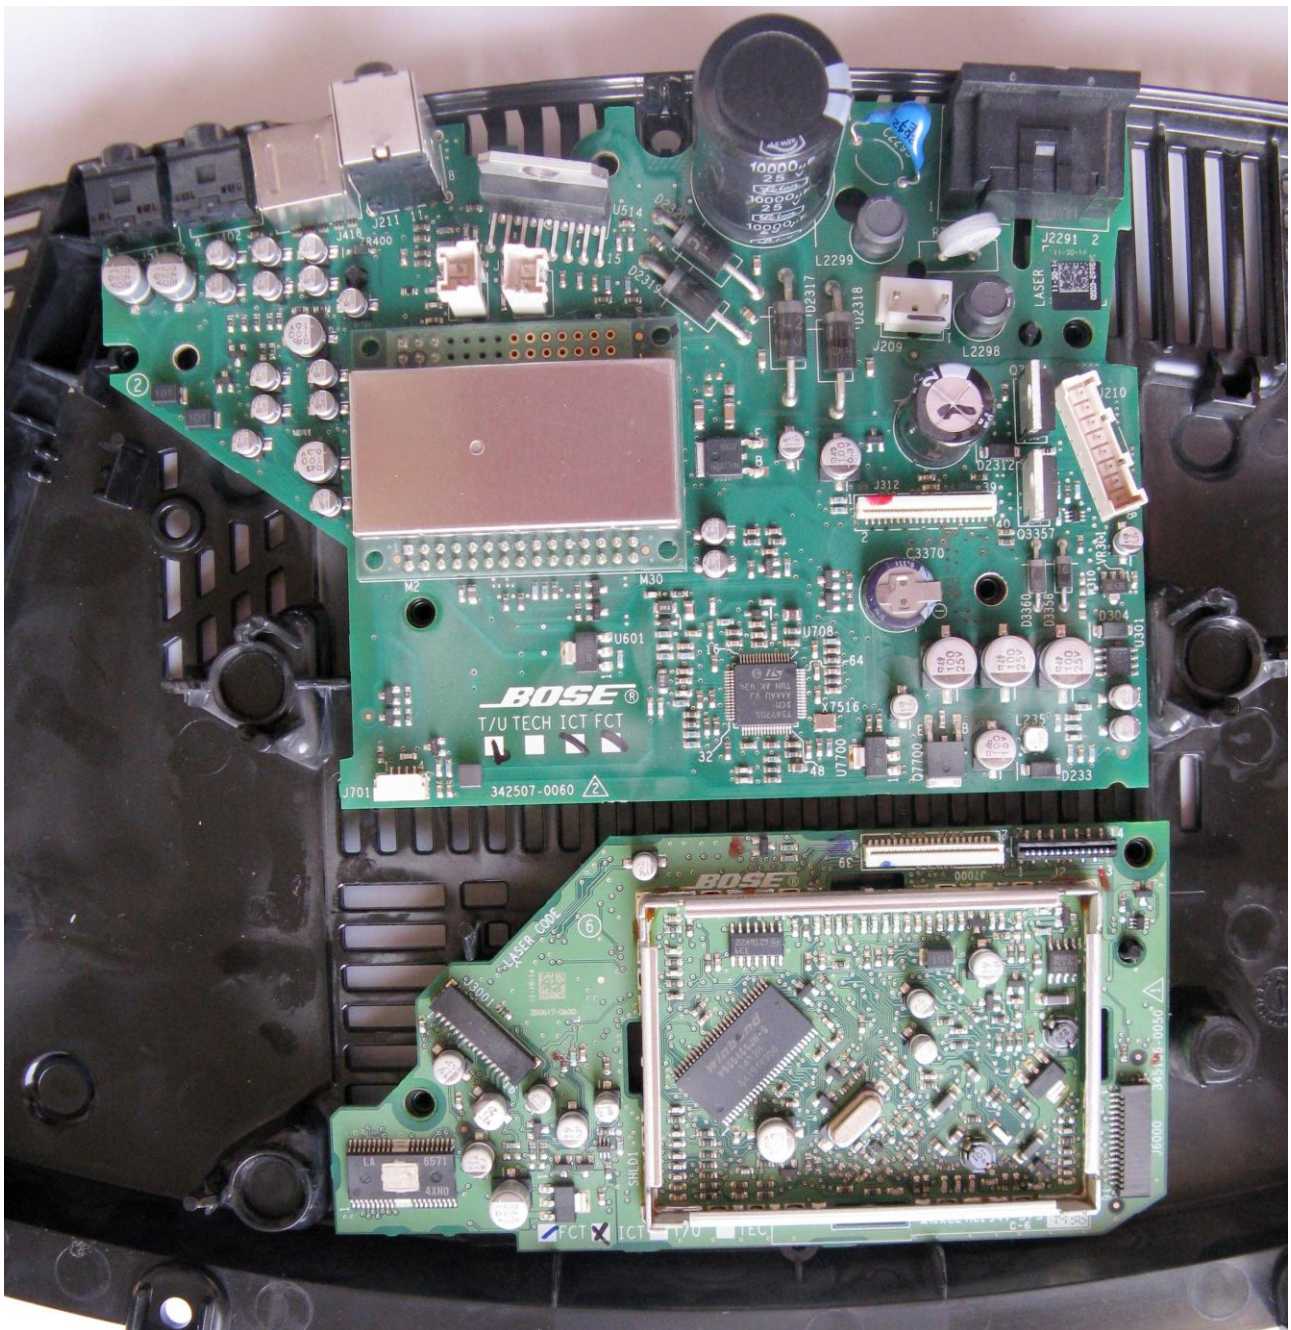
This is the later version BEFORE starting work - the CD mechanism and speaker cabinet have been removed.

When remounting this PCB into the Black casing, it is necessary to mount this PCB 2.5mm lower than originally installed, to allow clearance for the vertical height of the new capacitors, below the CD mechanism.

To achieve this, simply remove the top 2.5mm of the 3 mounting studs on the Black casing, by either grinding off with a Dremel, or melting off with a flat soldering iron.

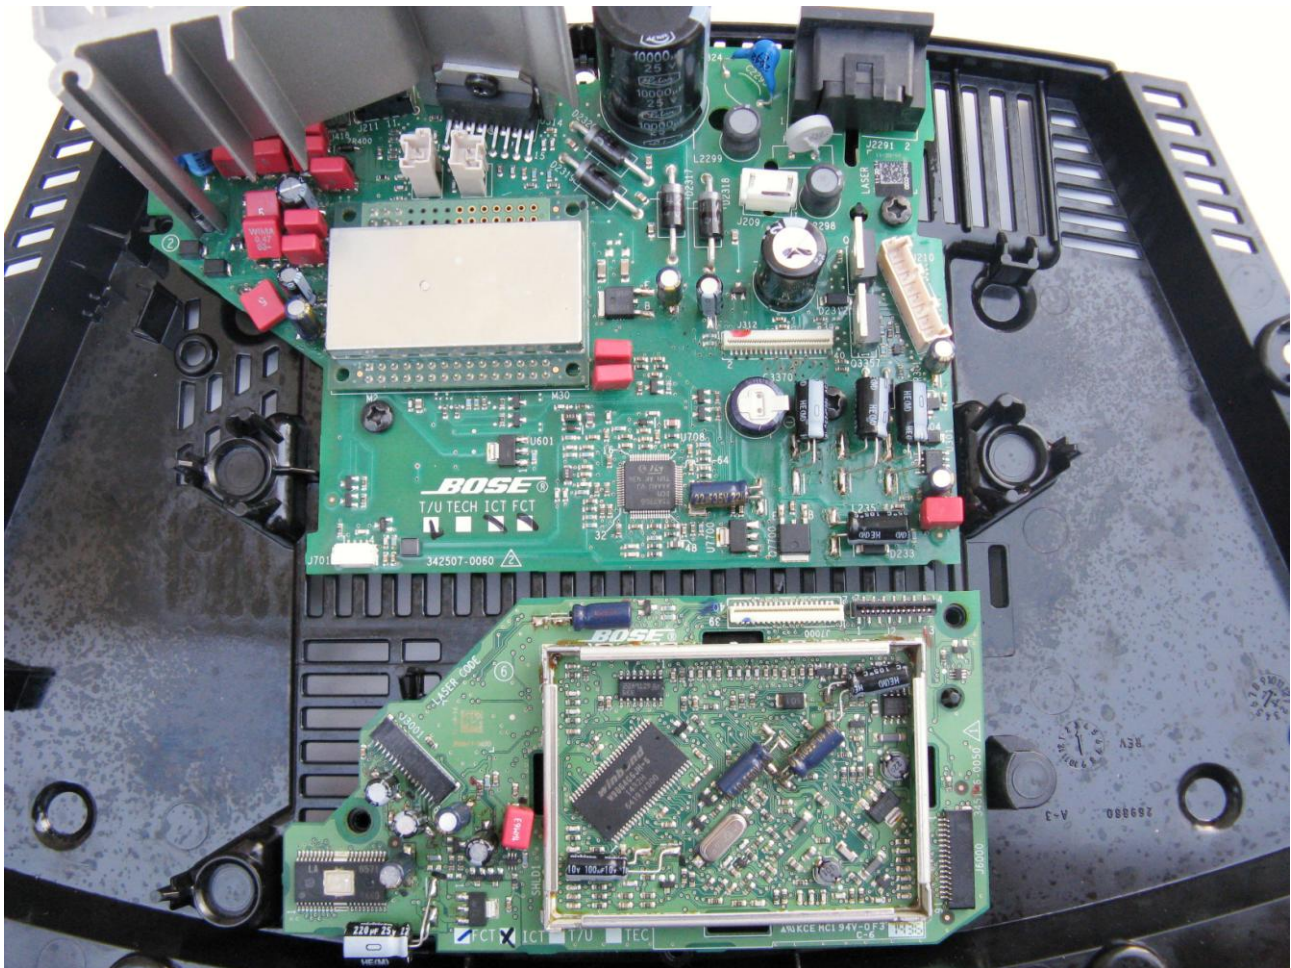
This is the later version AFTER completing work – the CD mechanism and speaker cabinet have not yet been reinstalled.

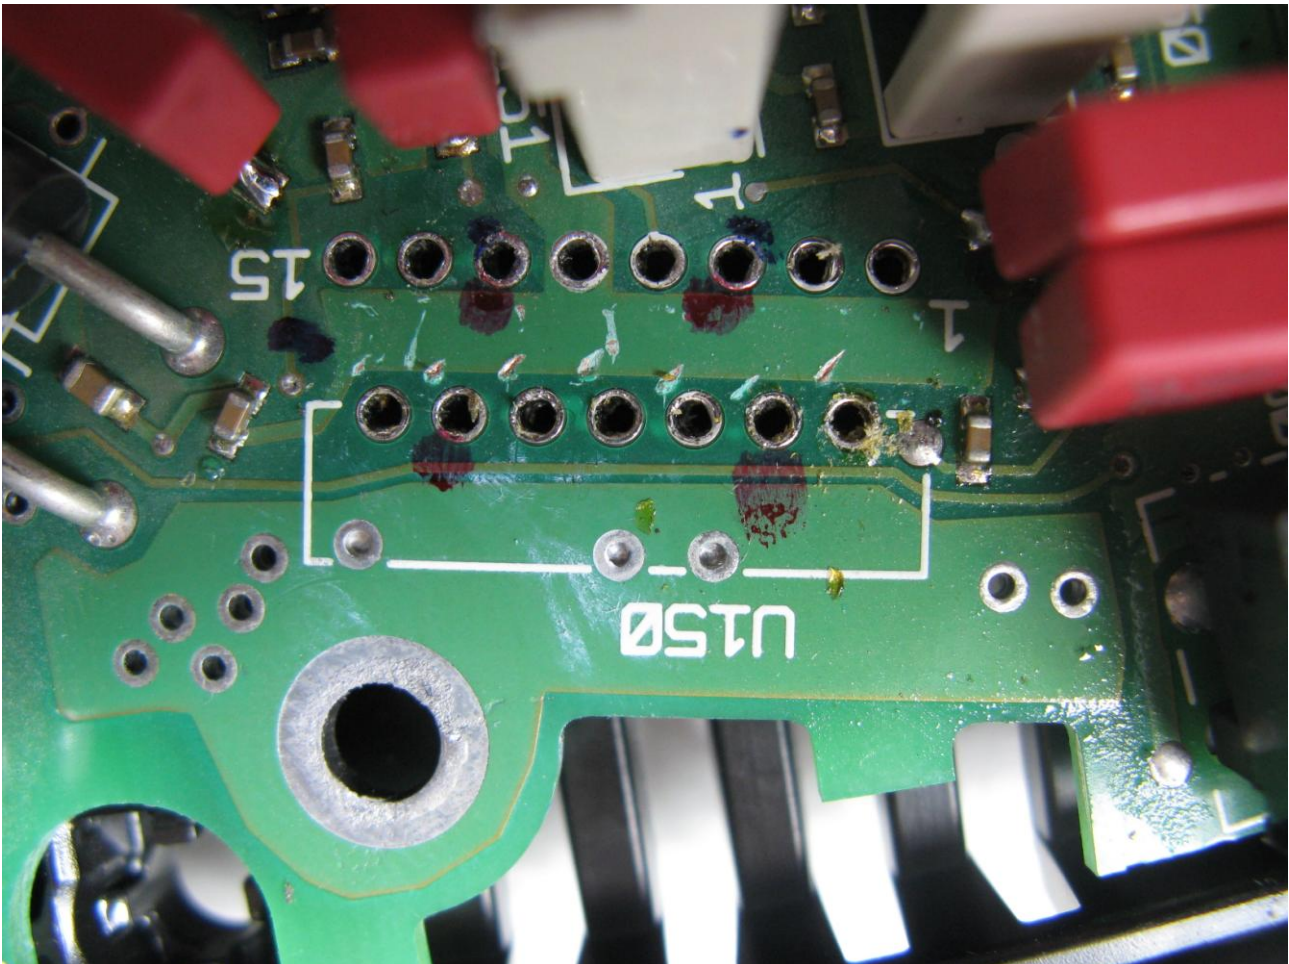
Here, the relevant pins are shown marked in red (with the destroyed TDA7376 removed).

For example - if Pin 4 has a good waveform, but Pin 1 waveform is defective, obviously the TDA7376 is defective, and must be replaced.

If Pin 4 has a defective waveform, then the audio signal is not arriving from the preamplifier section, and the cause must be traced. This was the problem in this case.

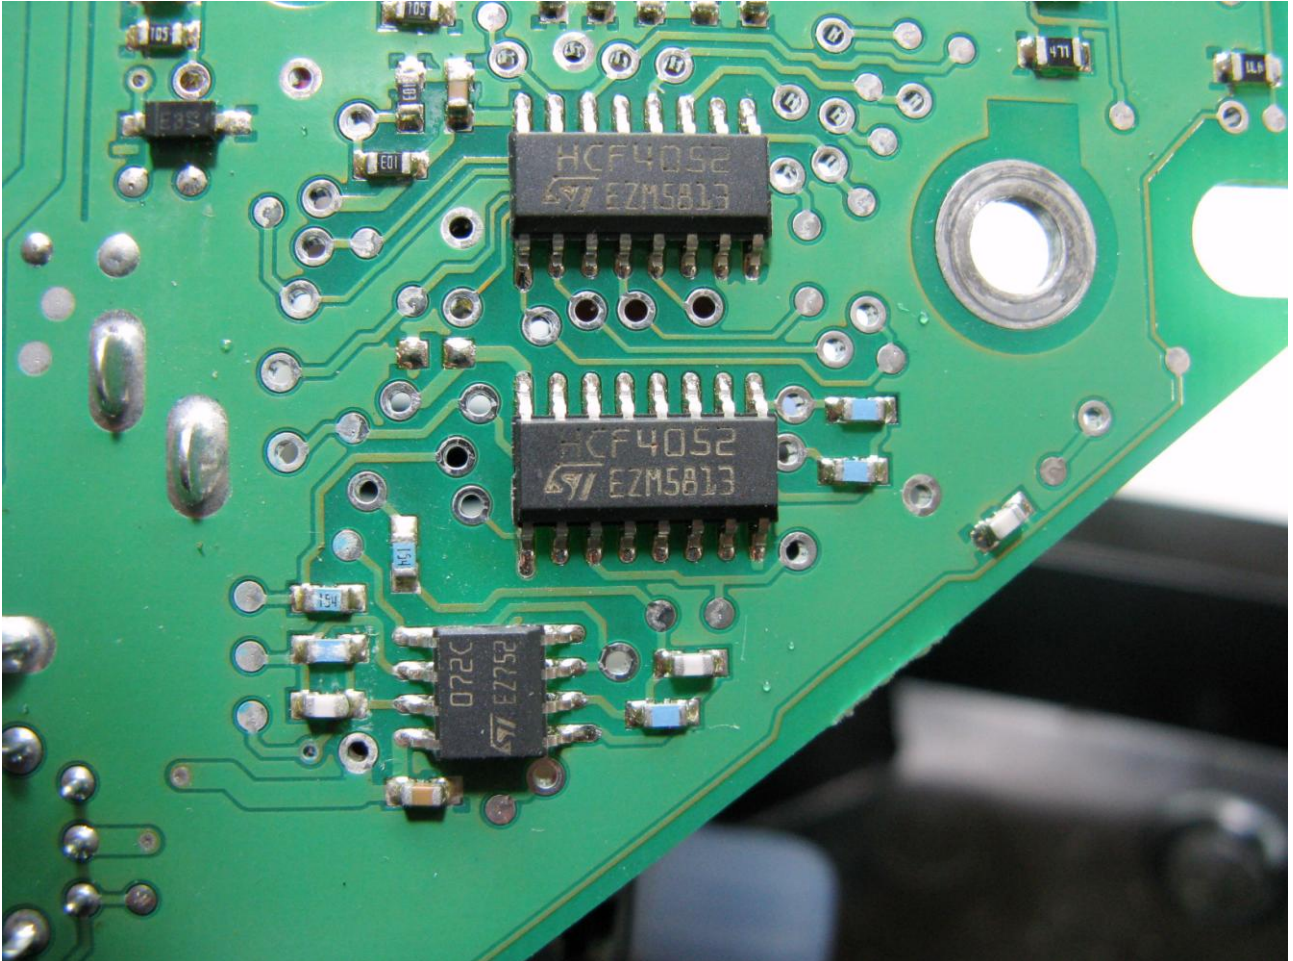
1. Scoping the waveforms on the input and output pins of the HCF4052 MPX and TL072 OpAmp IC's on the bottom of the PCB. A completely defective waveform showed an amplitude of less than 1mV P-P on all these components. That told me that these IC's were not performing correctly.
2. I decided to check the VCC and VSS pins for correct voltage. The VCC showed less than 1mV DC. That told me clearly that the DC Voltage rail is defective.

5. There is the EXACT problem - Cable break between 2SA473 Emitter to KSH210 Emitter. I connected my spotlight and magnifying glass and found a bit of black soot at the position shown with the red arrow. I scraped away the black soot, and discovered the break in the copper tracing.

6. That is a direct consequence of the original Bose low-quality capacitors failing and causing the KSH210 to become stressed, and burn its surrounding traces.
