U.S. Department  
of Transportation  
**Federal Aviation  
Administration**

## ADVISORY CIRCULAR 43-16A

# AVIATION MAINTENANCE ALERTS

ALERT NO.  
266

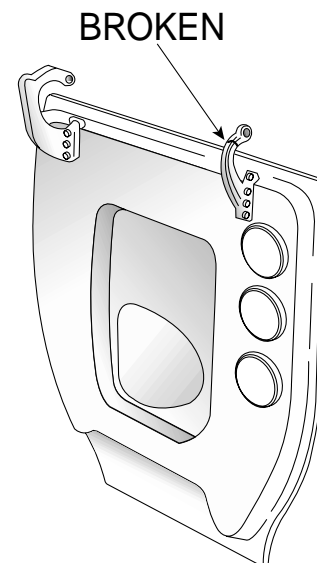
### **Beech; Model 58P; Baron; Landing Gear Door Failure; ATA 5280**

The technician discovered a broken aft hinge (P/N 35-815016-7) on the right main gear inboard door (P/N 35-815055-169). (Refer to the following illustration.)

The submitter speculated wear and misalignment associated with the pivot fastener hole caused this failure. He suggested inspecting both the front and aft fastener holes for wear and proper alignment by disconnecting the actuating rod and checking for free-play and fastener preload.

Part total time-3,799 hours.

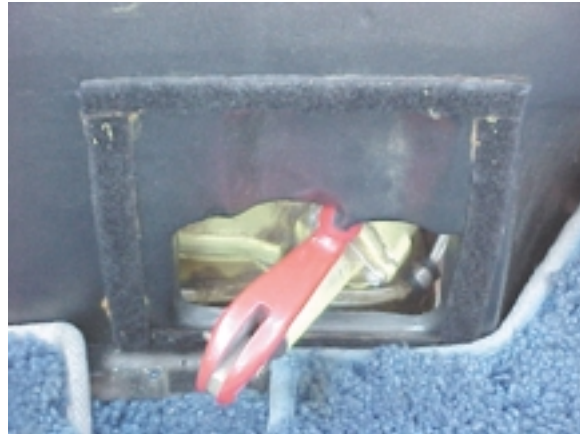
### **Beech; Model 58P; Baron; Landing Gear Malfunction; ATA 3230**

The inspector discovered that the emergency landing gear extension crank handle jammed under the spar carry-through cover. The crank handle had been improperly stowed under the spar carry-through cover during a recent inspection.

The manufacturer's technical data provides instructions for removing the spar cover; however, instructions for reinstalling the cover are not given. The spar cover has an access cutout for the emergency crank handle. Within this access cutout, a recessed portion extends half way down into the cutout. (Refer to the following illustration.) The manufacturer's data does not contain any warnings addressing the possibility of the spar cover jamming the emergency crank handle if the spar cover is installed improperly.

If the spar cover is not installed correctly, the recessed portion of the access cutout will prevent the pilot from engaging the emergency crank handle. This problem exists in most Beech Baron and Bonanza series aircraft. During a discussion of this matter with the aircraft manufacturer, their representative agreed to update the technical data to include the possibility of the emergency gear crank handle being jammed by improper installation of the spar carry-through cover.

Inspector Blanset recommended the following list of suggestions, which may resolve this safety problem.

1. Revise the Beech Service Manuals to include: warning instructions addressing reinstallation of the spar carry-through cover.
2. Issue a Service Bulletin or Airworthiness Directive, which would allow for a modification of the spar carry-through cover by removing the recess part of the cutout.
3. Add a "Caution" to the emergency procedures section of the Pilot's Operating

Handbook (POH), advising of these circumstances.

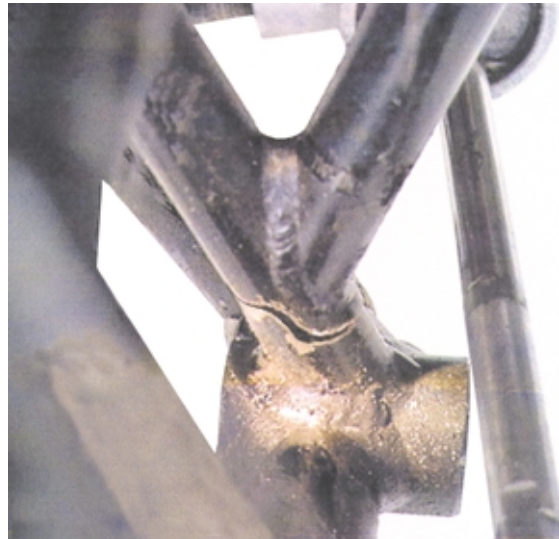
**Piper; Model PA 28R-201; Arrow; Broken  
Engine Mount; ATA 7120**

The right side engine mount (P/N 67119-57) broke where the drag brace attached. (Refer to the following illustration.) A previous pilot reported the "gear unsafe light" came on only during descent. The microswitch for the gear unsafe light is mounted above the broken engine mount. Apparently, when the pilot reduced engine power, torque caused mount

movement, and prevented the switch from maintaining contact. The broken mount may have been the culmination of previous damage suffered during a hard landing. The FAA data base contains reports of five additional failures of this part number.

Part total time-7,476 hours.

This is a good area for special attention during inspections.

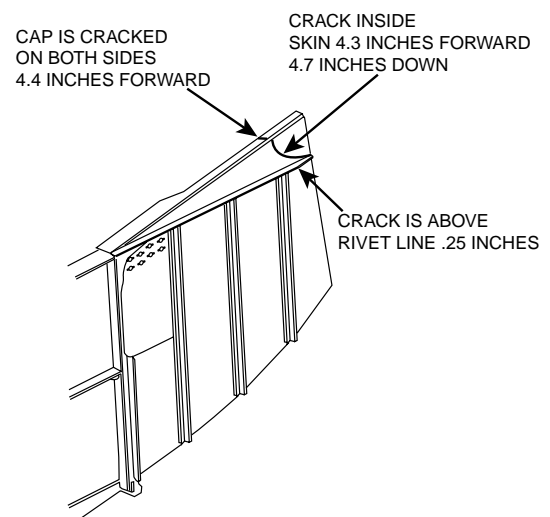
The submitter stated most of the fastener holes were not properly deburred during assembly.

Part total time-3,111 hours.

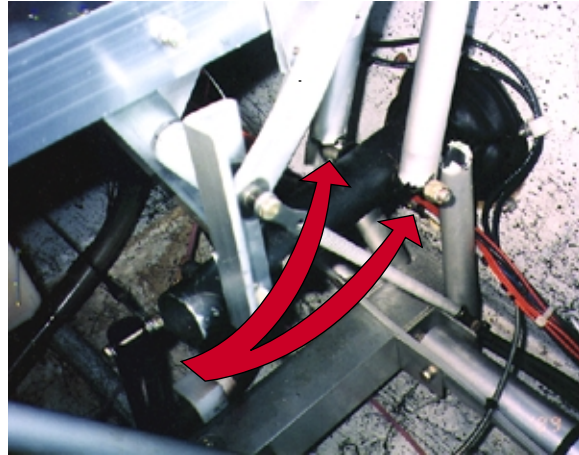
installation procedures and landing technique may alleviate recurrence of this defect.

Part total time-165 hours.

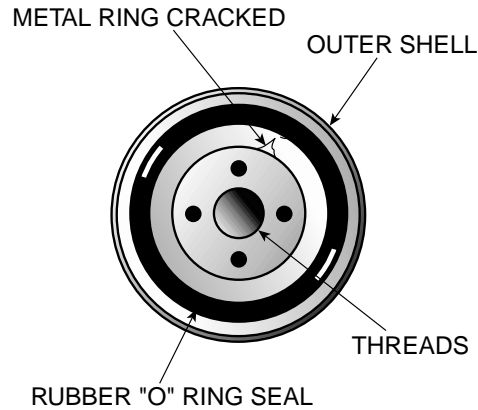
**CHAMPION OIL FILTER**

During a routine oil change, the technician examined the new oil filter (P/N CH48110, Lot number F06J02-1) prior to installation.
