AXOD/AXODE (AX4S) UPDATE HANDBOOK

*Updated
October, 2002*

This updated version of the AXOD "Update Handbook" will also cover the changes that occurred in the 1991 model year, when electronic controls were adapted to the AXOD transaxle, making it an AXODE, and now called an AX4S transaxle. We have included the changes on the AX4S transaxle up through and including model year 2002.

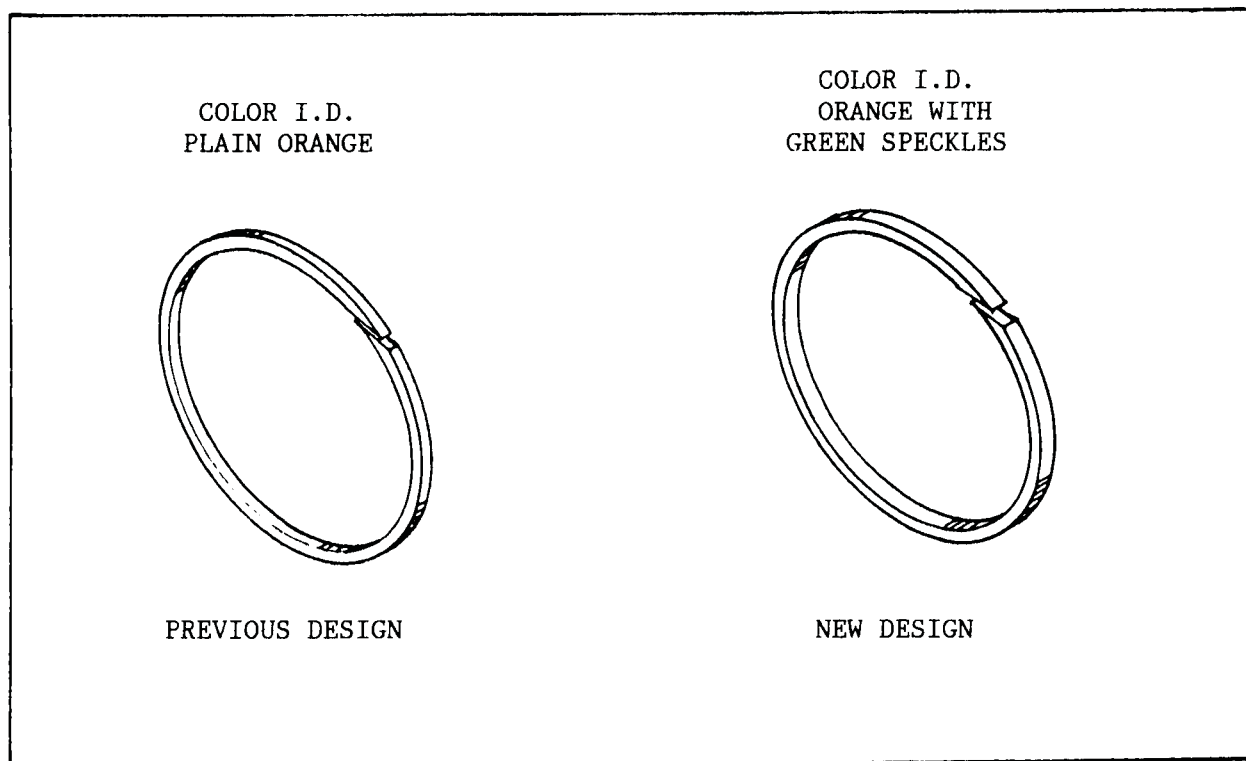
Figure 37

The five sealing rings on the driven sprocket support have been re-designed to help eliminate leakage in this area. The width of the sealing rings has been increased by approximately .015", and the new color identification is orange with green speckles (See Figure 37). The previous design sealing rings were plain orange in color.

The new design sealing rings are available under OEM number E6DZ-7D019-A, and should be used on ALL previous model AXOD transaxles.

DO NOT USE PREVIOUS DESIGN SEALING RINGS.

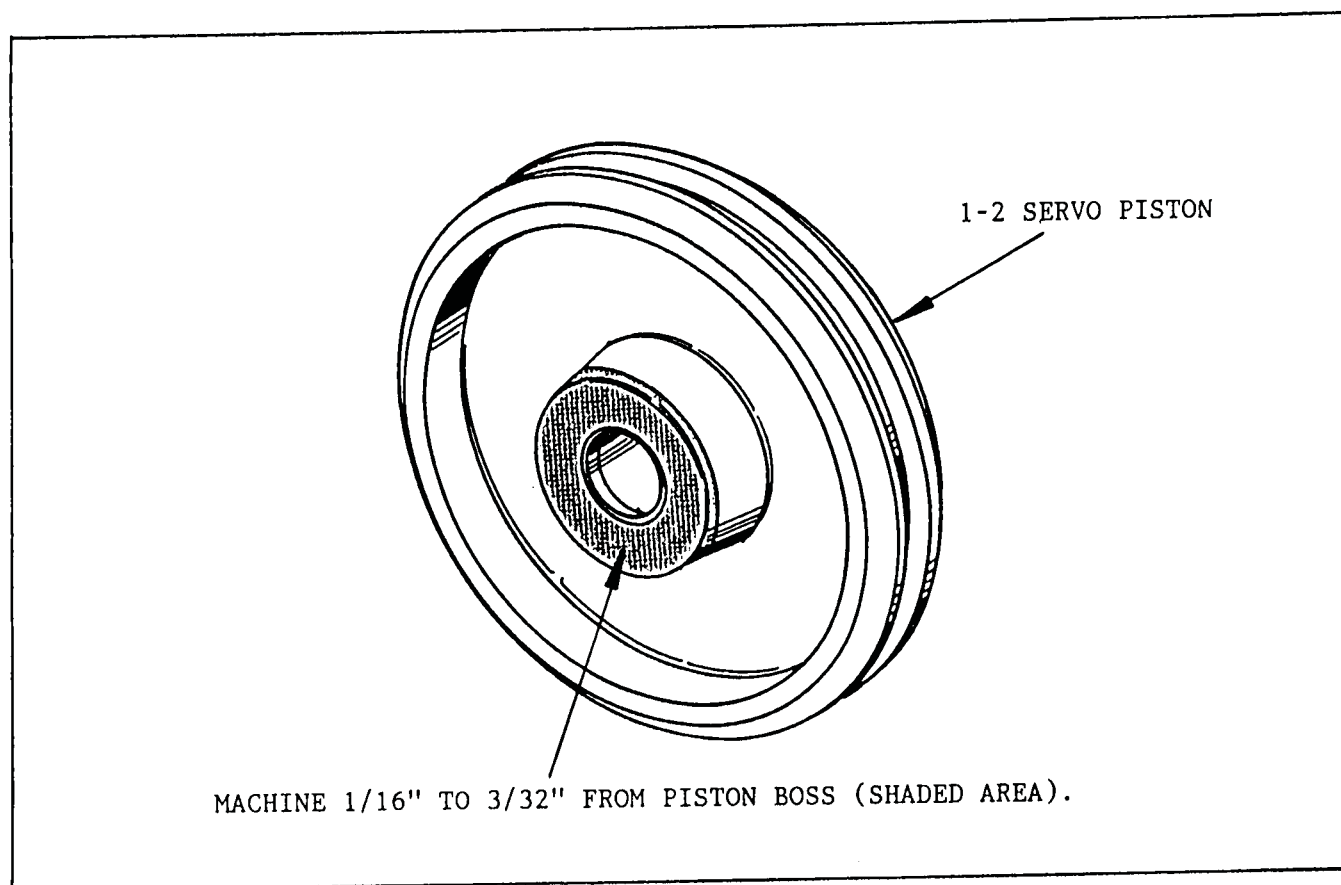
Figure 40

CAUSE: Insufficient travel of the 1-2 piston against the cushion spring.

CORRECTION: Remove 1/16" to 3/32" from the boss on the inside of the 1-2 servo piston as shown in Figure 40. We have shaded the area to be machined (See Figure 40).

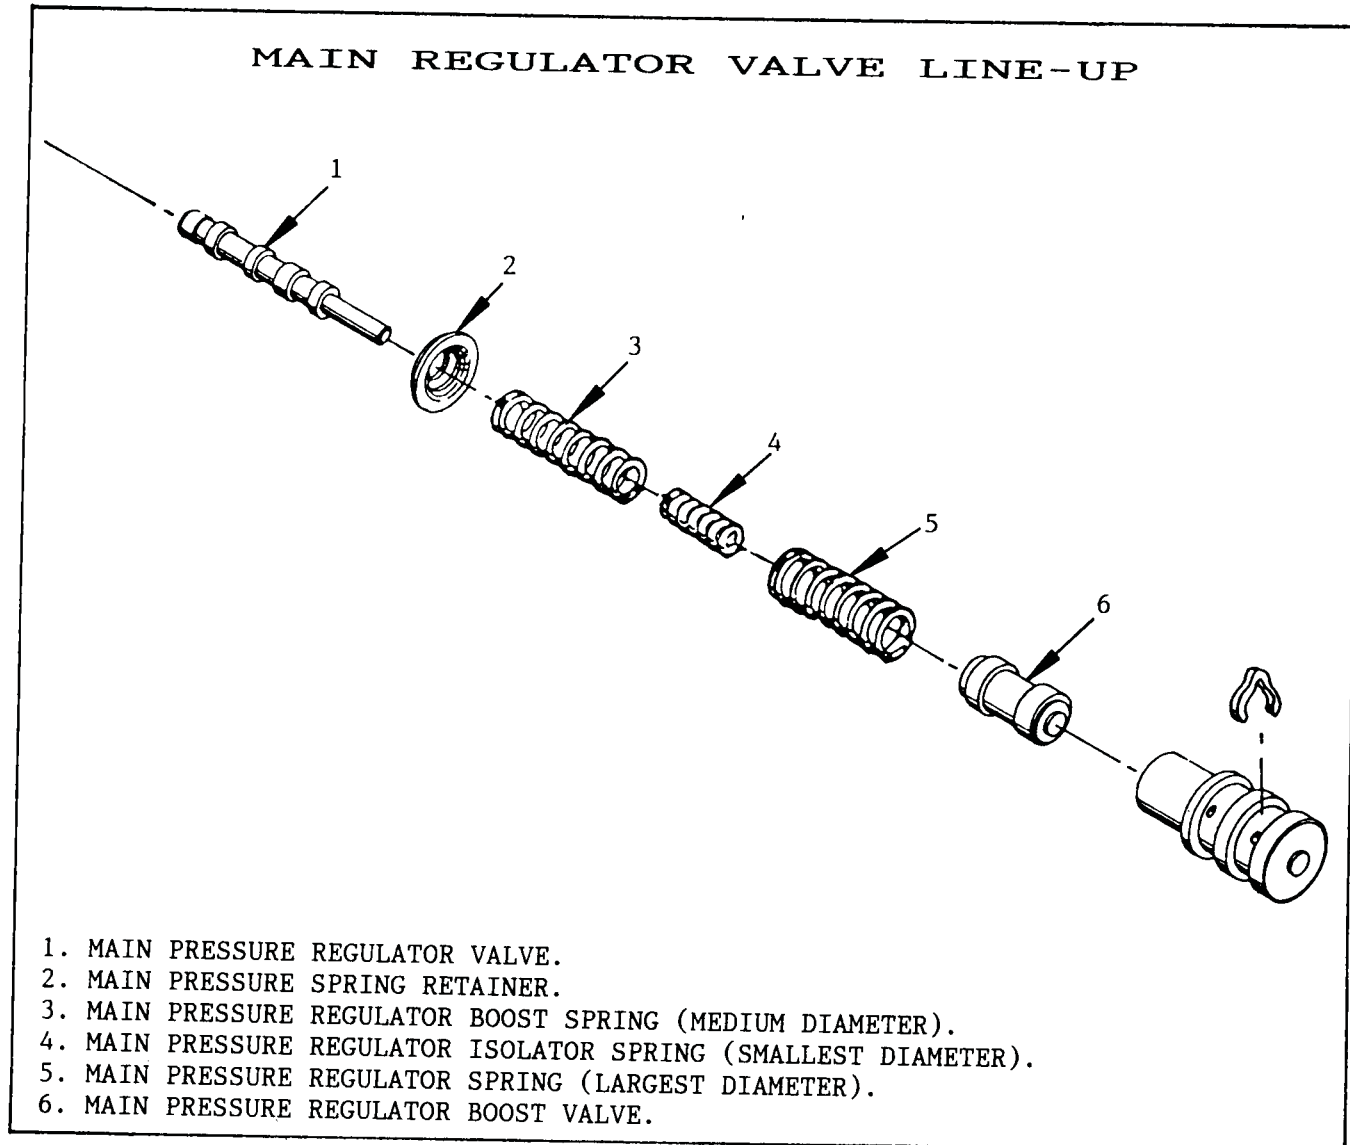
Figure 43

CAUSE: NO. 1. A "Shudder" during a 1-2 upshift will occur if the main pressure regulator "Isolator" spring is not installed after cleaning the valve body (See Figure 43). This is caused by fluctuations in main line pressure at the time of the 1-2 shift.

NO. 2. Delayed upshifts can be caused by the pressure regulator spring retainer being installed backwards (See Figure 43). This will create low main line pressure.

NO. 2. Insure that the main regulator spring retainer is installed in the proper direction (See Figure 43). The retainer is very similar to the one used in the AOD valve body, but is installed in the opposite direction of the AOD (See Figure 43).

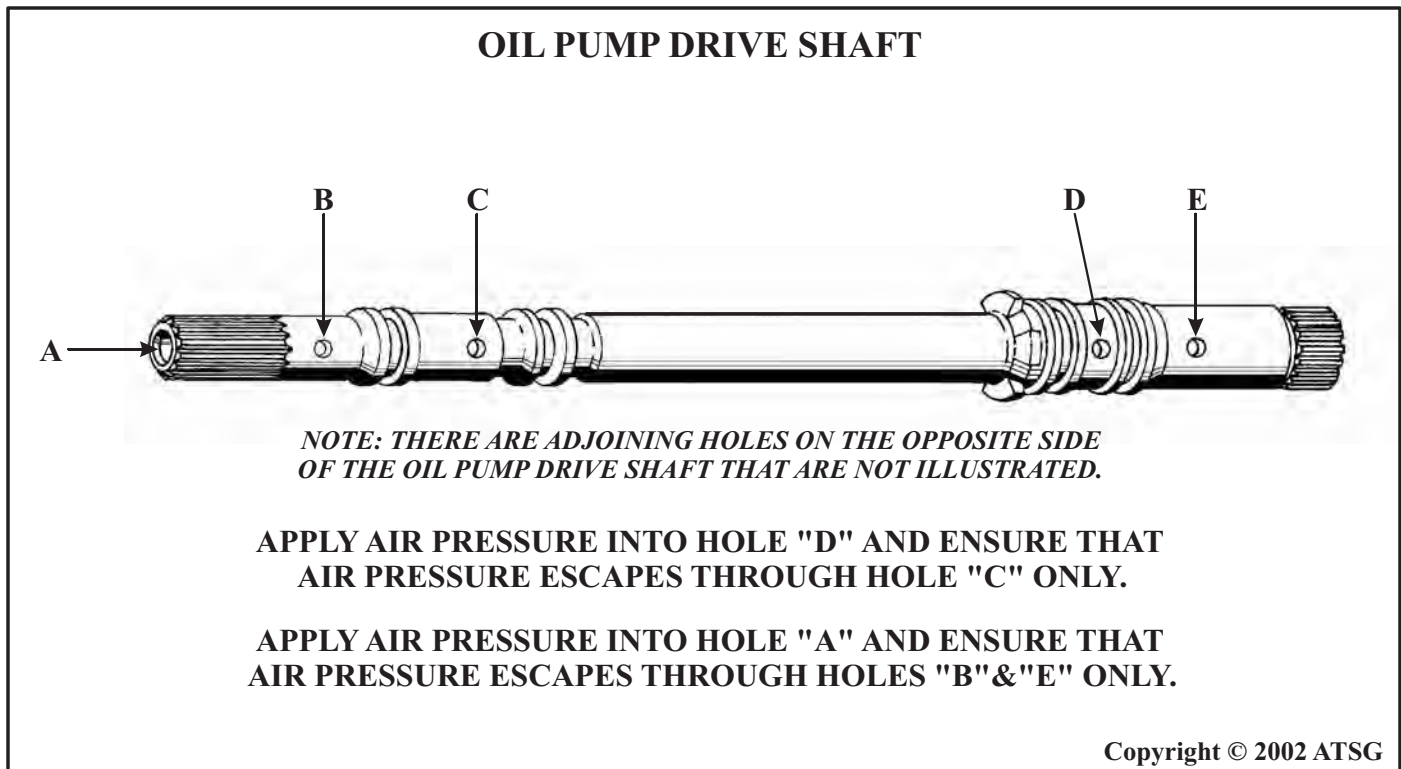
1. *The converter feed passage in the Oil Pump Drive Shaft blocked with debris or was not machined properly to allow converter feed oil to enter the converter.*
2. *The Oil Pump Drive Shaft leaking or not machined properly, allowing converter feed passage and converter release passage to be connected.*

NOTE: *We have seen some replacement shafts, both reman and new that were leaking between the converter apply and release passages.*

CORRECTION: Refer to Figure 64 to *check* the Oil Pump Drive Shaft, and clean or replace as necessary.

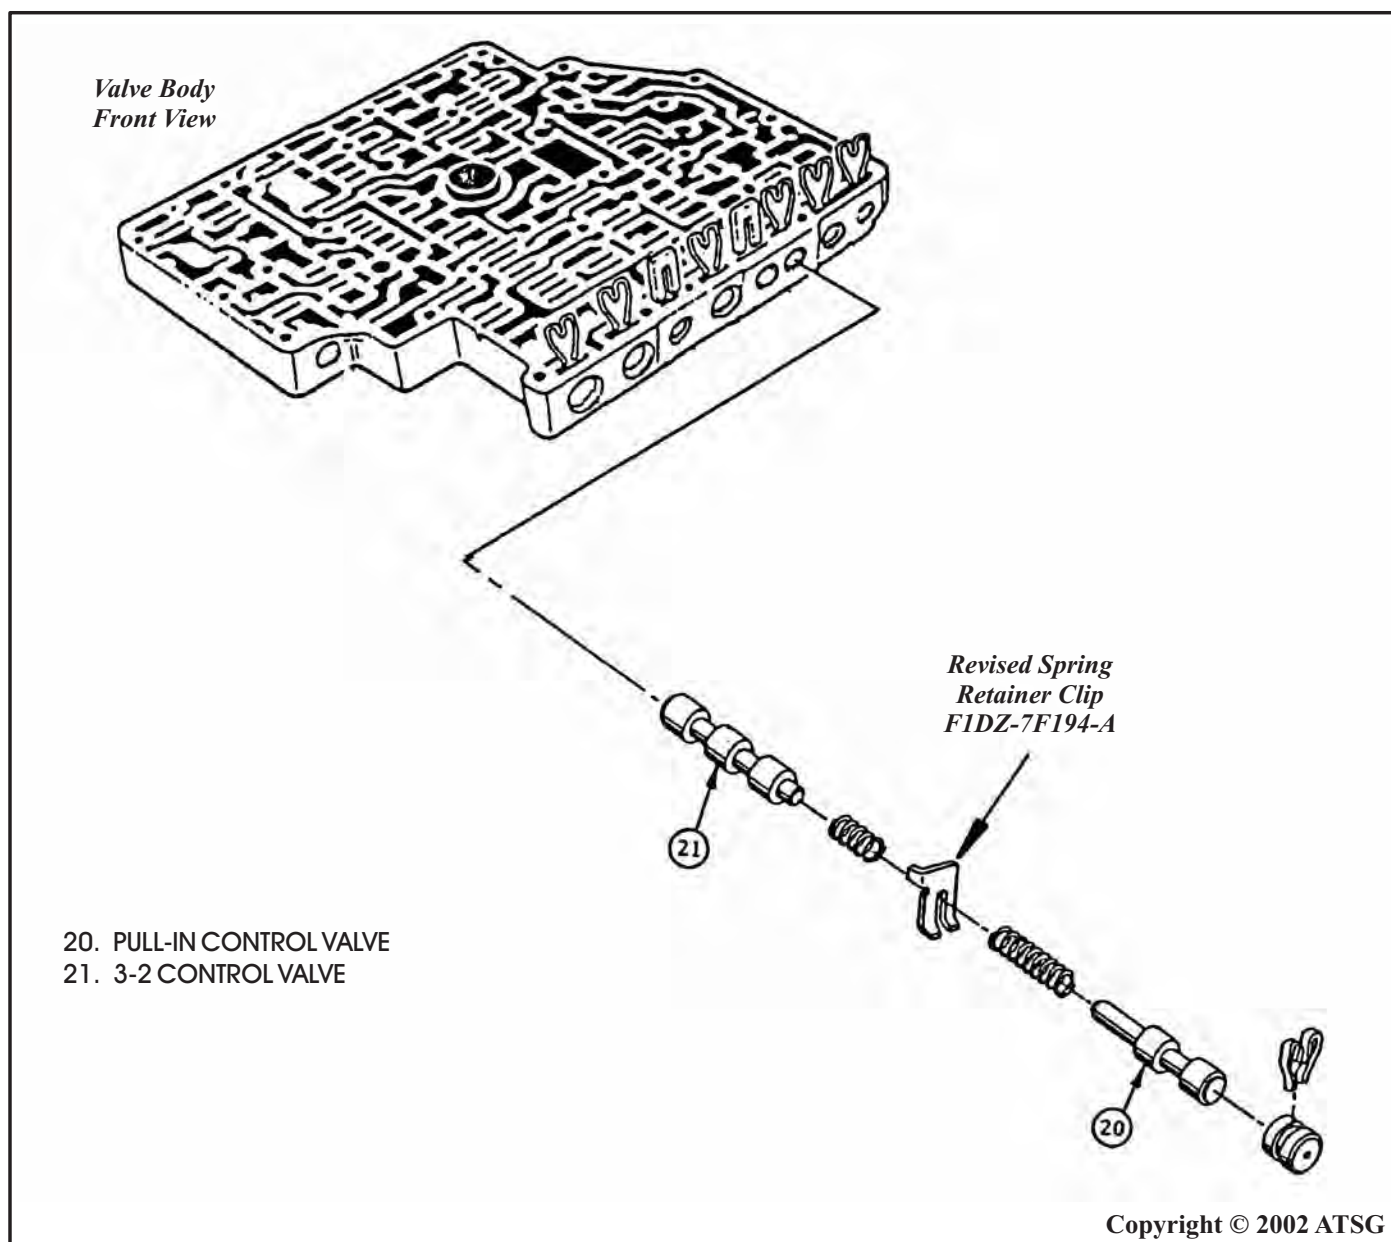
Figure 75

CAUSE: The cause may be, a broken spring retainer clip between the pull-in control valve spring and the 3-2 control valve spring, as shown in Figure 75.

CORRECTION: Replace the spring retainer clip with OEM part number F1DZ-7F194-A, as shown in Figure 75.

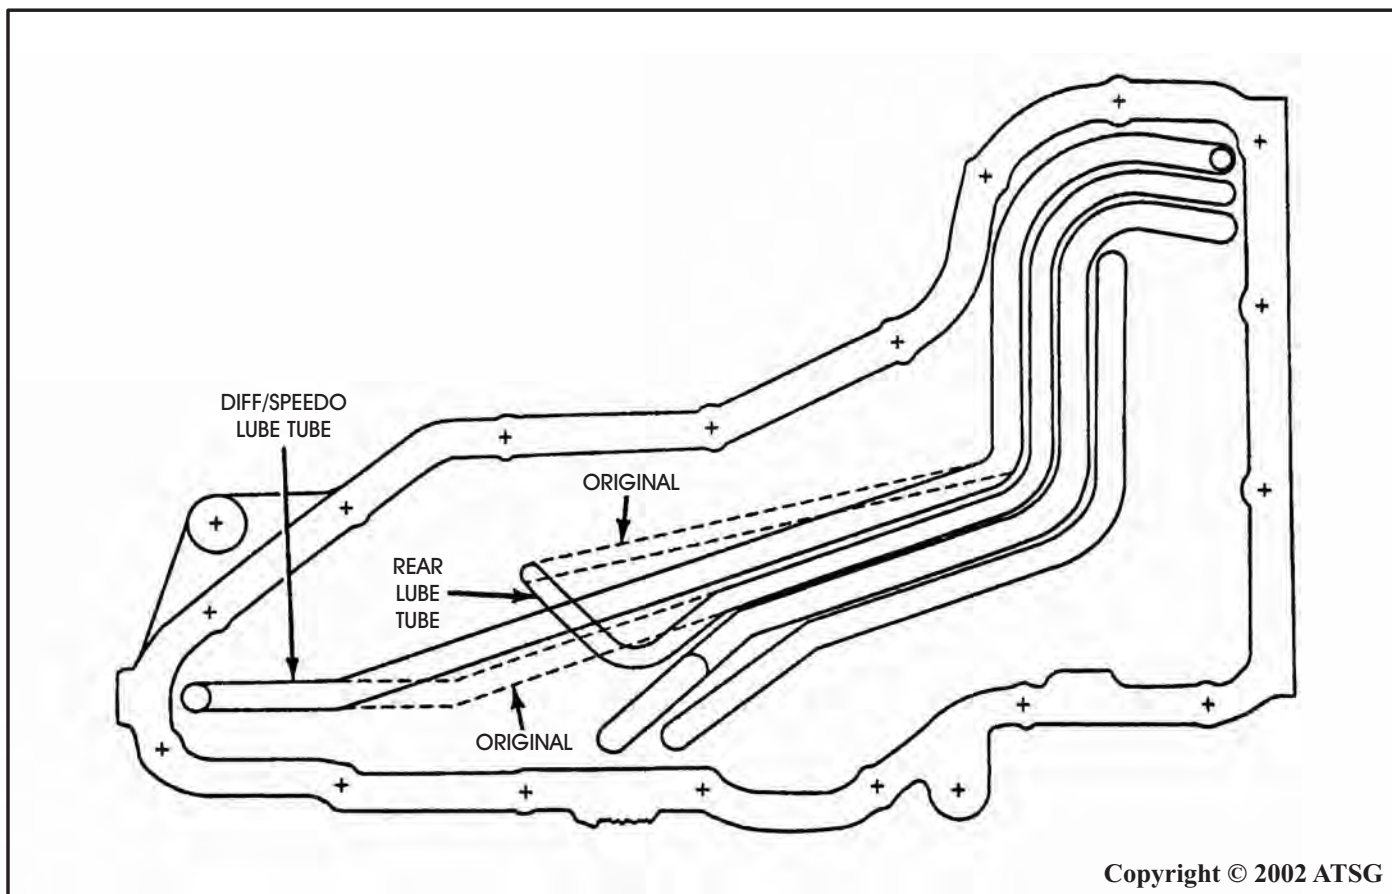
Figure 83

COMPLAINT: Front planetary and gear train failure with no visible root cause.

CAUSE: The cause may be, a limited volume of lube oil to the front planetary due to hydraulic control system demands.
