Building Audit
OSU Dixon Recreation Center
Corvallis, OR

Presented by Glumac

Revision 4

May 23, 2016
Job Number: 02.14.00586

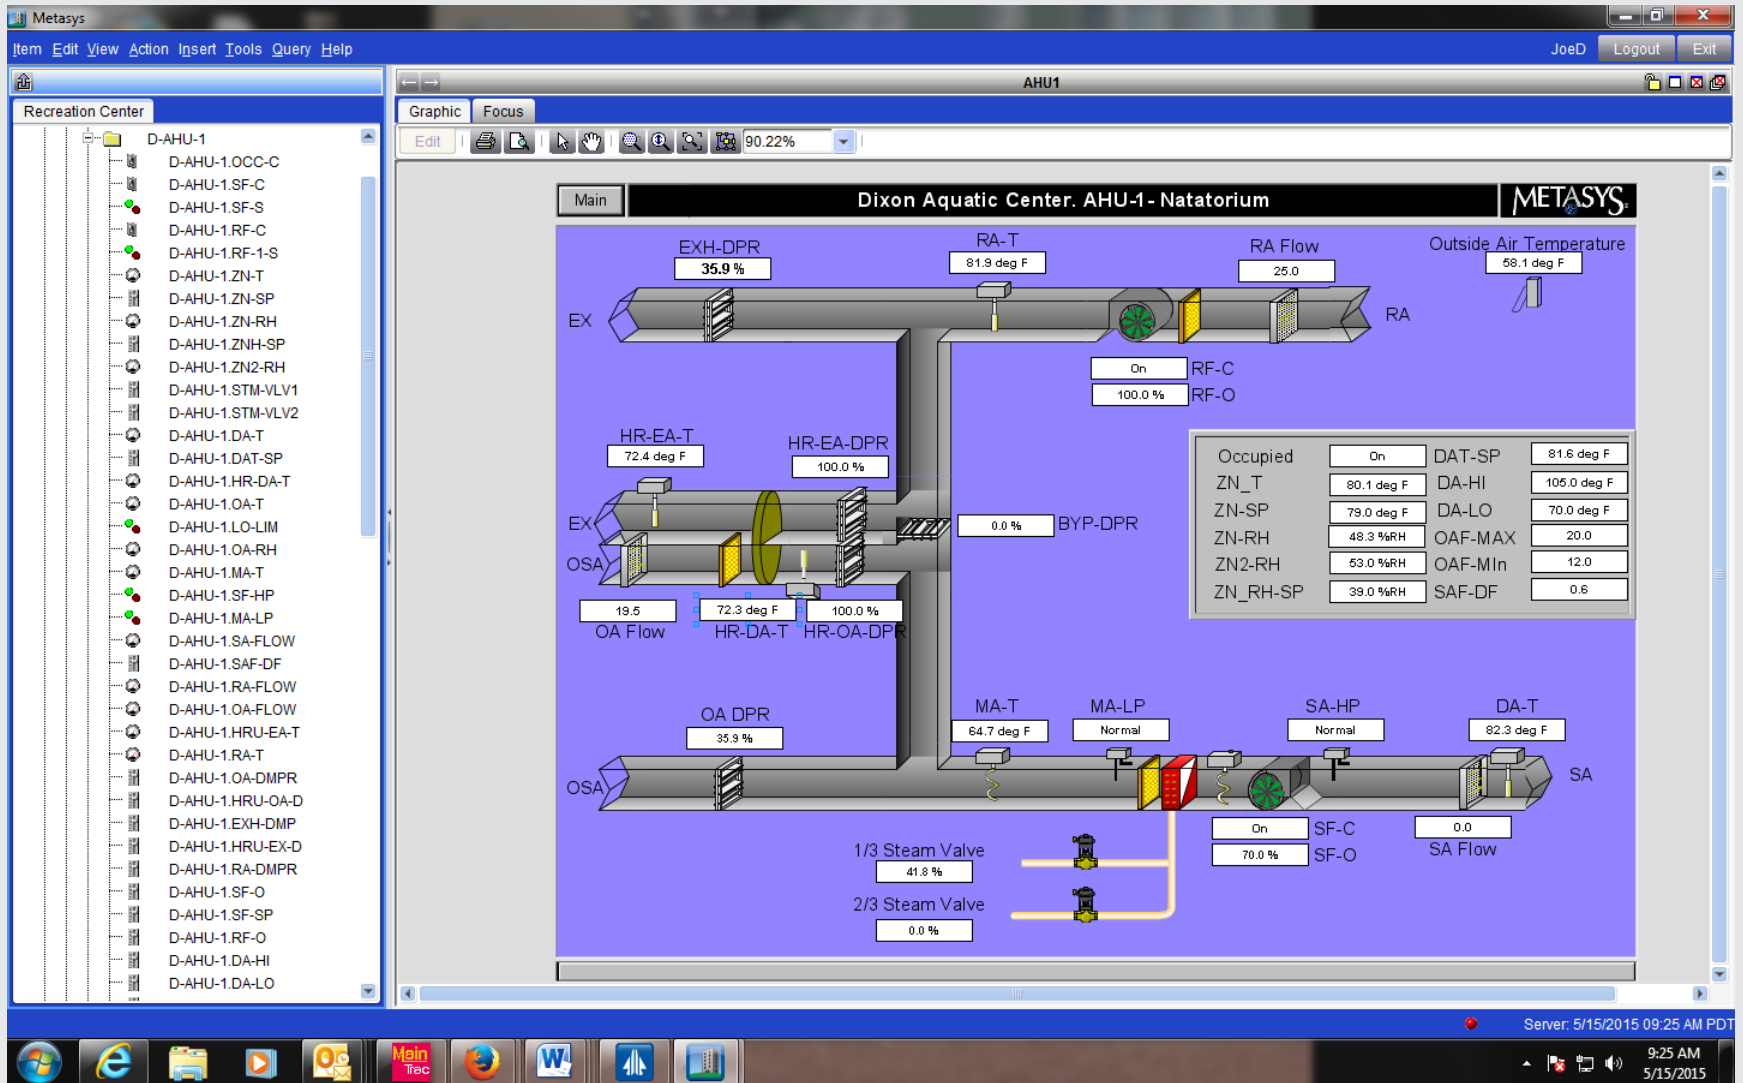
Figure 15 – AHU-1 - Natatorium

AHU-1 serving the Natatorium. It consists of a supply fan and return fan with full economizer capability as well as a heat recovery unit (HRU-3) to pre-condition the supply air. The fans are equipped with VFD's which currently operate at fixed speeds scheduled through time of day programming. HRU-3 is provided with control dampers on the OSA and exhaust ducts in addition to the separate OSA and exhaust ducts with control dampers (to bypass the HRU). The heating coil is steam and modulates via a 1/3, 2/3 valve configuration. No cooling coil is provided. There are 2 airflow stations. One is on the OSA duct that is part of HRU-3 and the other is on the supply air duct. Currently the SA airflow station appears inoperable with a reading of 0 CFM. The OSA airflow station should also be checked for accuracy.

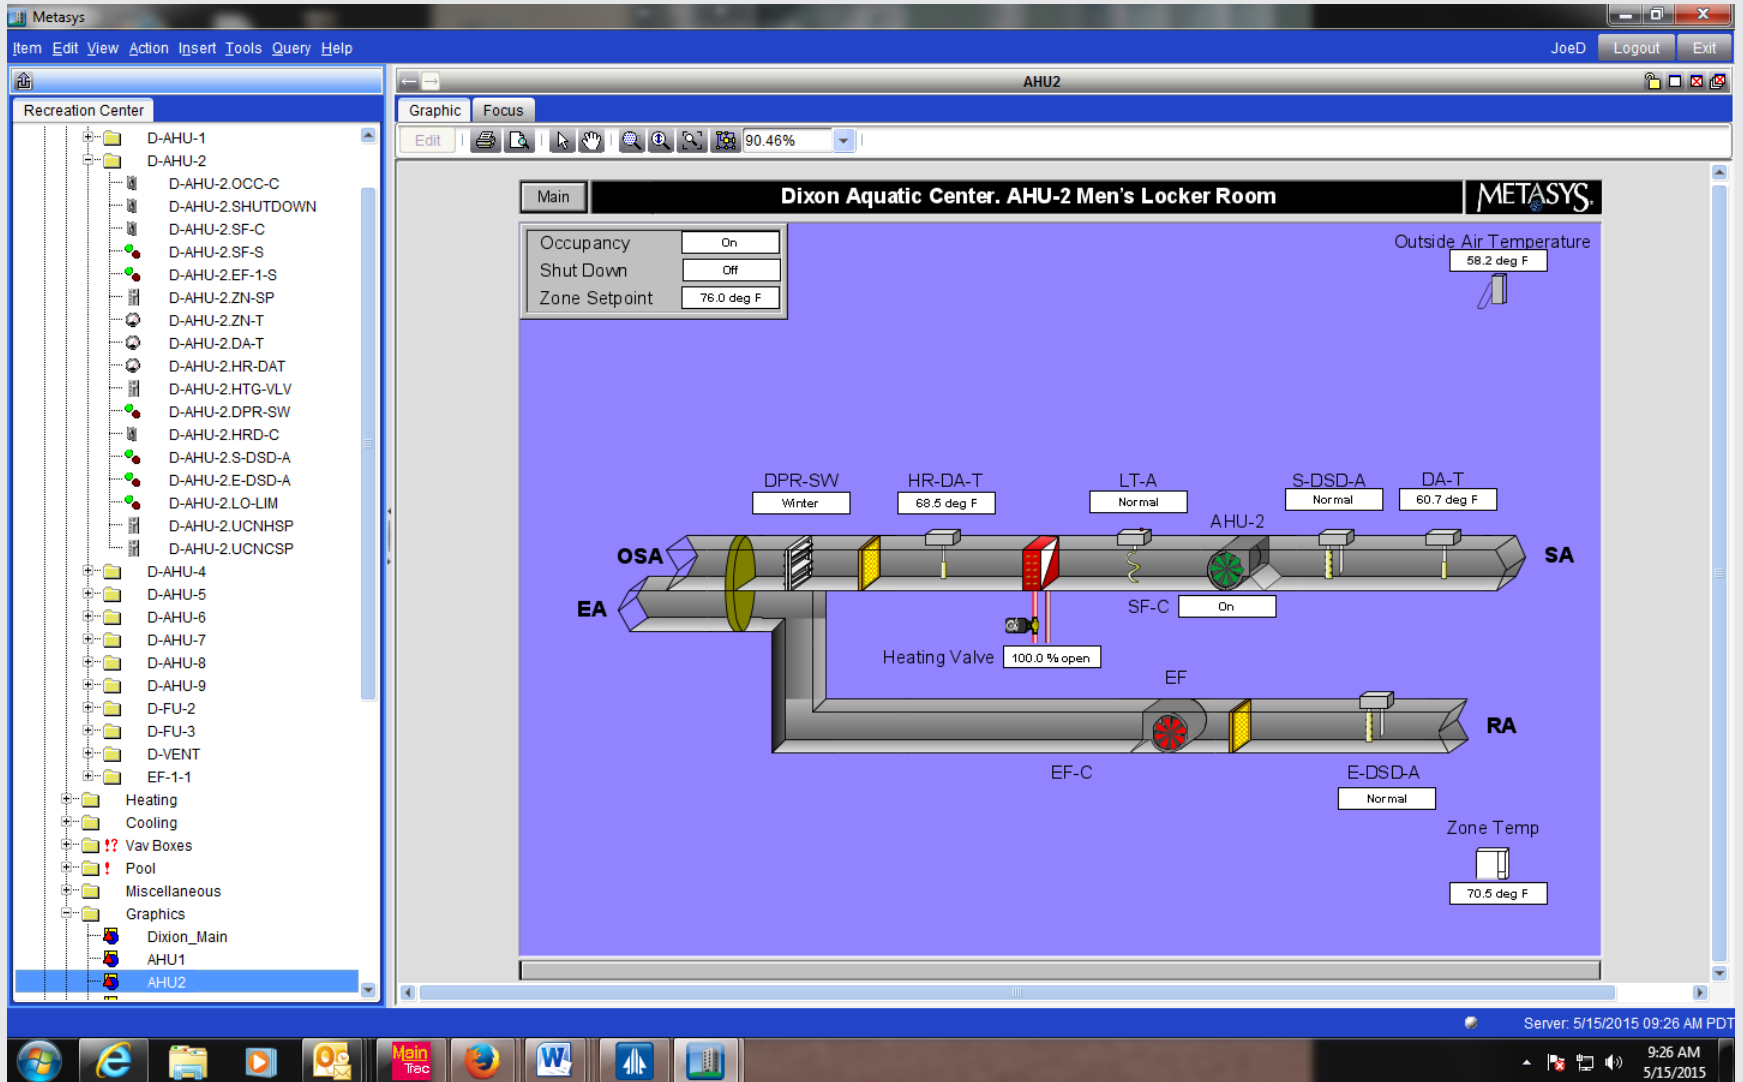
Figure 16 – AHU-2 – Men's Locker Room

AHU-2 and AHU-4 serving the Men's and Women's Locker Rooms (respectively). They consist of a 100% supply fan and 100% exhaust fan with a heat recovery units to pre-condition the supply air. The fans are constant volume. The heating coil is steam and modulates via a single control valve. No cooling coil is provided. There is a single damper on the OSA duct of each unit.

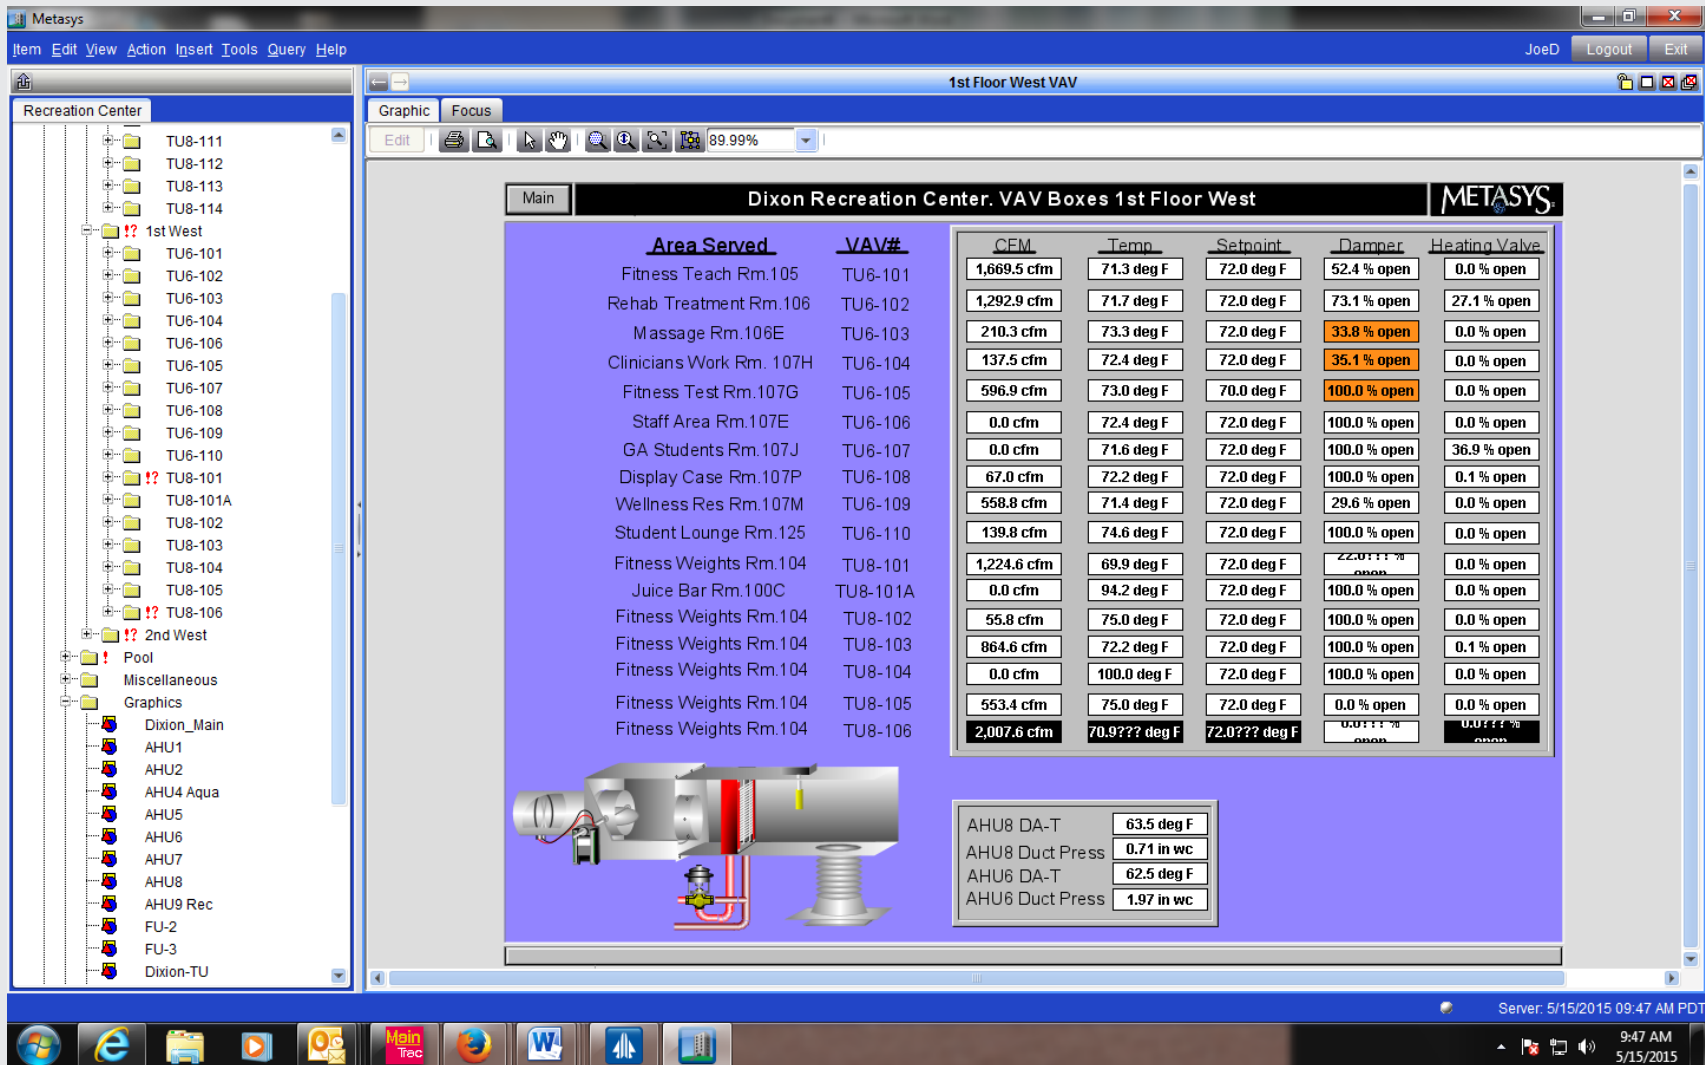
Figure 27 – VAV Boxes 1st Floor West

- TU6-106, TU-6-107, TU8-101A, TU8-104, damper at 100% but showing 0 CFM.
- TU6-108, TU8-110, TU8-102, TU8-103, TU8-105, damper at 100% but CFM shows well below design min.
- TU8-106, controller is failed or not communicating with the front-end.

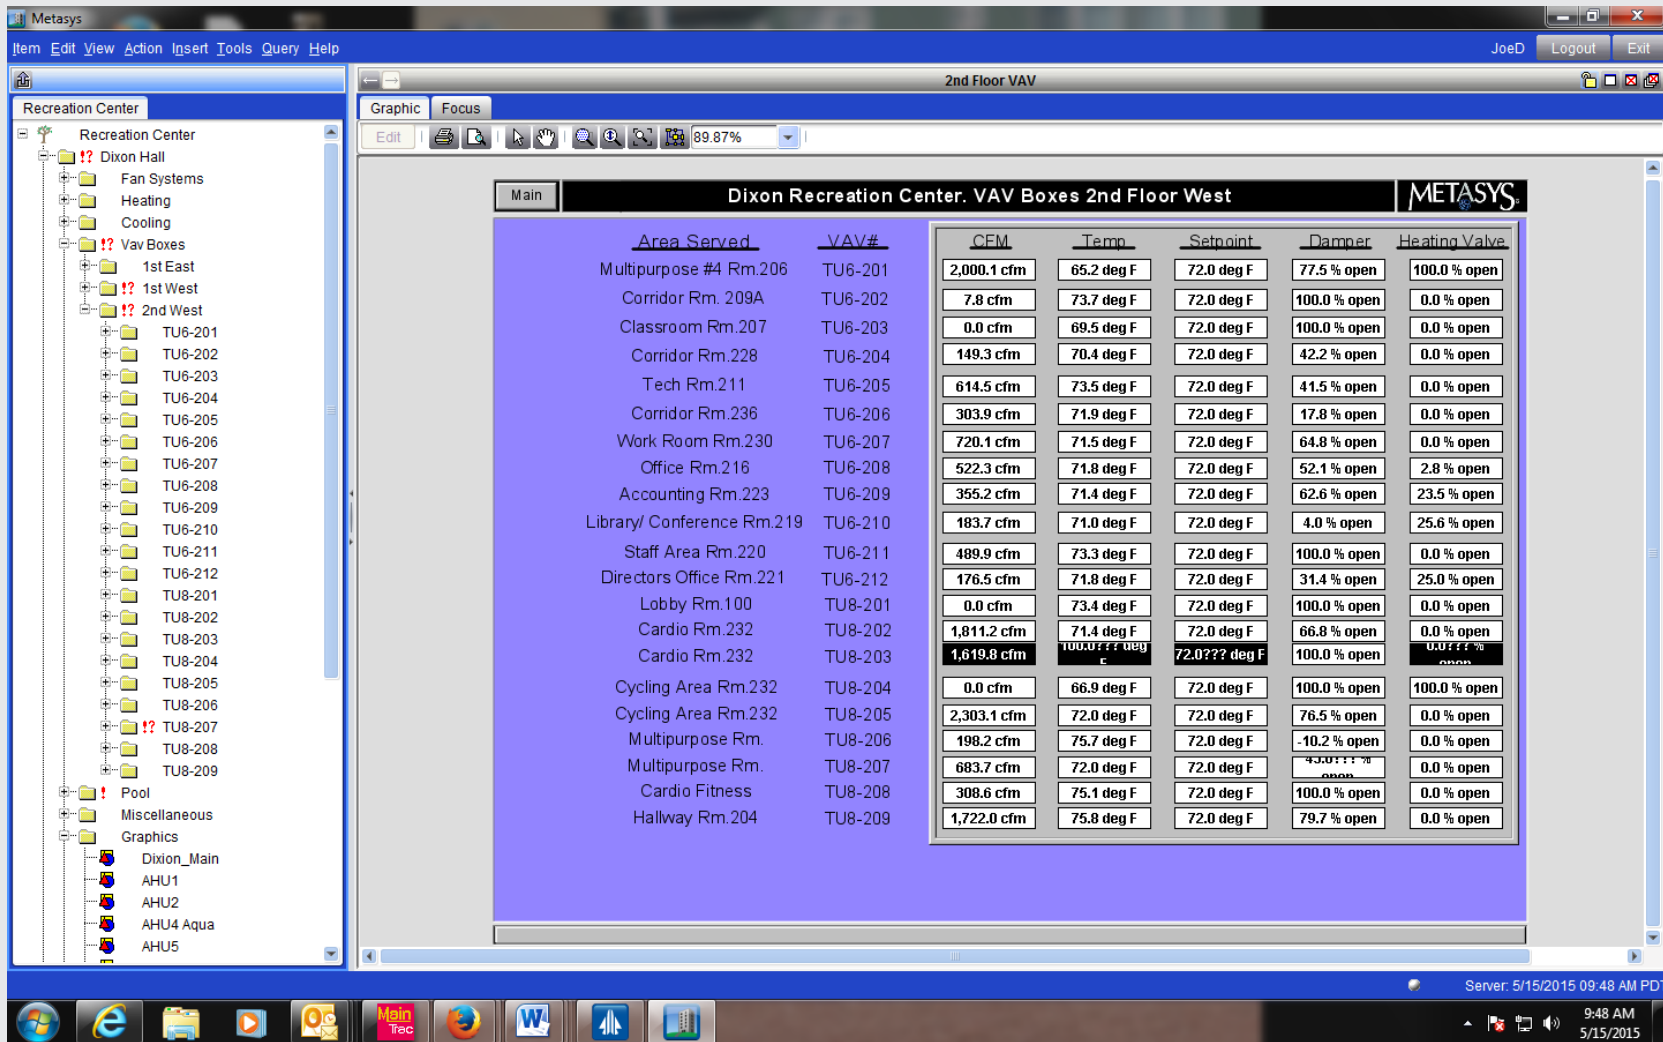
Figure 28 – VAV Boxes 2nd Floor West

- TU6-201, HW valve at 100% and not achieving setpoint. Damper is controlling to scheduled airflow of 2000 CFM.
- TU6-202, TU6-203, TU6-211, TU8-201, TU8-204, Dampers are 100% but below scheduled minimum airflow.
- TU6-204, Should be in heating mode but airflow is at scheduled cooling max and HW valve is closed.
- TU8-206, 3.7°F above setpoint. Damper is at -10.2% open?? Airflow well below cooling max design flow of 2150 CFM.
- TU8-207, damper position is failed or not communicating with the front-end.
- TU8-208, 3.1°F above setpoint. Damper is at 100% but airflow well below cooling max design flow of 1750 CFM.
- TU8-209, 3.8°F above setpoint. Cooling design flow max. CFM is being achieved.

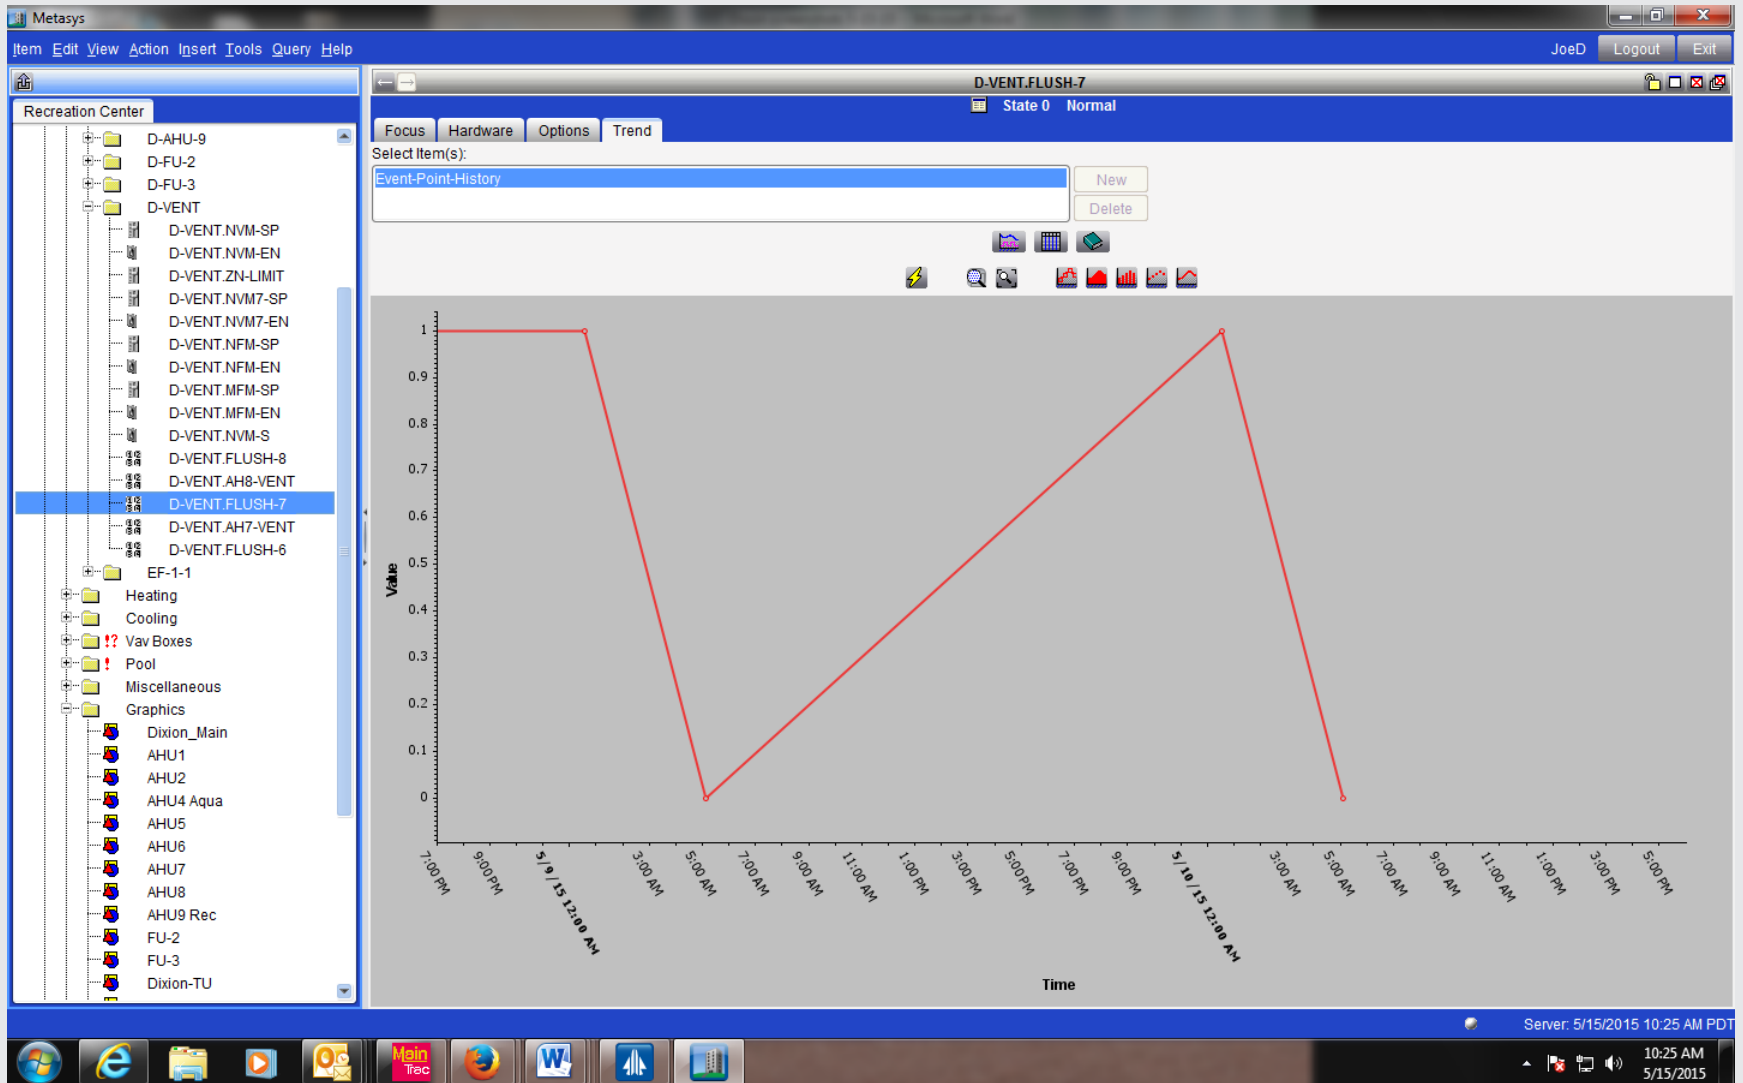
Figure 29 – AHU-7 Night Flush

- Operation confirmed through trending correctly based on 1 day observed.
