# Building Dilapidation Report

## **Building Dilapidation Report (Except ACT)**

The property inspected is a two storey, free standing home of full brick and brick veneer with timber frame construction. This structure is on an concrete infill slab and pier and strip footings, with a pitched and skillion roof covered in terracotta tiles.

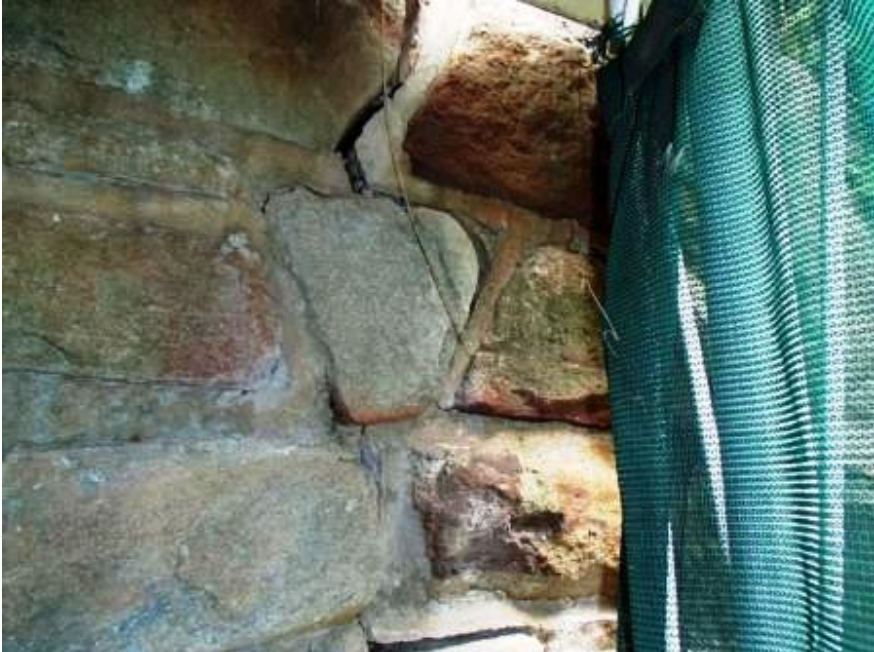
Location	Zone	Details
Exterior	Carport stone retaining wall on the left side boundary	<p>Structural cracking and subsidence to the stone retaining wall.</p>

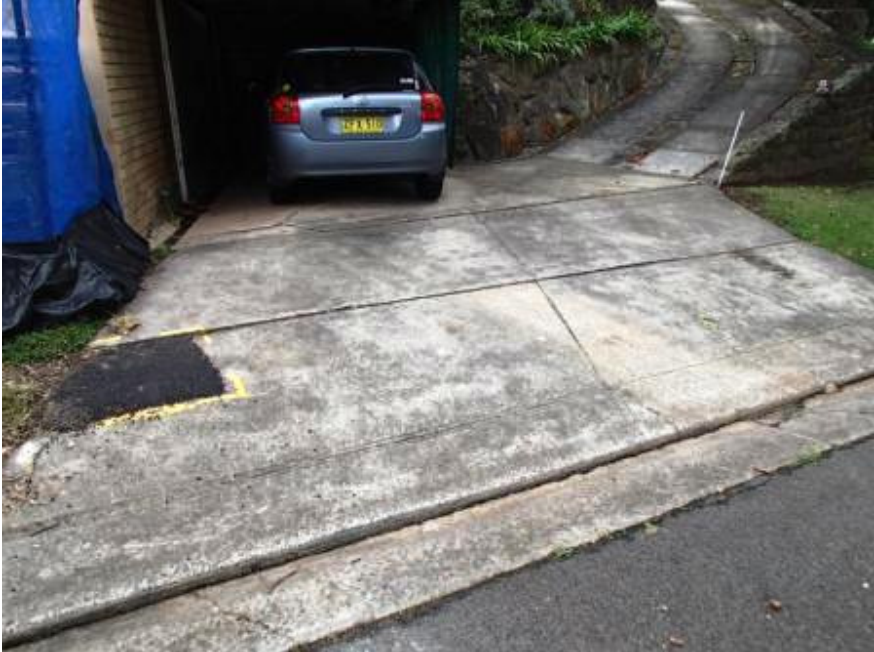
Location	Zone	Details
Exterior	Front of the property	<p data-bbox="507 365 1430 450">Cracking and patched concrete to the driveway, crossing and gutter.</p>

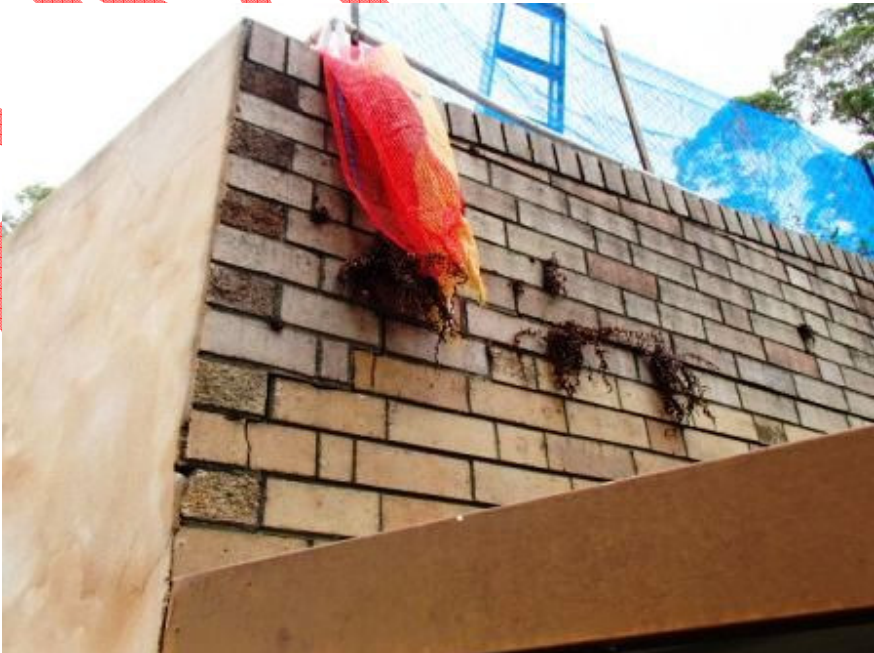
Exterior	Front / left boundary	<p data-bbox="507 1142 1337 1182">Structural cracking to boundary brick retaining wall.</p>

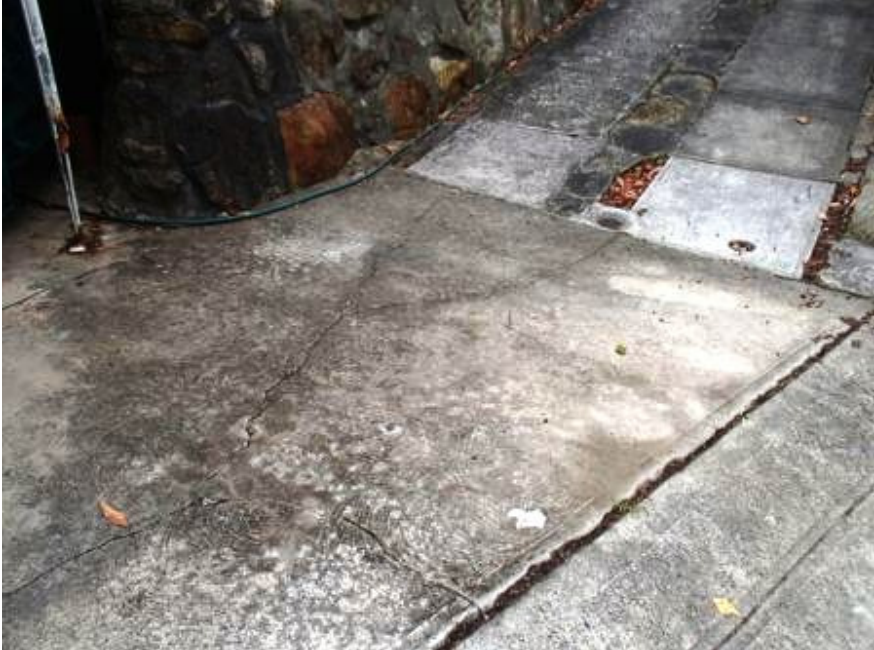
Location	Zone	Details
Exterior	Driveway	<p data-bbox="507 367 1066 405">Cracking to the concrete driveway.</p>

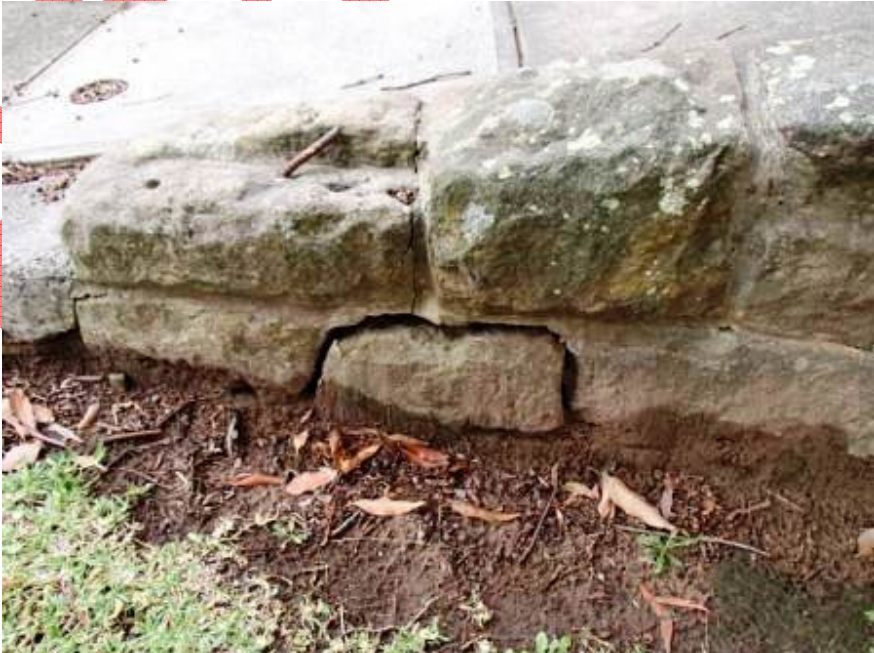
A photograph showing a concrete driveway with several cracks. A metal pipe is visible on the left side of the driveway.
Exterior	Front boundary	<p data-bbox="507 1102 1348 1182">Subsidence to the stone retaining wall in front of the driveway.</p>

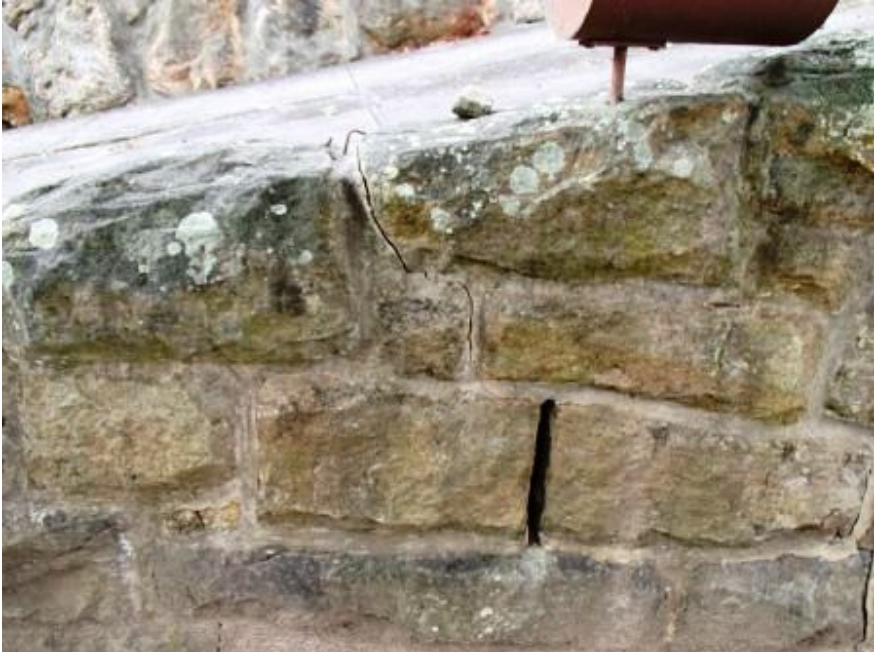
Location	Zone	Details
Exterior	Front boundary	<p data-bbox="507 367 1469 405">Cracking to the stone retaining wall in front of the driveway.</p>

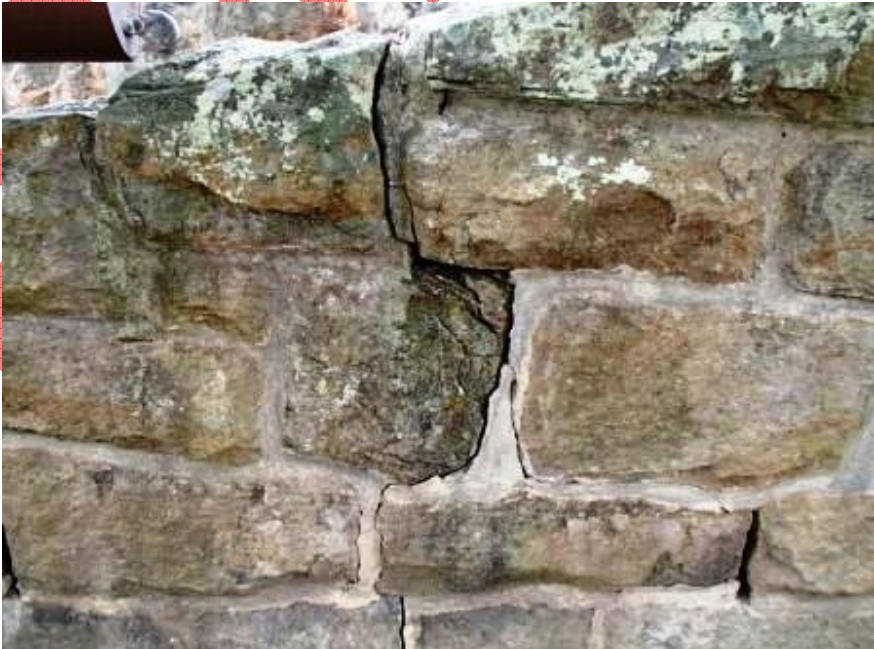
Exterior	Front boundary	<p data-bbox="507 1102 1469 1140">Cracking to the stone retaining wall in front of the driveway.</p>

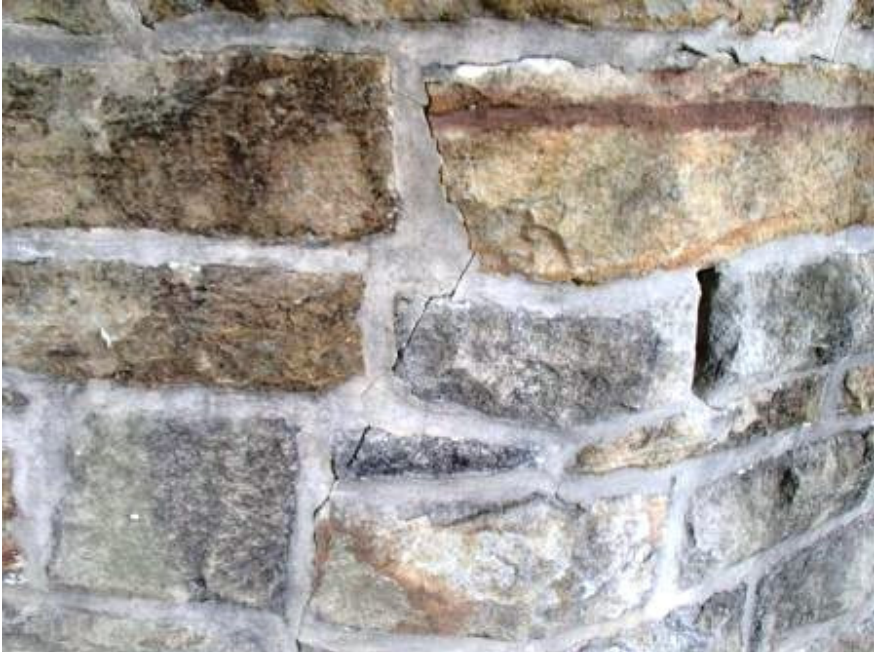
Location	Zone	Details
Exterior	Front boundary	<p data-bbox="507 367 1469 405">Cracking to the stone retaining wall in front of the driveway.</p>

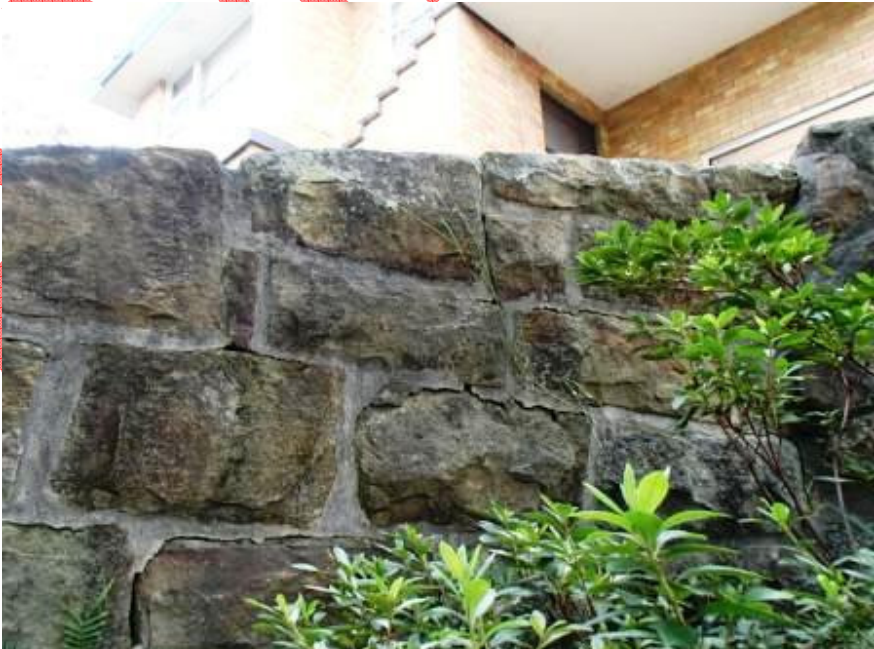
Exterior	Front boundary	<p data-bbox="507 1102 1469 1140">Cracking to the stone retaining wall in front of the driveway.</p>

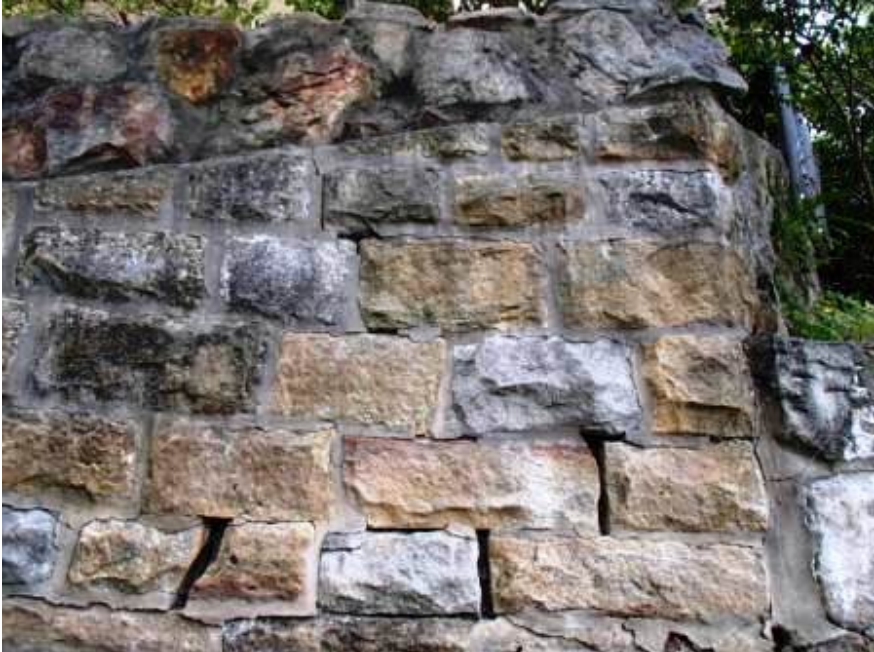
Location	Zone	Details
Exterior	Front boundary	<p data-bbox="507 367 1469 405">Cracking to the stone retaining wall in front of the driveway.</p>

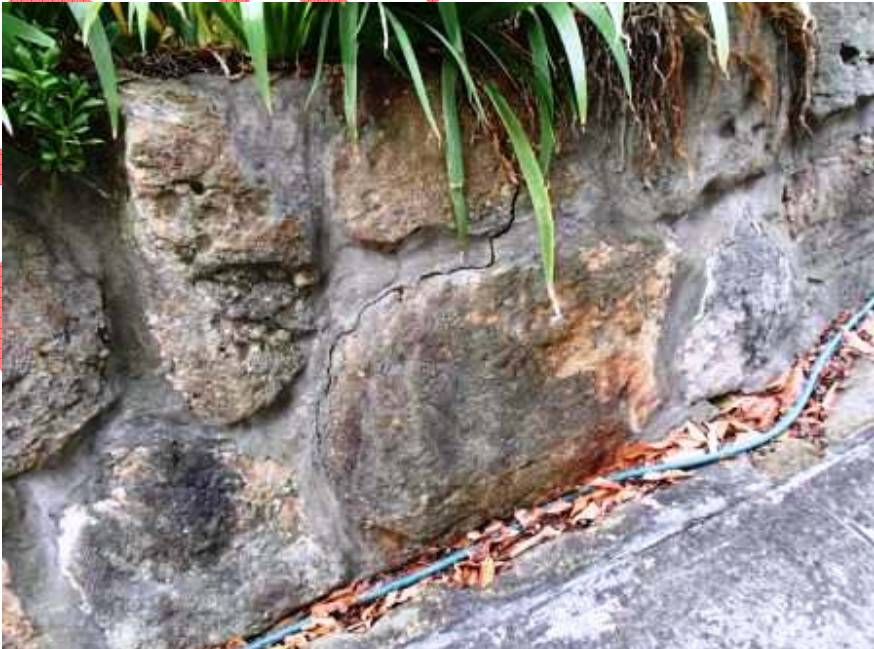
Exterior	Driveway top side retaining wall	<p data-bbox="507 1102 1412 1140">Cracking to the stone retaining wall above the driveway.</p>

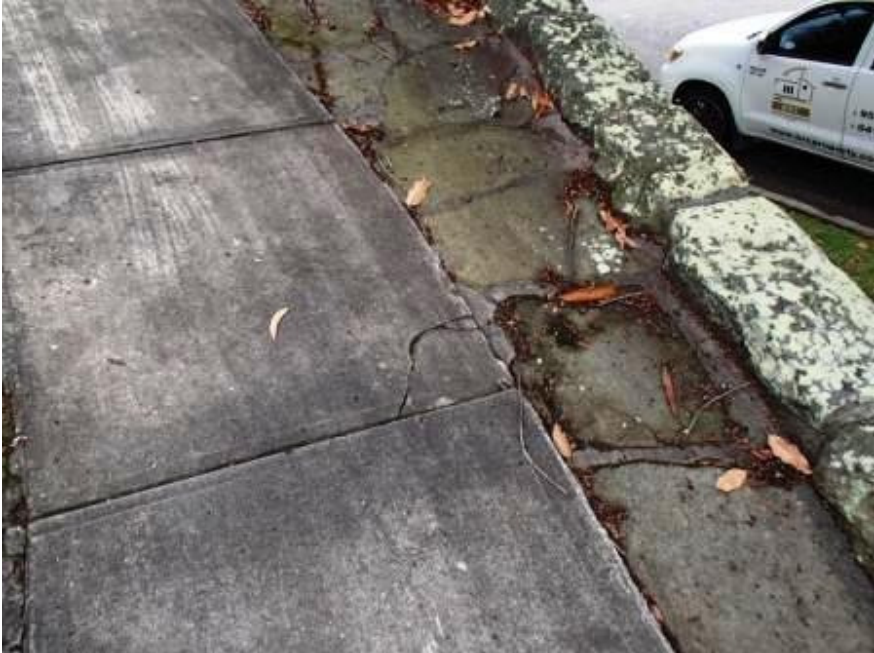
Location	Zone	Details
Exterior	Driveway	<p data-bbox="507 367 1337 405">Cracking and subsidence to the concrete driveway.</p>

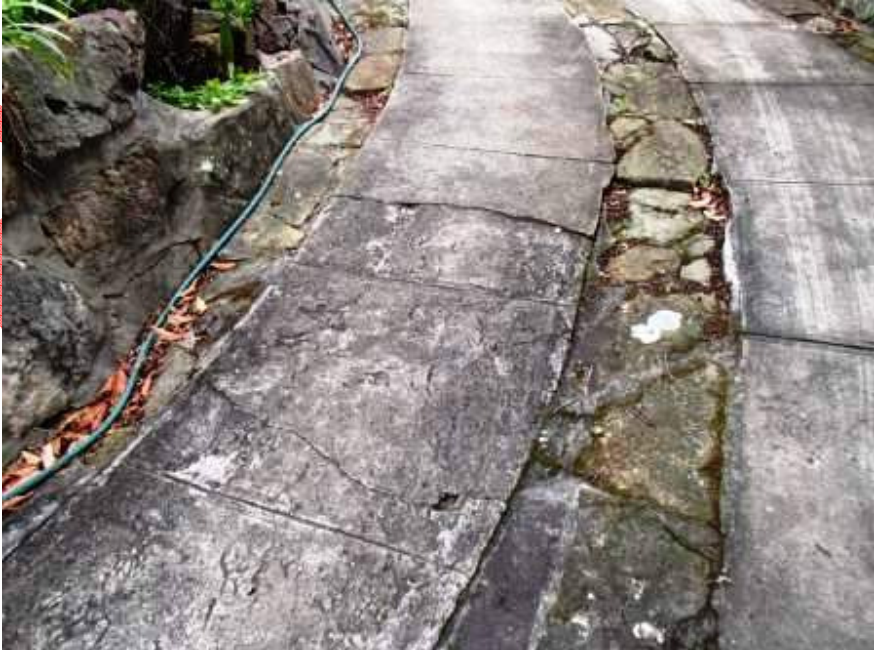
Exterior	Driveway	<p data-bbox="507 1102 1342 1182">Cracking and subsidence to the concrete and stone driveway.</p>

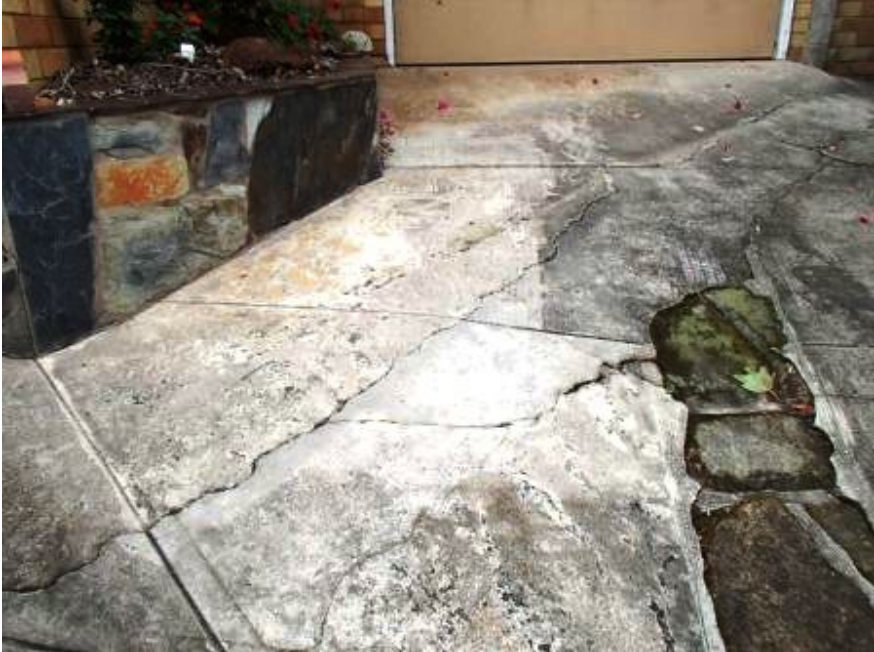
Location	Zone	Details
Exterior	Driveway	<p data-bbox="507 367 1342 450">Cracking and subsidence to the concrete and stone driveway.</p>

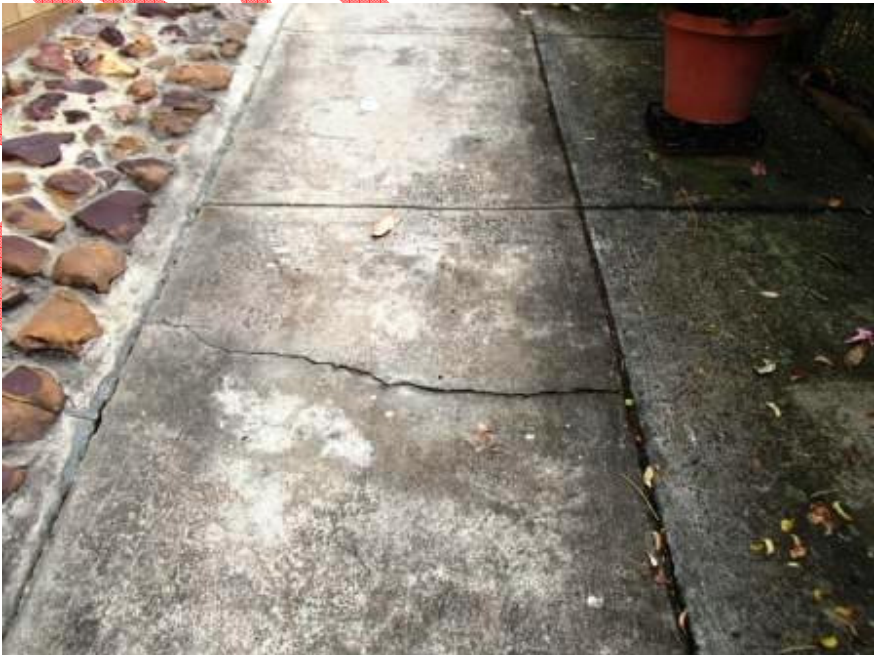
Exterior	Right side of the property	<p data-bbox="507 1144 1299 1182">Cracking and subsidence to the concrete paving.</p>

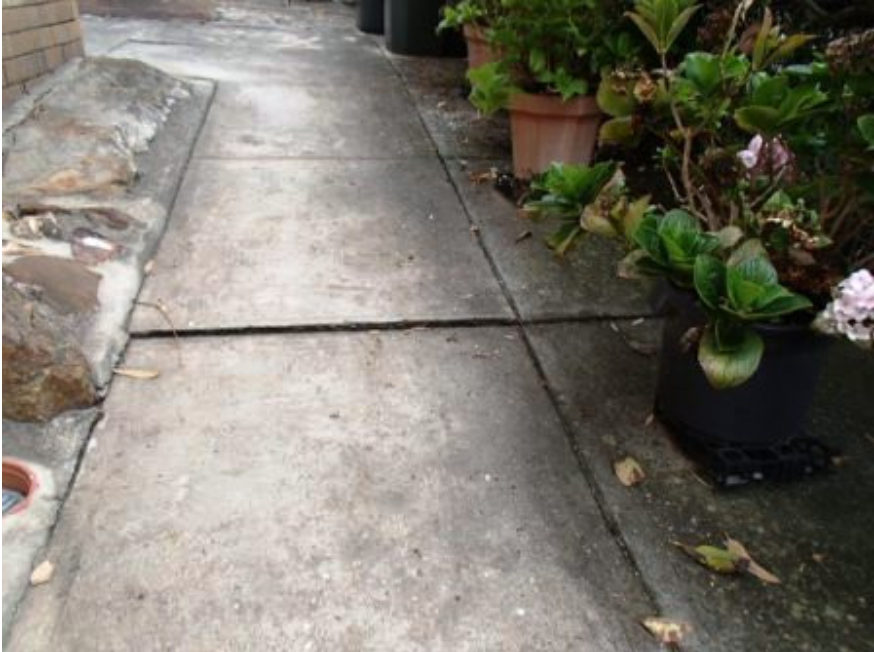
Location	Zone	Details
Exterior	Right side of the property	Cracking and subsidence to the concrete paving.

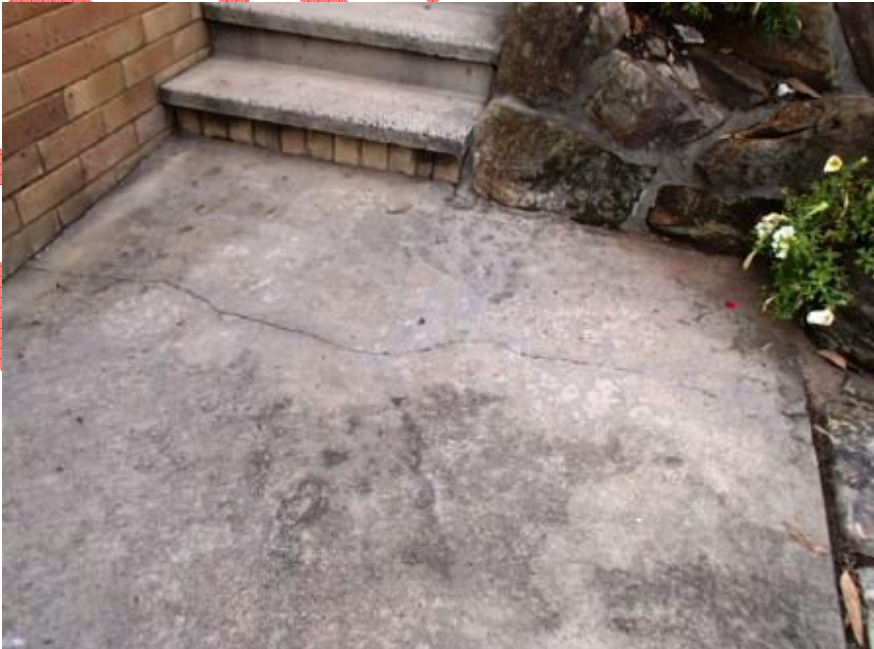
Exterior	Rear of the property	Cracking to the concrete paving.

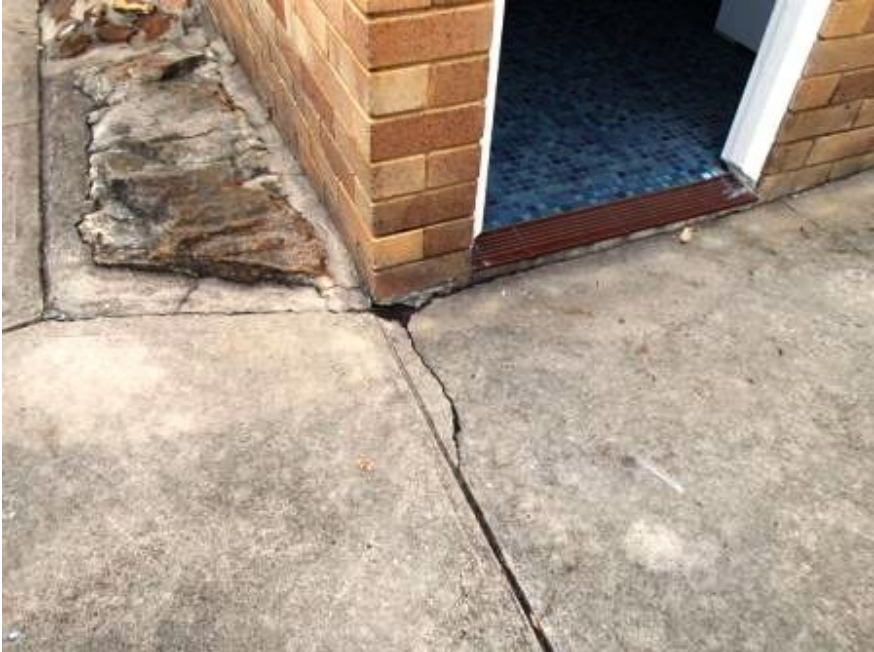
Location	Zone	Details
Exterior	Rear of the property	<p data-bbox="507 365 1299 405">Cracking and subsidence to the concrete paving.</p>

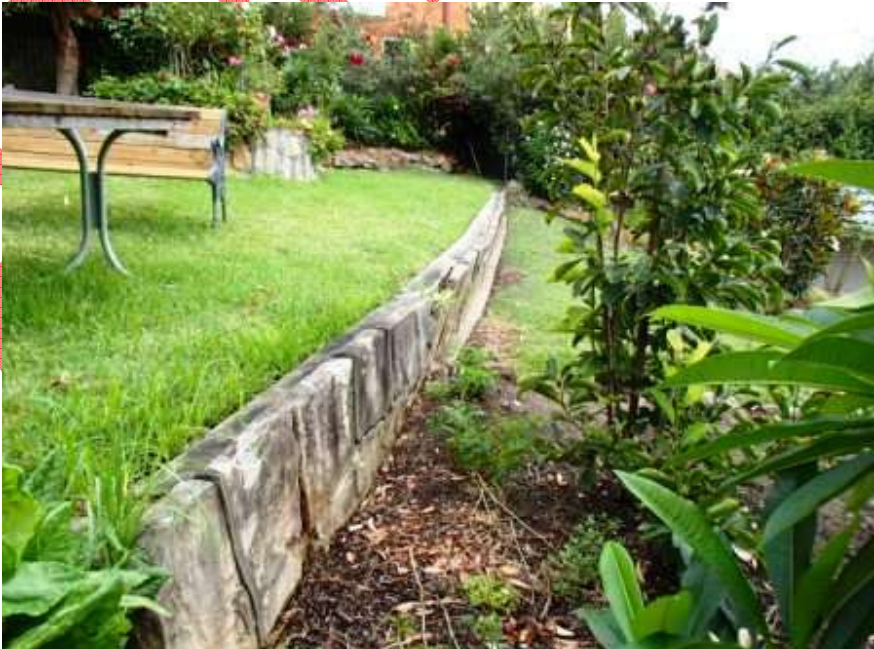
Exterior	Rear of the property	<p data-bbox="507 1099 1426 1140">Subsidence and cracking to the rear stone retaining wall.</p>

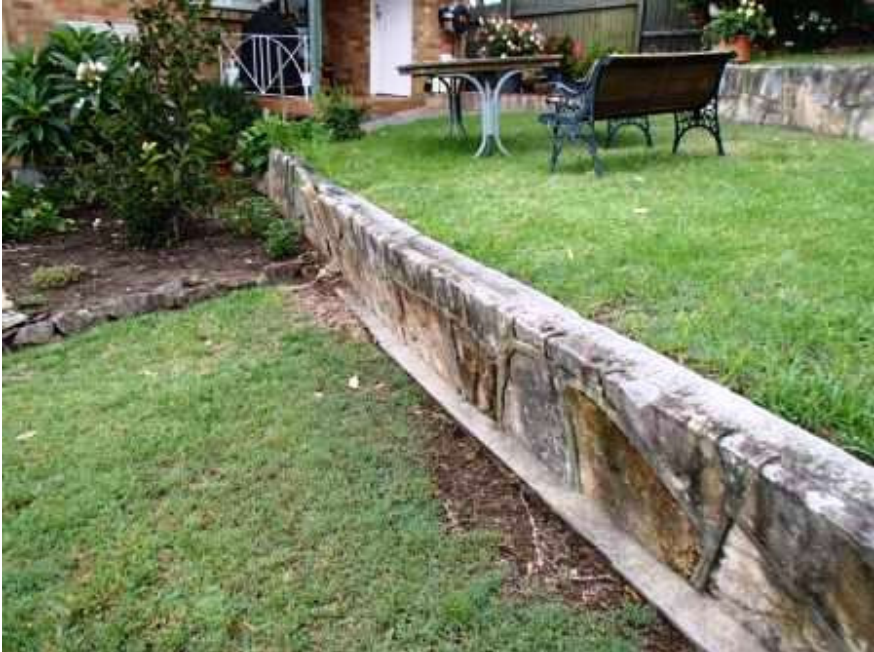
Location	Zone	Details
Exterior	Rear of the property	<p data-bbox="507 367 1428 405">Subsidence and cracking to the rear stone retaining wall.</p>

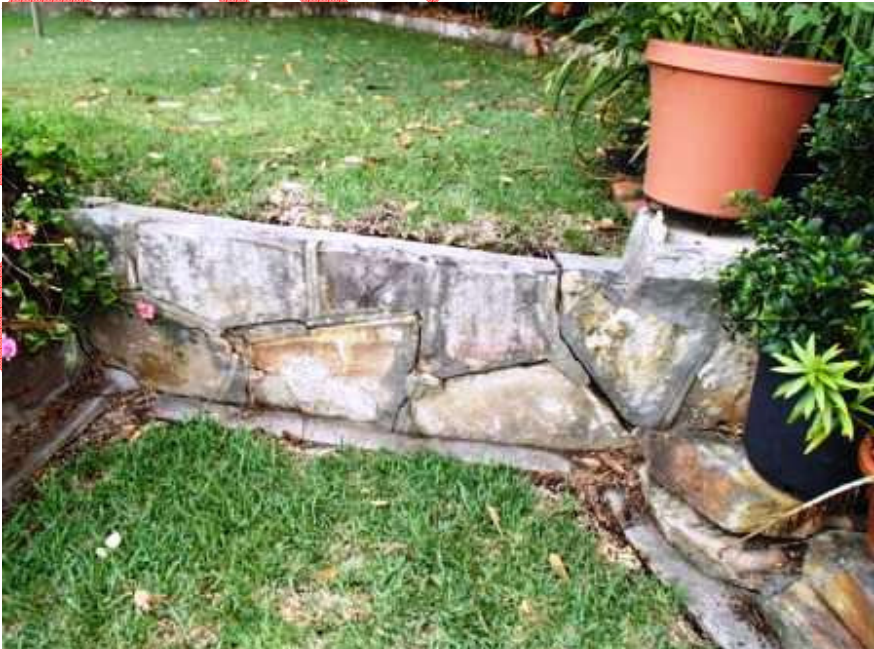
Exterior	Rear of the property	<p data-bbox="507 1102 1428 1140">Cracking and subsidence to the rear stone retaining wall.</p>

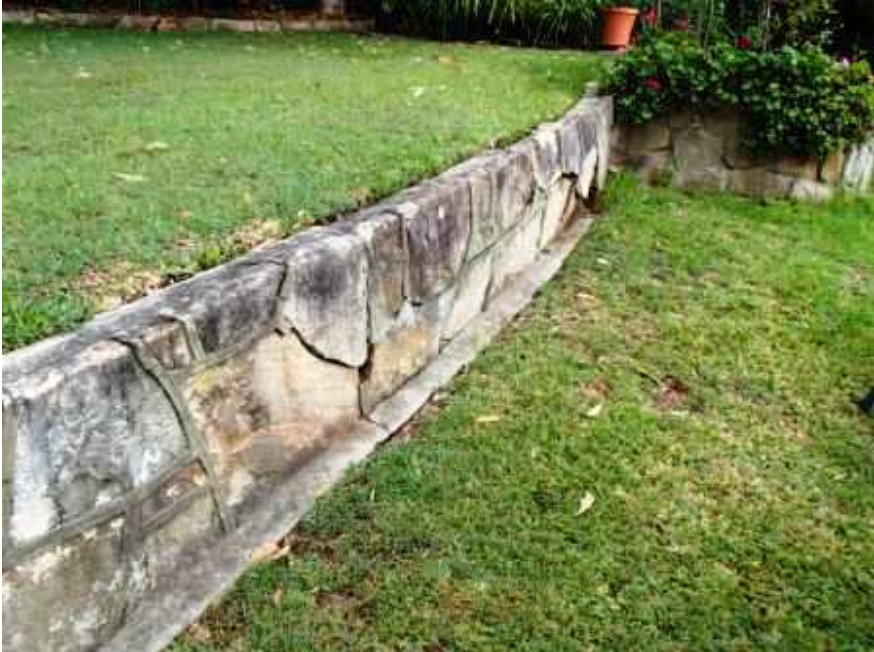
Location	Zone	Details
Exterior	Rear of the property	Cracking and subsidence to the rear stone retaining wall.

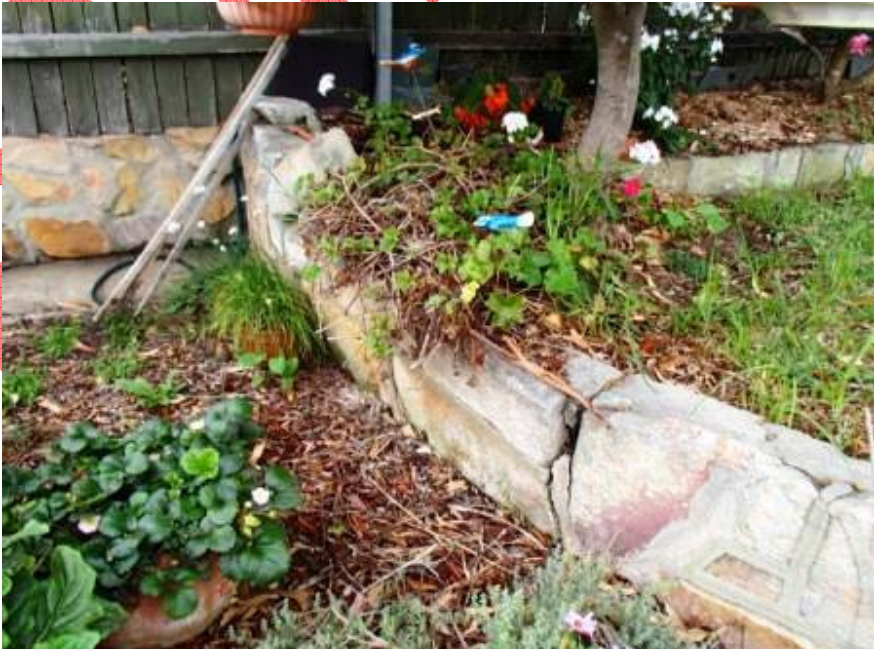
Exterior	Rear of the property	Cracking and subsidence to the rear stone retaining wall.

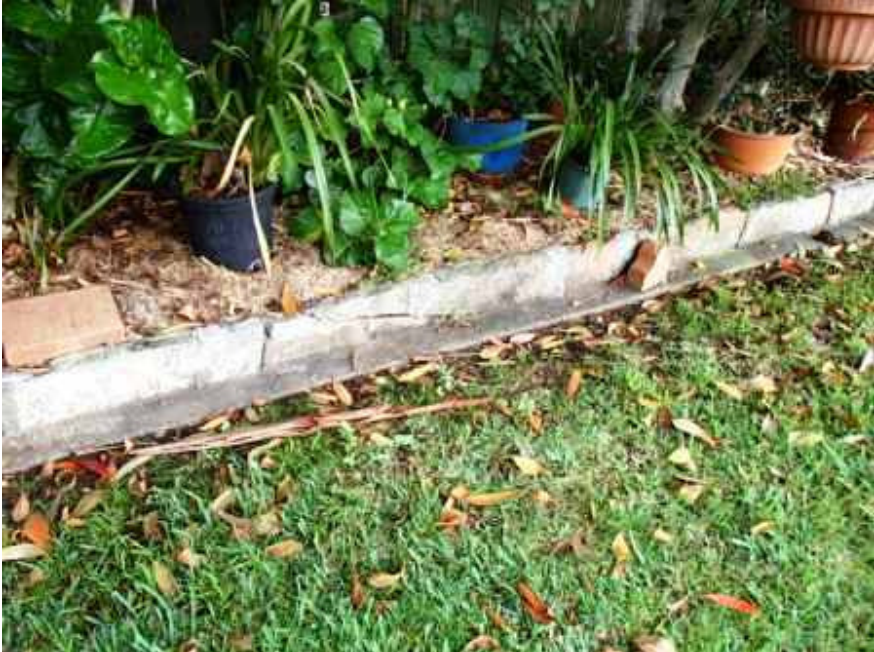
Location	Zone	Details
Exterior	Rear of the property	Cracking and subsidence to the rear stone garden wall.

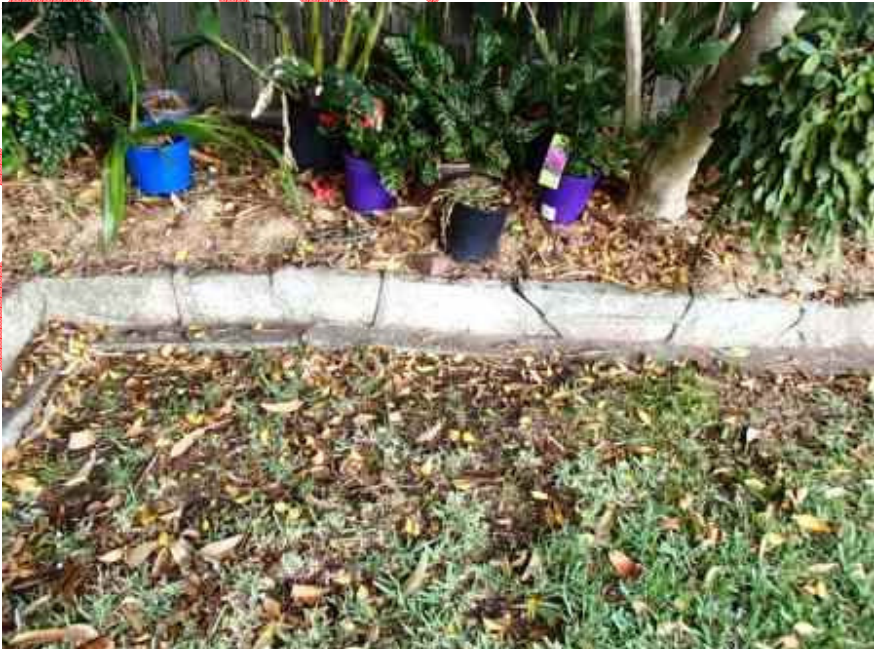
Exterior	Rear of the property	Cracking and subsidence to the rear stone garden wall.

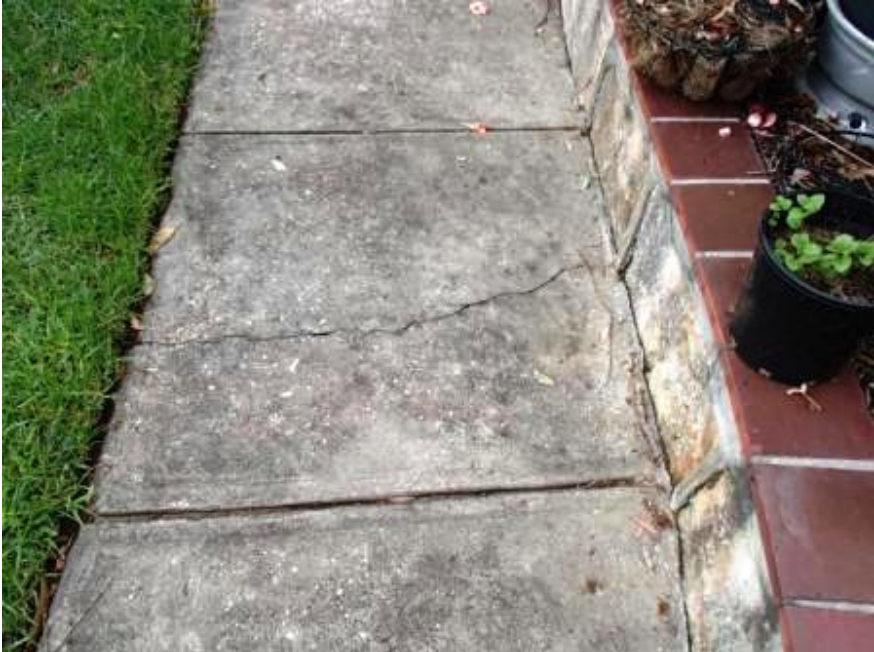
Location	Zone	Details
Exterior	Rear of the property	<p data-bbox="507 367 1299 405">Cracking and subsidence to the concrete paving.</p>

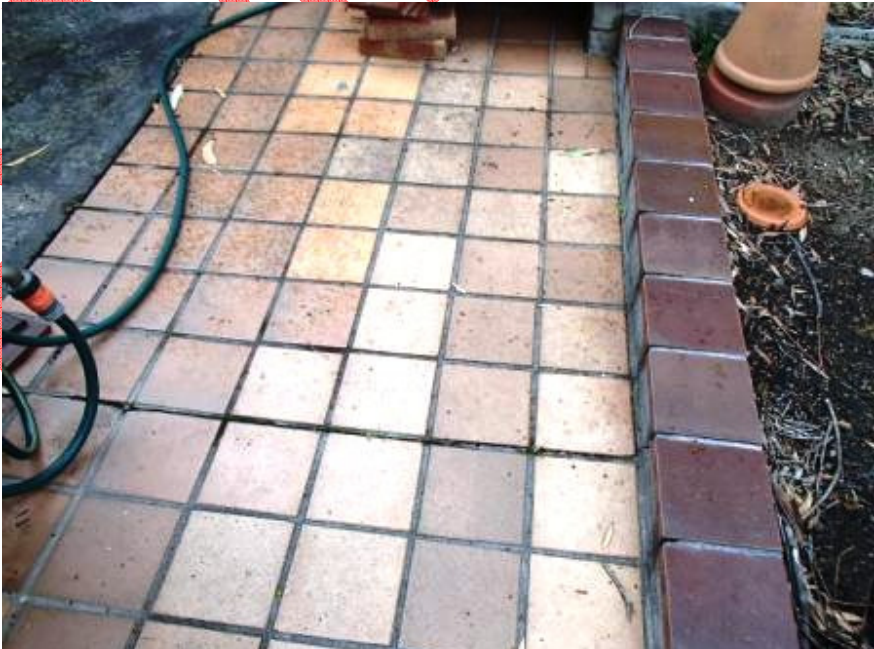
A photograph showing a concrete paving slab with a prominent diagonal crack. The slab is adjacent to a brick wall on the right and a grassy area on the left. A potted plant is visible near the brick wall.
Exterior	Rear of the property	<p data-bbox="507 1102 1026 1140">Drummy tiles to the rear paving.</p>

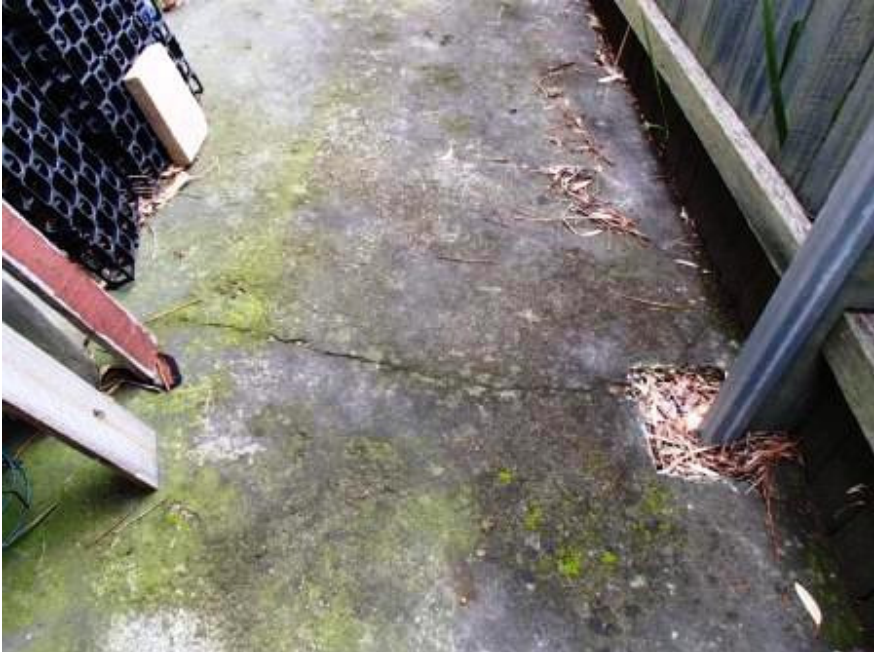
Location	Zone	Details
Exterior	Left side of the home	Cracking and subsidence to the concrete paving.

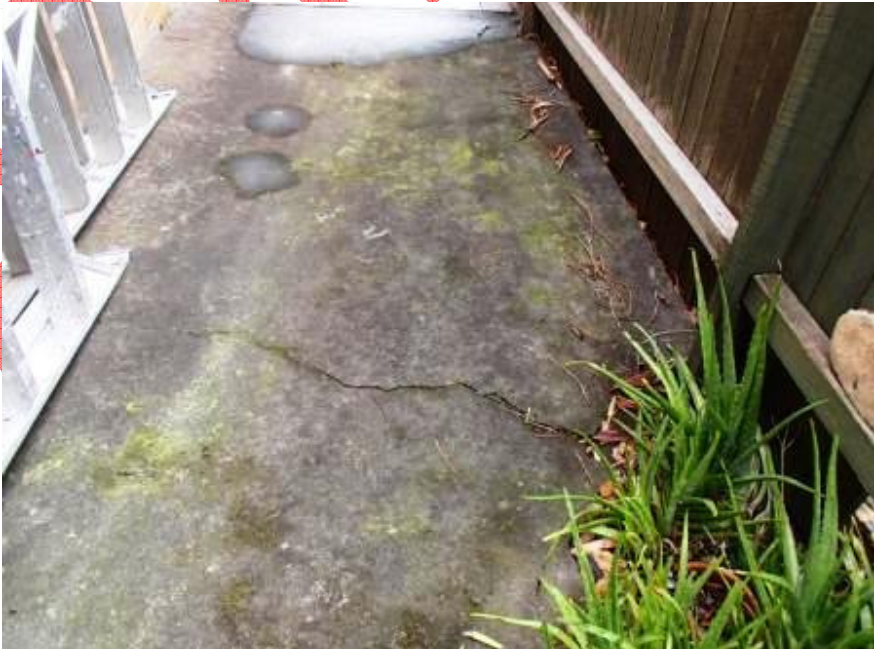
Exterior	Left side of the home	Cracking and subsidence to the concrete paving.

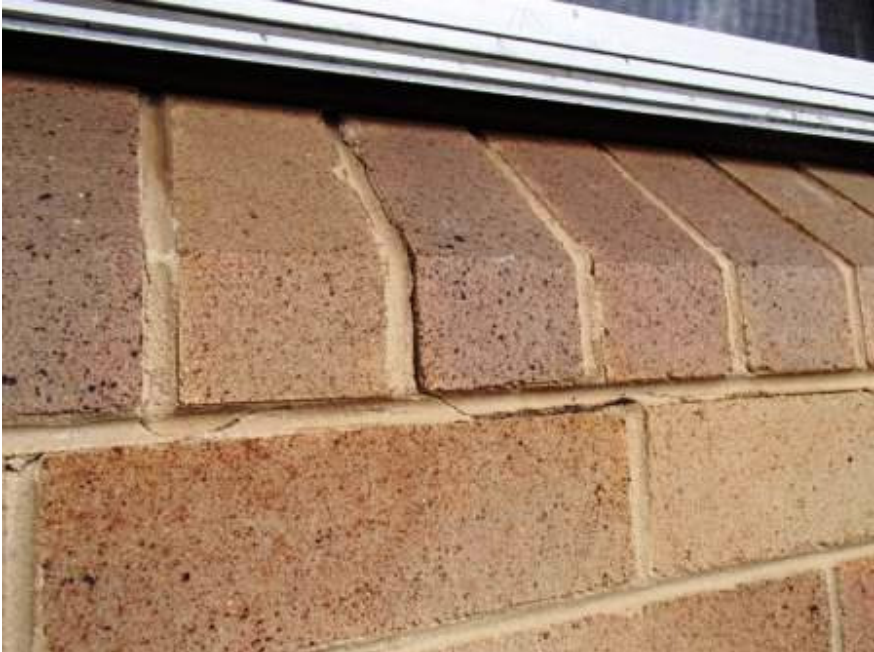
Location	Zone	Details
Exterior	Left side of the home	Cracking to the brickwork mortar join.

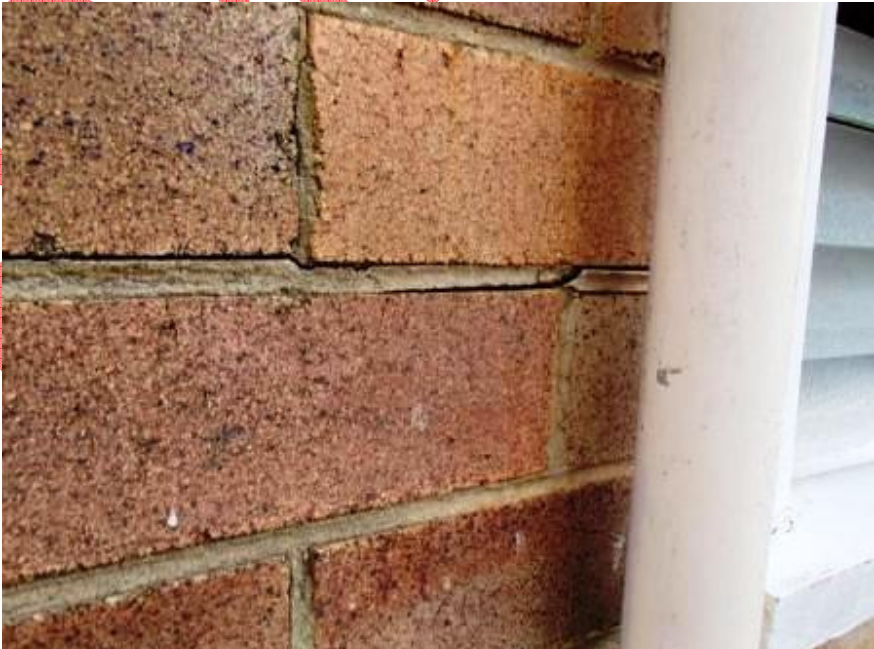
Exterior	Left side of the home	Cracking to the brickwork mortar join.

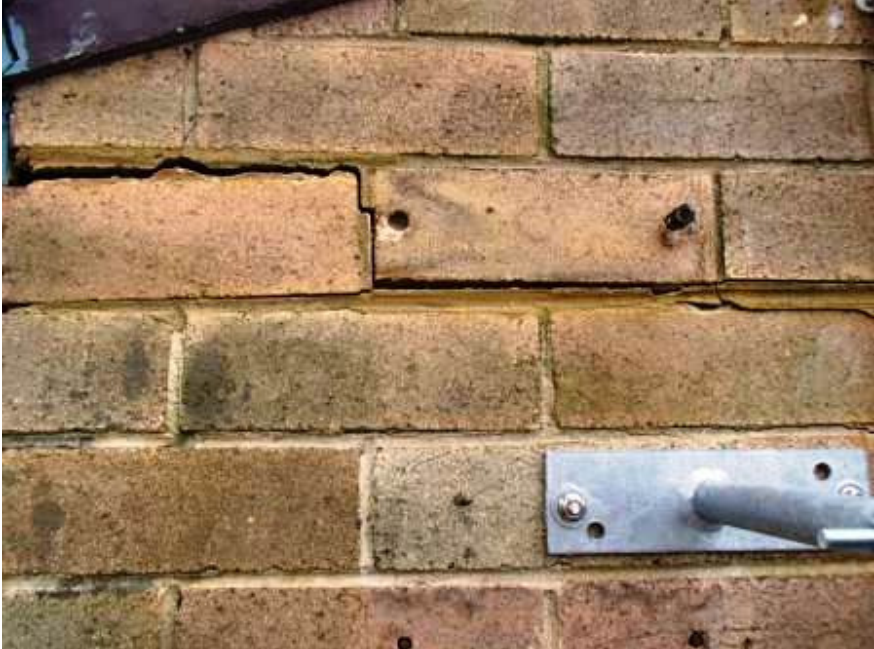
Location	Zone	Details
Exterior	Left side of the home	<p data-bbox="507 367 927 405">Cracking to the brickwork.</p>

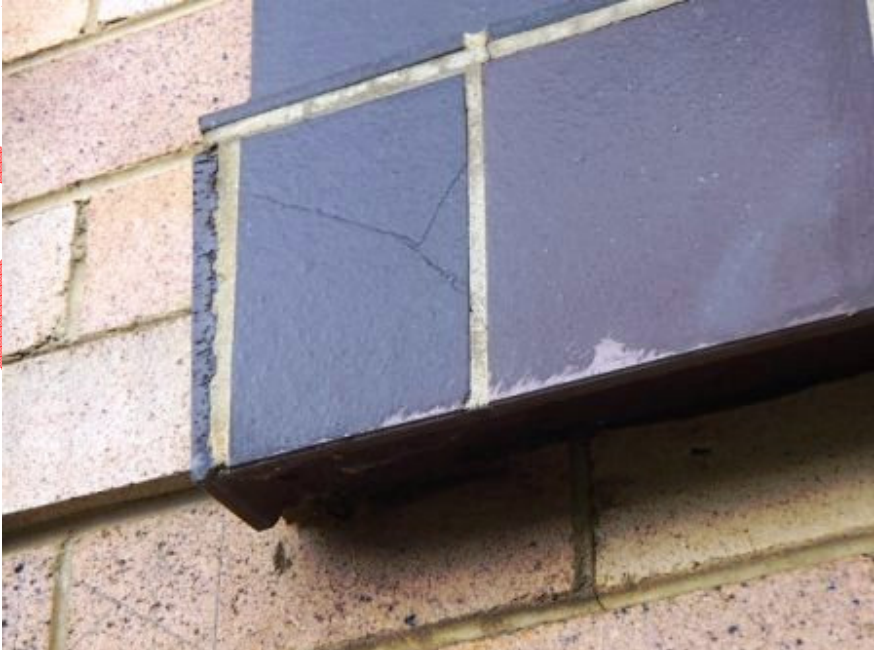
Exterior	Rear of the home	<p data-bbox="507 1102 1246 1140">Cracked and drummy balcony slab edge tiles.</p>

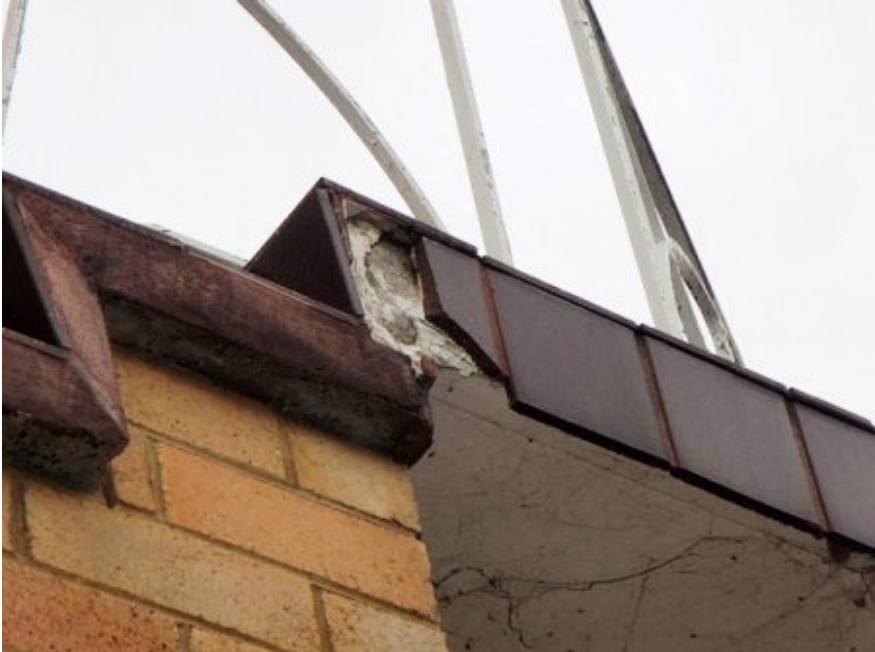
Location	Zone	Details
Exterior	Front balcony	<p data-bbox="507 365 1054 405">Damaged balcony slab edge tiles.</p>

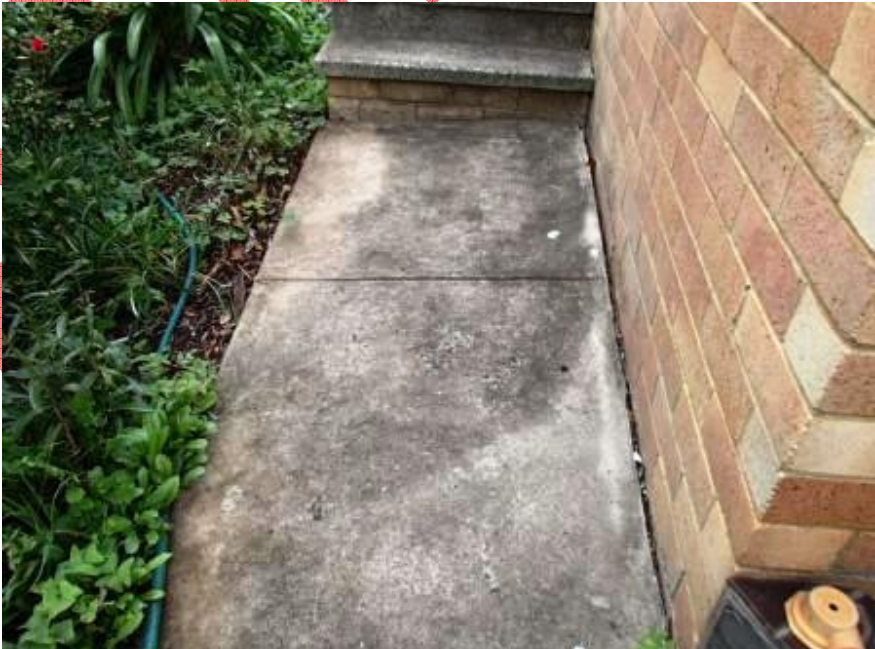
Exterior	Front of the home	<p data-bbox="507 1099 1299 1140">Cracking and subsidence to the concrete paving.</p>

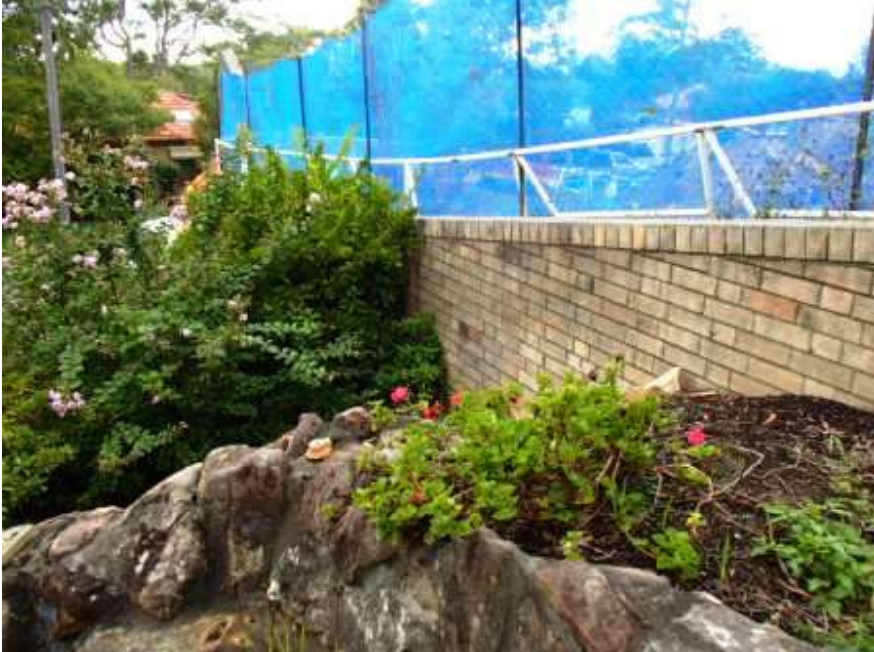
Location	Zone	Details
Exterior	Retaining wall on the left side boundary	<p data-bbox="507 367 1422 443">Structural cracking and subsidence to the brick retaining wall.</p>

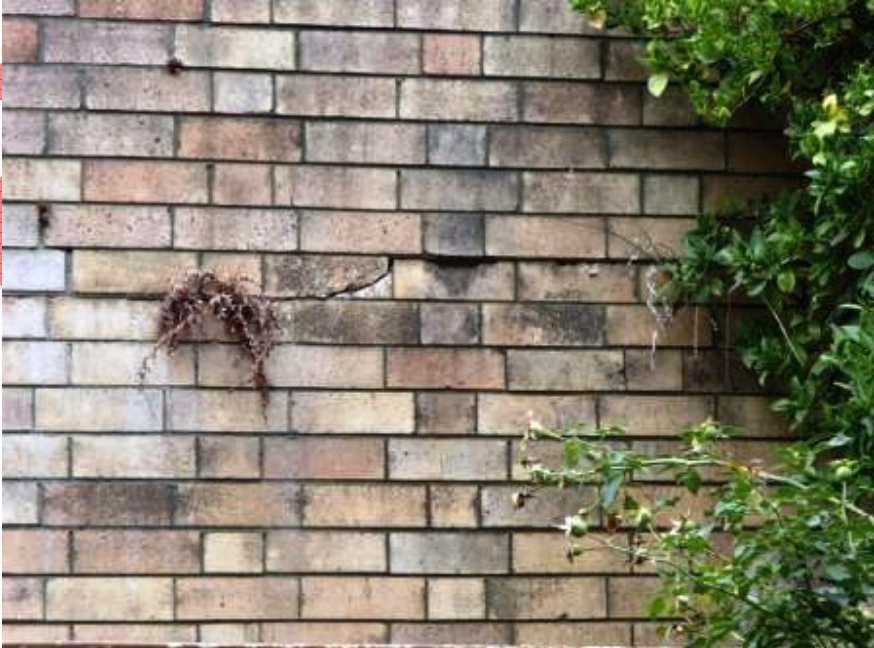
Exterior	Retaining wall on the left side boundary	<p data-bbox="507 1144 1422 1220">Structural cracking and subsidence to the brick retaining wall.</p>

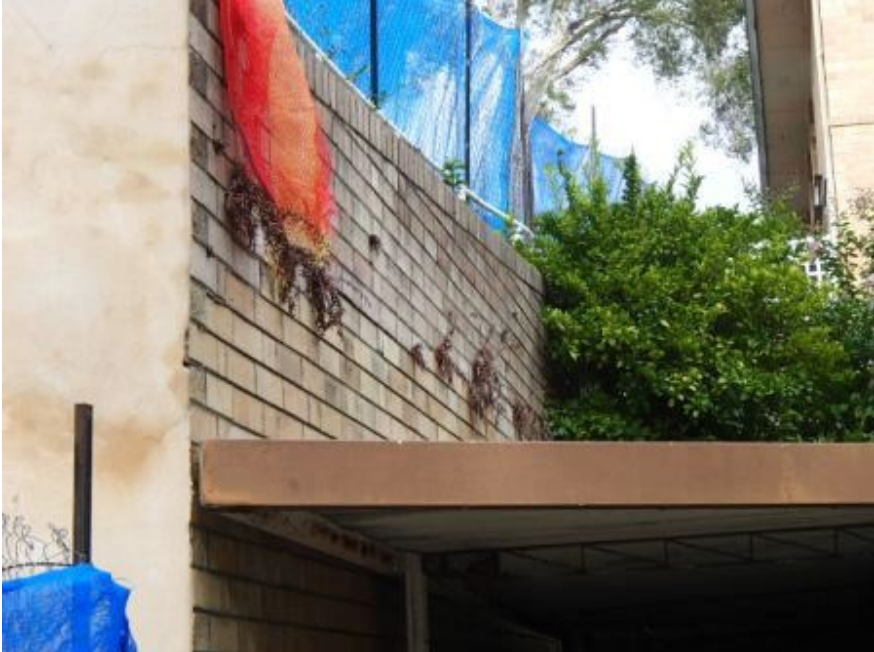
Location	Zone	Details
Exterior	Retaining wall on the left side boundary	<p data-bbox="507 365 1422 443">Structural cracking and subsidence to the brick retaining wall.</p>
