# Building Dilapidation Report

## **Building Dilapidation Report (Except ACT)**

The property inspected is a two storey, free standing home of full brick and brick veneer with timber frame construction. This structure is on an concrete infill slab and pier and strip footings, with a pitched and skillion roof covered in terracotta tiles.

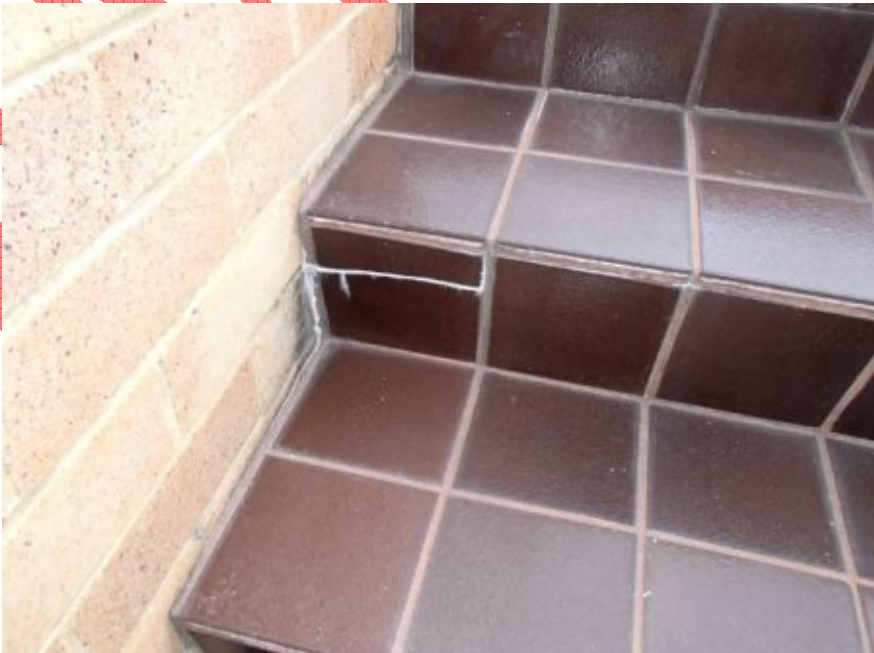
Exterior	Front balcony stairs	<p data-bbox="507 1142 810 1182">Cracked stair tiles.</p>

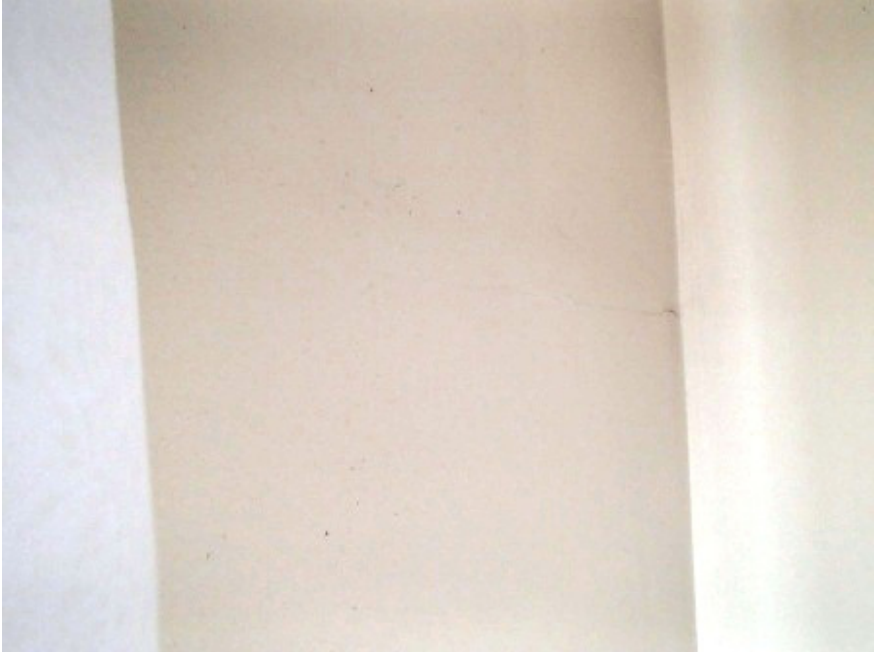
Location	Zone	Details
Interior	Bedroom 1	<p>Minor cracks were noted to the internal walls. These cracks have been caused by movement and settlement.</p>

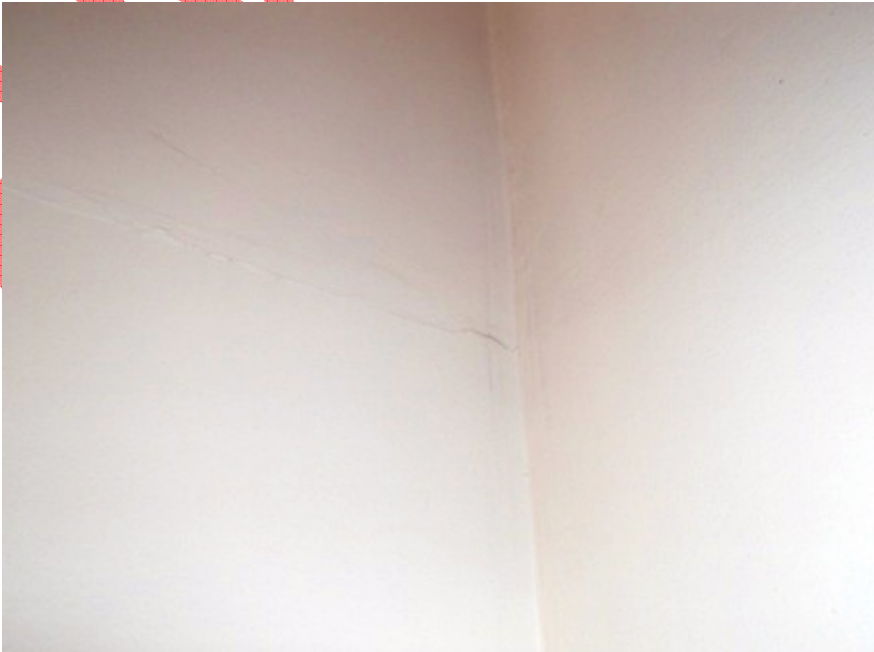
Interior	Bedroom 1	<p>Minor cracks were noted to the internal walls. These cracks have been caused by movement and settlement.</p>

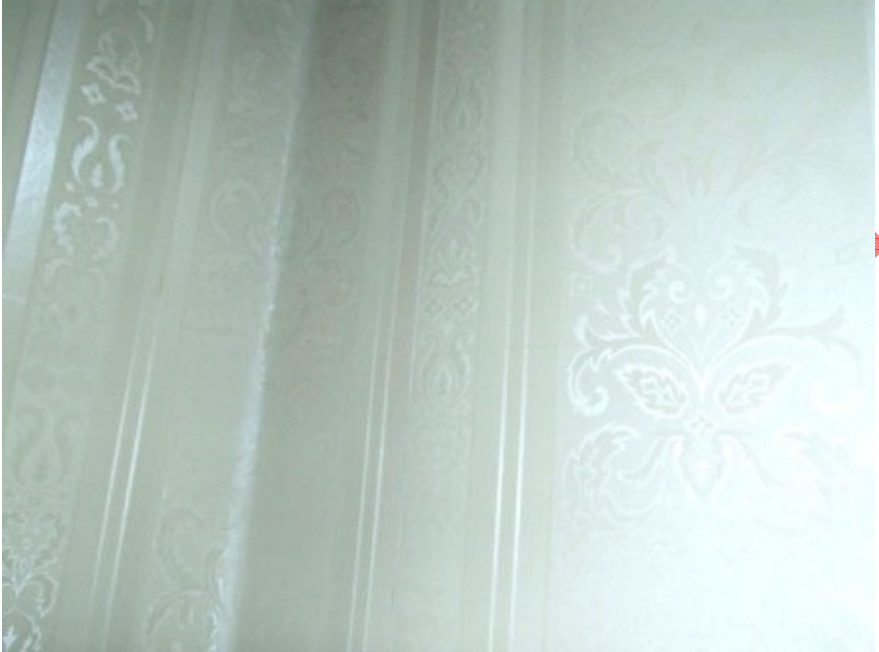
Location	Zone	Details
Interior	Hallway between bedroom 1 and study	<p>Minor cracks were noted to the internal walls. These cracks have been caused by movement and settlement.</p>

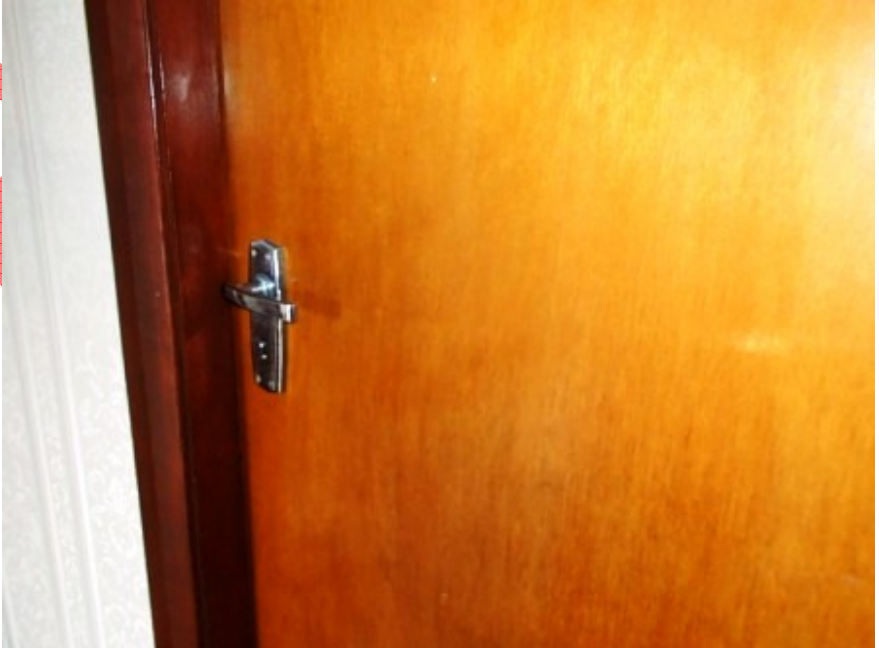
Interior	Study	<p>The door requires easing and adjustment in order for it to operate correctly.</p>

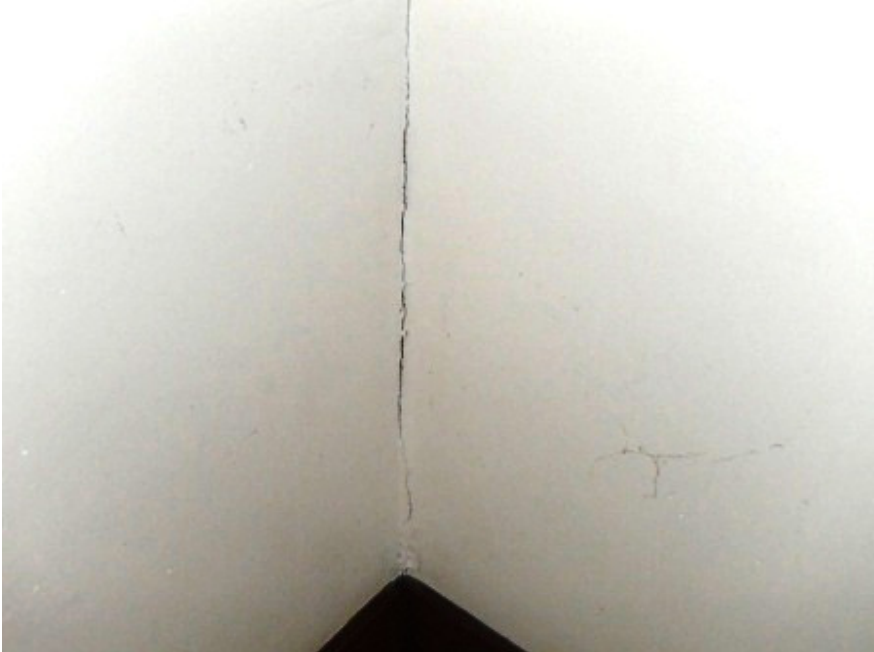
Location	Zone	Details
Interior	Study	<p data-bbox="507 365 1481 448">Minor cracks were noted to the internal walls. These cracks have been caused by movement and settlement.</p>

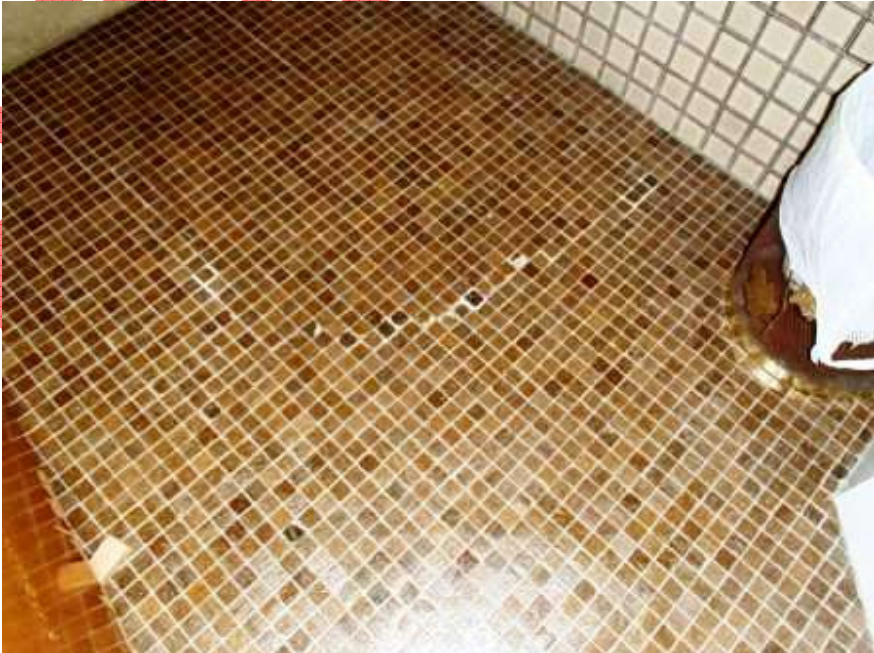
Interior	Bathroom	<p data-bbox="507 1142 1110 1182">Movement to the bathroom floor tiles.</p>

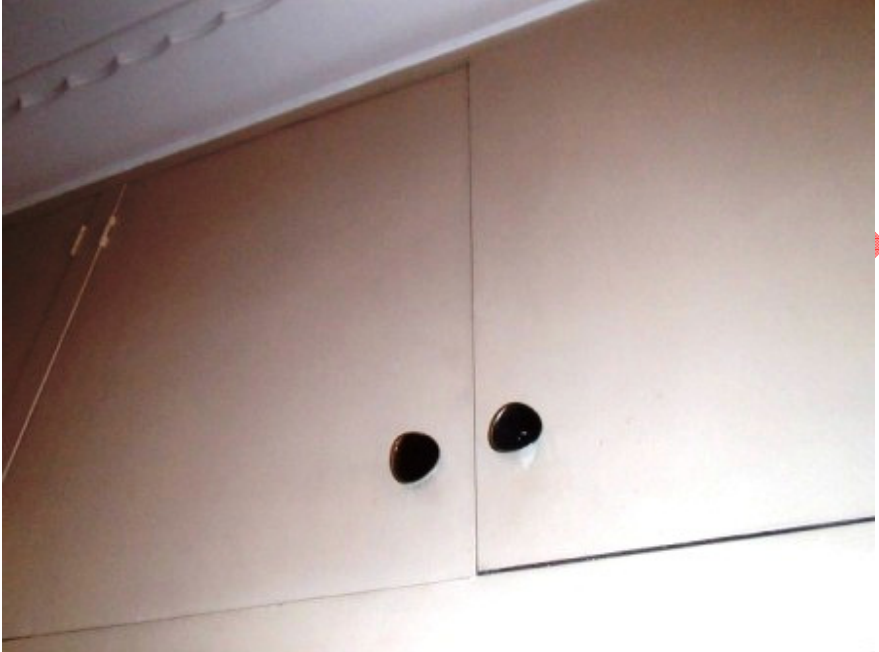
Location	Zone	Details
Interior	Hallway linen cupboard	<p>The doors require easing and adjustment in order for it to operate correctly.</p>

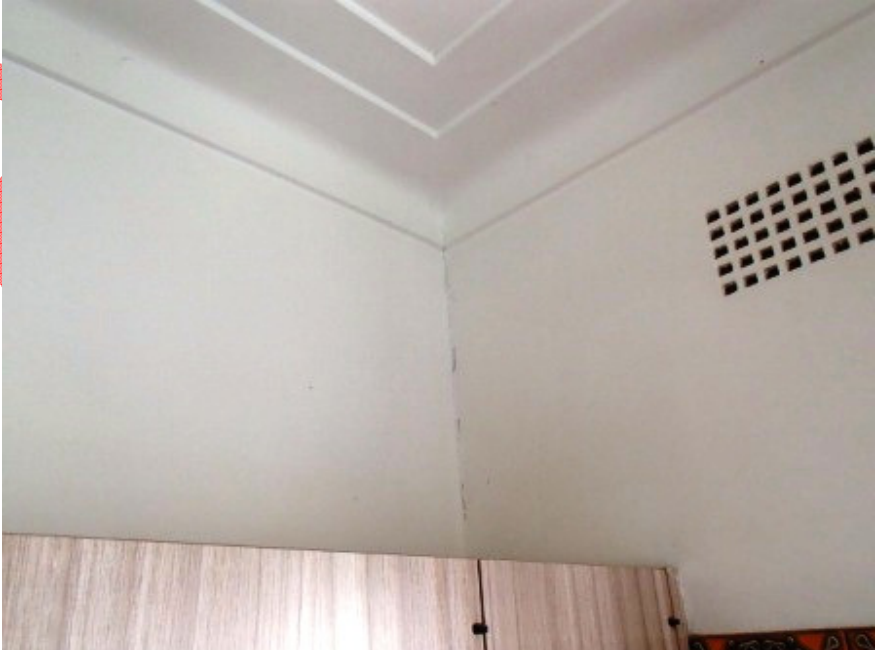
Interior	Kitchen	<p>Minor cracks were noted to the internal walls. These cracks have been caused by movement and settlement.</p>

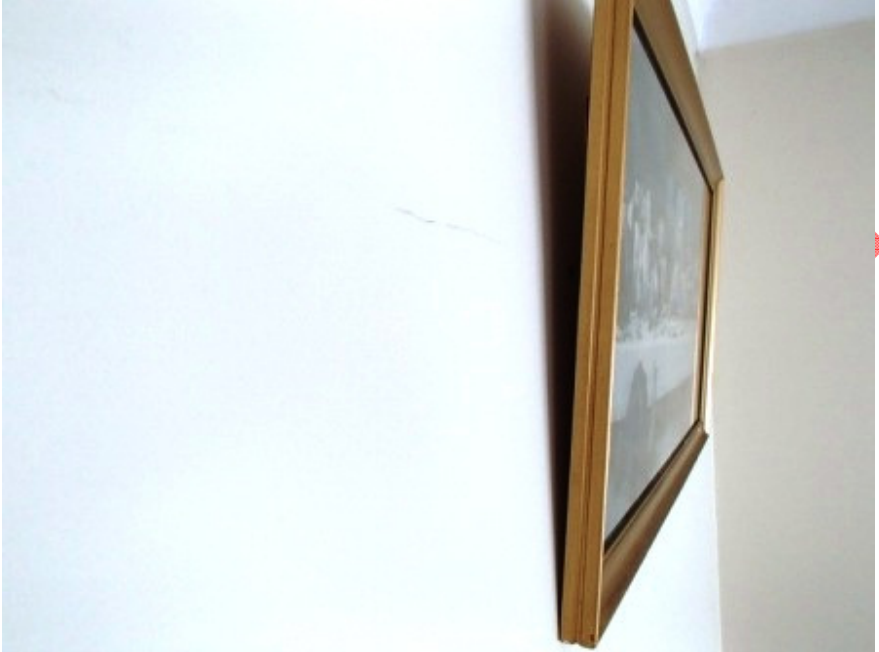
Location	Zone	Details
Interior	Lounge room	<p data-bbox="507 367 1479 450">Minor cracks were noted to the internal walls. These cracks have been caused by movement and settlement.</p>

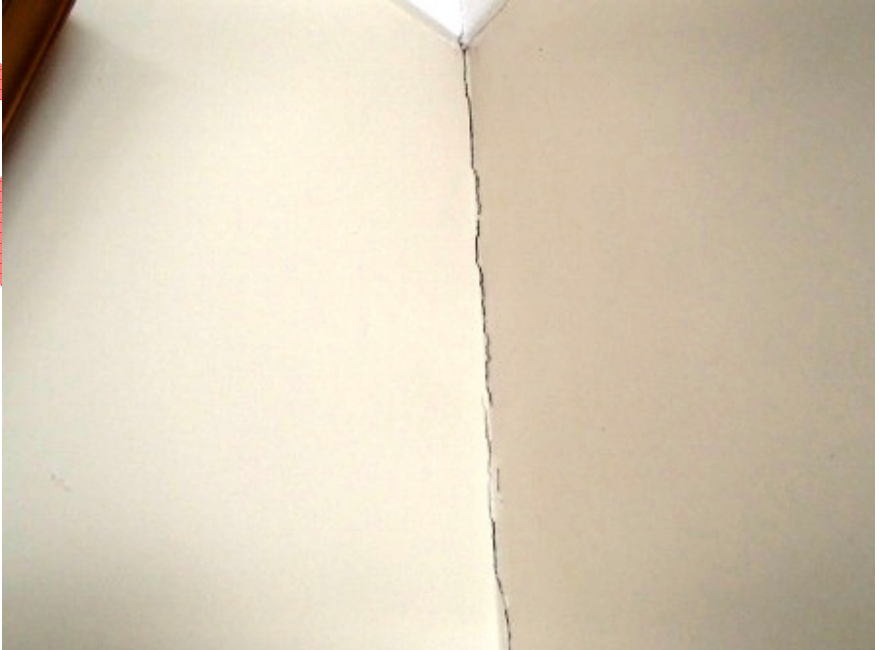
Interior	Lounge room	<p data-bbox="507 1144 1479 1227">Minor cracks were noted to the internal walls. These cracks have been caused by movement and settlement.</p>

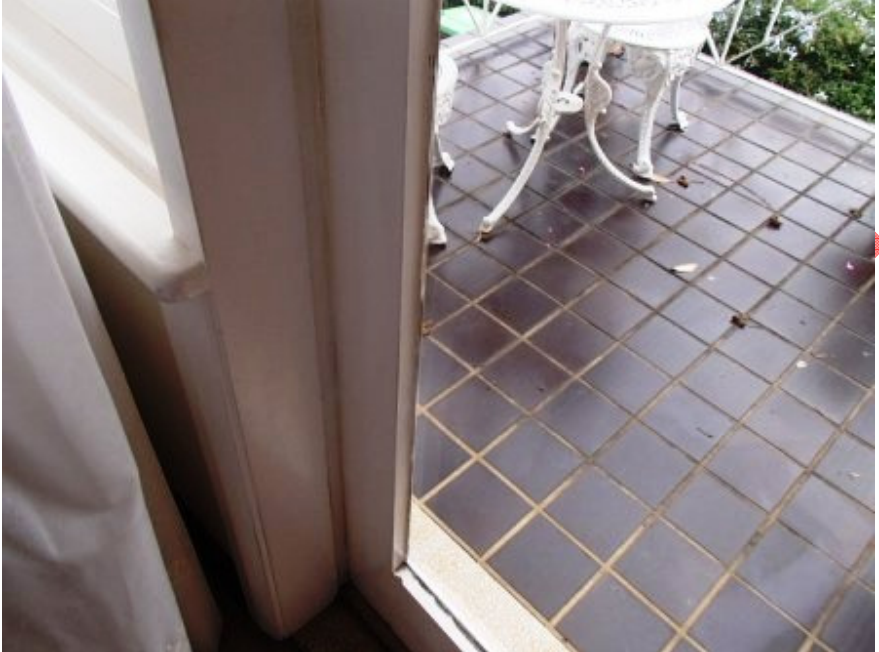
Location	Zone	Details
Interior	Lounge room / balcony	<p>The door requires easing and adjustment in order for it to operate correctly.</p>

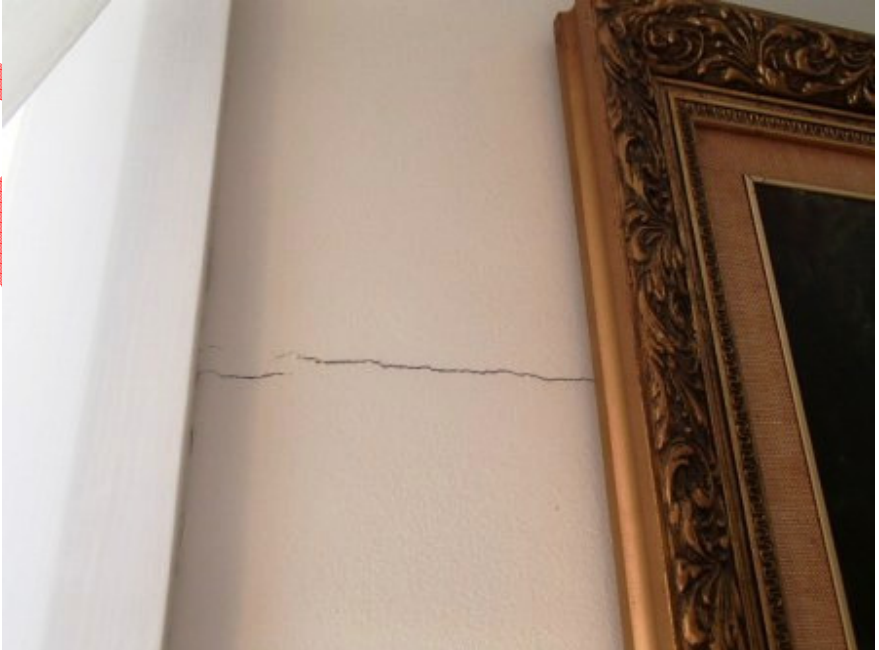
Interior	Lounge room	<p>Minor cracks were noted to the internal walls. These cracks have been caused by movement and settlement.</p>

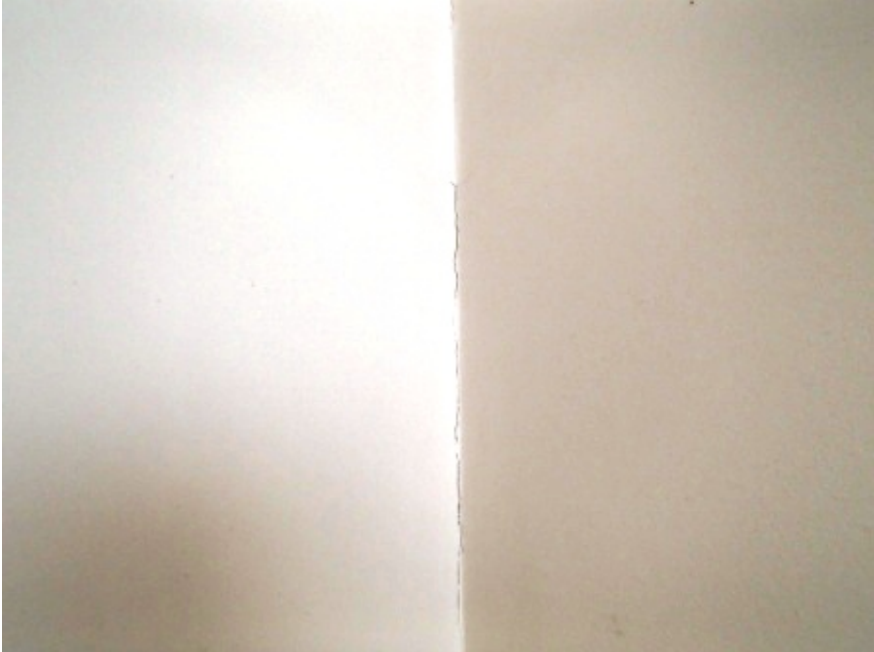
Location	Zone	Details
Interior	Lounge room	<p data-bbox="507 365 1477 450">Minor cracks were noted to the internal walls. These cracks have been caused by movement and settlement.</p>

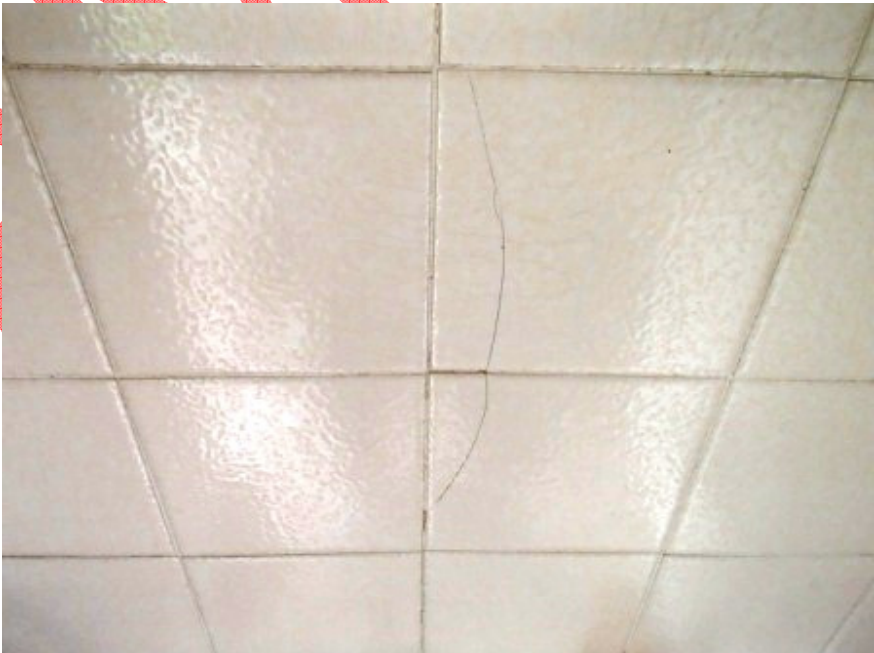
A photograph showing a vertical crack in a light-colored wall. The crack runs from the top to the bottom of the frame, slightly to the right of the center. The wall surface appears slightly textured and is illuminated from the left, creating a soft shadow.
Interior	Rear toilet	<p data-bbox="507 1142 1018 1182">Cracked and drummy wall tiles.</p>

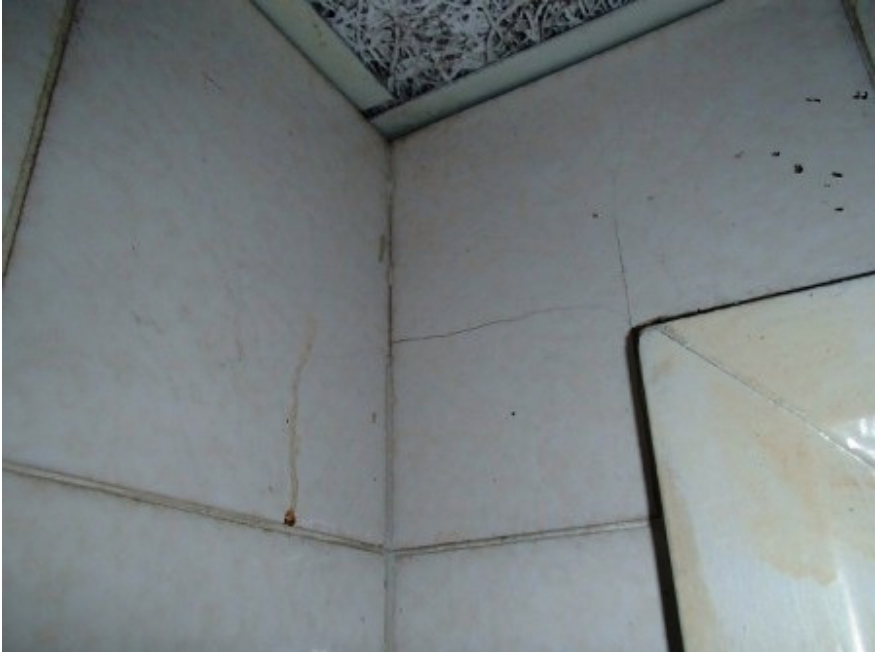
Location	Zone	Details
Interior	Rear toilet	<p data-bbox="507 365 1018 405">Cracked and drummy wall tiles.</p>

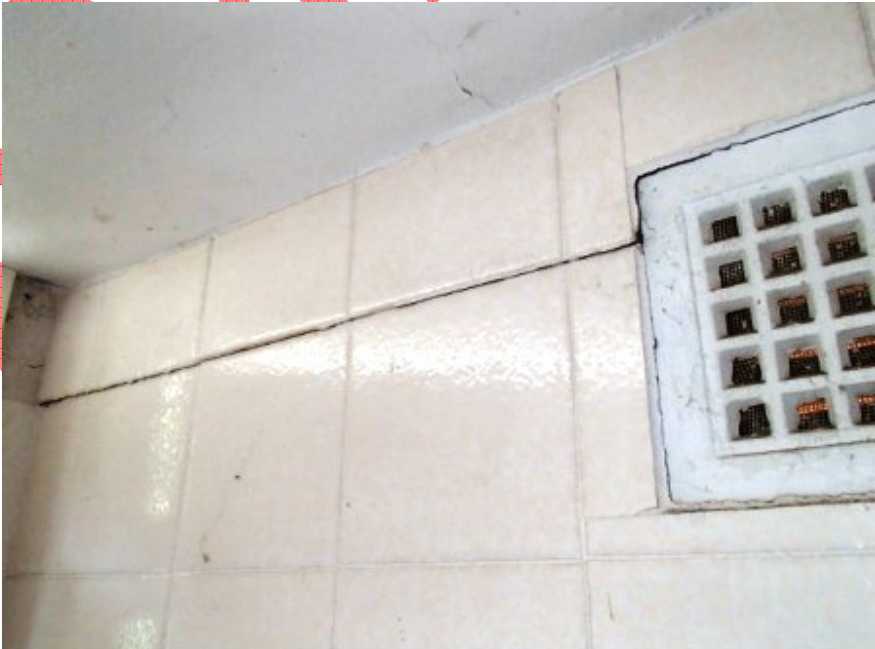
Interior	Laundry	<p data-bbox="507 1099 1018 1140">Cracked and drummy wall tiles.</p>

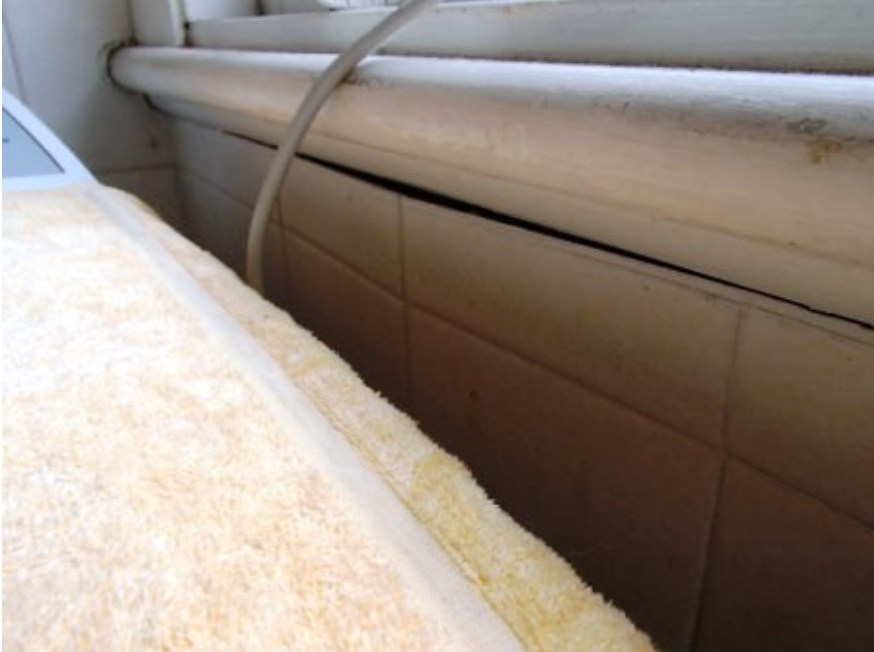
Location	Zone	Details
Interior	Laundry	<p data-bbox="507 365 1123 405">Cracked, loose and drummy wall tiles.</p>

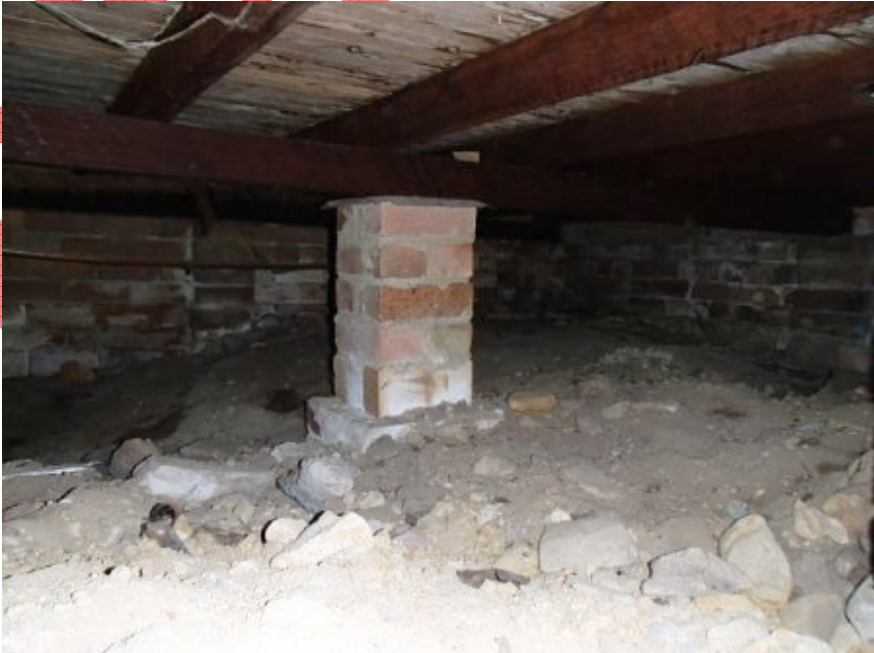
Interior	Kitchen sub-floor	<p data-bbox="507 1142 1348 1182">Minor subsidence to the brick pier below the kitchen</p>

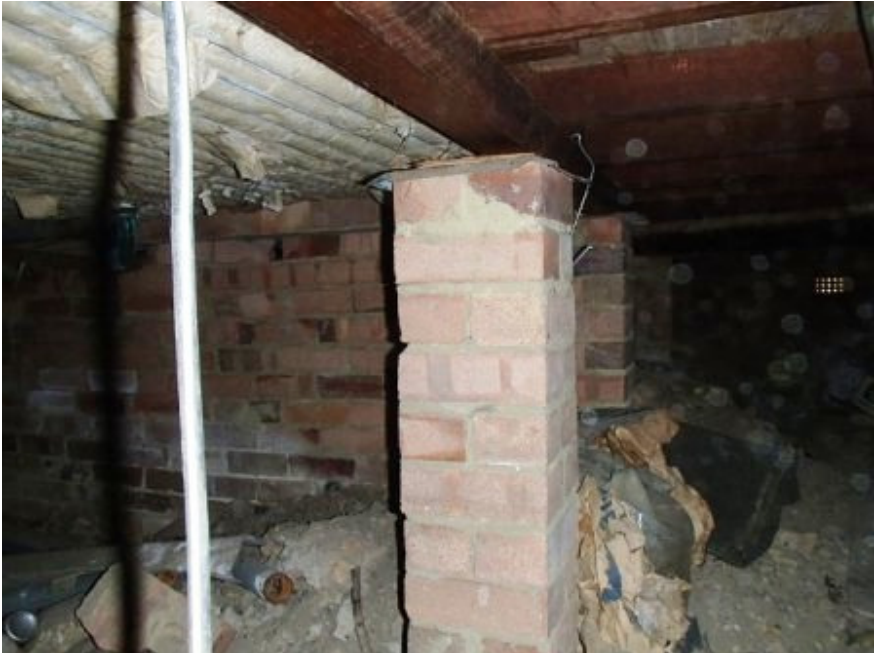
Location	Zone	Details
Interior	Bathroom / hallway sub-floor	<p>Minor subsidence to the brick pier.</p>

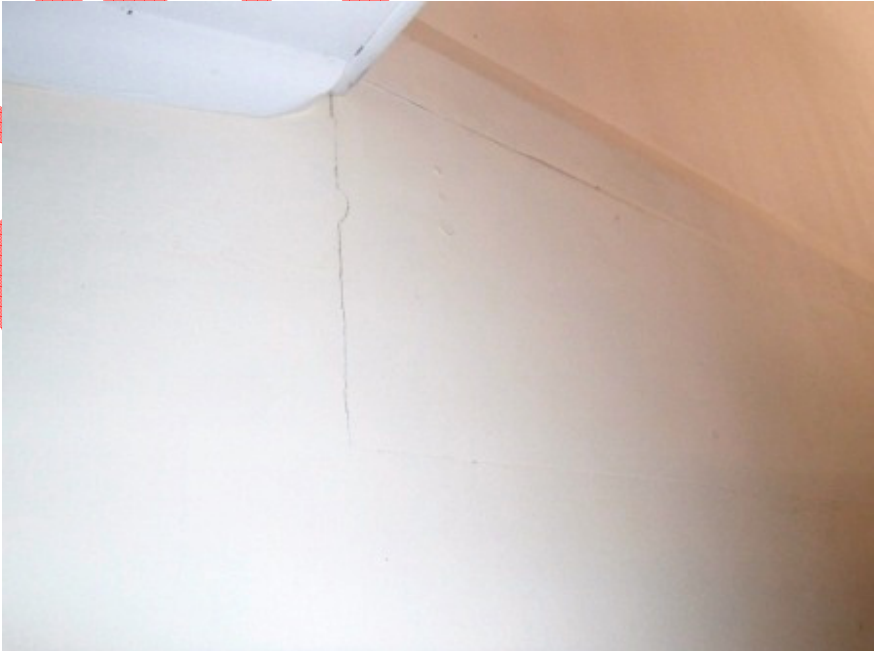
Interior	Stairwell	<p>Minor cracks were noted to the internal walls. These cracks have been caused by movement and settlement.</p>

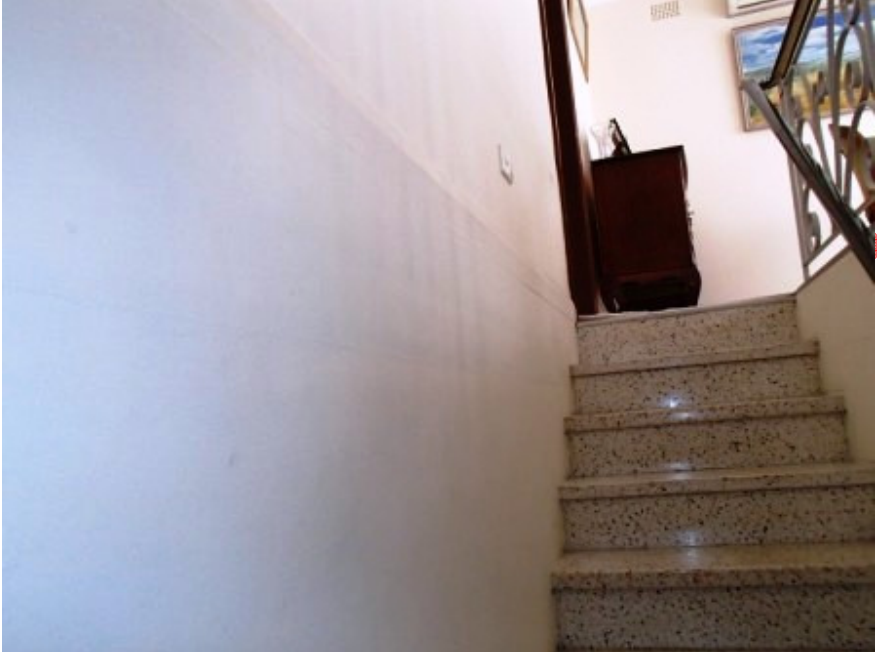
Location	Zone	Details
Interior	Stairwell	<p data-bbox="507 365 1481 448">Minor cracks were noted to the internal walls. These cracks have been caused by movement and settlement.</p>

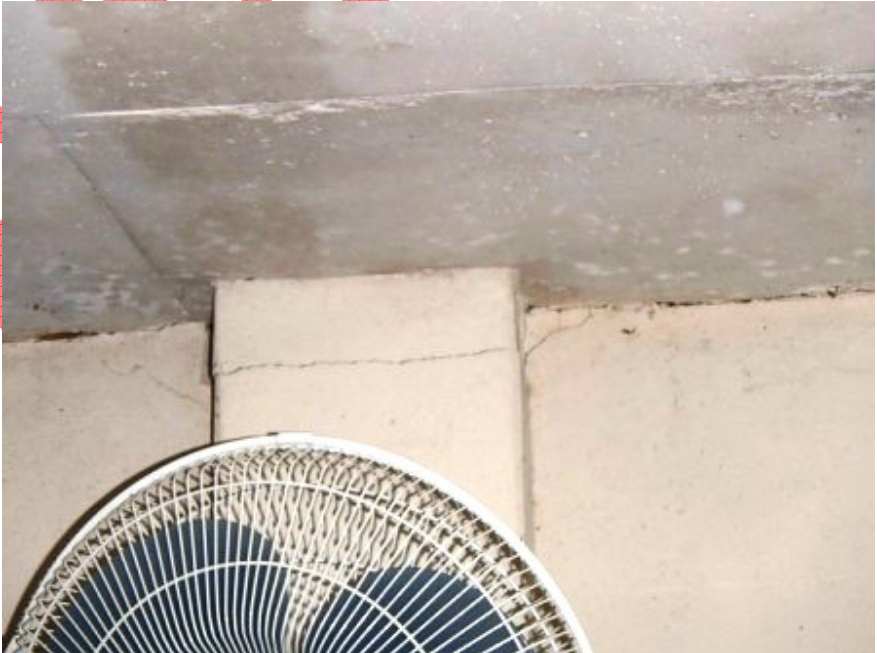
Interior	Garage	<p data-bbox="507 1142 925 1182">Cracking to the brick wall.</p>

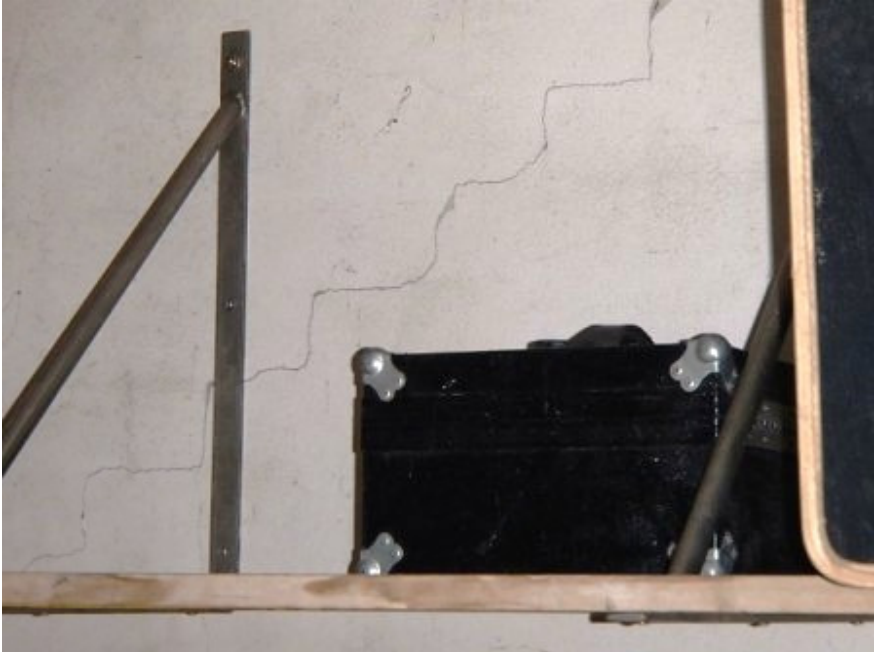
Location	Zone	Details
Interior	Garage	<p data-bbox="507 365 1305 405">Cracking to the brick wall above the garage door.</p>

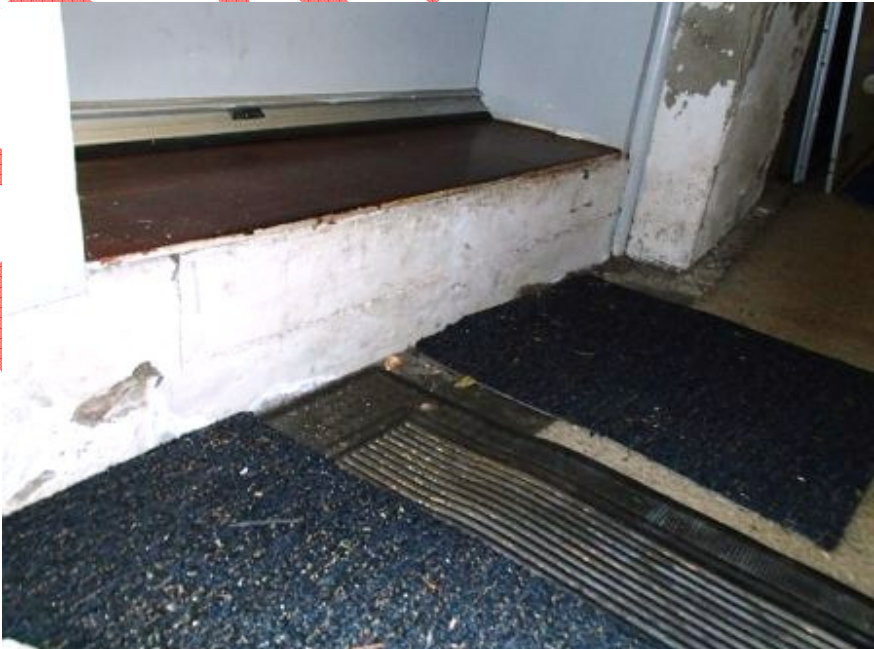
A photograph showing a close-up of a brick wall above a garage door. A prominent vertical crack runs down the wall, with several smaller horizontal and diagonal cracks branching off. A metal support beam is visible on the left, and a black metal component of the garage door mechanism is on the right.
Interior	Garage	<p data-bbox="507 1099 1054 1140">Moisture damage to garage walls.</p>
