Service Bulletin

Subject: Water Leak in Rear Compartment/Trunk – Convertible Top Water Management Bag Repair or Replacement

Models: 2011-2015 Chevrolet Camaro Convertible

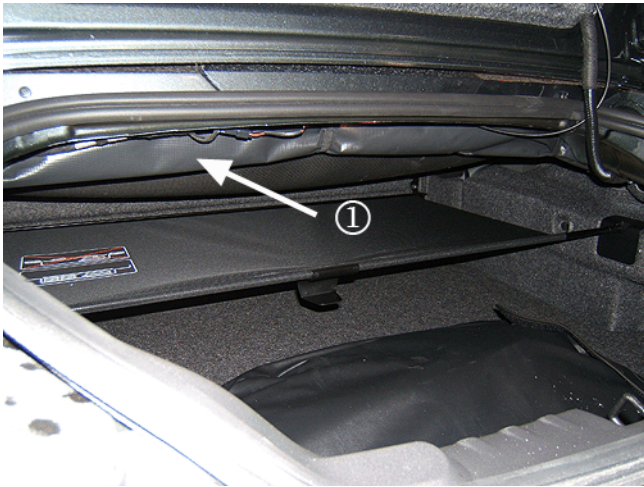
Some customers may comment on finding water in the trunk of the vehicle.

After water testing and visual inspection, the technician may find that the convertible top water management bag (1) is leaking due to a puncture or tear in the material. Aside from obvious holes/tears, the following locations should be closely inspected as potential leak areas:

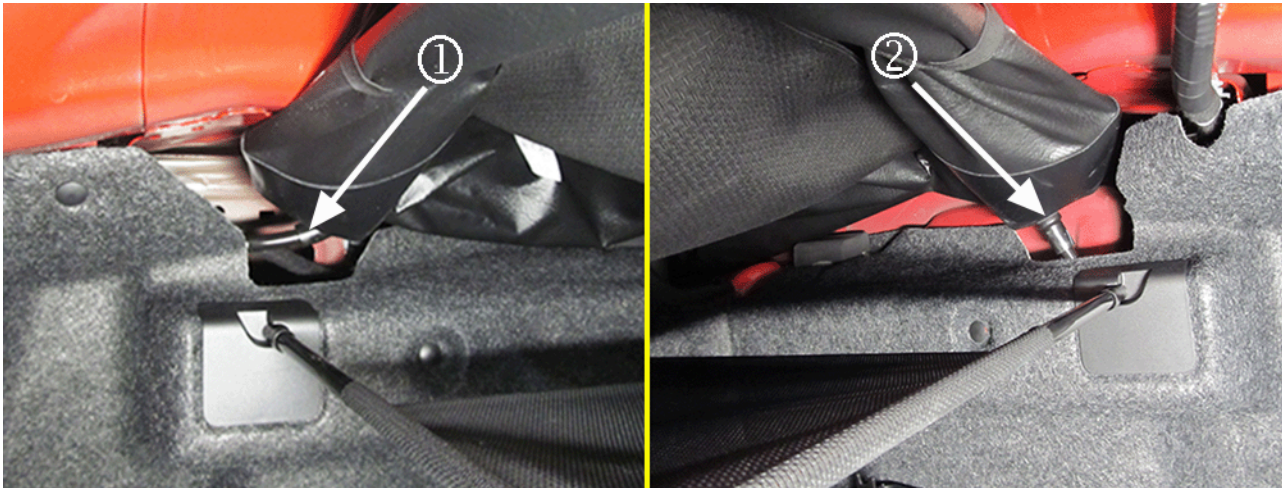
Open the trunk and inspect either side of the inner compartment trim opening for evidence of a drain hose. The left (1) and right side (2) hoses are shown in the graphic above.

- If a drain tube is NOT evident, the bag is the first design 4 drain bag and should NOT be repaired. Replace the bag with the second design 6 drain bag noted in the part table below. Refer to Folding Top Quarter Outer Drain Panel Replacement in SI.
- If the drain hose IS evident, continue ahead and complete the Water Management Bag Repair Procedure.
