Cal Pacific Airmotive, Inc. **Mandatory Service** Revision: 0 **Bulletin Title:** Inspection of Flight Control System

North American Aviation P-51B, P-51C, P-51D, P-51K, F-51D, F-51K S.B. No. P51-001

Issue Date 5-1-2013 Page 1 of 8

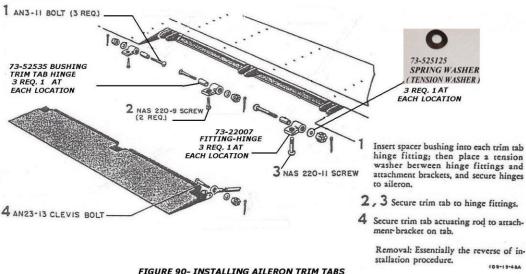
FIGURE 90- INSTALLING AILERON TRIM TABS
REF. MAINTENANCE INSTRUCTIONS PAGE 84 AN 01-60-JE2

Supplement No. 1 to Service Bulletin P51-001 dated May 1, 2013 is to correct information contained in AN 01-60JE-2 Handbook Maintenance Instructions USAF Series F-51D, ZF-51K, F-51M, TF-51D dated December 20, 1944, revised December 20, 1952. Handbook page 84 figure 90 "Installing Aileron Trim Tab" incorrectly notes P/N NAS220-9 and NAS220-11 (8-32 thread structural screws) to be installed in spline nut P/N 22D8-02 (or 22ND8-02) 10-32 thread. This spline nut is installed in each of the trim tab hinge fittings P/N 73-22007.

This Handbook is FAA approved for use in the Limited Type Certificate LTC-11-5 and is also reference for P-51D thru P-51K aircraft. A copy of figure 90 was included in Service Bulletin P51-001, dated May 1, 2013 page 7.

- 1. Refer to Parts Catalog AN 01-60JE-4 USAF Series F-51D, TF-51D and F-51K Aircraft dated March 10, 1945, revised May 15, 1953, page 20D figure 4B "Aileron Assembly" index no. 33 to install the correct part number structural screw NAS221 series (10-32 thread). This parts catalog is also reference for the P-51D thru P-51K aircraft. Length of screw may vary from those published in the North American Aviation & USAF maintenance and parts manuals if trim tab is original, rebuilt, phenolic or metal covered.
- 2. When installing structural screws to secure the trim tab to the hinge fitting P/N 73-22007, make sure the screw shank does not bottom in the threads of the spline nut and at least one full thread extends through the locking nut insert.
