Case Studies in Engineering Failure Analysis

Investigation on brittle fracture mechanism of a grade E cast steel knuckle

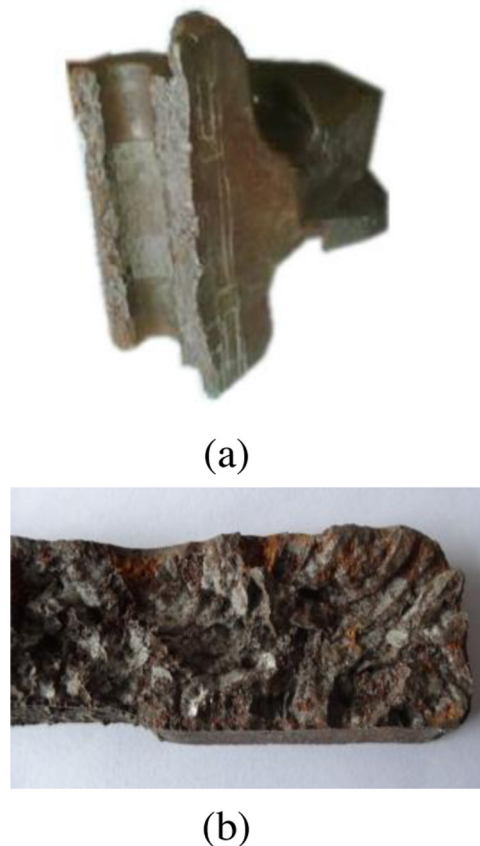
Fig. 1. Photographs of failed knuckle (a); the fracture surface of the knuckle (b).

The failed knuckle used in present investigation, as shown in Fig. 1a, came from a railway wagon that was used to transport iron ore in an iron mine in Australia. The fracture of this knuckle occurred at the fifteenth day of its service. Its fracture view is demonstrated in Fig. 1b and appears a characteristic of brittle fracture. This knuckle was cast in green sand mold with grade E cast steel. During heat treatment process, it was firstly normalized at 900–920 °C for 3.5–4 h and cooled in the air, then heated up to 870–880 °C and holding time was 3–3.5 h, quenched in water, and finally followed by tempering of 510–550 °C for 3.5–4 h and cooled in water again. The microstructure of the knuckle after heat treatment is tempered sorbite. Tables 1 and 2 summed the chemical compositions and mechanical properties of Keel block of the knuckle and corresponding to the standard values of AAR-M201 grade E cast steel. It can be seen that

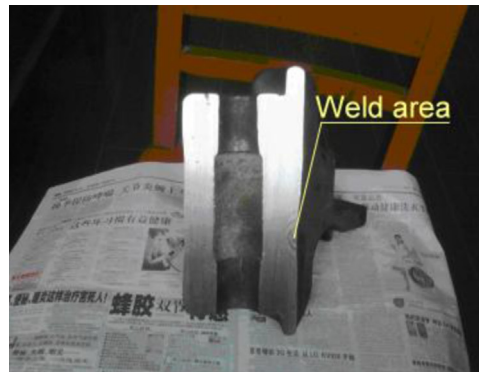
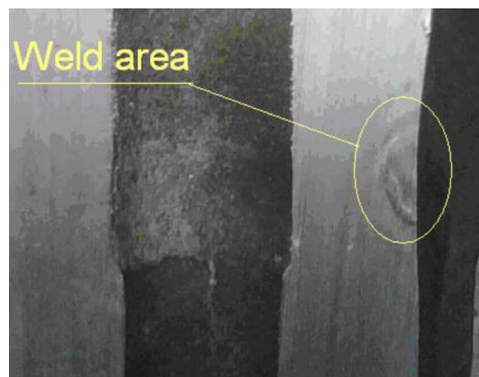
Fig. 4. A weld area located on the sectioned surface of the failed knuckle (a); an enlarge view of the weld area (b).

In addition, a welding repair area with high hardness is found in the fracture region of the failed knuckle.

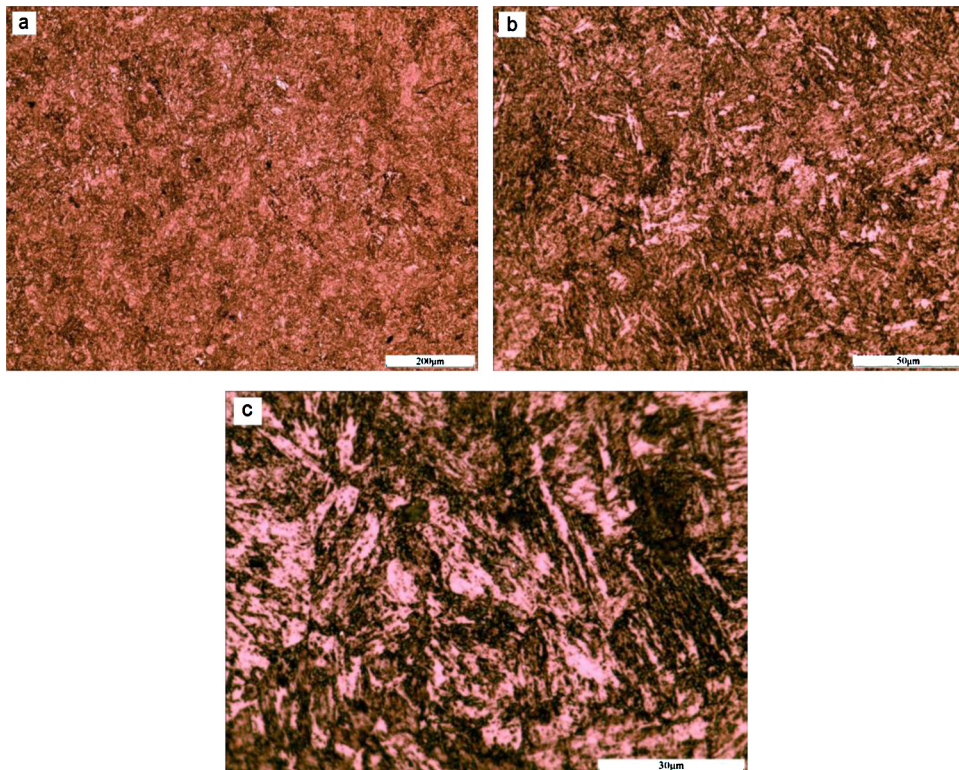
Fig. 5 is the metallographic photos adjacent to the fracture surface of the failed knuckle. It can be seen that the microstructure of the knuckle mainly consists of tempered sorbite. However, the undissolved ferrite phase (the white areas in the metallographic photos) and coarse crystal grains are also found in these photos. This means that the knuckle's metallic matrix was not austenitized completely before quenching during heat treatment, which also resulted in the poor mechanical properties.

Fig. 5. Metallographic photos of the failed knuckle entity, (a) 100 \times , (b) 500 \times , (c) 1000 \times .

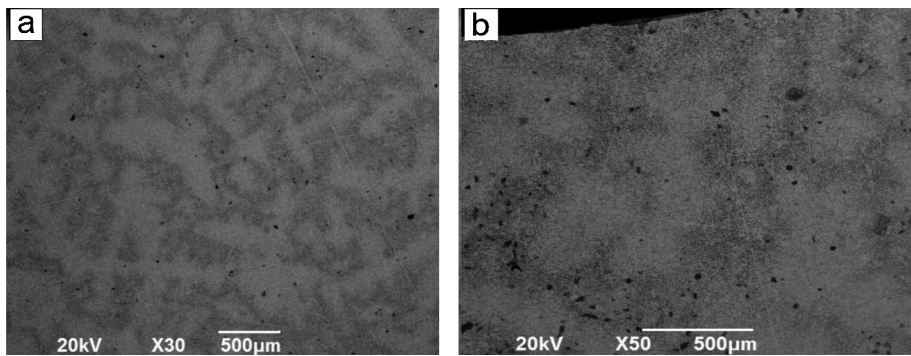
Fig. 6. SEM images of solidification microstructure adjacent to the fracture surface of the failed knuckle: (a) specimen A; (b) specimen E.

Fig. 6 is the SEM images of the solidification microstructure in the specimens A and E. It can be clearly identified that the solidification microstructure of the failed knuckle primarily consists of developed coarse dendrites (light gray areas in Fig. 6a–b). The diameter and length of their primary dendrite can reach 0.3 mm and 1 mm, respectively. Furthermore, large amounts of shrinkage porosity in interdendritic regions can be observed (dark gray and black spot areas in Fig. 6a–b), which have separated the metallic matrix and resulted in a decreasing in the mechanical properties.

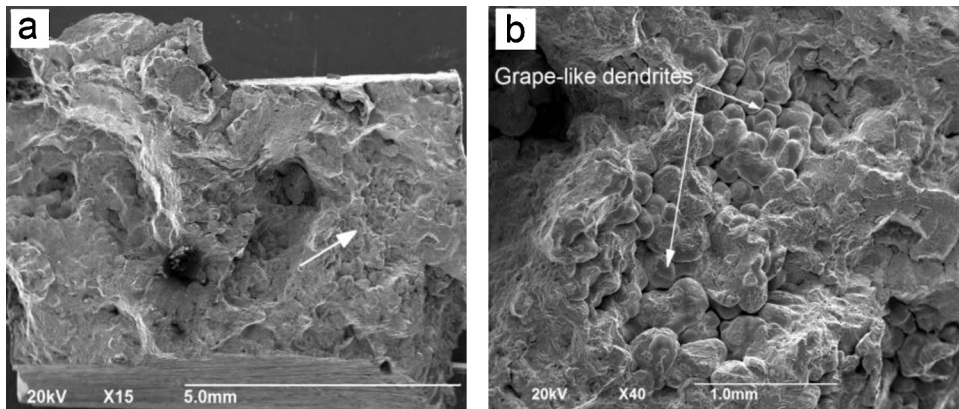
Figs. 8–10 are SEM images of the fresh fracture morphology of specimens D, C and E, respectively. From the SEM images, it can be found that the solidification microstructure of the failed knuckle mainly consists of developed dendrites. Fig. 8b is a local enlarged view in Fig. 8a (indicated by arrow), where the dendrites look like grape clusters and there are large amounts of shrinkage porosity in interdendritic regions. The specimens were fractured along the free surfaces of the dendrites and gaps between dendrites. Fig. 9b and c are the SEM images of two local enlarged views of the fracture surfaces of dendrites in Fig. 9a (indicated by arrows 1 and 2, respectively), in where the tearing ridges, dimples and micro-void structures with ductile fracture features can be observed. Obviously, the fracture of the dendrites in the metallic matrix belongs to ductile fracture.

Fig. 8. SEM images of the fresh fracture surfaces of specimen D (a); a local enlarged view at a region indicated by arrow in (a), (b).

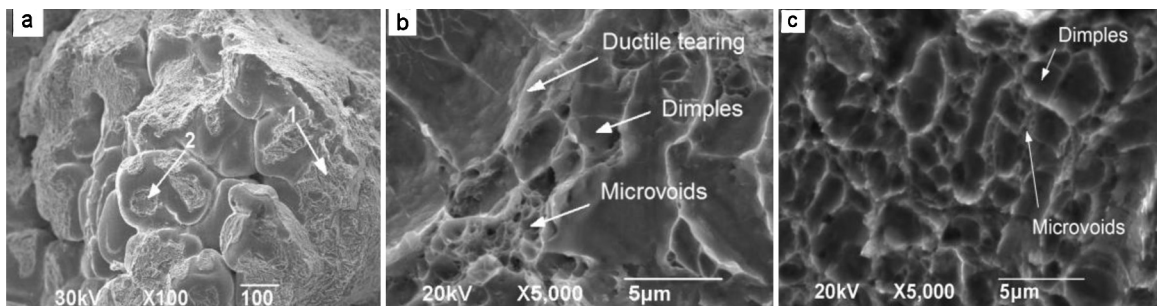
Fig. 9. SEM image of the fresh fracture surface of specimen C (a); the local enlarged views of the fracture surfaces of the dendrites at the regions indicated by arrows 1 and 2 in (a), (b) and (c), respectively.

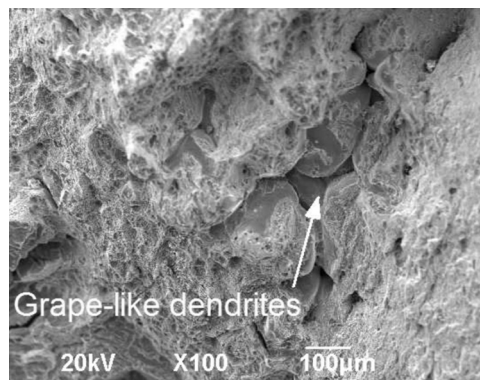
Fig. 10. SEM image of the fresh fracture surface of specimen E.

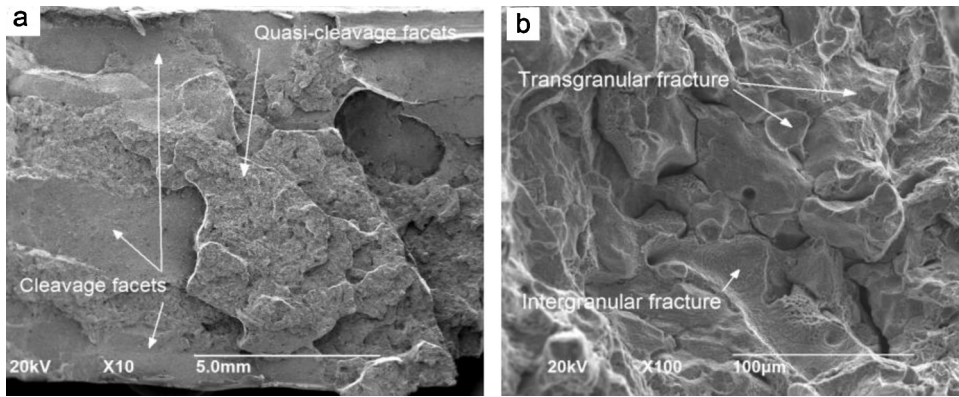
The original fracture surface is the failed knuckle's fracture surface formed in wagons running accident. Figs. 11–13 are the SEM images of original fracture surfaces of the specimens F, B and G. Fig. 11a shows the fracture appearance with cleavage and quasi-cleavage facet features, which can be ascribed to brittle fracture. Fig. 11b, a local enlarged view in Fig. 11a (indicated by arrow1), clearly displays trans-granular and inter-granular fracture surfaces. However, Fig. 12a demonstrates the dendritic structure feature. Fig. 12b is a local enlarged image in Fig. 12a. It reveals that the part microstructure of the

Fig. 11. SEM image of original fracture surface of specimen F (a); a local enlarged view in (a), (b).

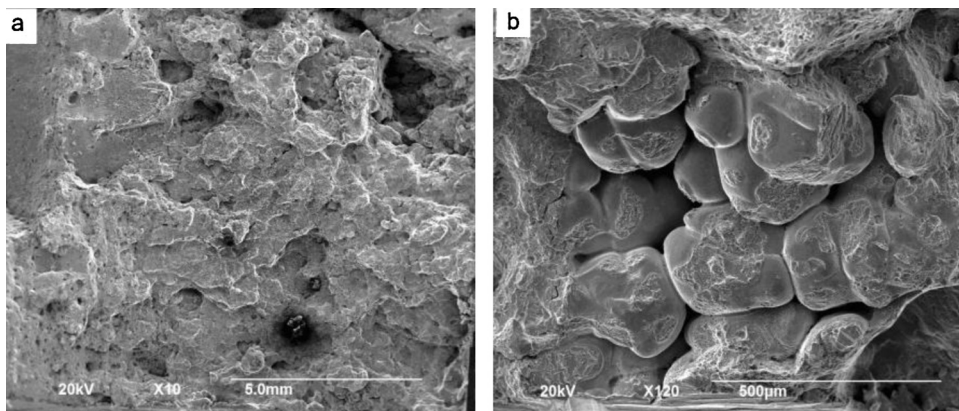
metallic matrix consists of developed coarse dendrites with grape clusters shape and shrinkage porosities. Fig. 13 exhibits the quasi-cleavage fracture surfaces with less “river” and tearing ridge patterns. As a result, it can be identified that failure of the knuckle can be ascribed to the mixed type fracture with the features of cleavage and quasi-cleavage of brittle fracture and less ductile fracture.

Fig. 12. SEM image of original fracture surface of specimen B (a); a local enlarged view in (a), (b).

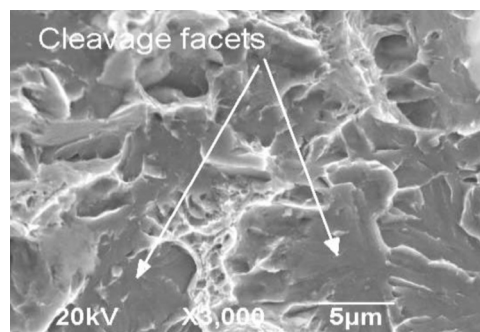
Fig. 13. SEM image of original fracture surface of specimen G.

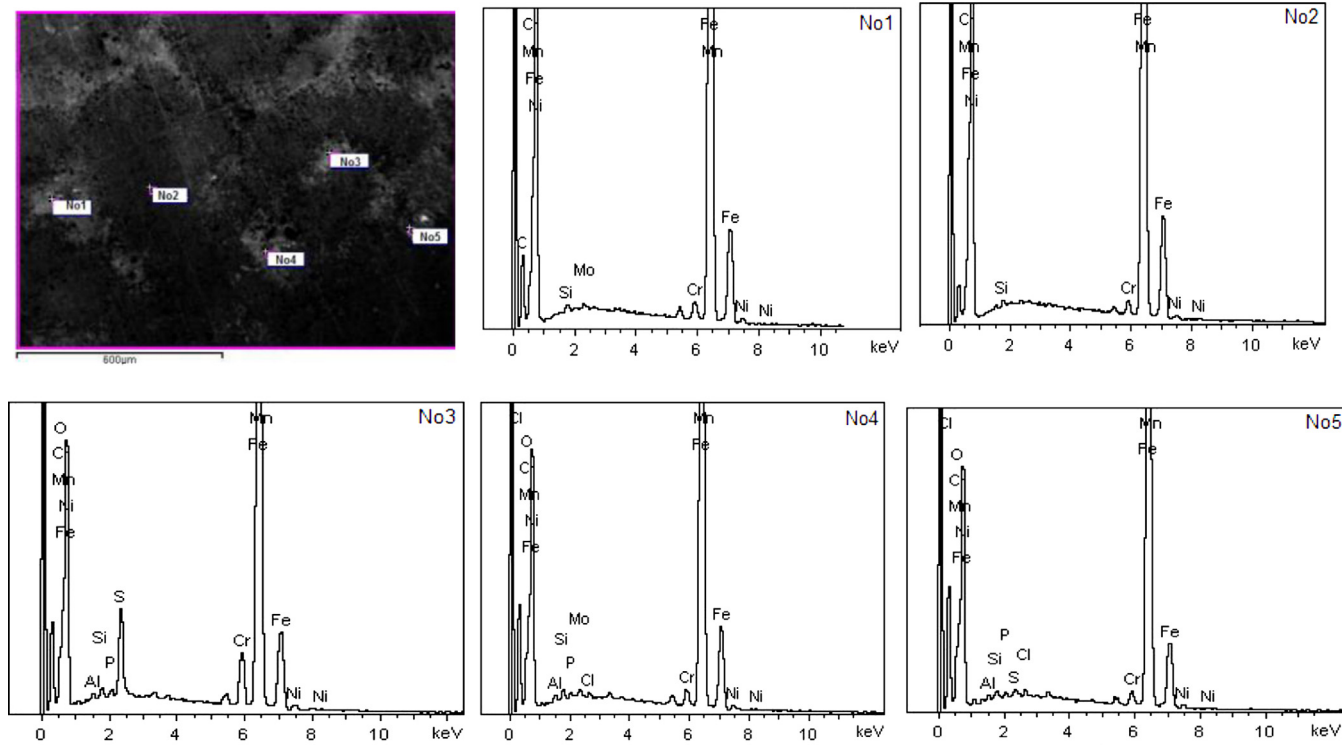
and 0.018 wt%, respectively, which would not affect the knuckle's mechanical properties. But the level of aluminum reaches up to 0.088 wt%, which may lead to the formation of AlN hardness phase. Therefore, it is important to detect non-metallic inclusions or harmful elements in the fracture region of the failed knuckle. Fig. 14 shows the SEM image of specimen A with the detecting spots for EDS and the EDS spectra corresponding to each detecting spot (indicated by labels). In this image, the developed coarse dendrites (black-gray regions) as well as shrinkage porosity (gray-white regions and black spots) are clearly observed. The EDS spectra reveals that sulphur, phosphorus and aluminum as well as oxygen elements existed in interdendritic regions, whereas nothing of these elements is observed in the interior of dendrites. Therefore, a reasonable speculation is that the non-metallic inclusions such as manganese sulfide, silicate, alumina, phosphide existed in the interdendritic regions. Obviously, due to the existence of shrinkage porosity, fracture resistance behavior of the knuckle would be less affected by these non-metallic inclusions.

Fig. 14. SEM image of specimen A with detecting spots of EDS and EDS spectra corresponding to detecting spots (indicated by labels).
