Case Study of the Performance of Prestressed Concrete Buildings During the 1985 Mexico Earthquake

The overall effects of the 1985 Mexico earthquake on buildings are summarized, with specific consideration of the performance of prestressed concrete buildings. Then, for five typical prestressed concrete buildings, results of analyses of the dynamic response, with due consideration of the soil-structure interaction, are presented. In general, the computed response of the buildings under the effect of a ground motion simulating the 1985 earthquake, corresponded reasonably well with their observed performance. Nevertheless, in some cases the analyses indicated that the buildings should have experienced a greater nonlinear behavior than the ones perceived from their level of damage. Some reasons for these differences are discussed. Recommendations on earthquake-resistant design of prestressed concrete buildings are given. The importance of providing lateral stiffness by shear walls or bracing, and of achieving ductility and continuity through mild steel reinforcement, is emphasized.

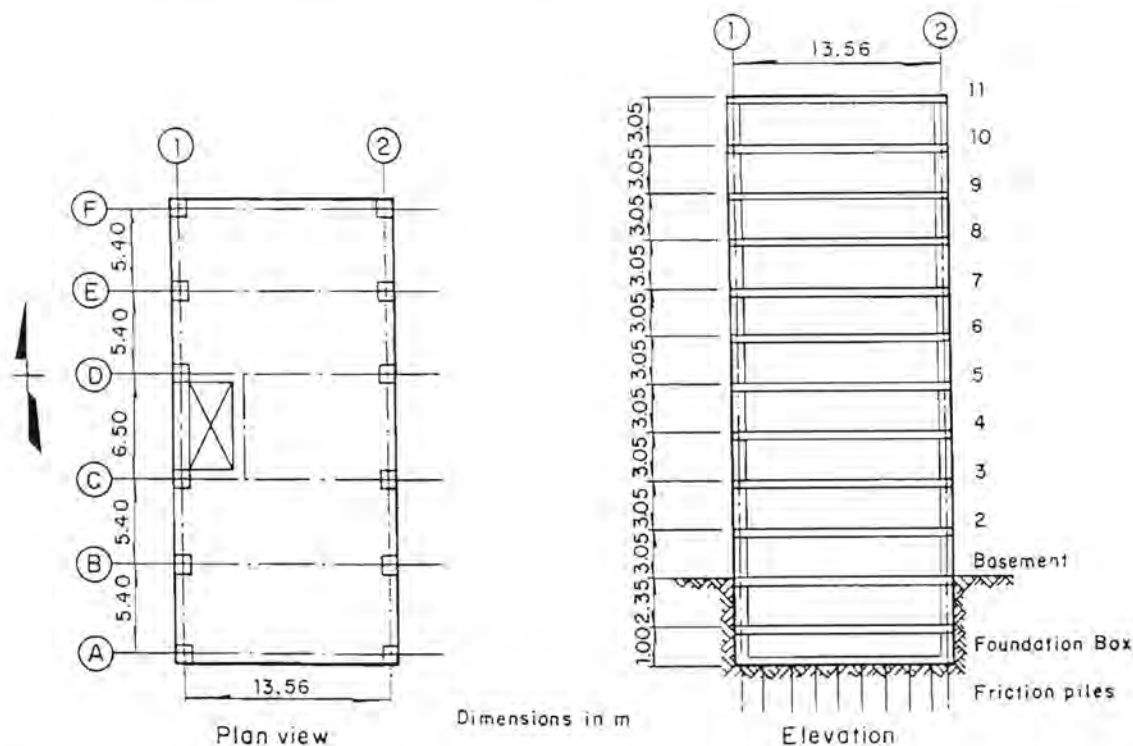
Fig. 7. Plan and elevation of the QRO Building.

An inspection of the building after the earthquake revealed extensive cracking in the masonry walls around the elevator shaft and distortion and falling of some ceiling panels. No

cracks were found in the main structural members. The building showed a significant tilting in its short direction (corresponding to about 2 percent of the building height).

It cannot be excluded that some tilting already existed before the earthquake, although it had not been noticed by the tenants. It is assumed that overturning moments, caused by the lateral forces, produced compressive forces on the piles in excess of those that could be transmitted through friction to the soil. Settlement and non-symmetrical vibration of the building were then generated.

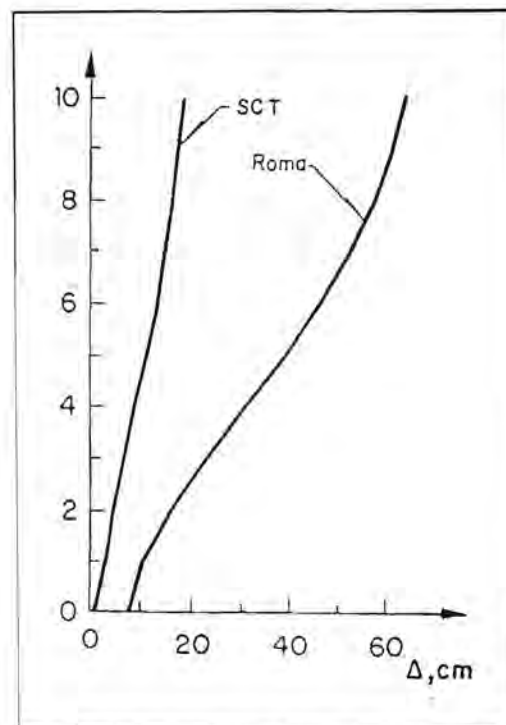
Fig. 10. Maximum lateral displacements using linear analysis for the QRO Building.

cent for the ROMA record. Lateral displacements of this order of magnitude should have caused significant structural damage.

From the analysis, it is apparent that the observed response did not correspond to that predicted, since the lack of structural damage indicates that the structure remained linearly elastic. It cannot be excluded that some cracks formed during the vibration and then closed, leaving no visible evidence; nevertheless, strains in the steel and concrete could not reach the values indicated by the analysis.

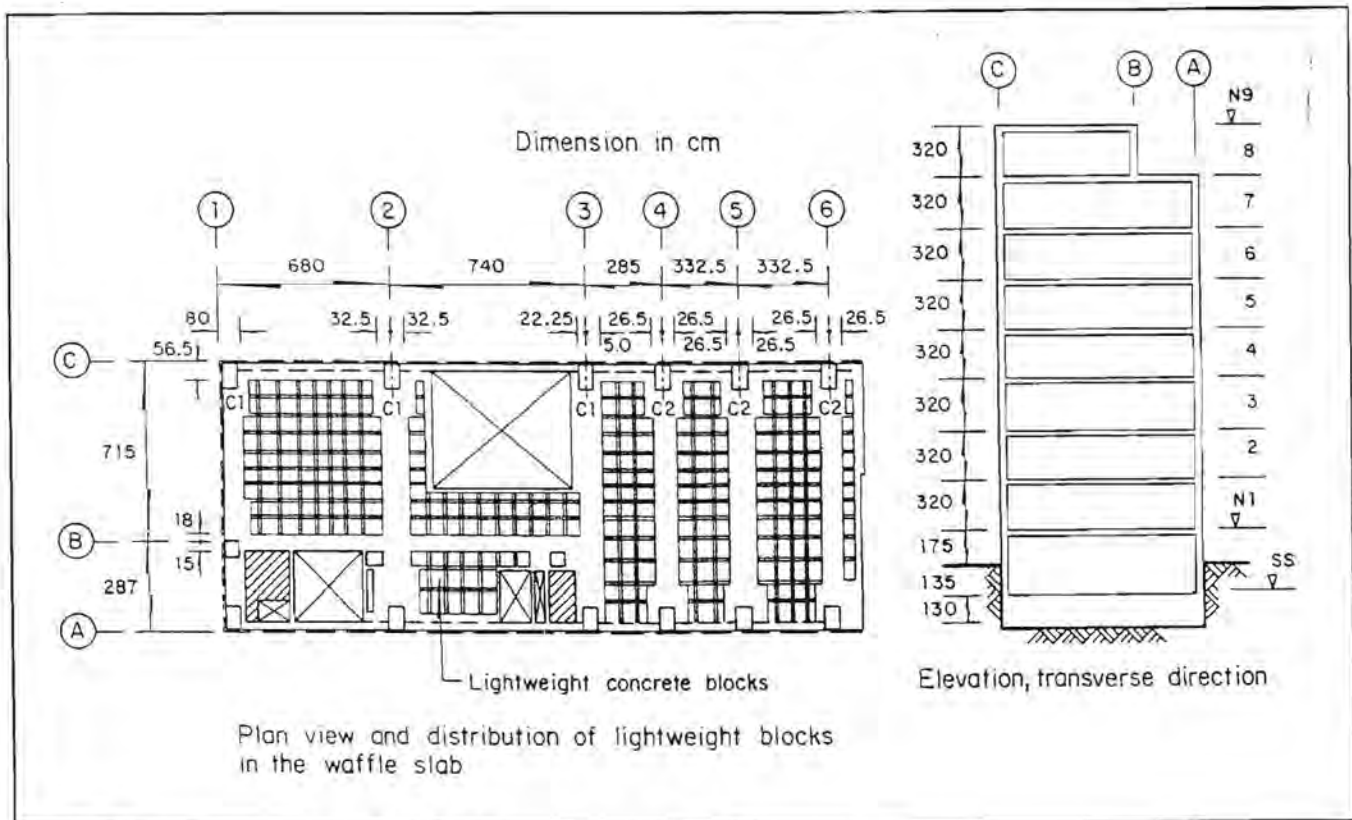
Fig. 13. Plan and elevation of the TAM Building.

damage was found when the building was inspected. Tenants mentioned that large lateral displacements were felt and that light non-structural damage was caused by the earthquake.

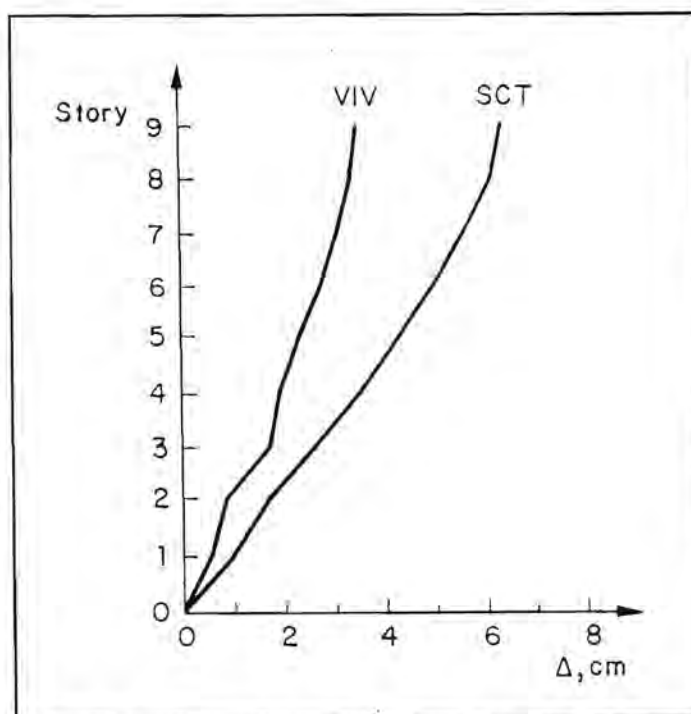
Fig. 15. Maximum lateral-displacements in the TAM Building.

Since the building was located at the boundary of the lake zone, it was analyzed both for the effect of the SCT and VIV ground motions. Maximum lateral displacements are shown in Fig. 15. For the SCT records, interstory drifts in some stories reached values that are commonly associated with structural damage. Bending moments in the beams at column faces exceeded resisting values.
