Causes and Repair of Deterioration to a California Bridge Due to Corrosion of Reinforcing Steel in a Marine Environment

I. Method of Repair

**M. W. GEWERTZ, Senior Bridge Engineer
California Division of Highways**

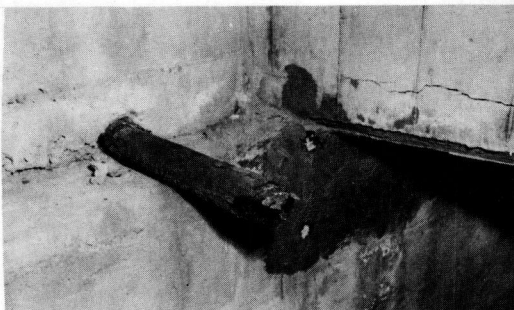
Figure 2. Typical condition of open cracks in beams. Projecting member is an iron pipe sleeve installed through end diaphragm during construction and now completely disintegrated.

The pattern of corrosion as exposed does not appear to have resulted from corrosion or mill scale which might have existed on the reinforcement at the time of pouring the original concrete. The typical condition of open cracks adjacent to a beam end is shown in Figure 2. The projecting member in this view is an iron pipe sleeve installed through the end diaphragm during construction and now completely disintegrated by corrosion, demonstrating the severe effect of atmospheric exposure at the structure site.

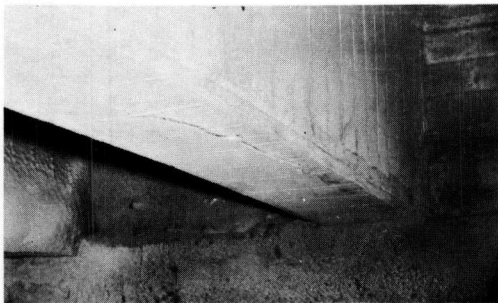
Figure 3 shows typical cracking of a beam bottom, where longitudinal cracks generally appear on the side of the member in or near the plane of the lower main reinforcement (about 3 in. above the bottom of the member), or along the bottom surface, or in both locations. Figure 4 shows the similar condition in a cap, with the cracks lying generally in or near the plane of the lower reinforcement. Figure 5 shows typical cracking along the corner of a pile.

Figure 3. Typical cracks in beam. Note crack in soffit and crack in side of beam in plane of lower reinforcement.

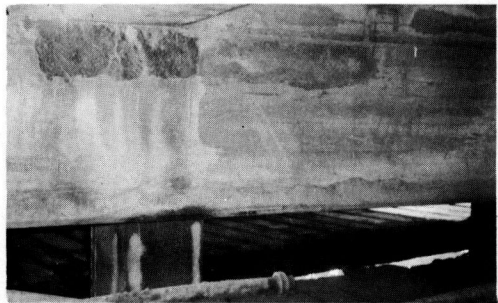
Figure 4. Typical crack in side of pile cap in plane of bottom reinforcement.

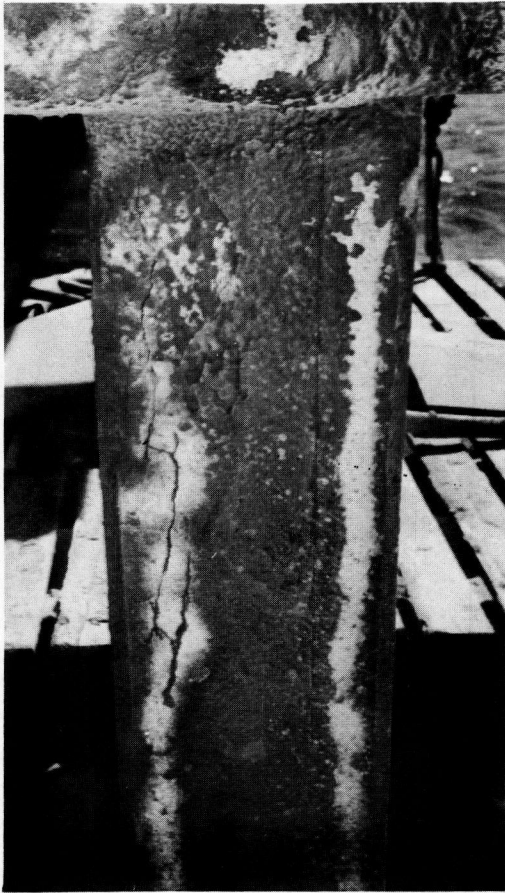
Figure 5. Typical crack along corner of pile. White areas on pile have had asphaltic coating sandblasted off to disclose possible cracks hidden by coating.

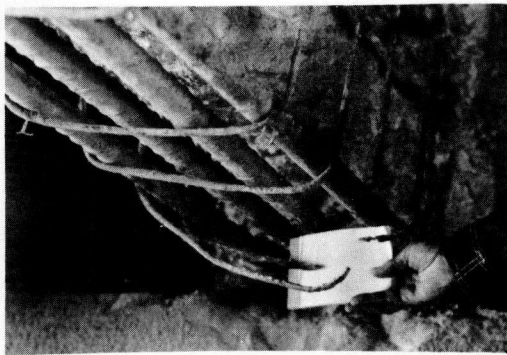
Figure 7. Tapered ends of severed $3/8$ -in. round stirrups show almost 100 percent loss of cross-section.

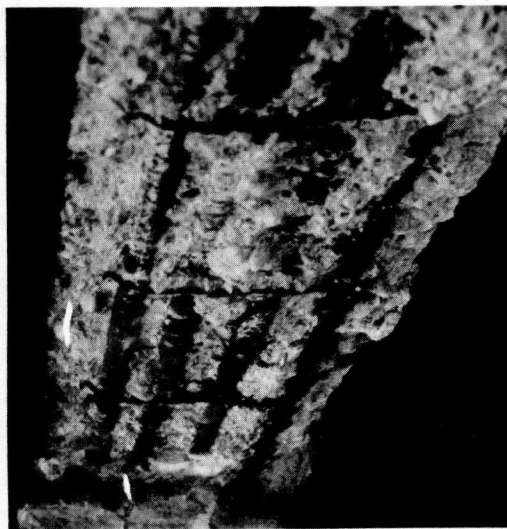
Figure 8. Area where deterioration has advanced to such degree as to spall off a considerable portion of the beam bottom.
