State of Nevada
Department of Conservation & Natural Resources
Department of Wildlife
CNR / Wildlife Offices
Facility Condition Analysis

CNR / WILDLIFE OFFICES LAS VEGAS

4747 Vegas Drive
Las Vegas, Nevada 89108

Site Number: 9878
STATE OF NEVADA PUBLIC WORKS DIVISION
FACILITY CONDITION ANALYSIS

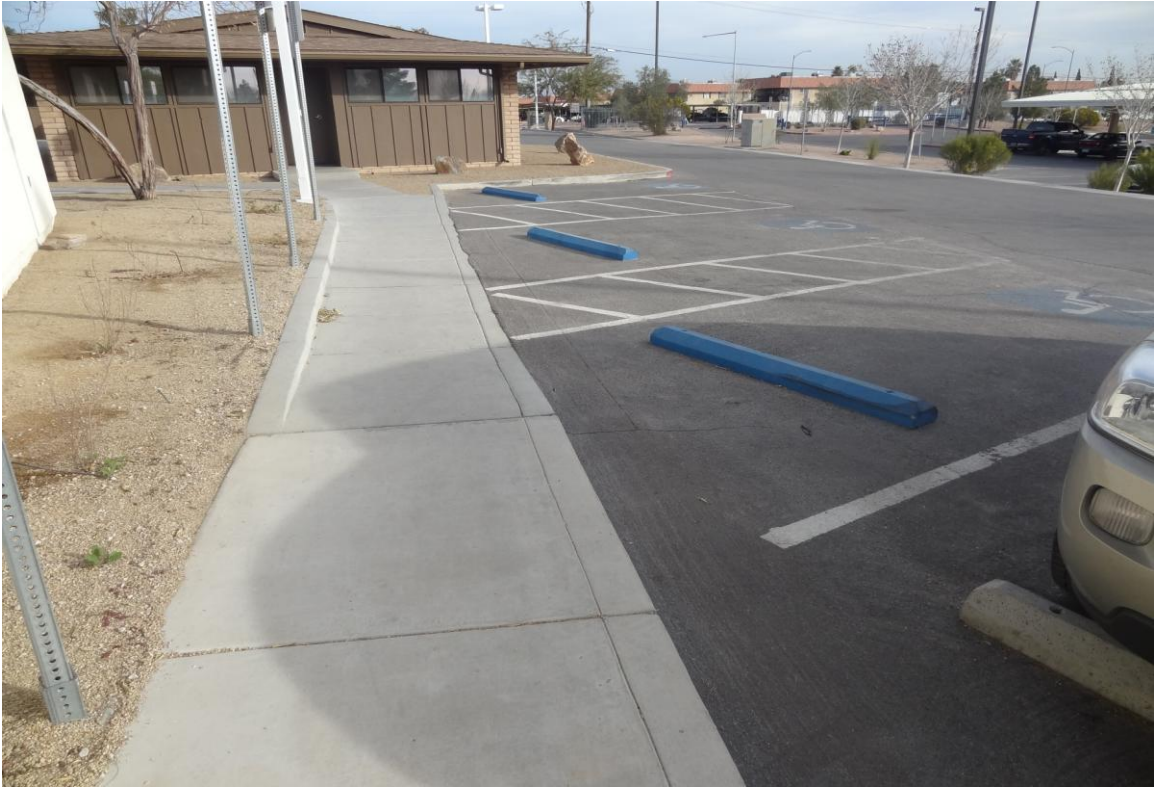
CNR / Wildlife Offices Las Vegas Site – FCA Site #9878
Description: ADA accessible parking.

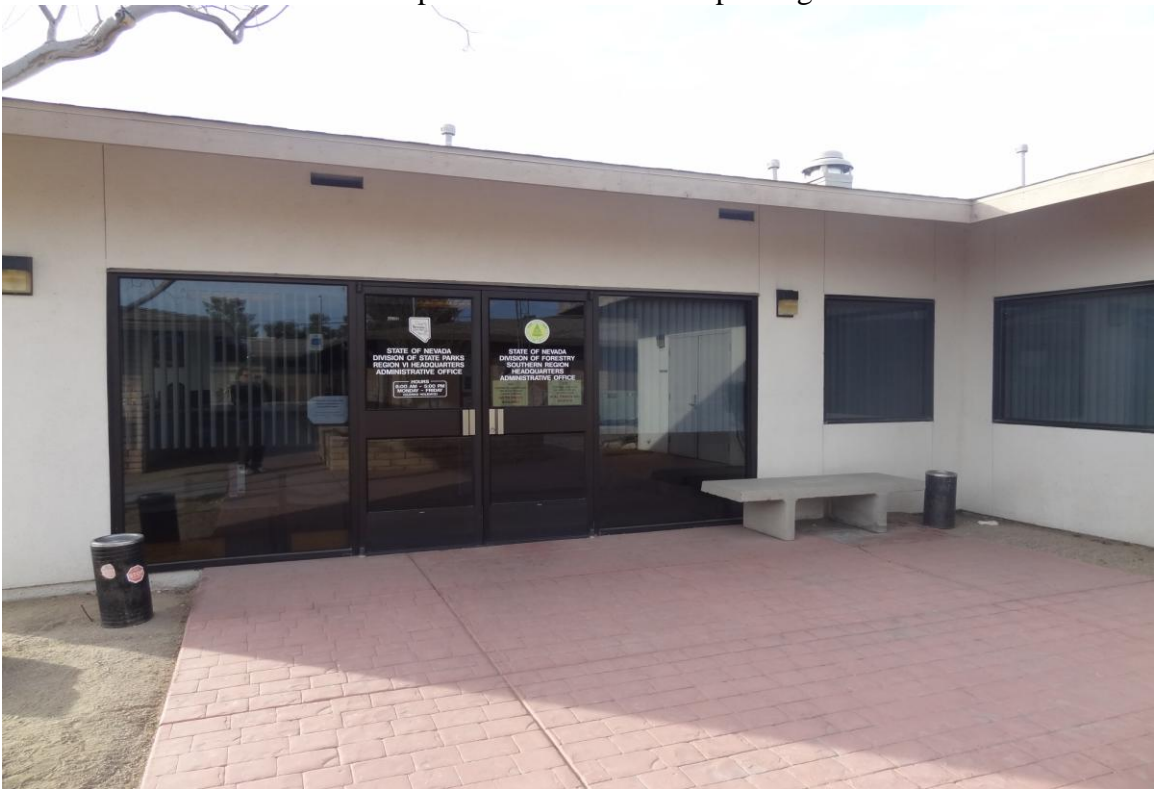
NDF / State Parks Office Building – FCA Building #2033
Description: Exterior of the building / public entrance.

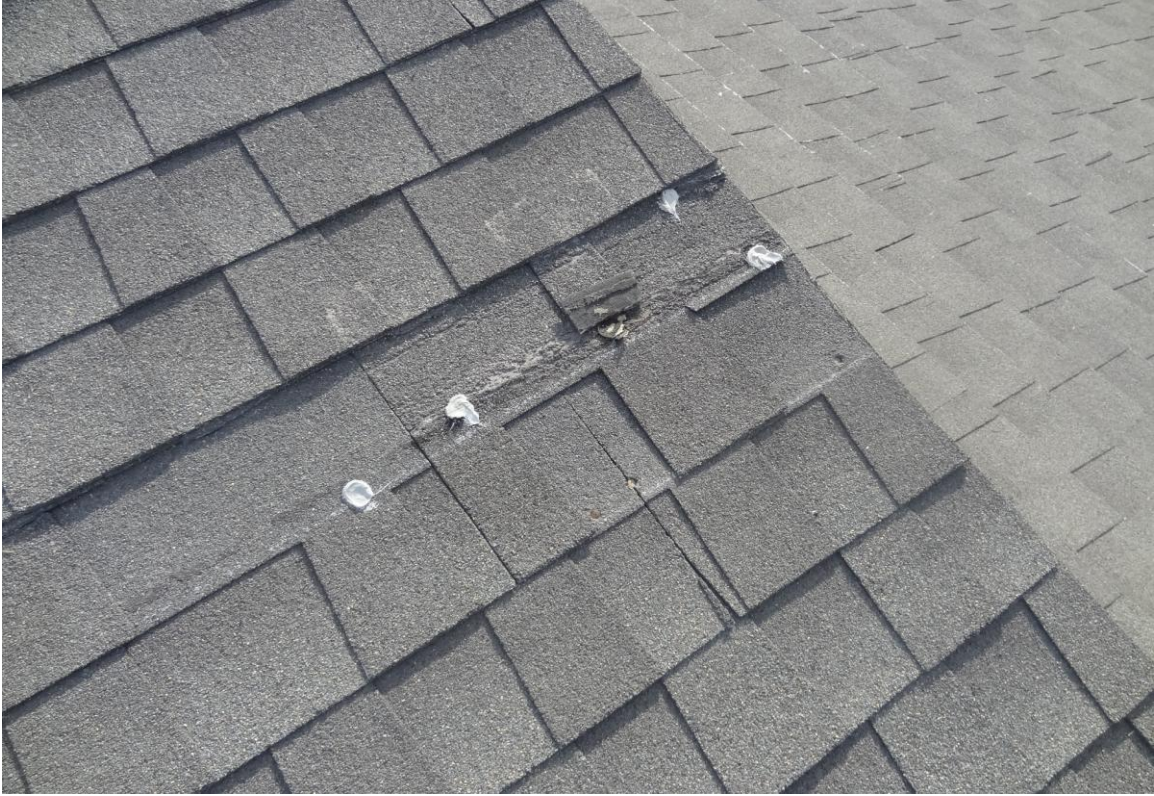
The asphalt composition shingle roof on this building was in poor condition at the time of the survey. Repairs have been made recently as shingles have broken or blown off in the wind. The wood eaves have lost their finish and the wood has dried out. It is recommended that this building be re-roofed in the next 2-3 years with a new 50 year asphalt composition roofing shingle and new underlayments. Additional costs are provided to replace the wood eaves. This estimate includes removal and disposal of the old roofing.

NDF / State Parks Office Building – FCA Building #2033
Description: Damaged shingles.

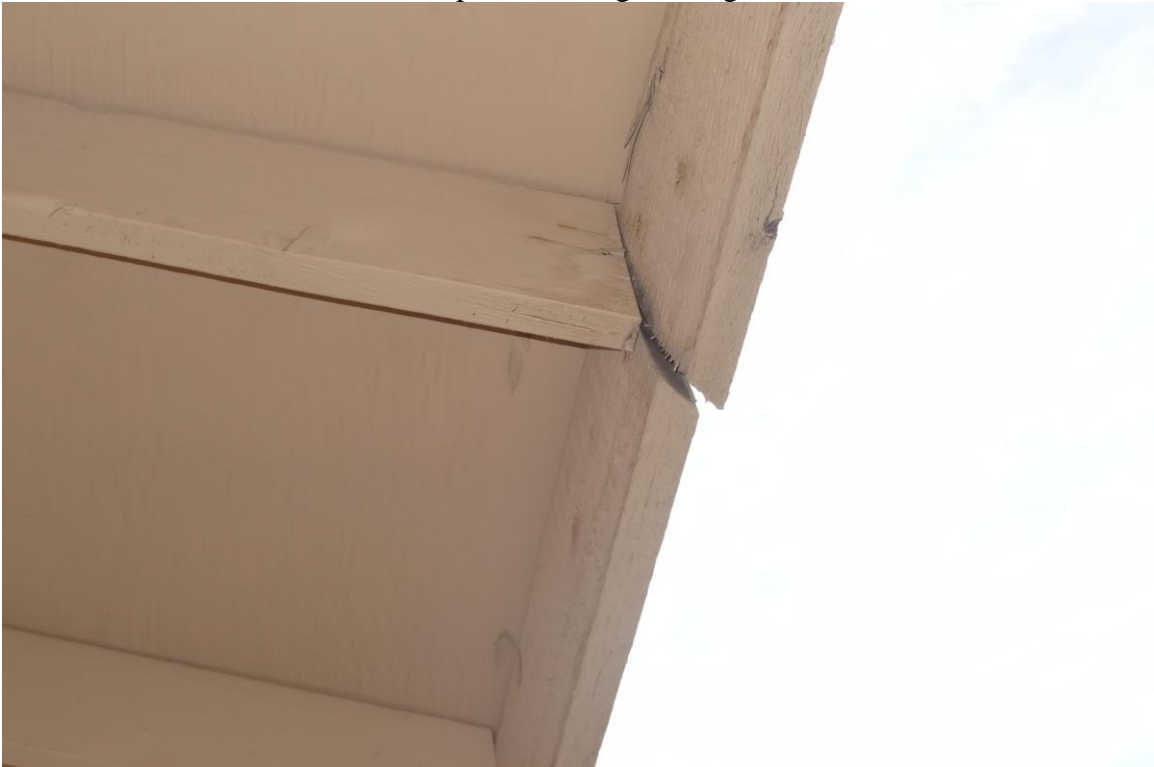
NDF / State Parks Office Building – FCA Building #2033
Description: Damaged fascia board.

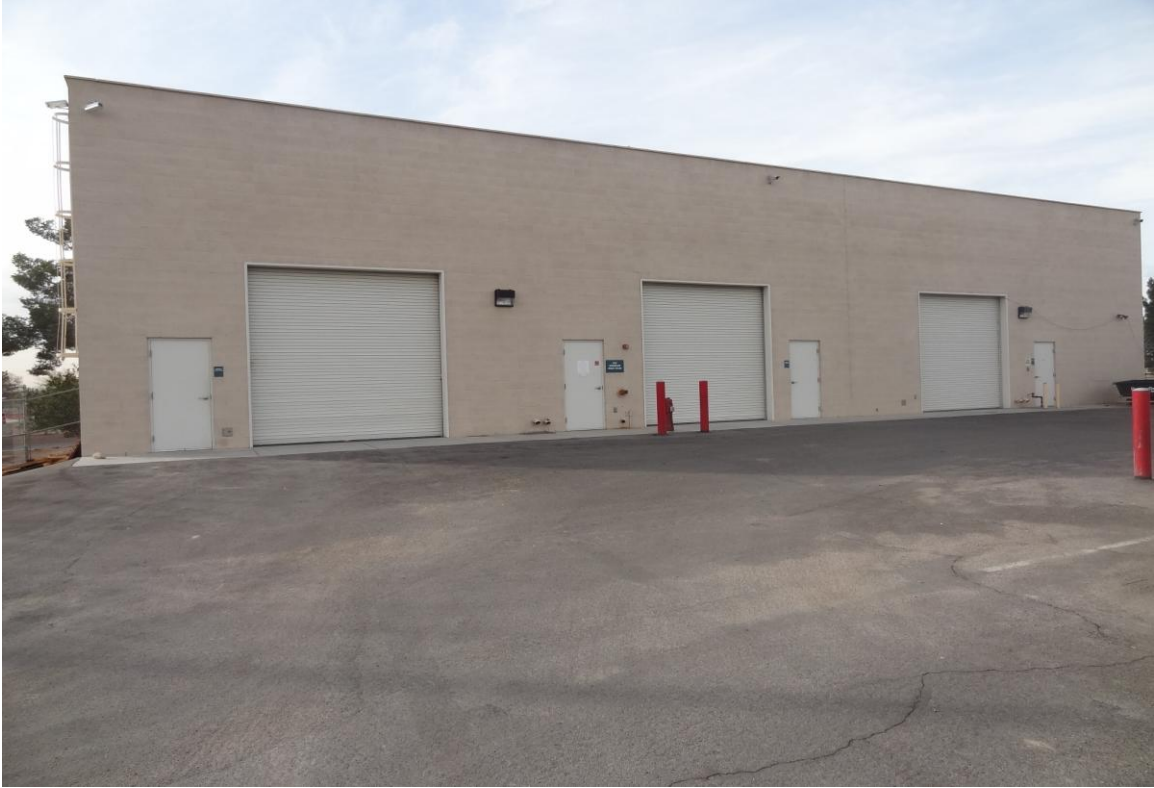
Warehouse / Shop – FCA Building #1989
Description: Exterior of the building.

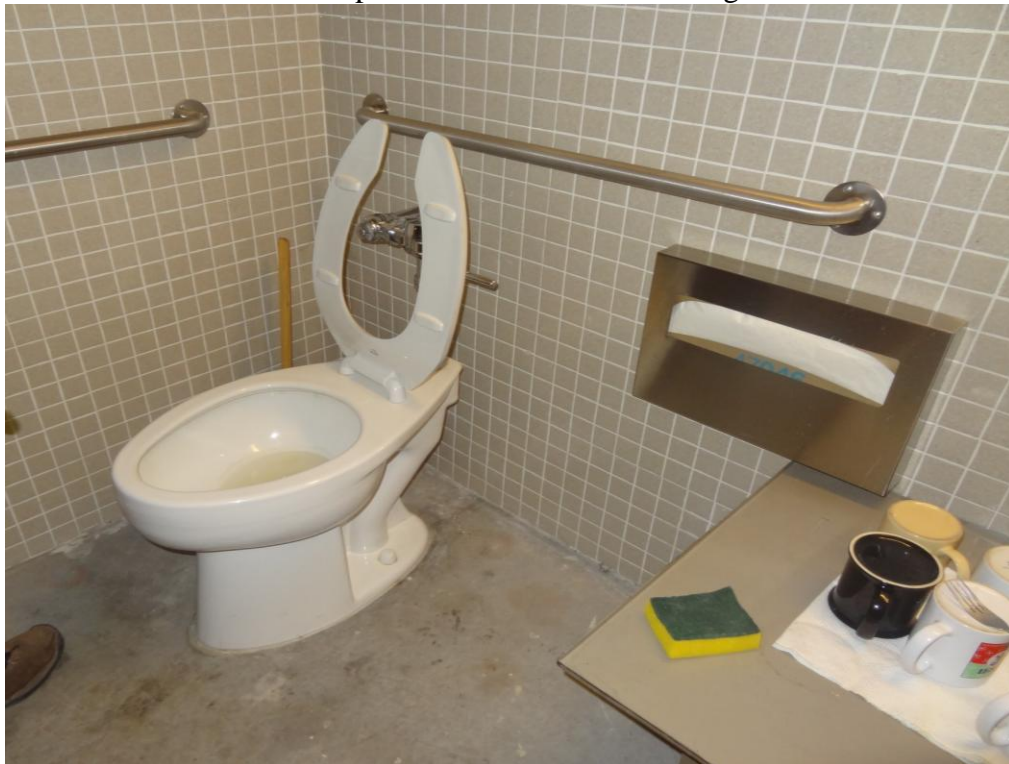
Warehouse / Shop – FCA Building #1989
Description: Restroom.
