CONDITION SURVEY, ELLSWORTH AIR FORCE BASE, SOUTH DAKOTA

P. J. Vedros

April 1973

Conducted by U. S. Army Engineer Waterways Experiment Station

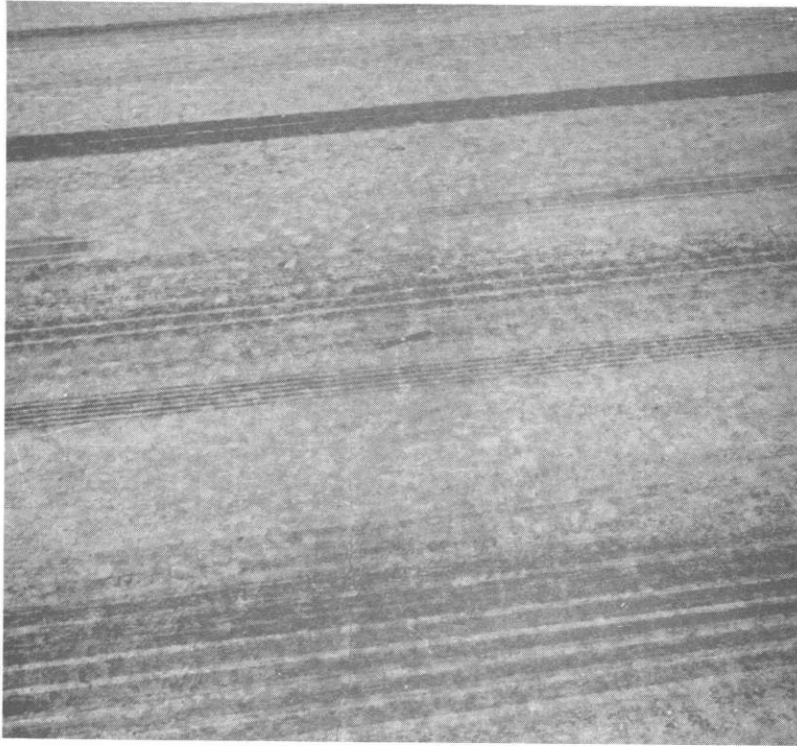
runway was considered to be excellent. The 1000-ft runway ends were in excellent condition with only two major structural defects recorded (table 3). The 75-ft inlay section of the interior portion of the runway from sta 40+06 to 65+06 (features R12C, R14C, and R15C), which consisted of 18-in. reinforced portland cement concrete (PCC), had nine slabs that contained transverse cracks. The crack openings were very small and appeared to be held tightly together by the reinforcement (photo 1). The condition of this inlay section was rated as good.

Photo 1. Transverse crack in reinforced PCC slab of NW-SE runway

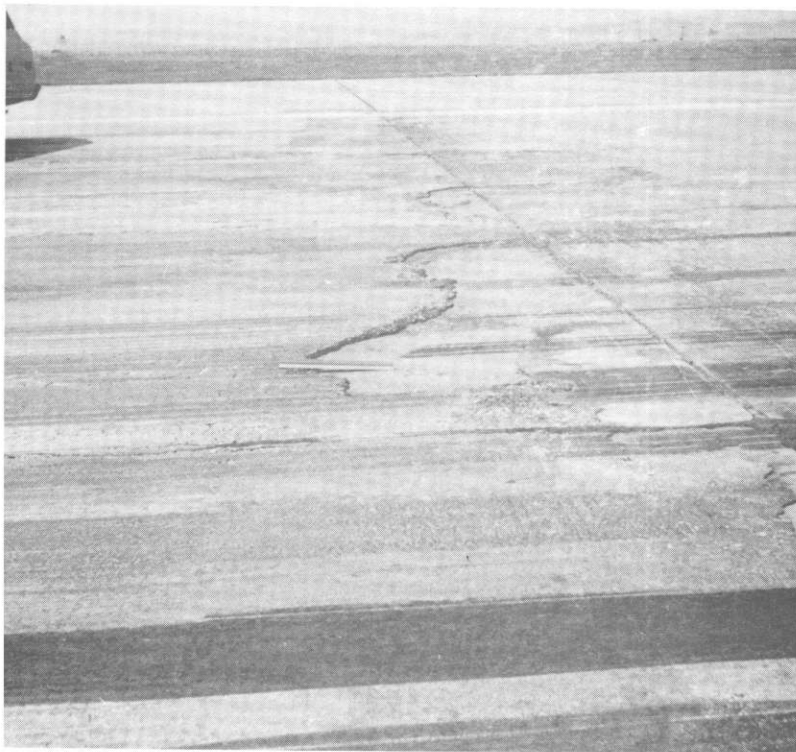
12. An asphaltic concrete (AC) overlay was placed on the runway from sta 135+30 to 160+03 in 1966 and from sta 65+06 to 135+30 in 1969; and, at the time of this survey, the overlay pavement was in excellent condition. There was evidence of some reflection cracking at the joints, with some free water in the cracks, probably from frost melting. The overlay was feathered at sta 165+03, and the edges of the overlay were raveling at this point (photo 2).

Photo 2. Raveling of feathered edge of AC at sta 165+03 of NW-SE runway

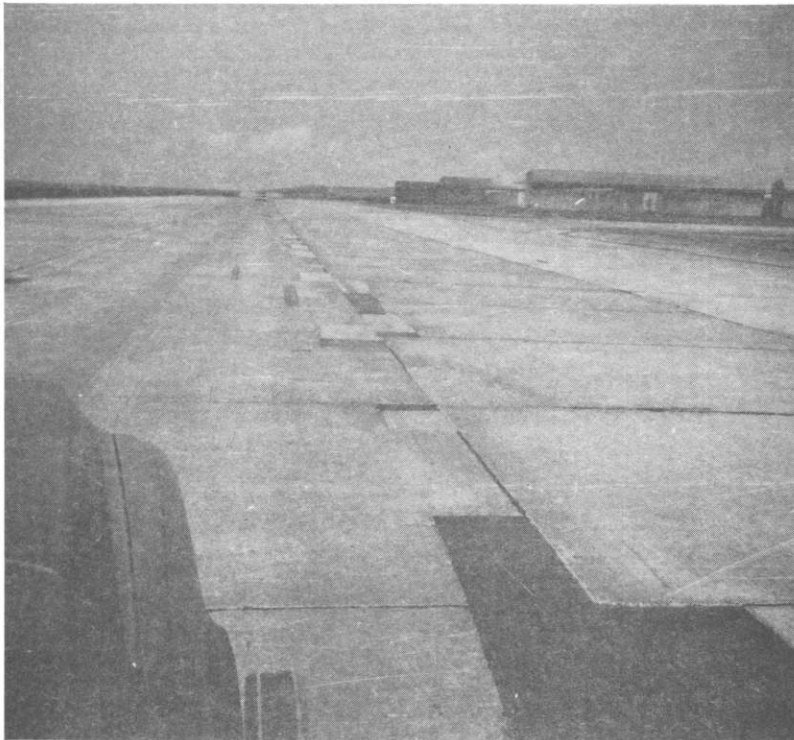
Photo 3. Patched joint spalls on taxiway 26 near parking apron. Note that patches are on each side of joint

27. Maintenance of the longitudinal spalls on the north end of taxiway 26 has consisted of sawing to a minimum depth of 2 in. in the sound concrete beyond the spalled area and chipping out the unsound concrete to the depth of the keyway. The exposed surface is then brushed with a tack coat, and hot-mix AC is used in the patch. When existing patches have settled 1/2 in. or more below the adjacent slab, additional hot-mix AC has been applied. These patches have been performing fairly well for the past 10 years. It was reported that, in the area of taxiway 26 that contained dowels, patching the spalls required the removal of only about 4 in. of unsound concrete (i.e., the depth of the patch was less than the depth of the dowel).

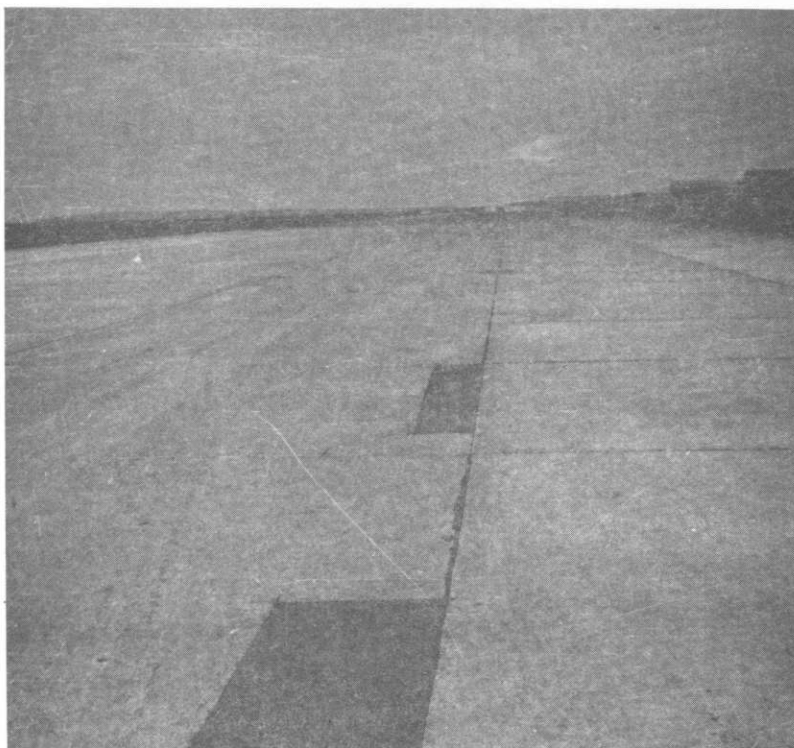
Photo 4. Patched joint spalls near north end of taxiway 26 (feature T4A)
