INSPECTION SERVICES NORTHWEST

CONFIDENTIAL INSPECTION REPORT FOR THE PROPERTY LOCATED AT:

12314 Sample Dr E, Medina, WA

INSPECTION COMPLETED ON: AUGUST 8, 2017

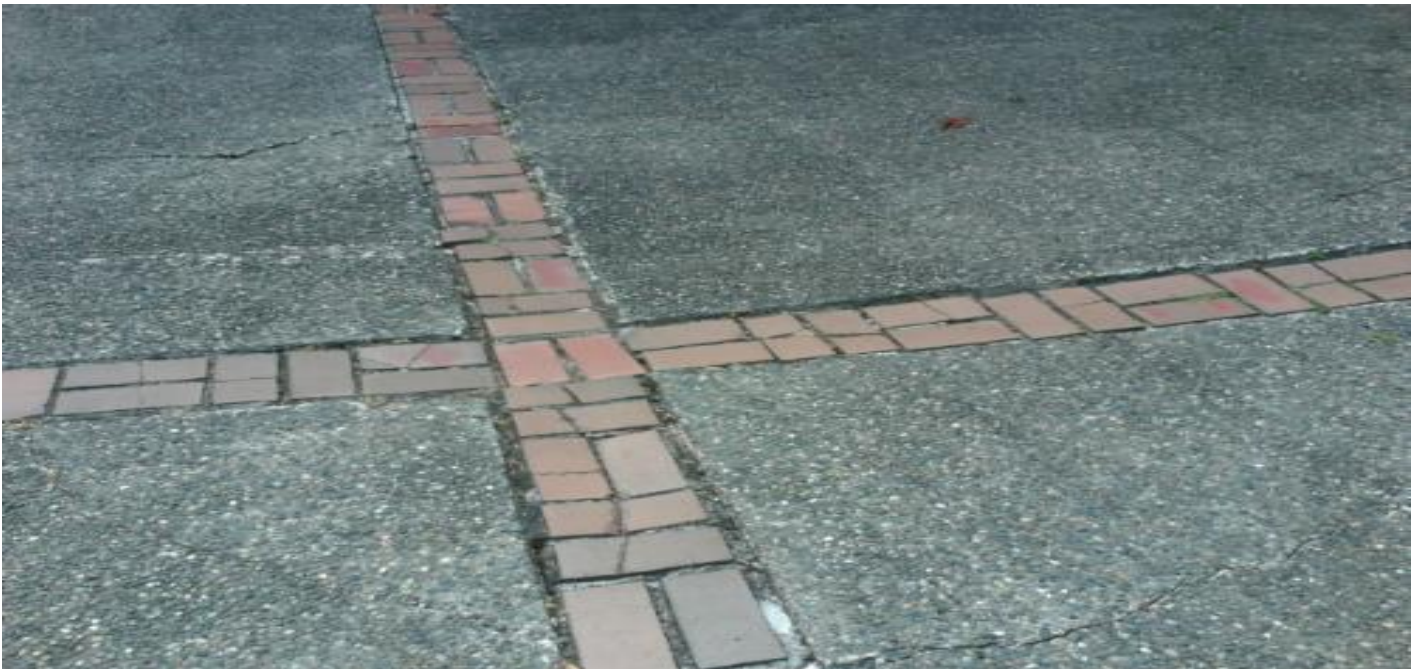
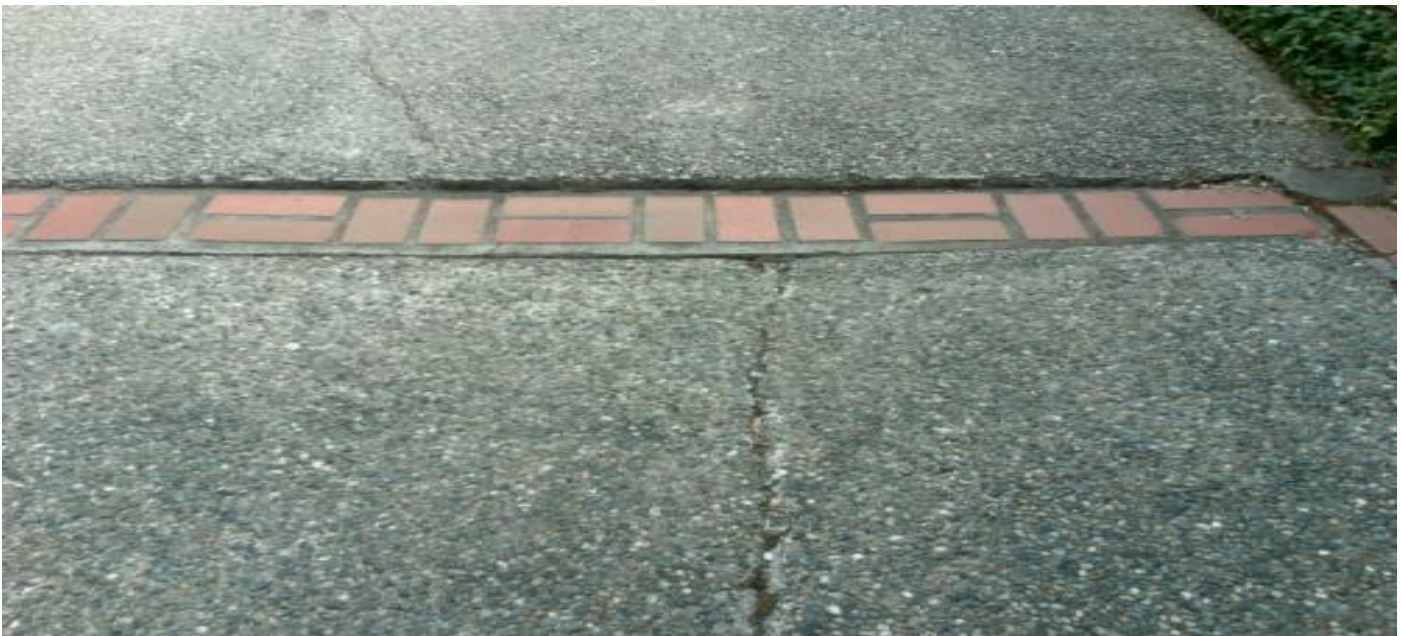
Trip Hazard / Previous settling: Previous settling has created trip hazards at the driveway / walkways. This damage appears to have been from either a lack of proper compaction of the materials or faulty drainage from the downspout or foundation drainage.

PREVIOUS SETTLING WAS NOTED AT THE DRIVEWAY. REPAIR ALL TRIP HAZARDS, SEAL ALL CRACKS AND ENSURE ALL RUNOFF IS PROPERLY ROUTED AWAY FROM THE STRUCTURE.

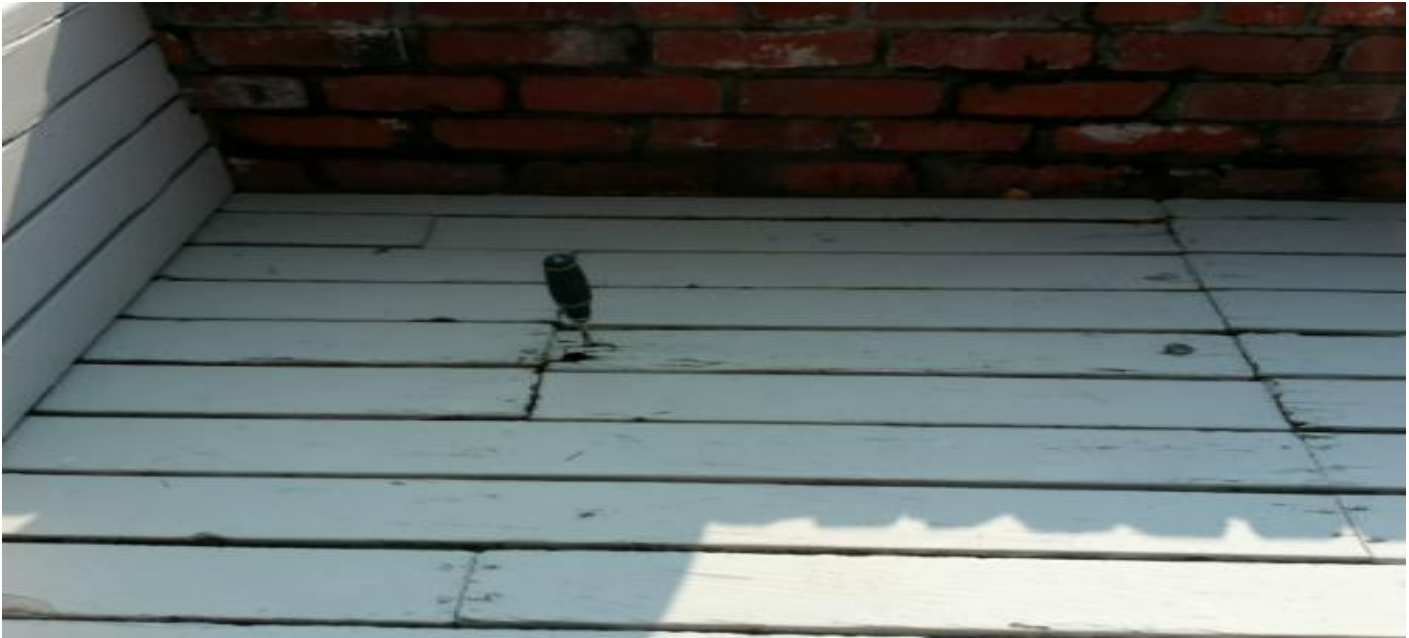
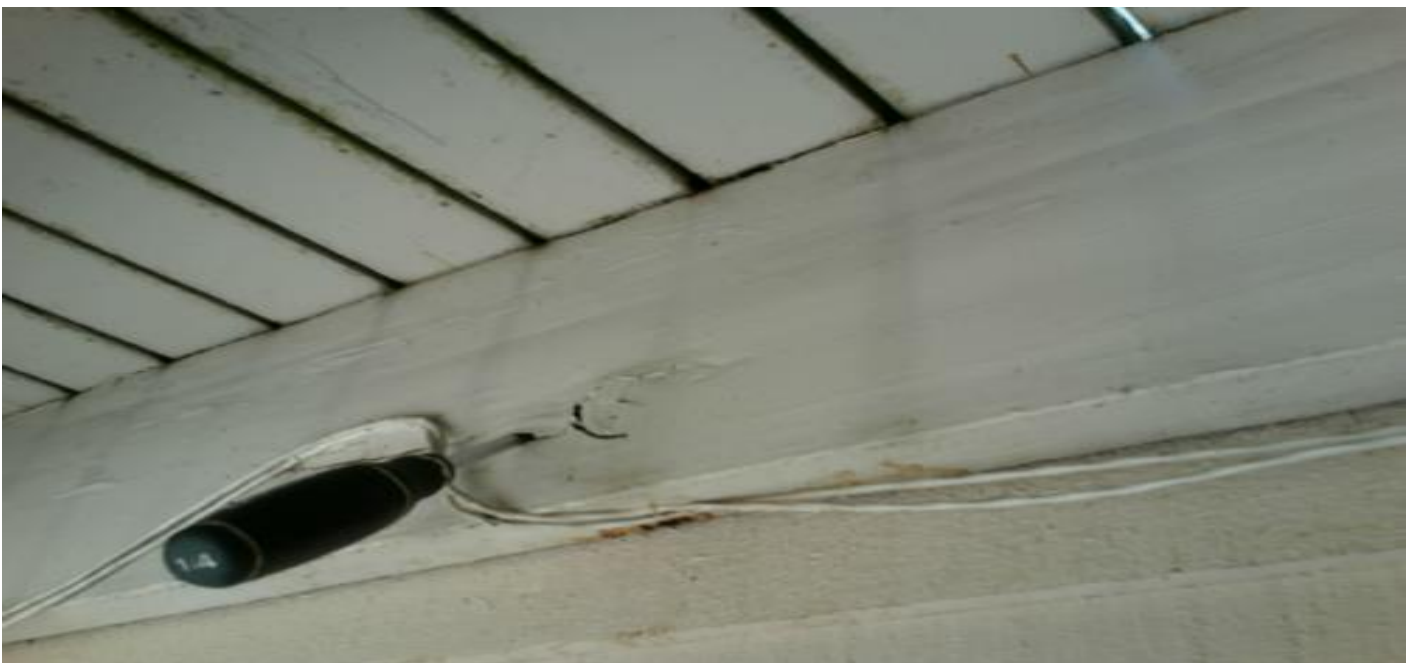
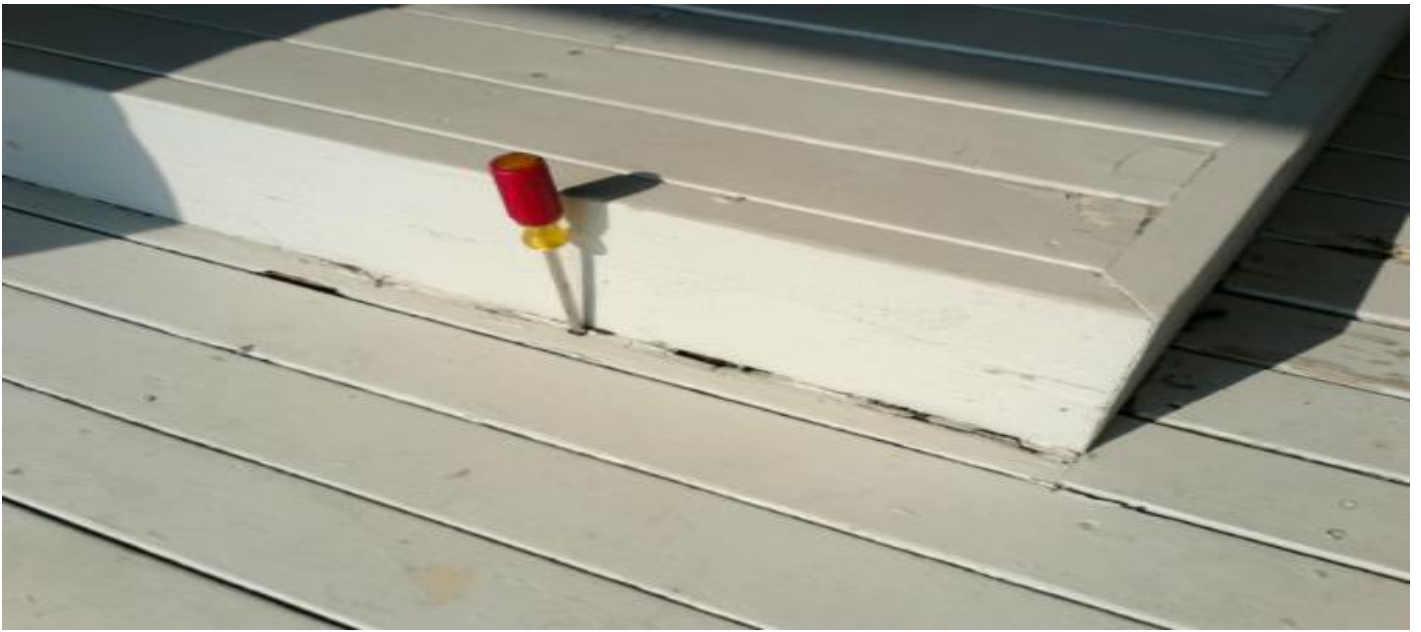
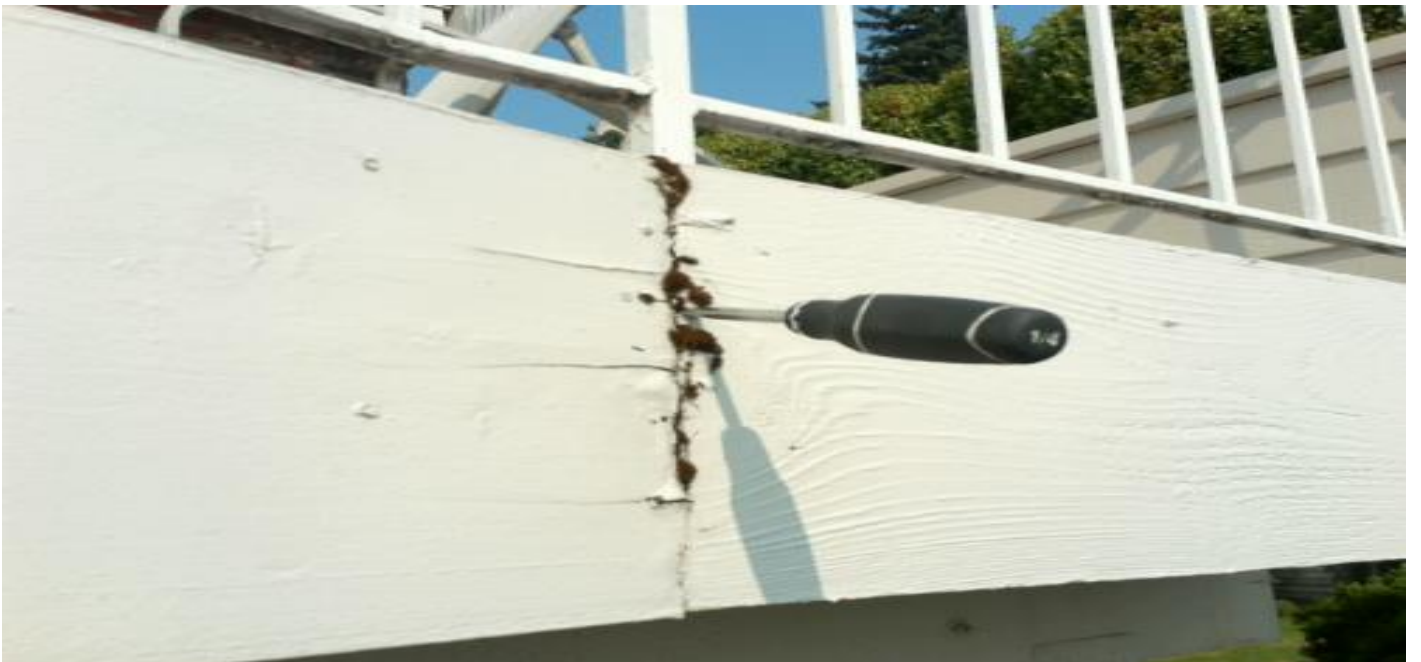
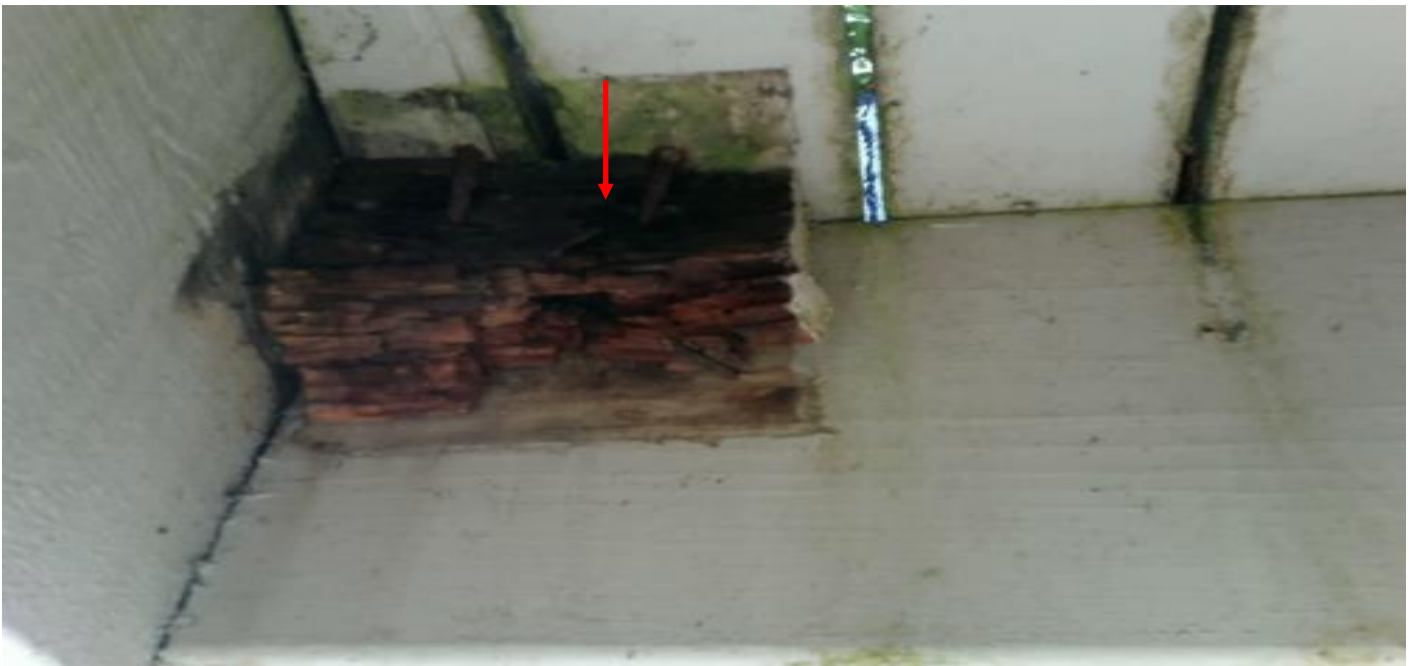
Decayed deck / porch and stair material located: Decayed material was located at the south side and front porches during the course of the inspection. The exact extent of the damaged material and repair required cannot usually be determined until the area has been dismantled to reveal the underlying structure. All damaged material that is located during the process of repair must be replaced.

LOCATE AND REPLACE ANY AND ALL DAMAGED AND OR DECAYED DECKING, JOIST, FASCIA, RAIL BLOCKING AND STRUCTURAL MATERIAL AT ALL DECKS. ALL DAMAGED MATERIAL THAT IS UNCOVERED MUST ALSO BE REPLACED AS FOUND TO BE REQUIRED.

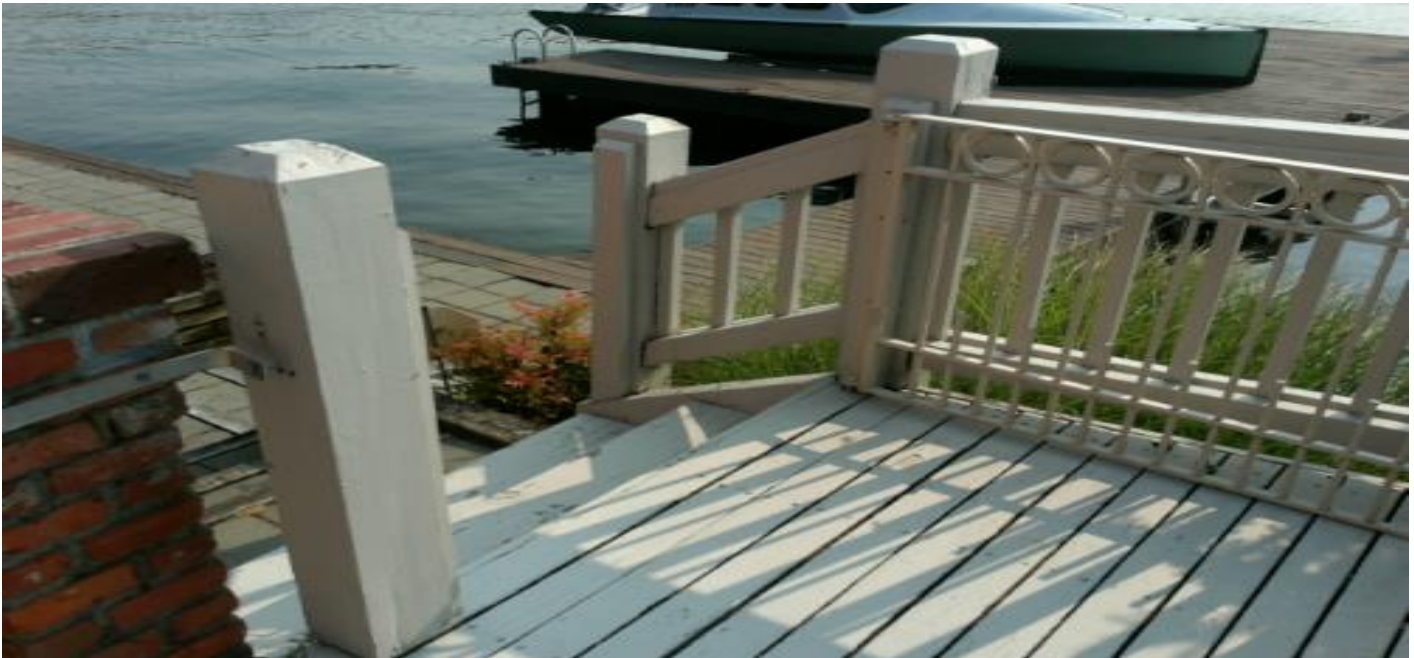
Loose deck guardrails: The deck railing is very loose and does not meet current standards for safety. It is highly recommended that during the railing repairs the system be upgraded to current safety standards. Current standards require the guardrail be no less than 36 inches in height have intermediate rails that prevent an object of six inches of diameter or more from passing through the rails.

REPAIR AND RE-SECURE THE LOOSE GUARDRAILS ON THE LOWER DECK SURFACE AT THE SOUTHEAST SIDE OF THE STRUCTURE AND AT THE DECK OFF OF THE MASTER BEDROOM.

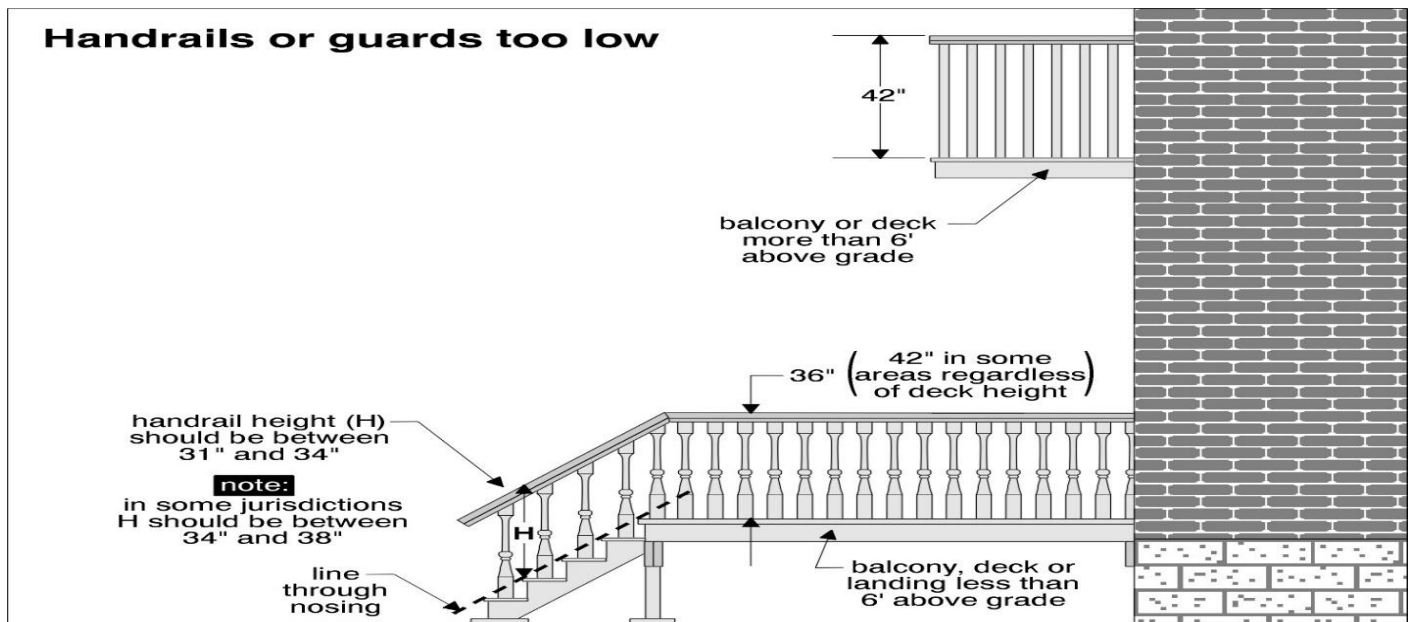
Deck guardrails/ handrails: The deck railing does not meet current standards for safety. It is highly recommended that during any deck or railing repairs the system be upgraded to current safety standards. Current standards require the guardrail be no less than 36 inches in height at ground level or 42 inches above first floor level and have intermediate rails that prevent an object of four to six inches of diameter or more from passing through the rails.

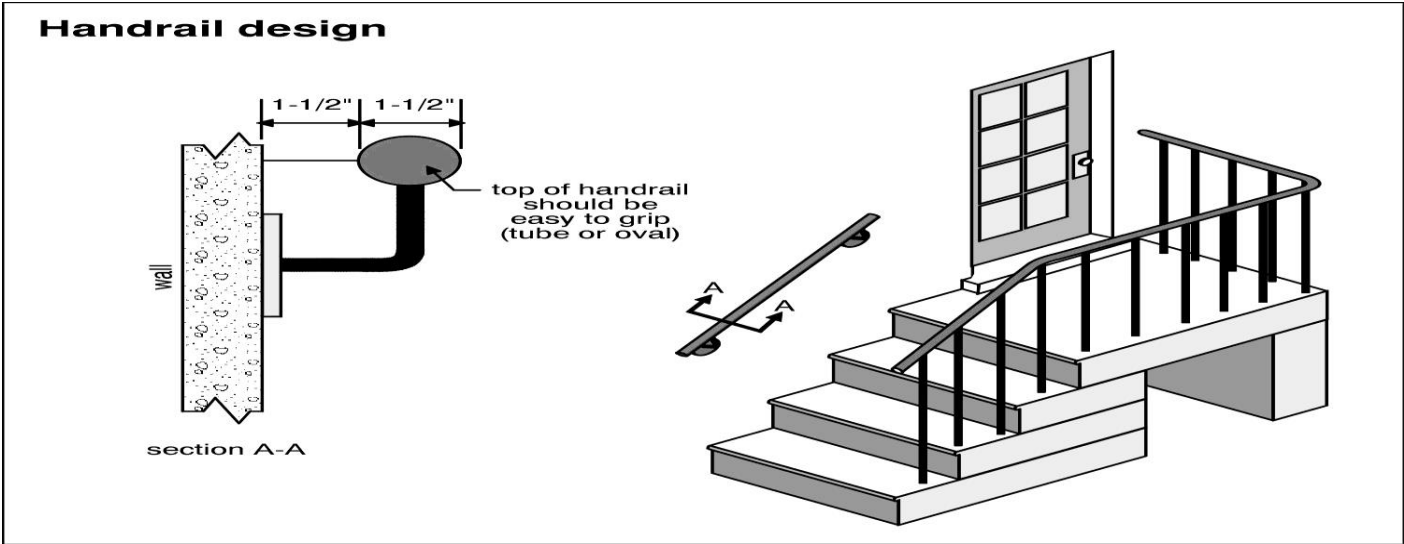
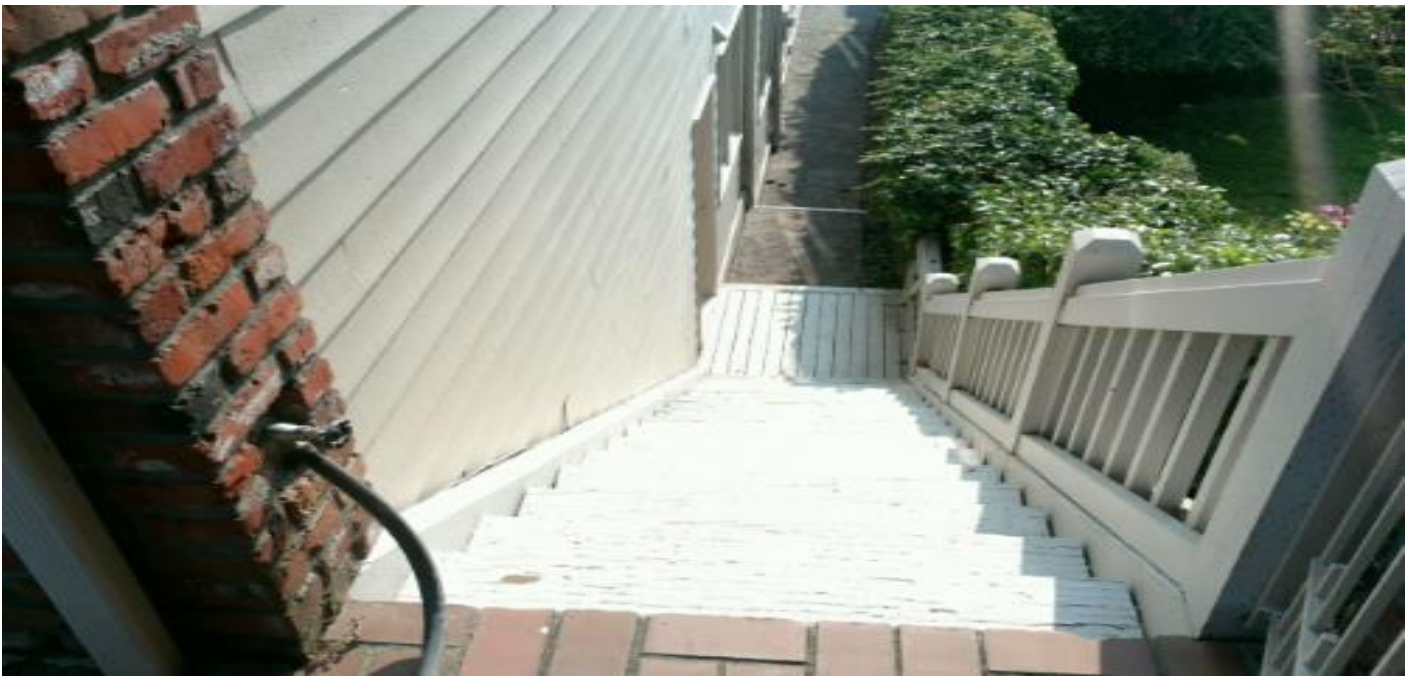
Stair handrails: All stairwells of three or more risers must have a hand railing in place for the entire length of the stairs. The railing must be between thirty and thirty-eight inches high as measured from the nosing of the treads.

INSTALL A PROPER HAND RAILING ON THE SOUTH EXTERIOR STAIRWELL.

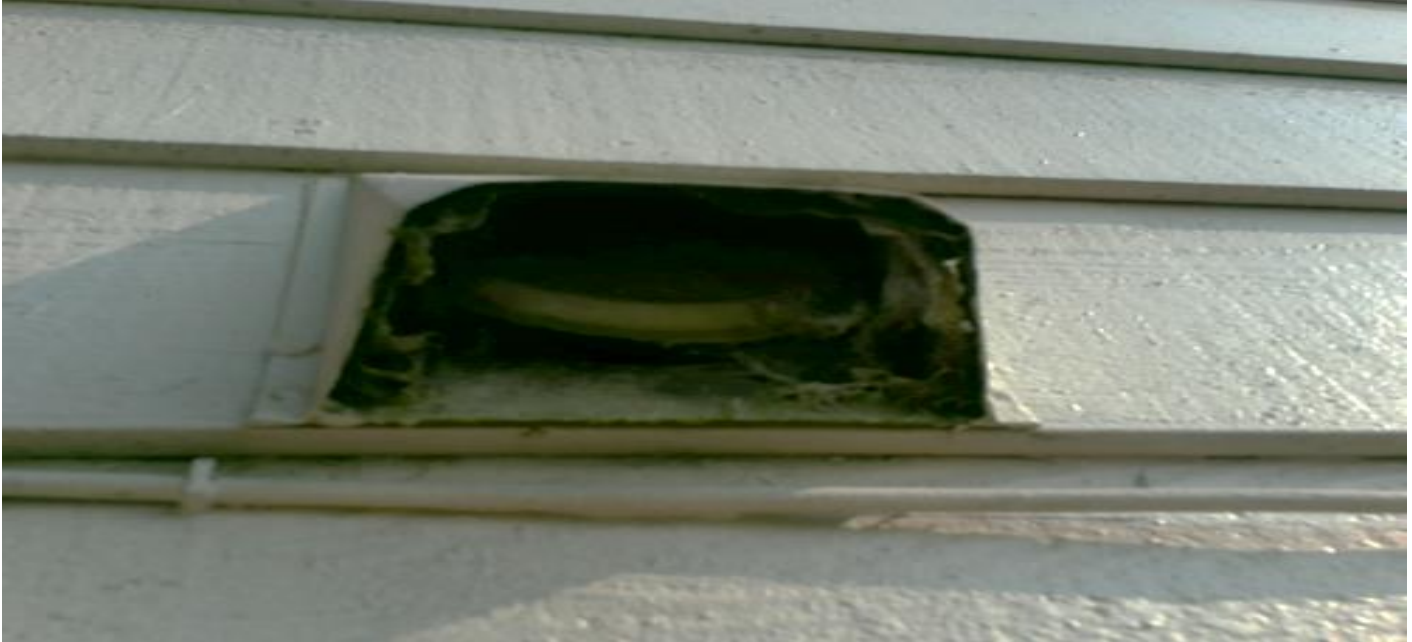
THE CLOTHES DRYER VENT AND PIPE IS CLOGGED WITH LINT AND IS A FIRE HAZARD. THE DRYER VENT LINE MUST BE PROFESSIONALLY CLEANED AND INSPECTED TO ENSURE IT IS SAFE AND IN PROPER OPERATING CONDITION.

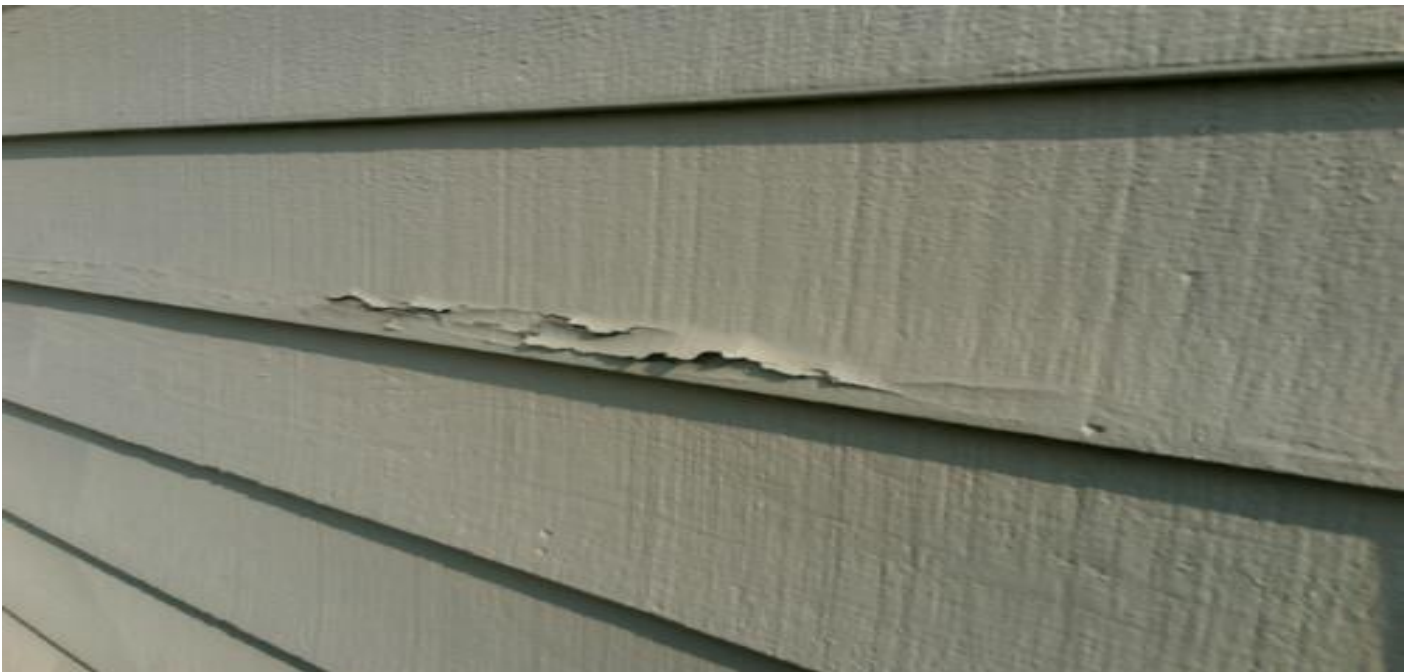
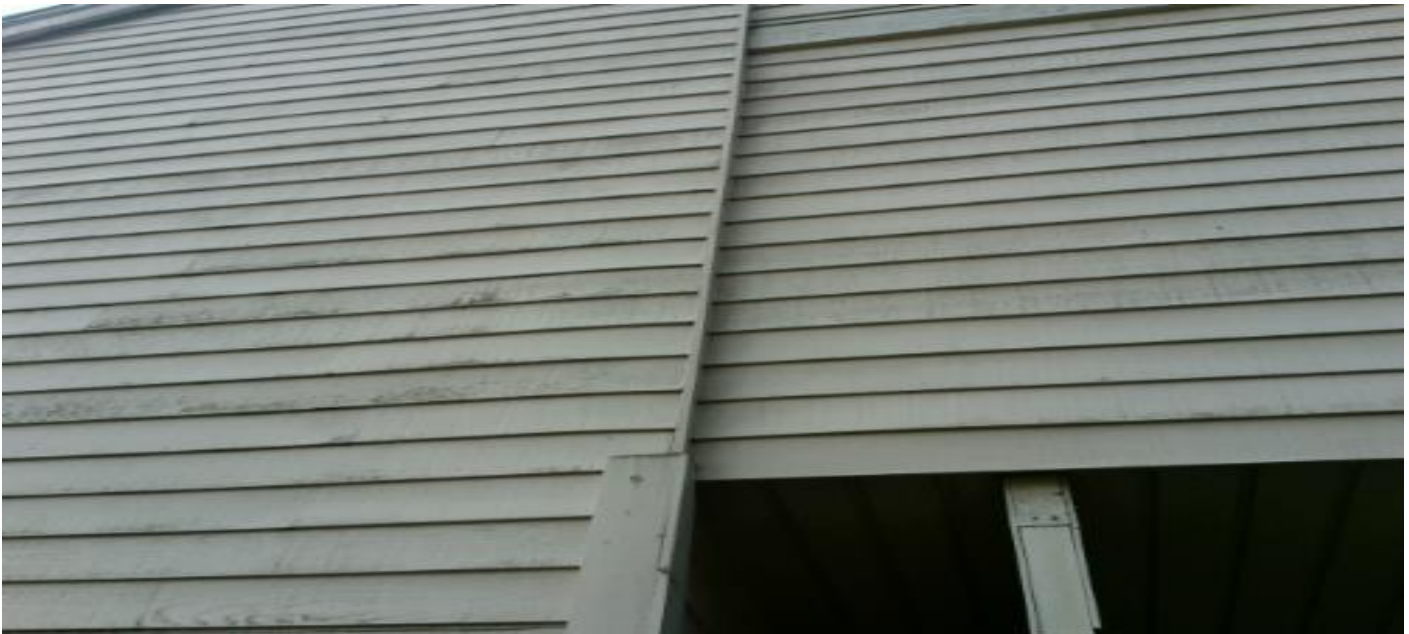
Exterior Paint: The exterior paint work on a building is installed as a weather shield against water and sun damage to the building materials. The life expectancy of the exterior components of the building is substantially reduced if the paint fails. Proper repainting requires proper paint preparation. Installing new paint on failing paint is likely to cause more problems than it cures. The cheapest bid for paint work will cost you much more in the long run.

SCRAPE, PRIME AND REPAINT THE EXTERIOR OF THE BUILDING.

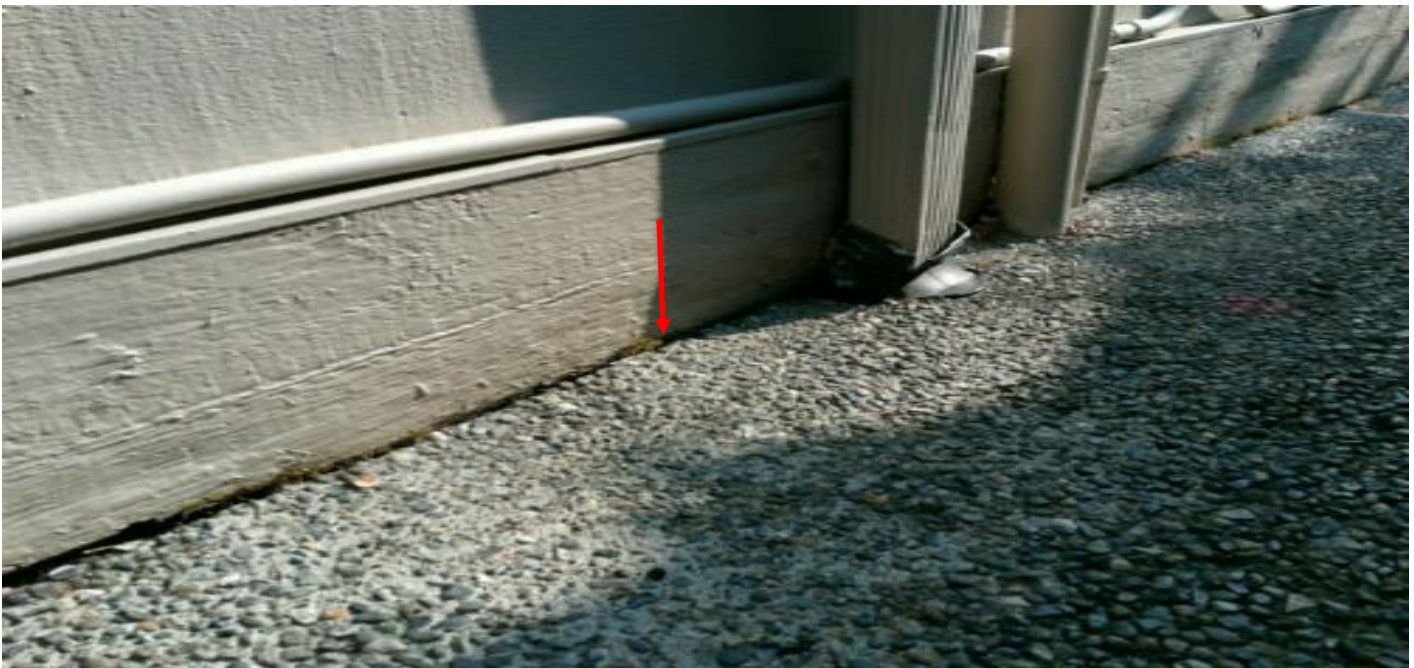
Decayed siding material located: Decayed siding material was located during the course of the inspection. The exact extent of the damaged material and repair required cannot usually be determined until the area has been dismantled to reveal the underlying structure. All damaged material that is located during the process of repair must be replaced.

LOCATE AND REPLACE ANY DAMAGED AND OR DECAYED SIDING TRIM MATERIAL AT THE BOTTOM TRIM AT THE SOUTH SIDE OF THE HOUSE. ANY FURTHER DAMAGE THAT IS REVEALED AFTER THE SIDING IS REMOVED MUST ALSO BE REPLACED.

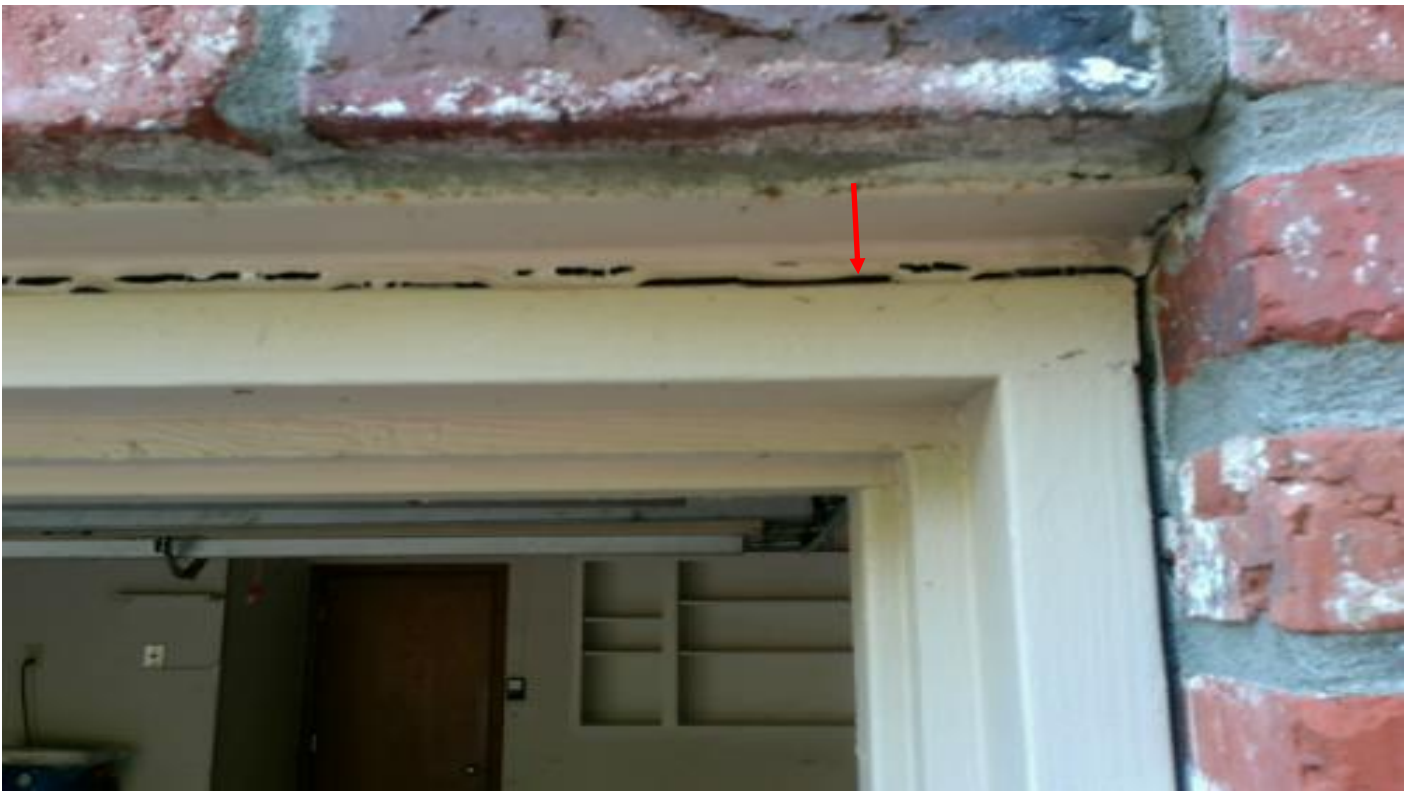
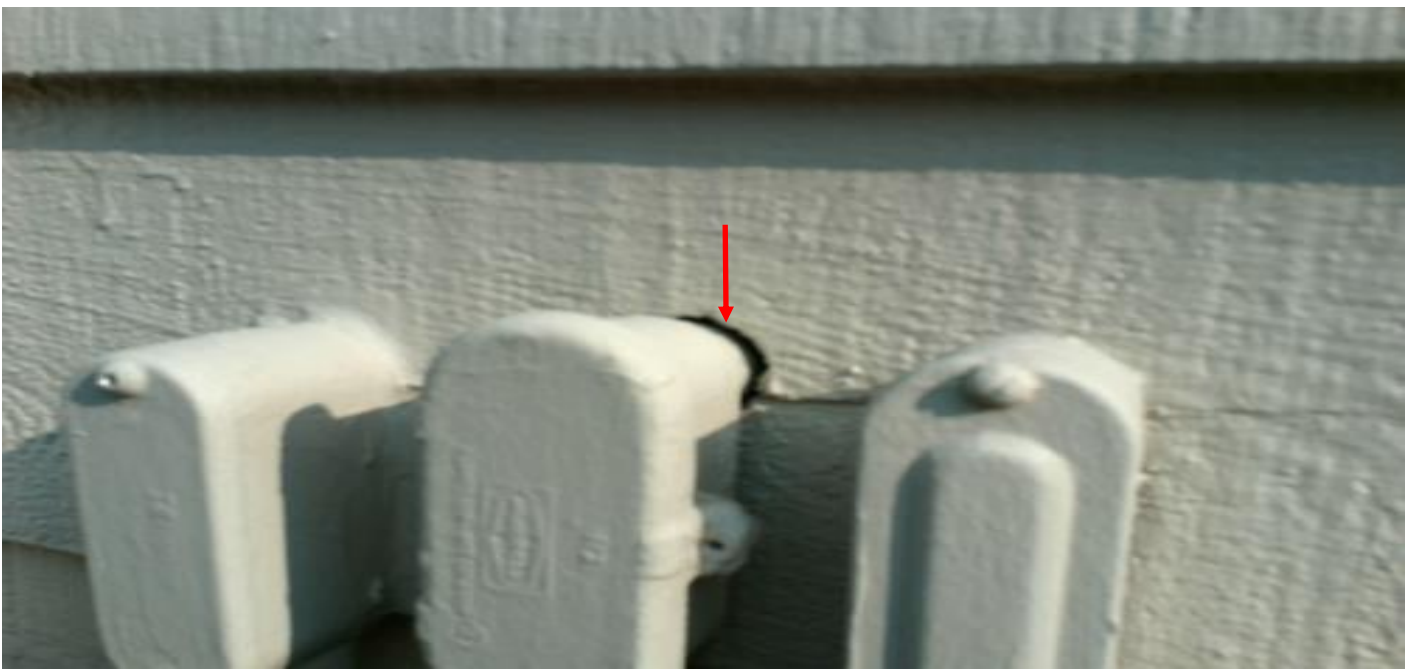
Failing siding caulking: All areas of failing caulking at the butt end of the siding, at the window and trim areas and at all face nailing must be re-caulked to stop water migration damage to the siding material. All composite siding material can be subject to failure from water migration. This process should be done at the driest period of the year to ensure that the water content of the wood does not affect the bonding of the caulking.

RE-CAULK ALL FAILING CAULKING AS LOCATED AT THE SIDING BUTT ENDS, TRIM WORK, CORNER BOARDS, WINDOW SYSTEMS AND AS FOUND TO BE REQUIRED TO PREVENT WATER MIGRATION INTO THE SIDING MATERIAL AT ALL SIDES OF THE HOUSE.

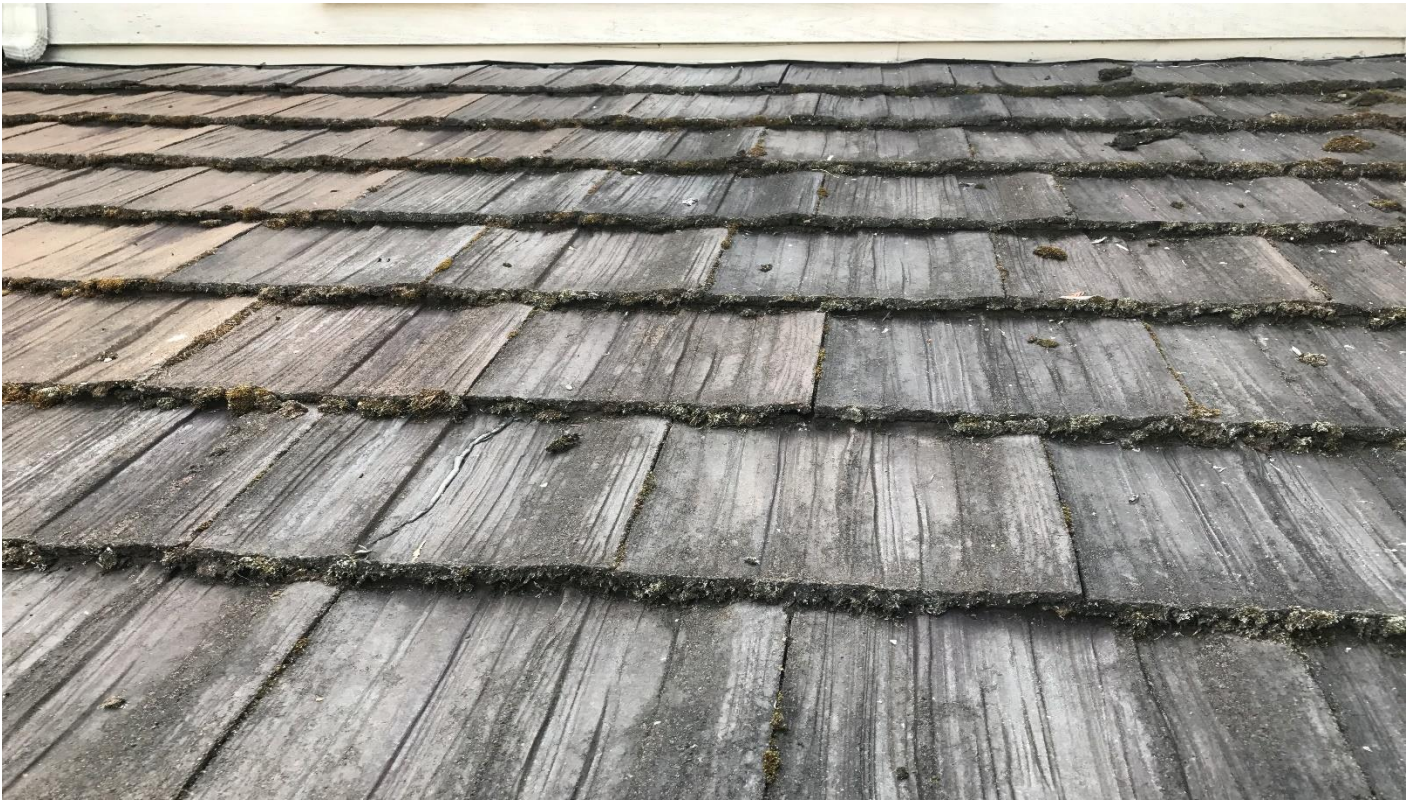
Cleaning the roof surface: The roof must be cleaned to remove all moss growth and windblown debris, then inspected by a licensed roofing contractor and repaired as required. **An excessive amount of debris on the roof surface does not allow a visual inspection of the entire roof surface, further analysis is required after the cleaning is completed to determine what repairs may be required.**

CLEAN THE ROOF WITH A METHOD THAT WILL NOT DAMAGE THE ROOFING SYSTEM, THE CLEANING MUST REMOVE ALL LICHEN GROWTH, MOSS, AND WIND BLOWN DEBRIS, AND IF ANY DAMAGED ROOFING MATERIAL IS LOCATED DURING OR AFTER THE CLEANING IT MUST BE REPLACED AS FOUND TO BE REQUIRED TO ENSURE THERE ARE NO ACTIVE LEAKS. THE GUTTERS AND DOWNSPOUTS AND TIGHT LINES MUST ALSO BE CLEANED AND ANY REPAIRS NEEDED MUST BE COMPLETED TO ENSURE THE SYSTEM IS PROPERLY DIRECTING ALL ROOF RUN OFF AWAY FROM THE STRUCTURE.

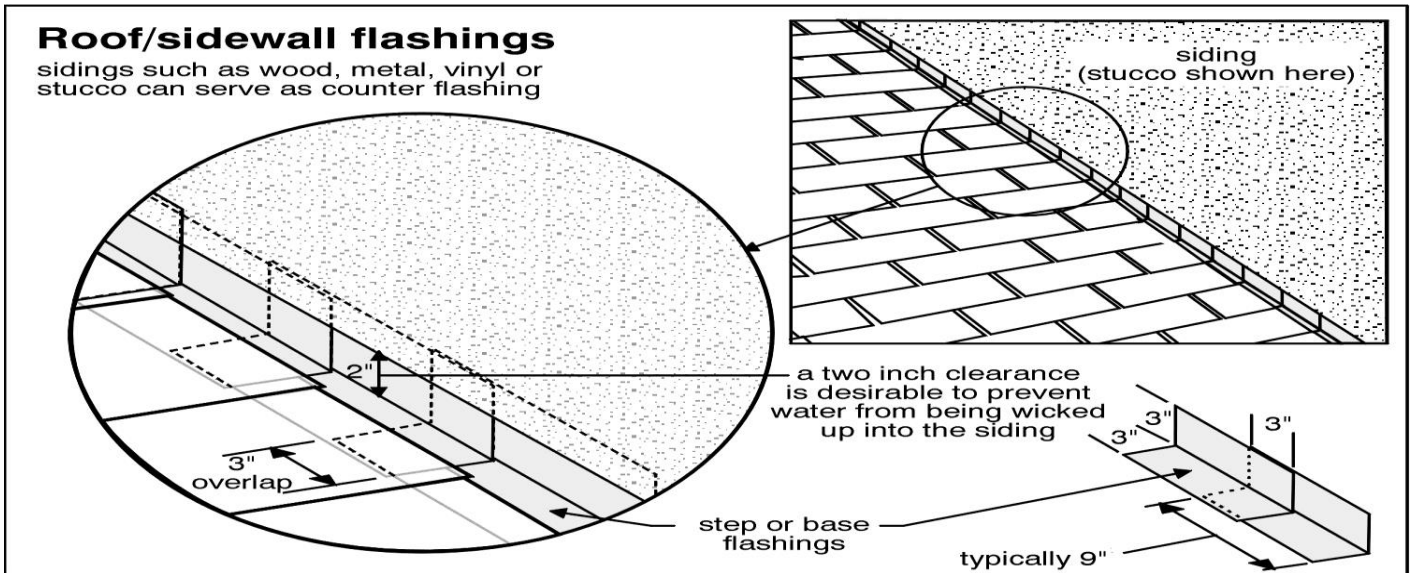
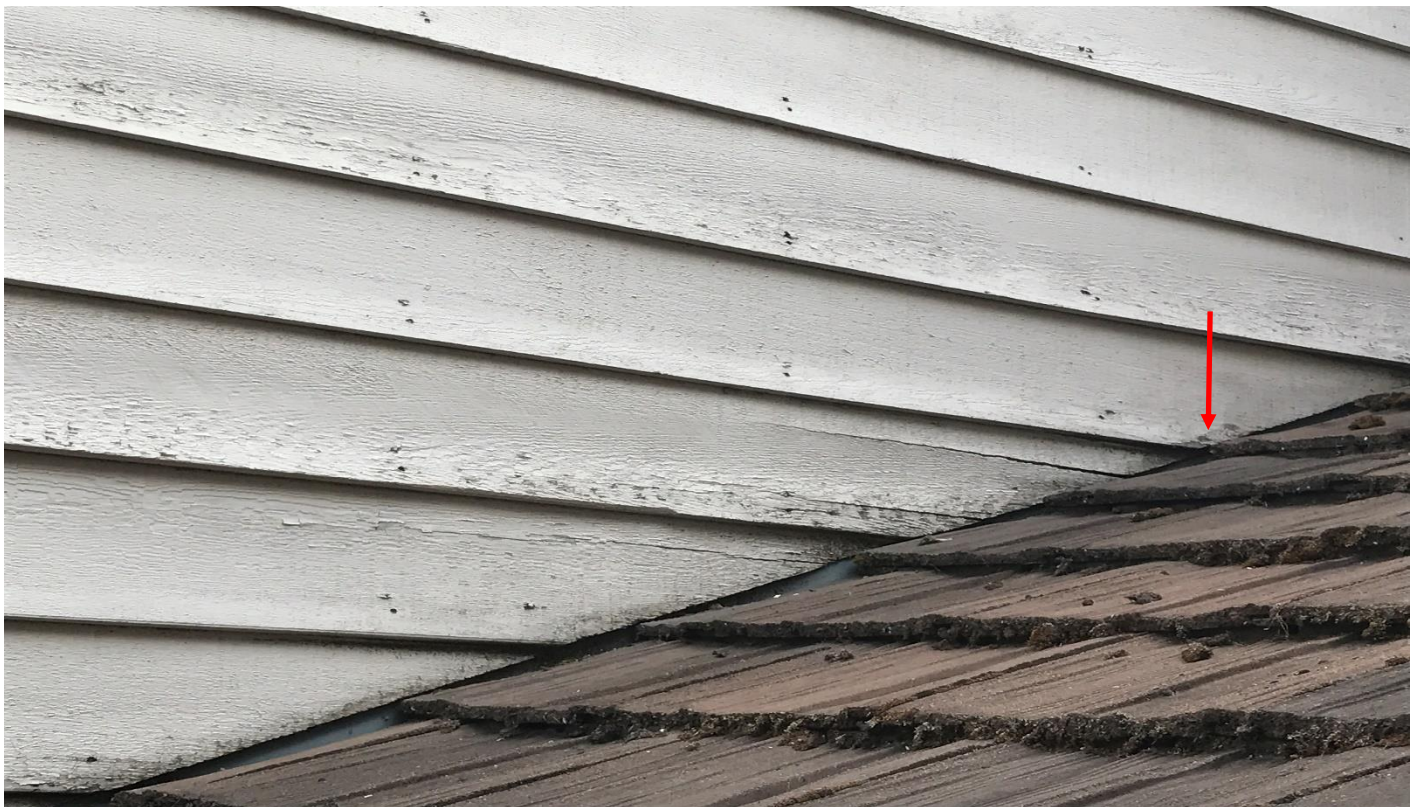
Improper roof to sidewall flashing: There are signs of leaks and previous repairs at the roof to sidewall area of the roof. Although these signs of leaks may be from previously repaired flashing problems, the flashing must be inspected and repaired as is found to be required by a licensed roofing contractor.

CUT THE SIDING BACK FROM THE ROOF SURFACE TO PROVIDE PROPER CLEARANCE FROM THE ROOF SURFACE.

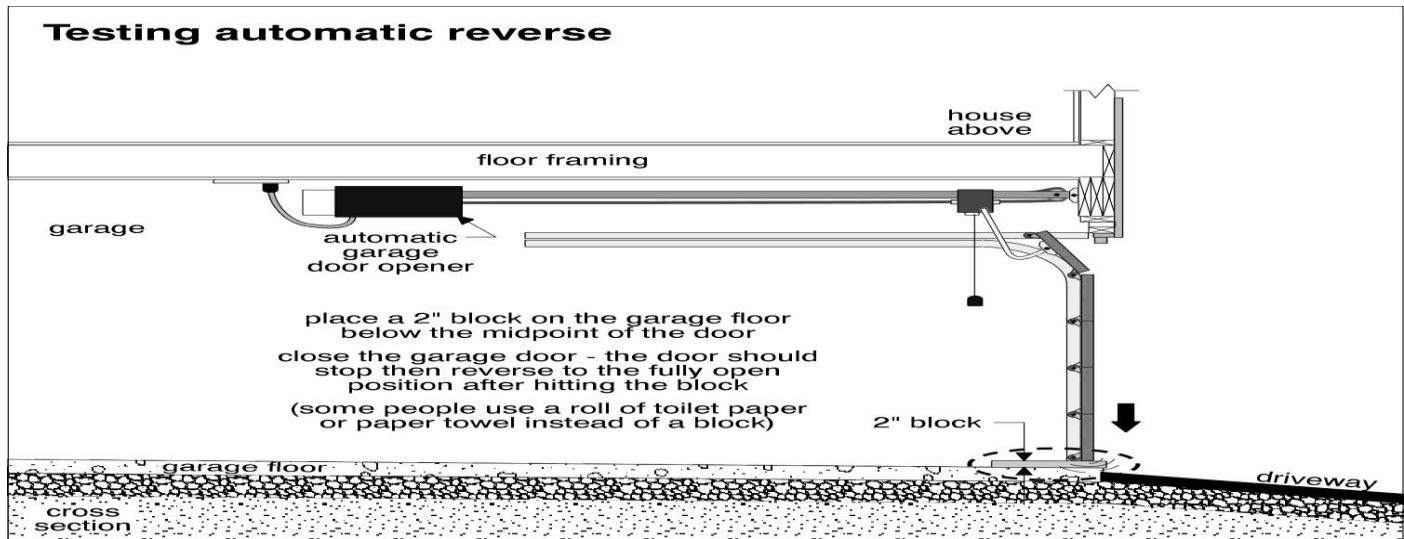
Garage: Resist: Adjust auto-reverse switch on garage door: Most electric garage door openers now have an auto-reverse feature which acts to stop and reverse the door should some object (a child) be encountered while the door is closing. It is a safety protection device and its proper adjustment should not be neglected. Adjustment screws are generally labeled and within easy reach with a screwdriver. These mechanisms should be finely adjusted so they will reverse upon contacting something soft, such as a child. Use a basketball, placed in the path of the closing door to test this function and adjust as needed.

BOTH GARAGE DOOR OPENER SAFETY STOPS SHOULD BE ADJUSTED OR REPAIRED AS IS FOUND TO BE REQUIRED TO ENSURE A PROPER SETTING OF APPROXIMATELY TEN POUNDS OF RESISTANCE PRESSURE TO RETURN THE DOOR TO AN OPEN POSITION.

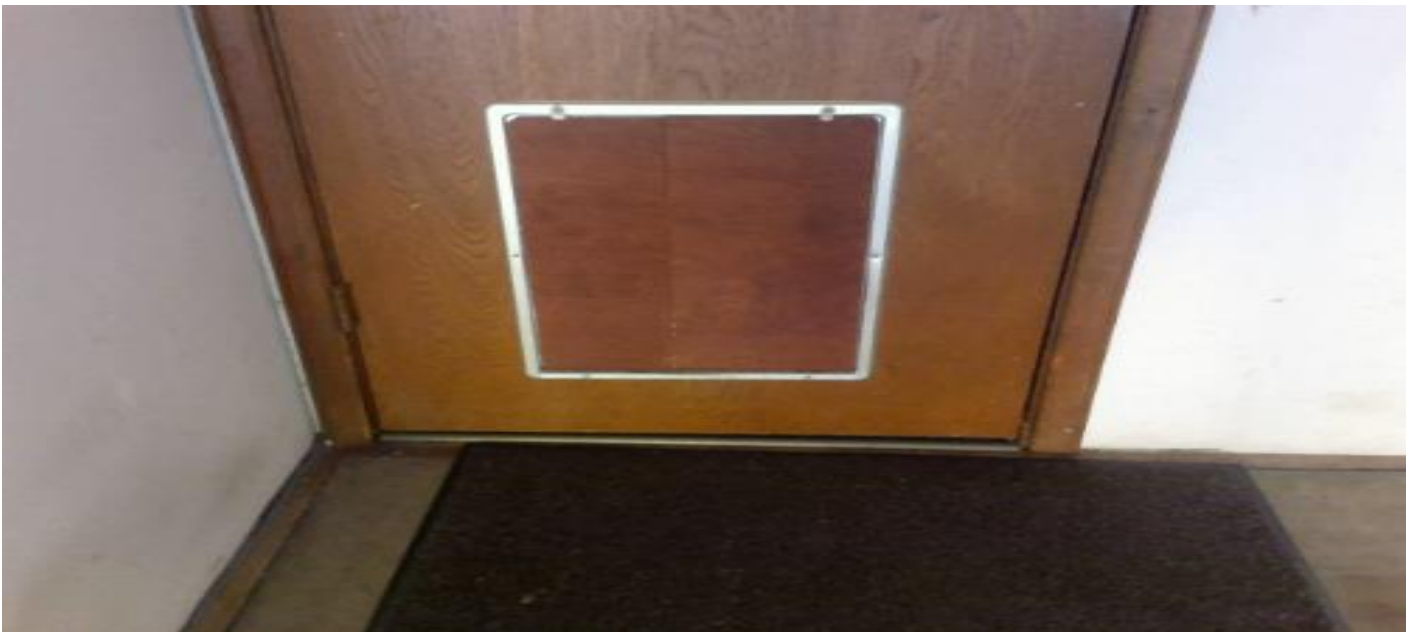
A PET DOOR HAS BEEN INSTALLED AT THE SOUTH GARAGE MAN DOOR. COMPLETE ALL REPAIRS AS FOUND TO BE REQUIRED TO RESTORE THE FIRE RATING TO THE DOOR SYSTEM.
