INSPECTION SERVICES NORTHWEST

CONFIDENTIAL INSPECTION REPORT FOR THE PROPERTY LOCATED AT:

12314 Sample Dr E, Medina, WA

INSPECTION COMPLETED ON: AUGUST 8, 2017

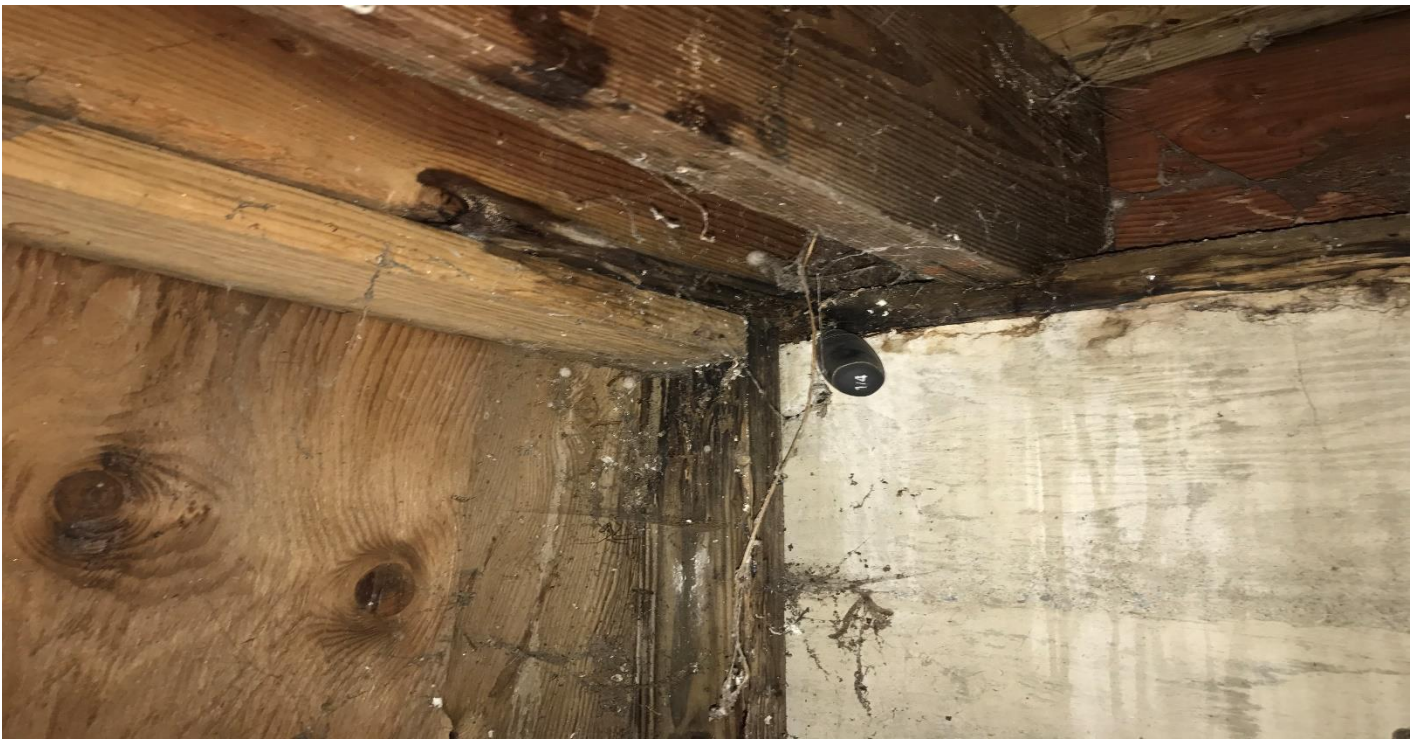
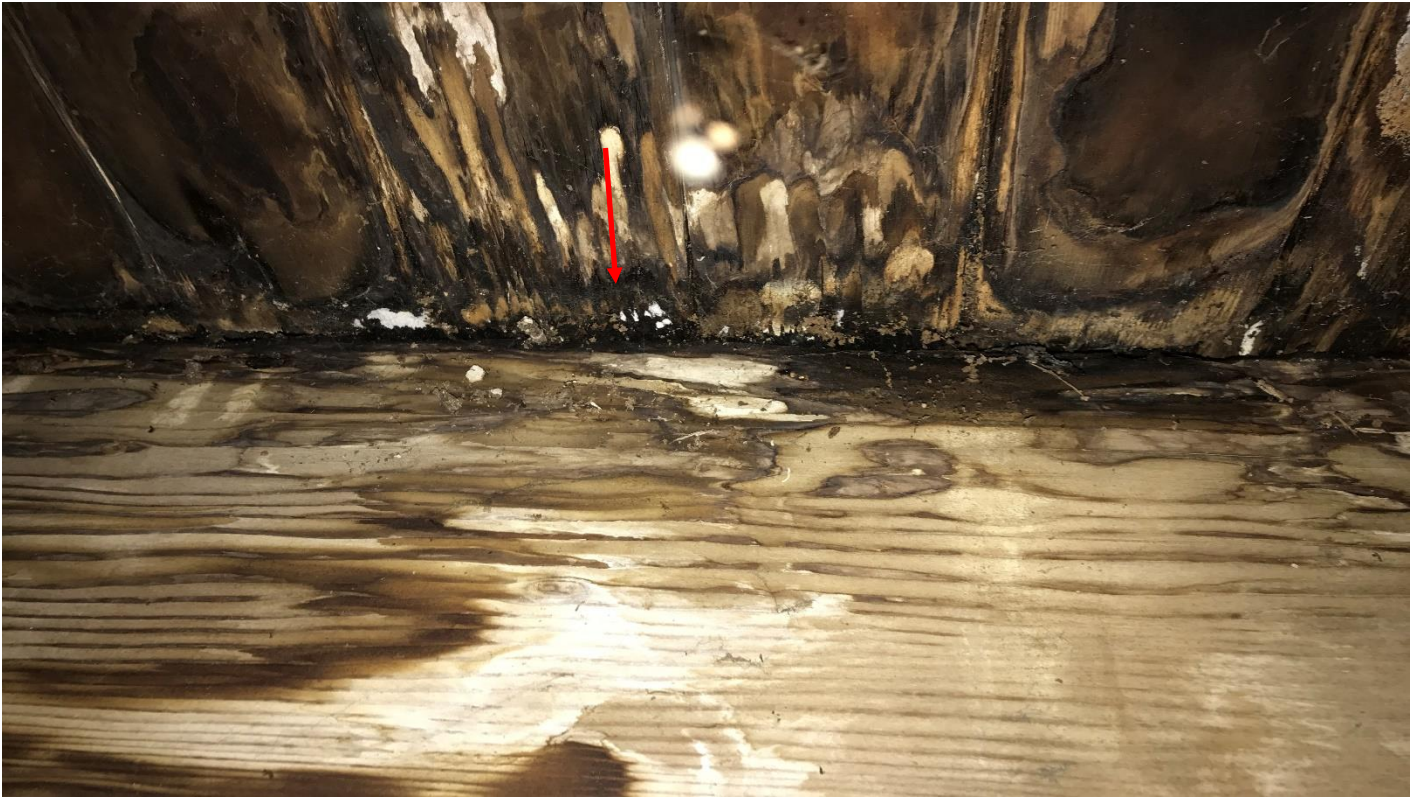
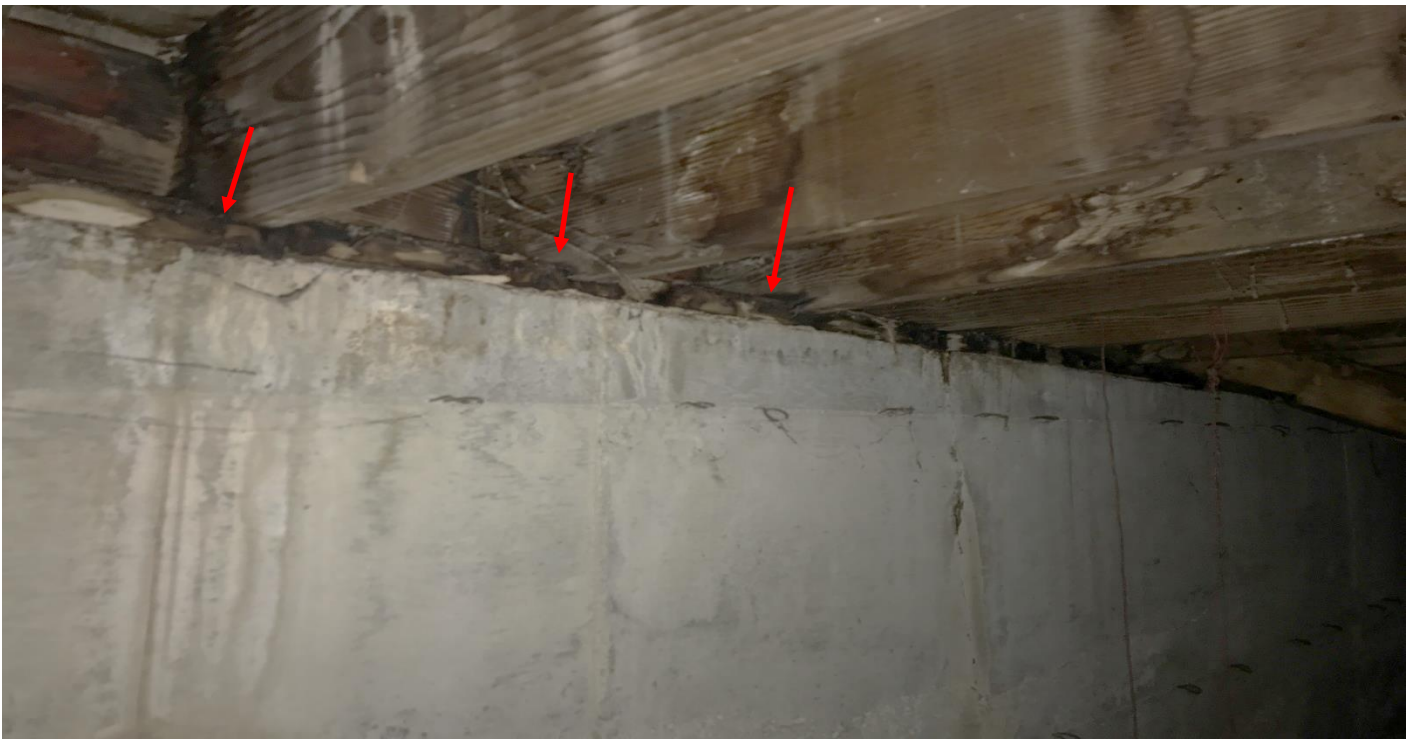
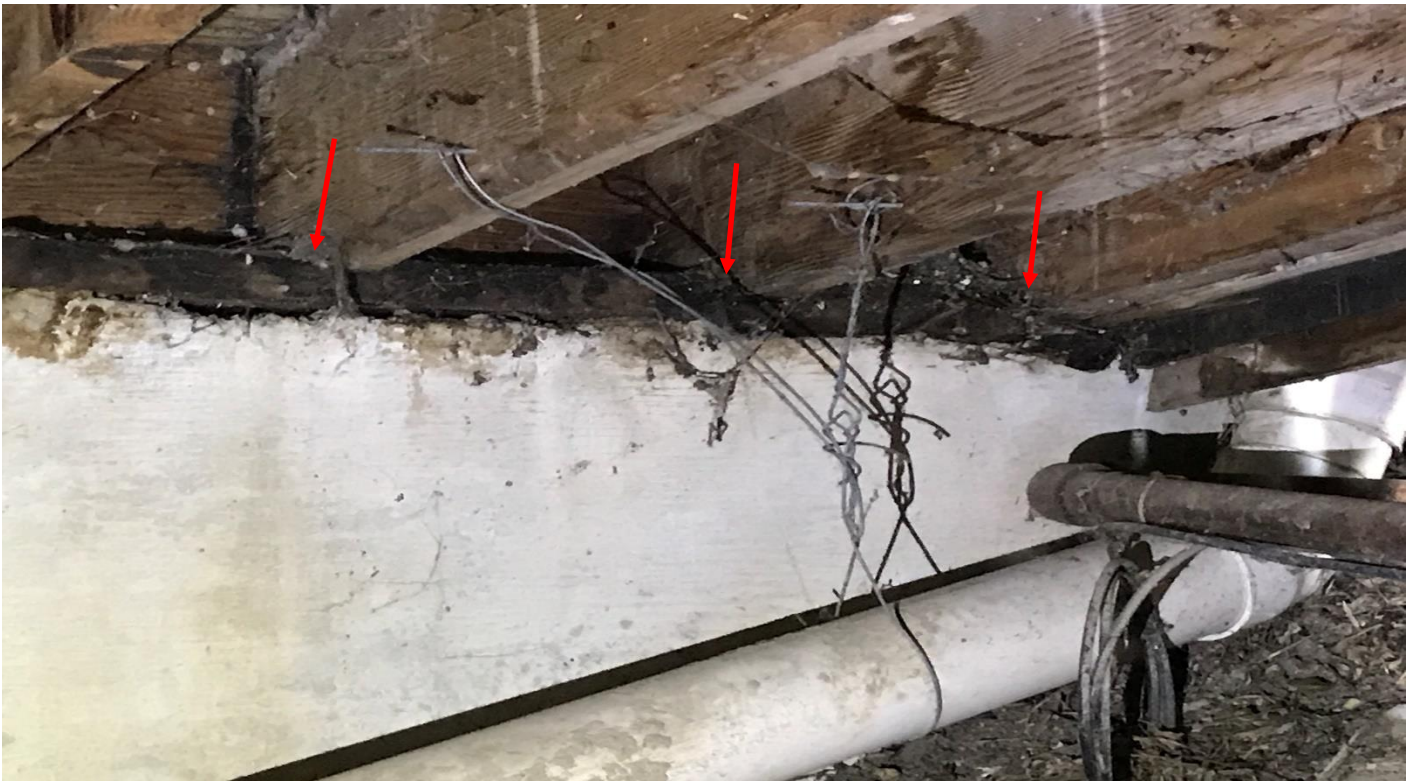
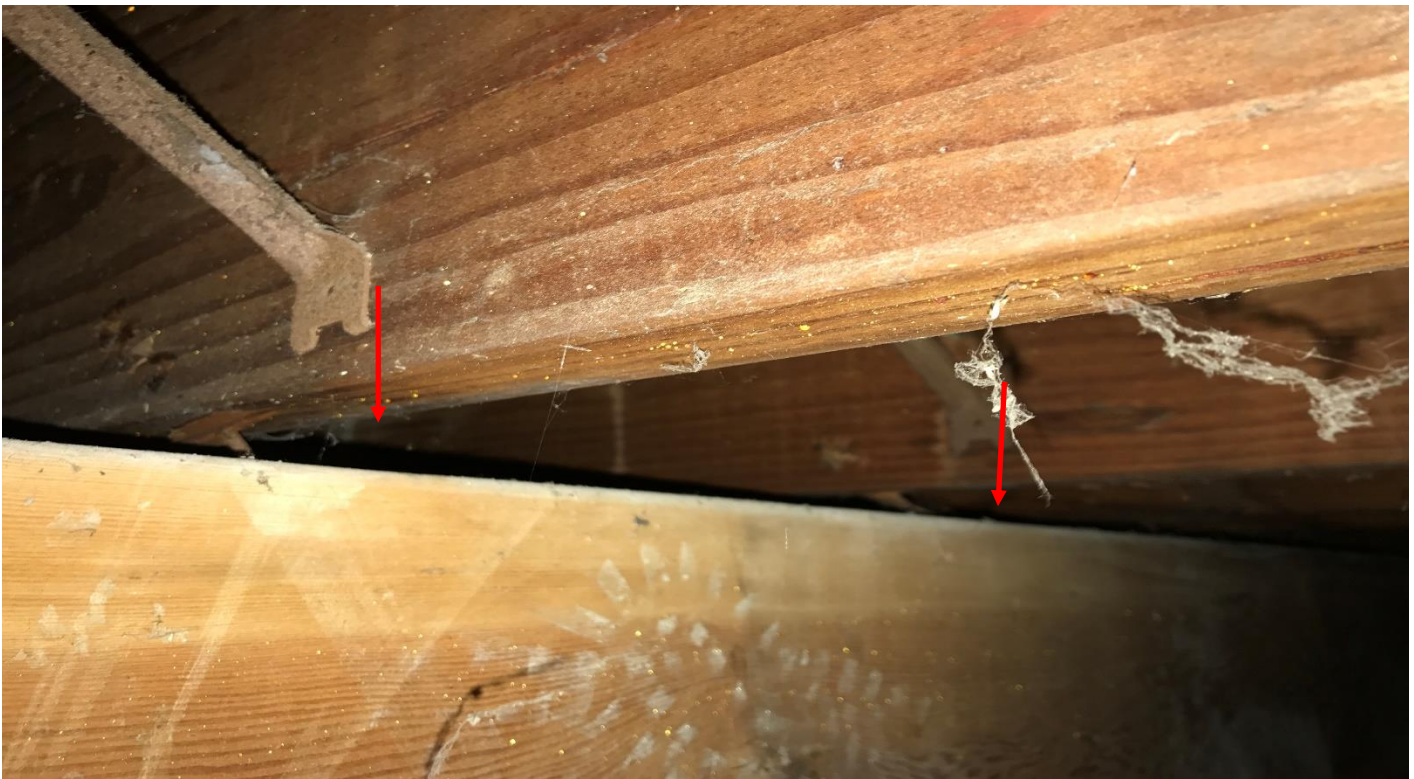
Decayed framing and finish material located: Decayed siding material was located during the course of the inspection. The exact extent of the damaged material and repair required cannot usually be determined until the area has been dismantled to reveal the underlying structure. All damaged material that is located during the process of repair must be replaced.

EVIDENCE OF PAST WATER MIGRATION AND DECAYED SUB-FLOOR AND FRAMING MATERIALS WERE LOCATED BELOW THE FRONT OF THE GARAGE. LOCATE AND REPLACE ANY DAMAGED AND OR DECAYED SUB-FLOOR AND FRAMING MATERIALS BELOW THE FRONT GARAGE AREAS AND REPAIR THE WATER MIGRATION ISSUES THAT CAUSED THE DAMAGE. THE MID-SPAN SUPPORT BEAM AT THE NORTH END OF THE GARAGE HAS SETTLED AND THE JOIST DO NOT REST ON THE BEAM. REPAIR THE BEAM THAT HAS SETTLED AS FOUND TO BE REQUIRED TO PROPERLY SUPPORT THE FLOOR JOISTS. ANY FURTHER DAMAGE THAT IS REVEALED AFTER THE DAMAGED MATERIALS ARE REMOVED MUST ALSO BE REPLACED.

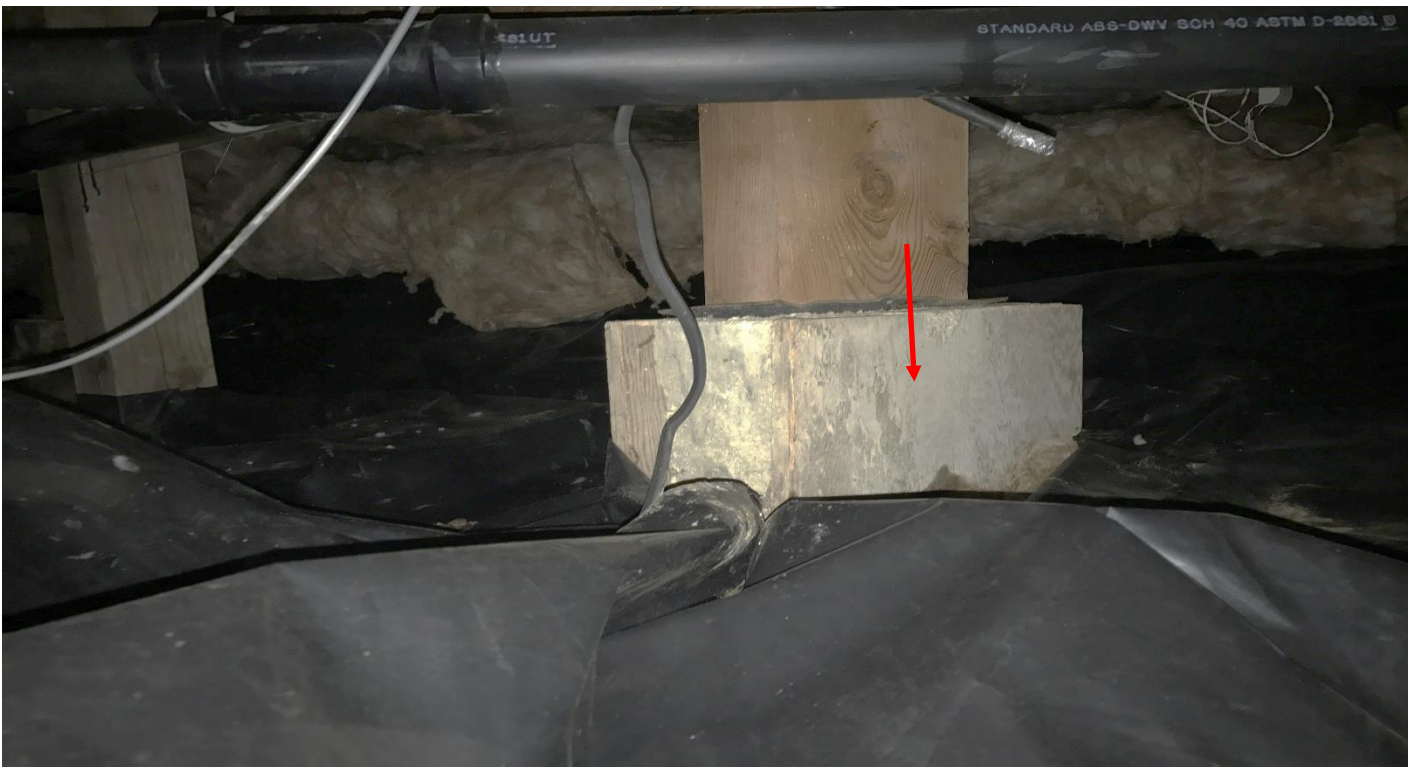
Cellulose debris: Cellulose debris (wood) left in the crawl space may become a breeding ground for wood destroying organisms which will over time migrate into the structural members of the home. All cellulose debris must be removed from the crawl space area.

REMOVE ALL CELLULOSE DEBRIS FROM THE CRAWL SPACE AREA. CELLULOSE DEBRIS INCLUDE ALL WOOD, CARDBOARD, WOOD FORM TIES AND ANY OTHER FOOD SOURCE FOR WOOD FUNGUS GROWTH.

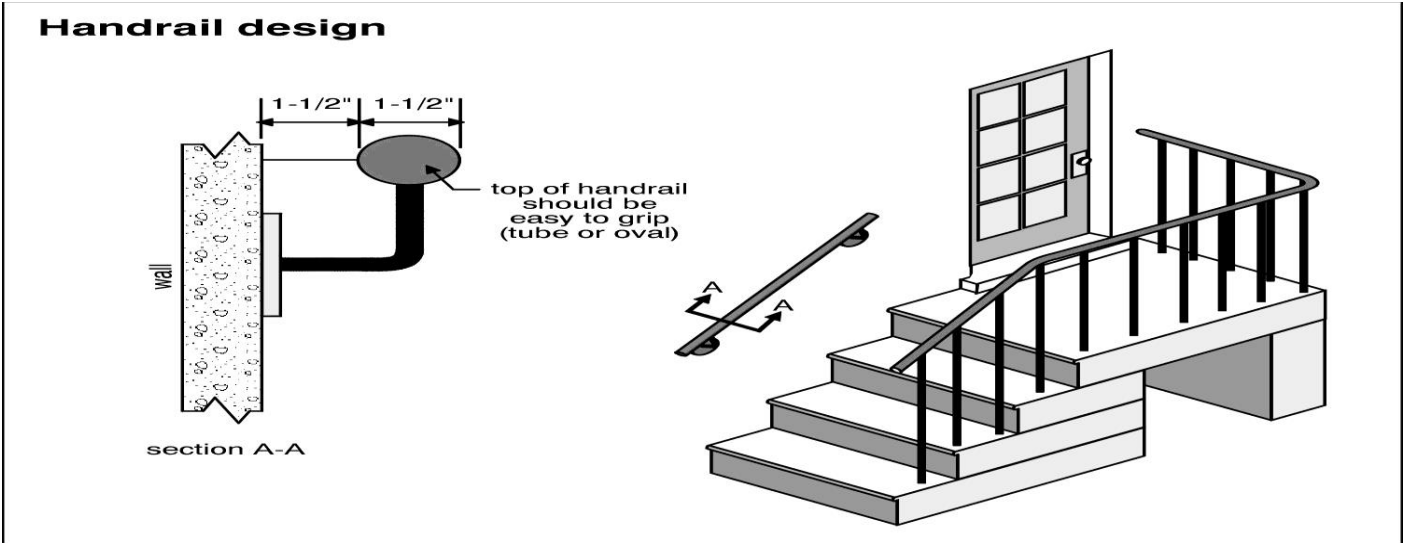
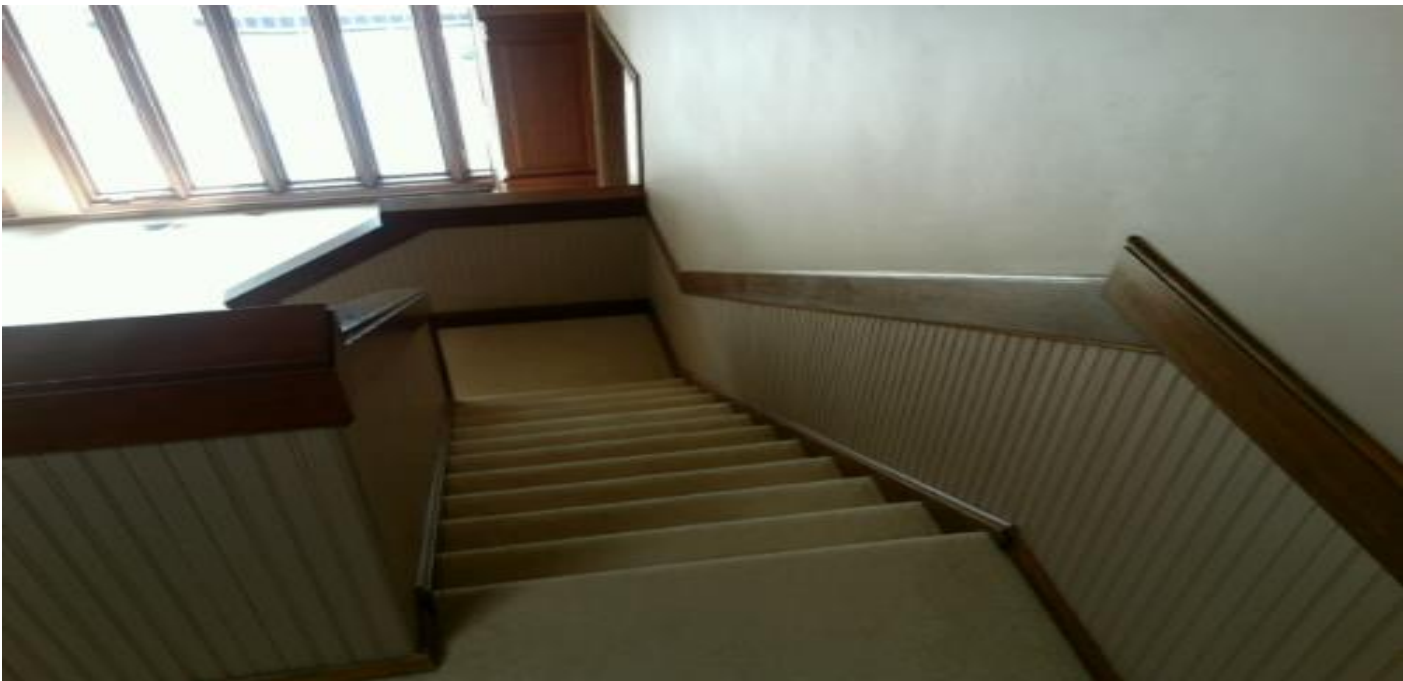
Stair handrails: All stairwells of three or more risers must have a hand railing in place for the entire length of the stairs. The railing must be between thirty and thirty-eight inches high as measured from the nosing of the treads.

INSTALL A PROPER HAND RAILING ON THE INTERIOR STAIRWELLS.

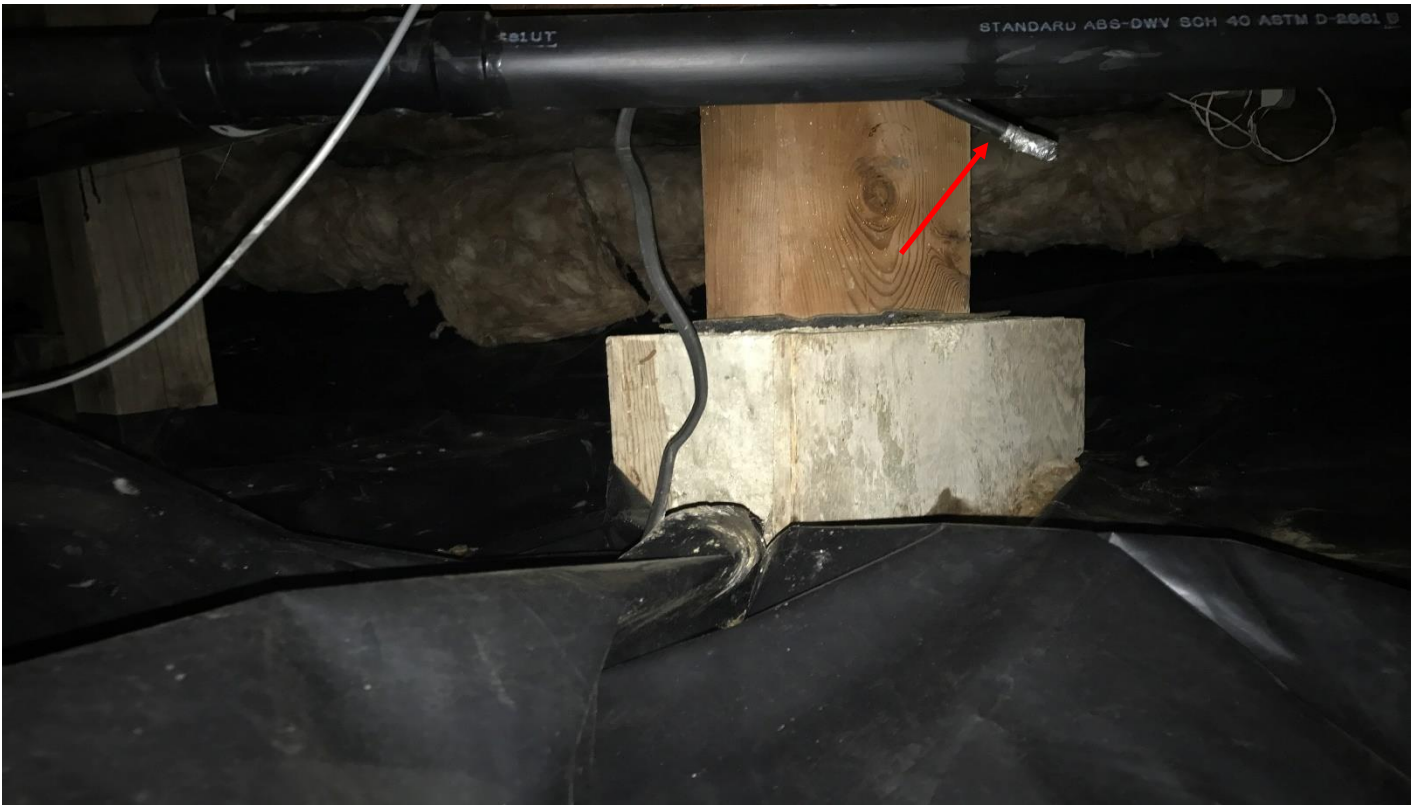
Electrical safety inspection: A complete safety inspection of the electrical system will be required. Enough electrical concerns were noted that a safety inspection will be required to determine the extent of repairs required.

THE ELECTRICAL SERVICE MUST BE INSPECTED BY A LICENSED ELECTRICAL CONTRACTOR AND ALL REPAIRS FOUND TO BE REQUIRED MUST BE COMPLETED. THE REPAIRS MUST INCLUDE BUT NOT BE LIMITED TO: REPLACING ALL BREAKERS WITH TEXTURE OVERSPRAY AND INSPECTING THE PANELS TO ENSURE IT IS CLEAN OF ALL FOREIGN MATERIAL AND SAFE FOR USE, INSTALLING ALL LOOSE/EXPOSED WIRING IN THE CRAWLSPACE IN A JUNCTION BOX WITH A COVER PLATE AND ANY OTHER REPAIRS DEEMED TO BE REQUIRED AND OR LISTED WITHIN THIS REPORT.

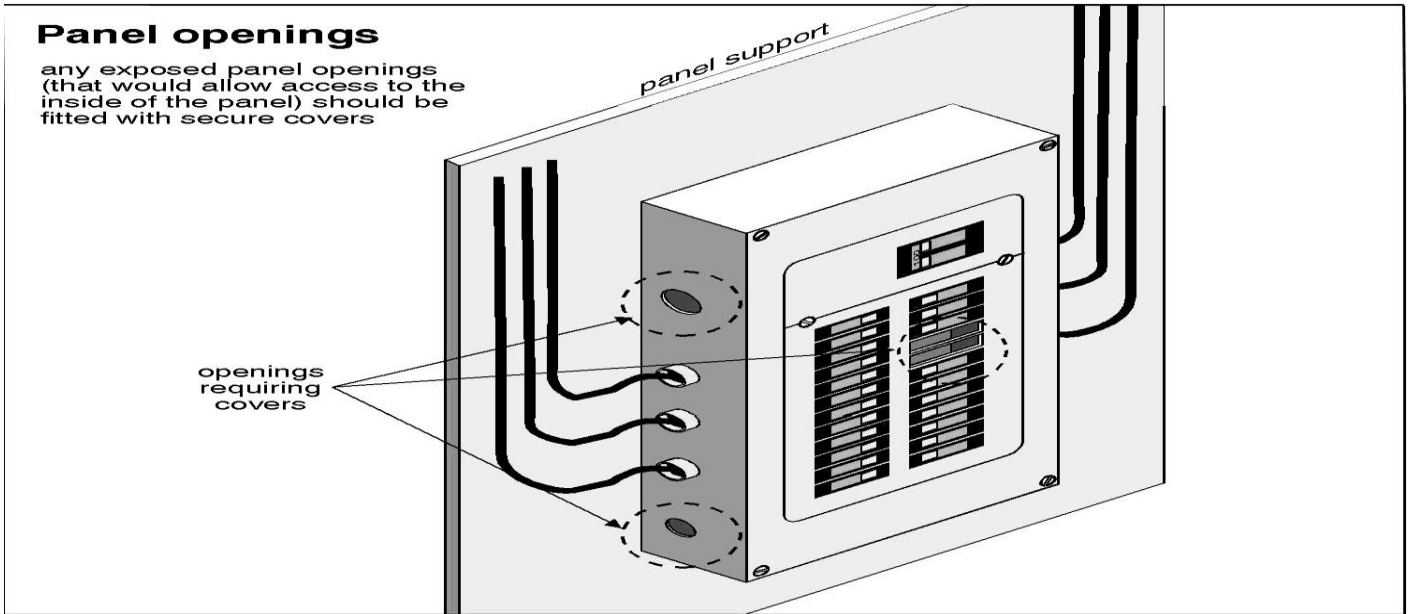
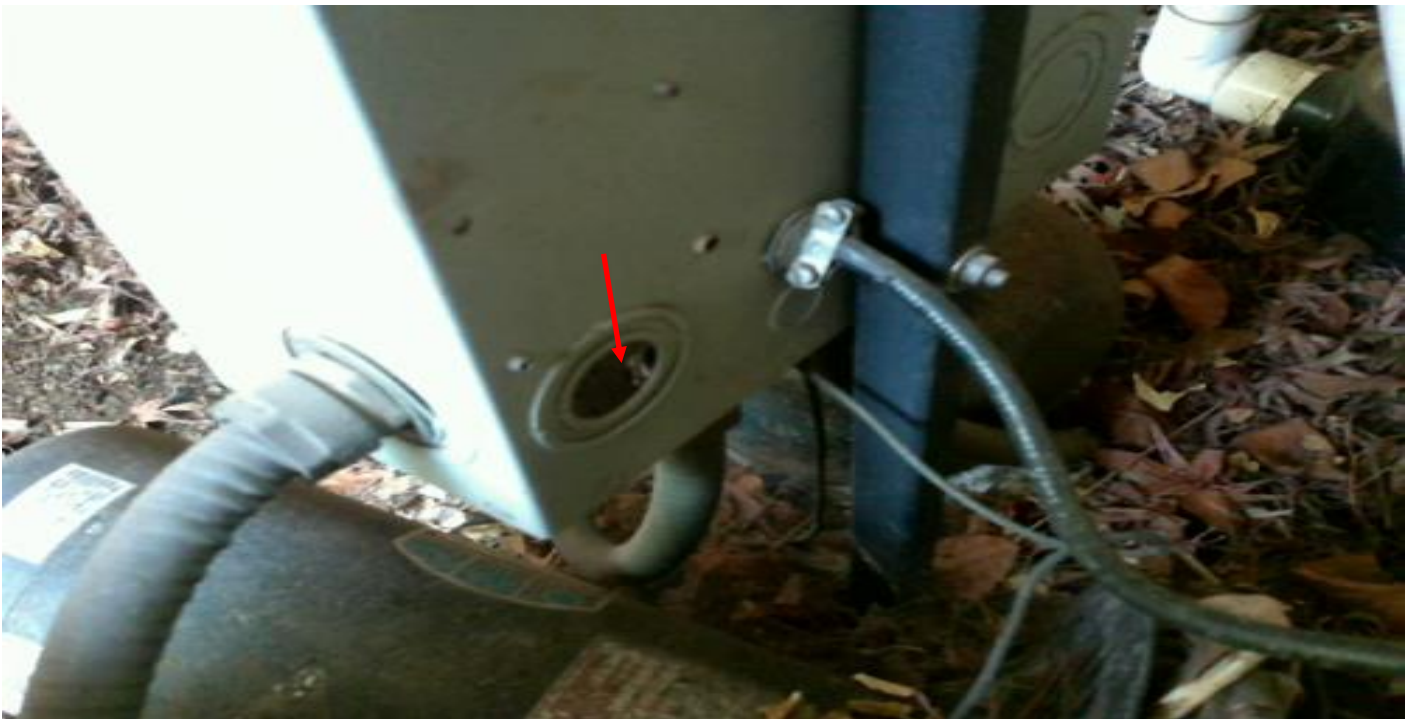
Electrical: Missing blockouts in the electrical service panel: All open unused breaker openings in the service panel must be properly covered so no tools or fingers have direct access to the buss bars. A blockout can be purchased at any hardware store.

INSTALL PROPER BLOCK OUTS ON THE OPENING AT THE BACK OF THE SUB-PANEL AT THE HOT TUB EQUIPMENT AT THE NORTH SIDE OF THE HOUSE.

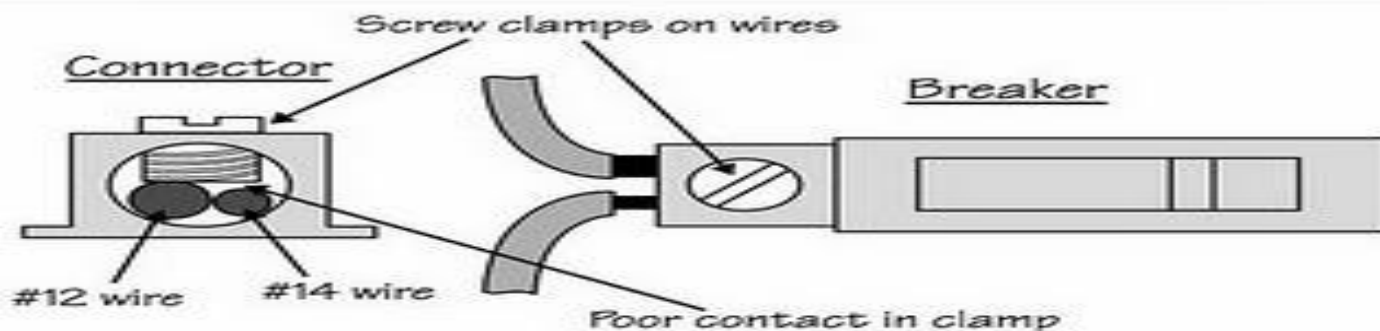
Double Tapping Electrical Breaker

Many breakers do not allow two wires per connection (double tap). Two wires of different wire gauge sizes (diameter) should never be used.

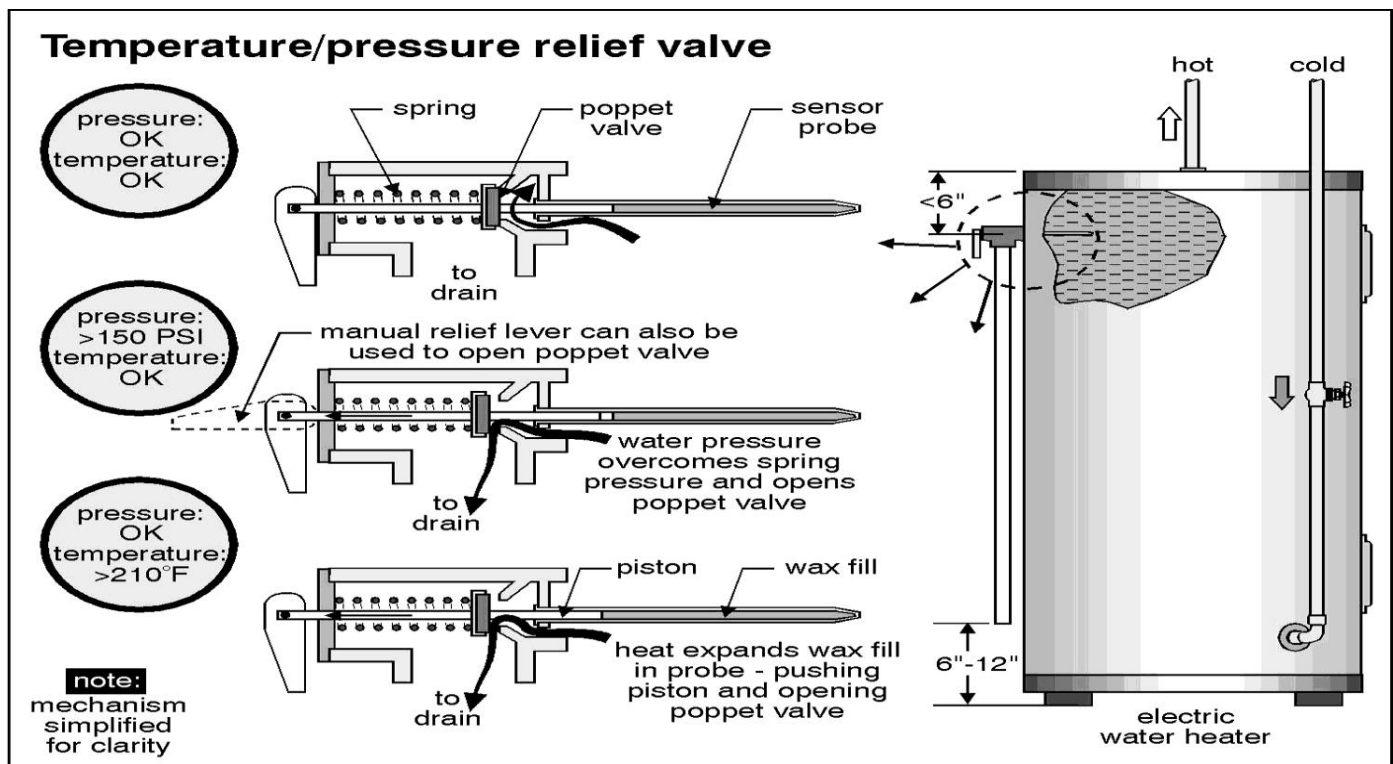
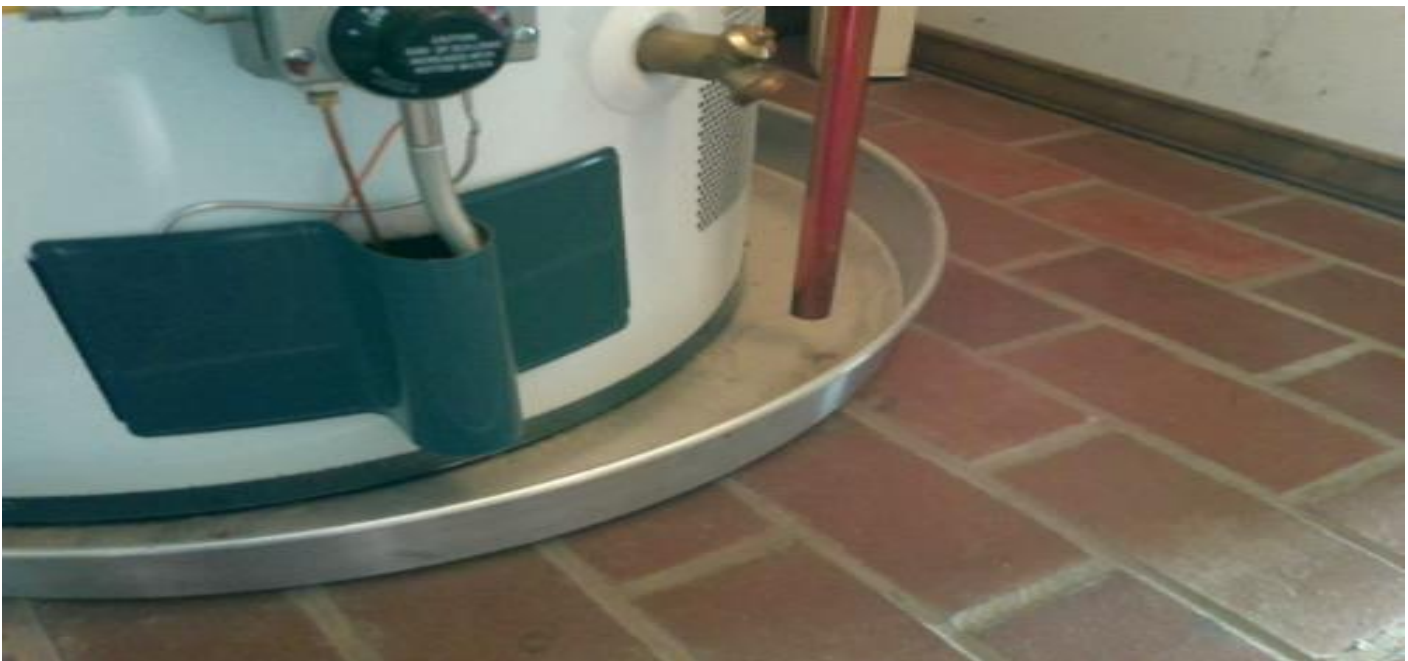
Hot water tank temperature pressure release valve: All water tanks must have a pressure release valve installed to allow excess water pressure to escape the plumbing system in the case of overheating. The valve must be routed outside, to a floor drain, or waste line.

THE TEMPERATURE PRESSURE RELEASE VALVE (TPR) ON THE HOT WATER TANK MUST BE PROPERLY ROUTED TO THE EXTERIOR, A SINK, OR A FLOOR DRAIN.
