CRASH TESTS  
OF  
FIVE-FOOT RADIUS PLATE BEAM GUARDRAIL

THE DEPARTMENT OF HIGHWAYS  
STATE OF MINNESOTA

TEXAS TRANSPORTATION INSTITUTE  
TEXAS A & M RESEARCH FOUNDATION

June 1975

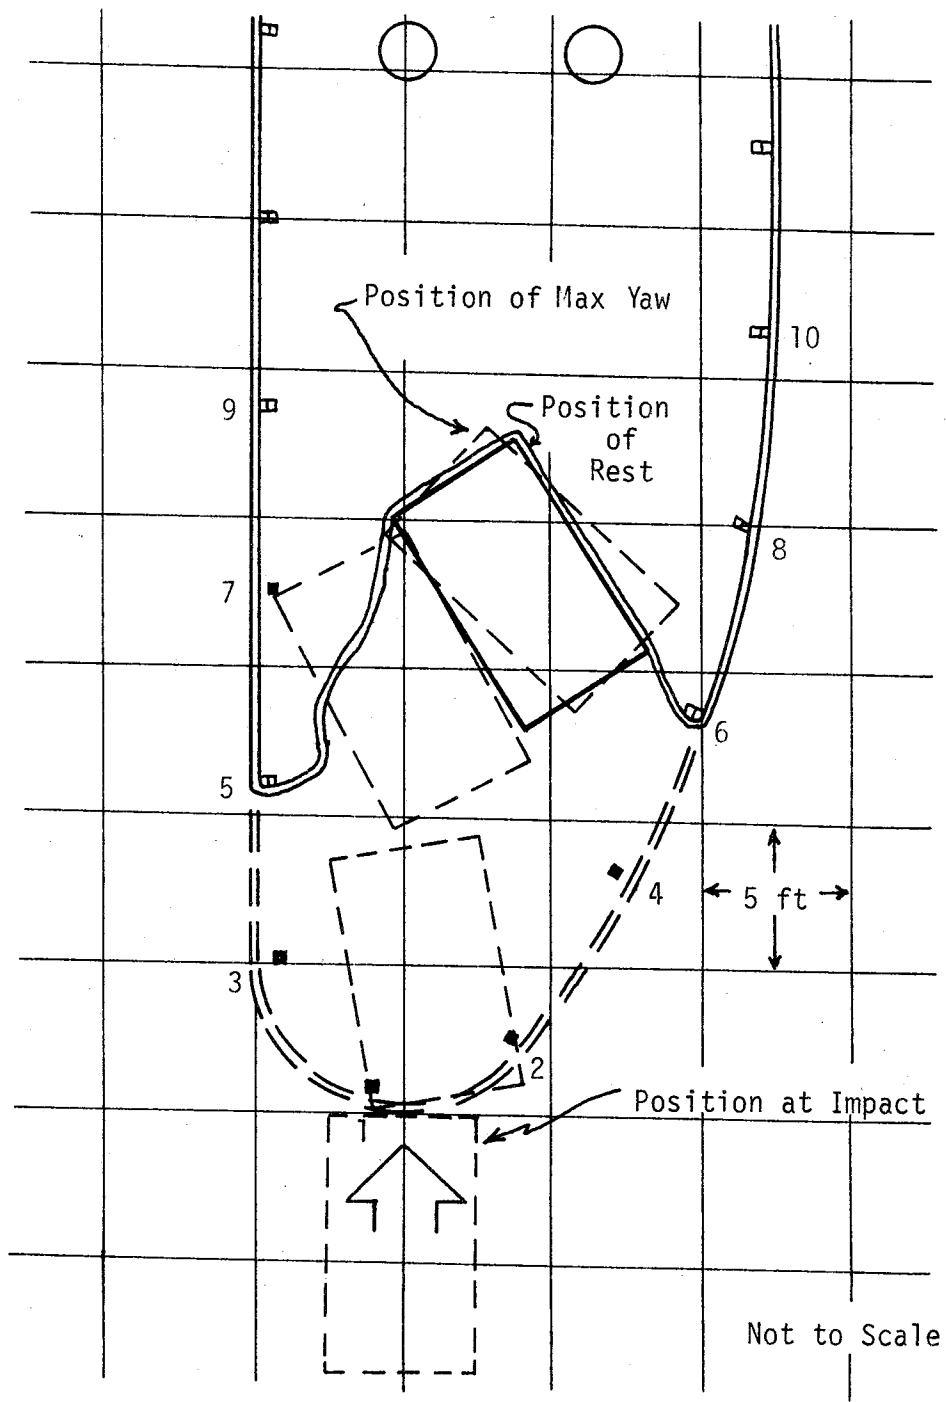
Figure 3. Vehicle Path during Test B1.

A 1971 Vega weighing 2290 lbs impacted the guardrail head-on (0 degrees) at 61.5 mph. Upon impact, post number 1 (Figure 3) failed at ground level. Shortly thereafter the hood of the test vehicle began to open. As the vehicle advanced into the attenuator, the guardrail buckled and wrapped around the front bumper. Then post number 2 failed at ground level. The vehicle continued to advance and began to yaw counterclockwise. The steel guardrail became taut against post numbers 3 and 4, and they failed almost simultaneously. By this time the guardrail was wrapped around the front half of the test vehicle. The left front of the test vehicle contacted post number 7 and broke it off at ground level. Subsequently, the maximum yaw of the vehicle reached 47 degrees. Pitching and rolling motions of the vehicle were negligible. After the complete failure of the five wooden posts and partial failure of four others, the vehicle came to rest with a yaw angle of 33 degrees. A diagram of the test vehicle path and position of rest is shown in Figure 3. The vehicle center of mass penetrated 23.2 ft into the barrier. Sequential photographs from the high-speed cameras are contained in Figures B-1 and B-2 of Appendix B. Time-displacement data for the test vehicle, obtained from the high-speed film, are also given in Appendix B.

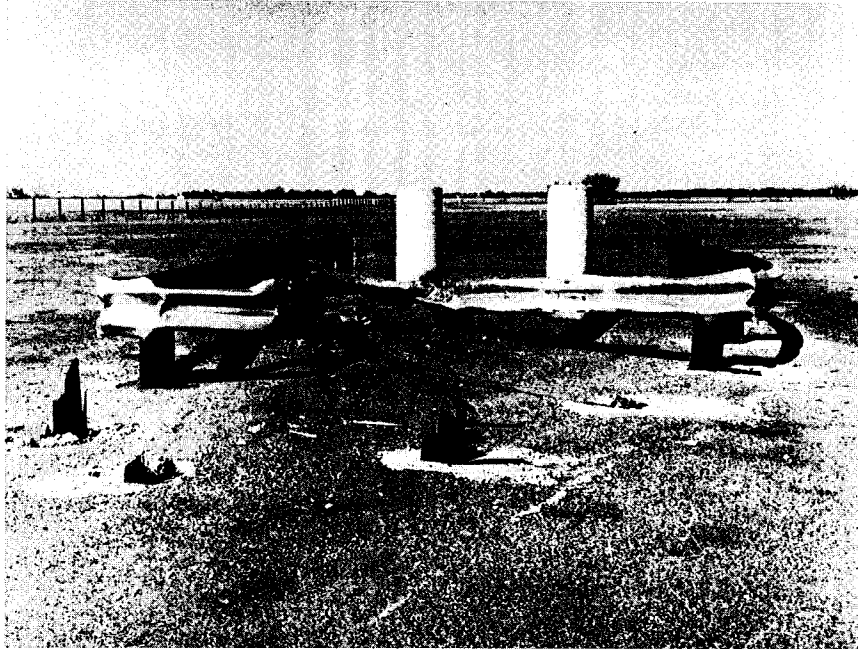
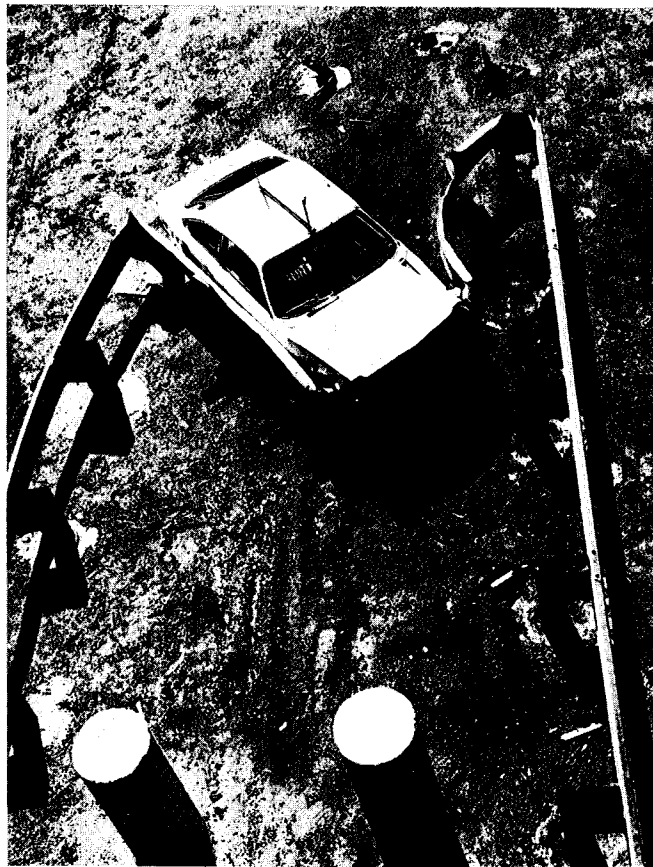
Figure 4. Minnesota Guardrail after Test B1.

The system, as constructed and tested, performs very satisfactorily when struck by a small automobile. The behavior of the system is adequate when struck by a heavier automobile. It should be noted that in each case the W-section was severely damaged locally (see Figures 4 and 10). Although tensile load in this element was not measured, its condition after impact indicated that it was loaded near ultimate capacity and not much reserve strength existed, especially in Test B2.

Failure (complete rupture) of the W-section could cause a severe impact with the fixed obstacles that the rail encloses.

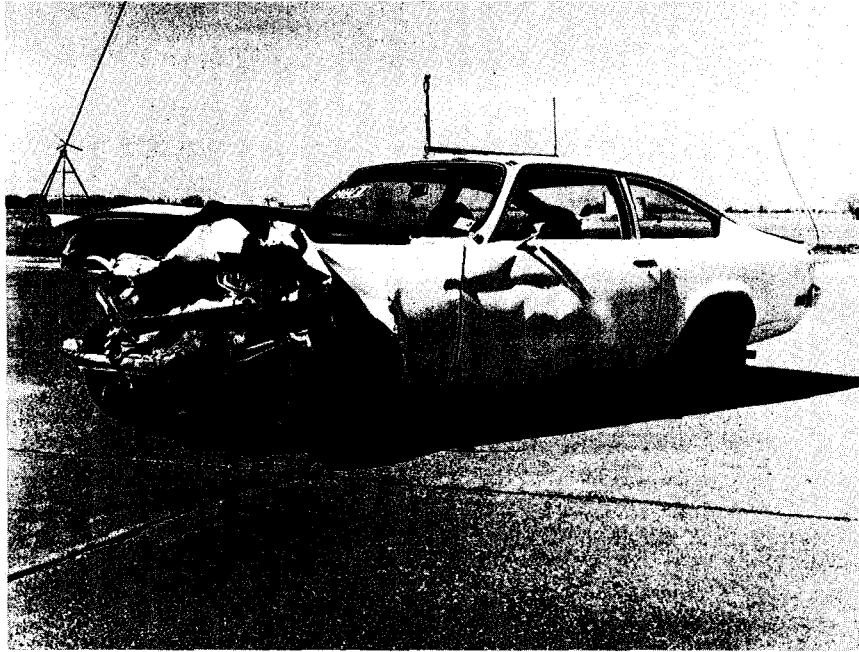
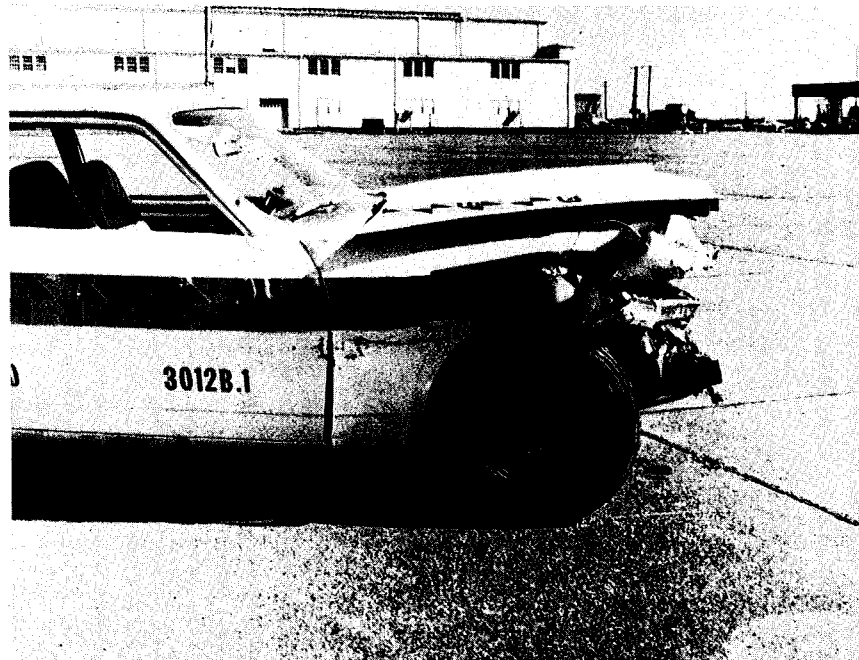
Figure 7. The Vega after Test B1.

The vehicle received moderate damage in the form of distortion of front frame members and considerable sheet metal deformation. Based on the TAD scale (2), the vehicle damage rating was FD-5. The SAE collision deformation classification (3) was 12FDEW3. Damage to the test vehicle is shown in Figure 7.

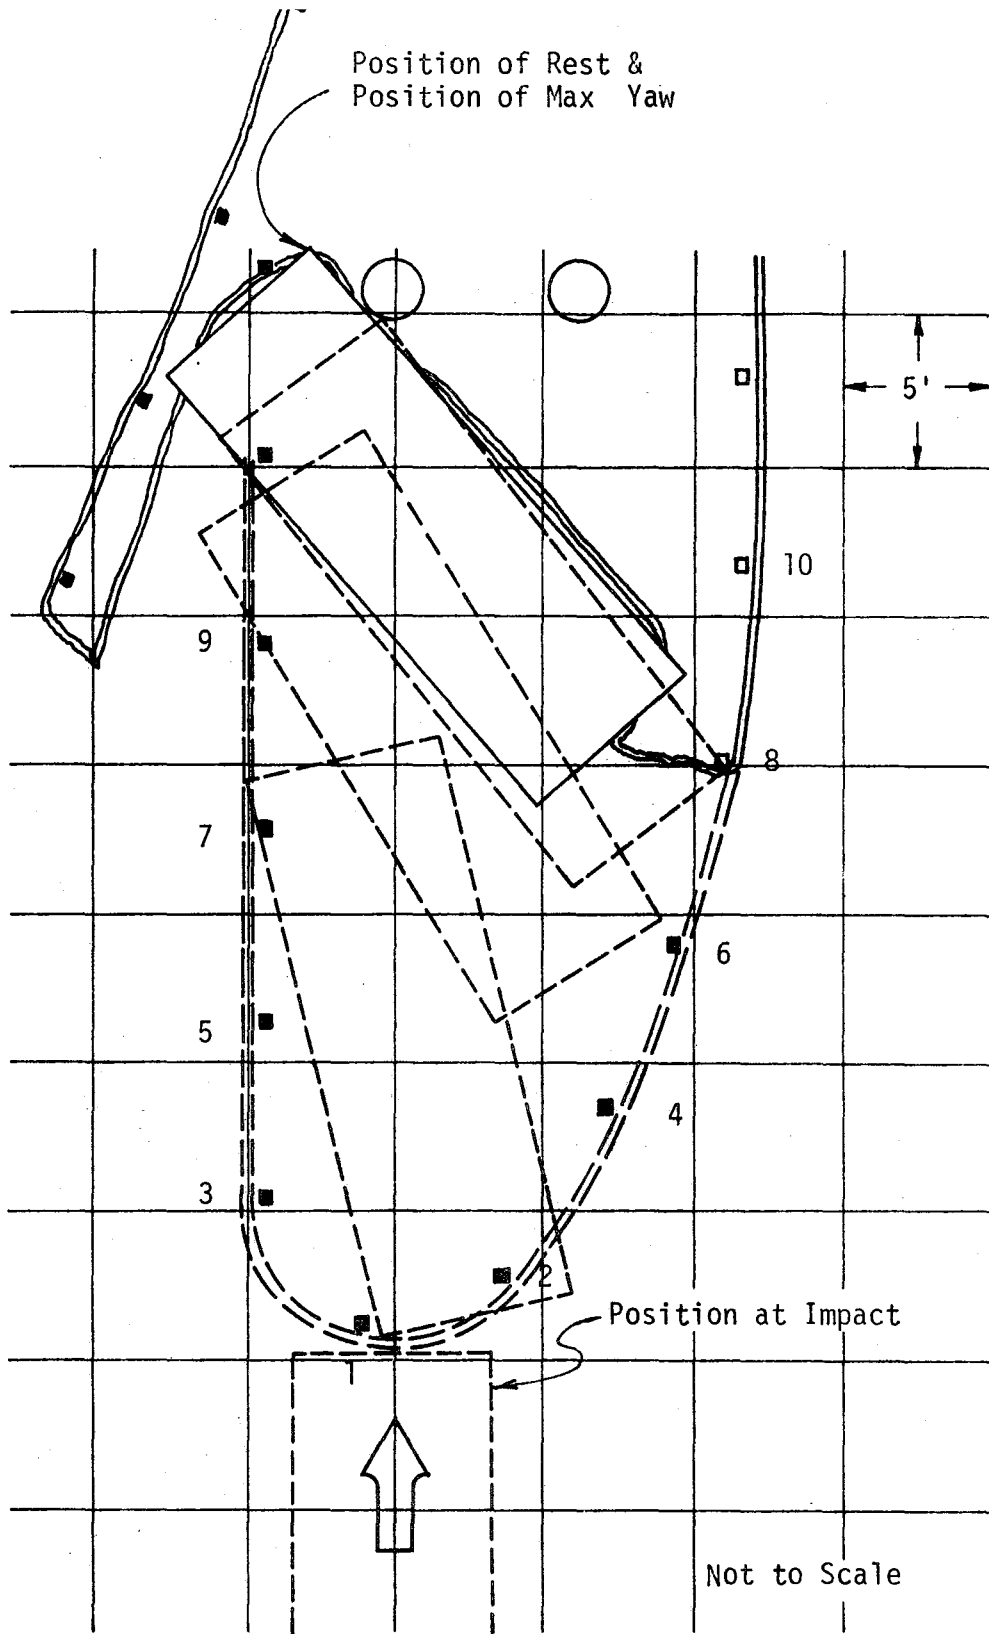
Figure 9. Vehicle Path during Test B2.

A 1969 Chrysler weighing 4500 lbs impacted the guardrail head-on at 62.3 mph. Upon impact, post number 1 (Figure 9) broke off and the vehicle began to yaw counterclockwise. Almost immediately post number 2 failed at ground level. About the time the steel guardrail became taut against post numbers 3 and 4, the left front corner of the vehicle contacted post number 5; and the three posts failed almost simultaneously. As the vehicle advanced further into the barrier, the left front bumper pushed over post number 7. Just after the steel guardrail became taut against post number 6 and pulled it over, the front of the vehicle pushed over post number 9. The rearward force on the steel guardrail caused the remaining three posts supporting the left side to split and the guardrail fell to the ground. The test vehicle continued to advance and yaw counterclockwise. The right front corner of the vehicle impacted one of the simulated concrete

piers. During contact with the pier, the vehicle roll displacement (about its longitudinal axis) reached about 45 degrees. The vehicle rebounded approximately two feet and came to rest with a yaw angle of 43 degrees as shown in Figure 9. The vehicle center of mass penetrated 38.8 ft during impact. Sequential photographs and time-displacement data are presented in Appendix C.

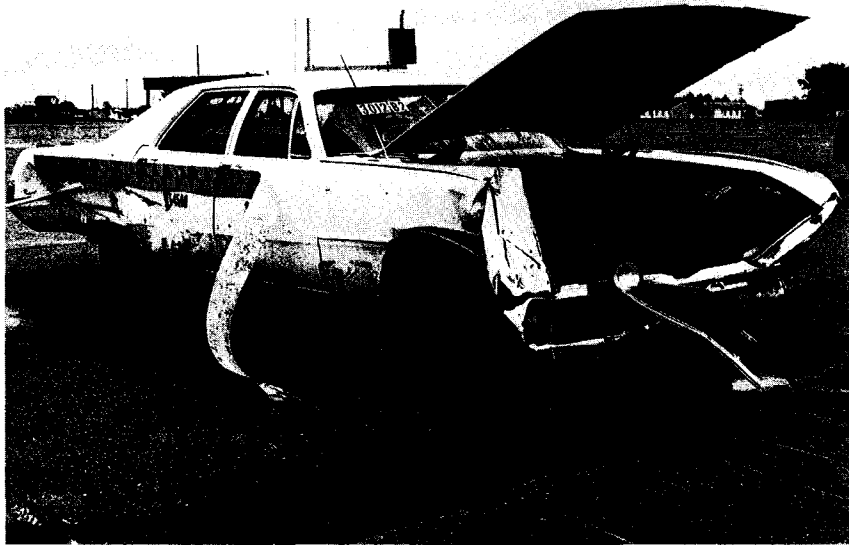
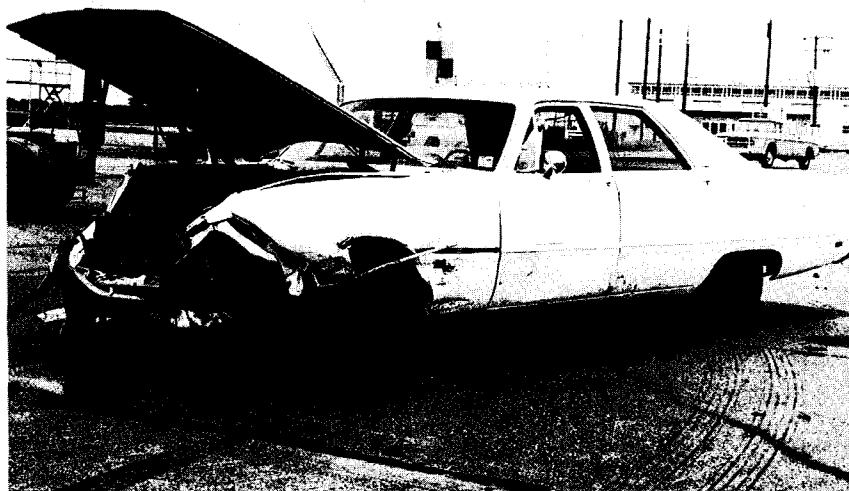
Figure 13. The Chrysler after Test B2.

Damage to the front of the vehicle was moderate and consisted of severely deformed sheet metal and somewhat distorted front frame members. Damage to the right rear consisted of minor dents in the sheet metal. Based on the TAD scale, the vehicle damage rating was

FD-5 and RBQ-3. According to SAE, the collision deformation classification was 12FDEW1. The vehicle after Test B2 is shown in Figure 13.

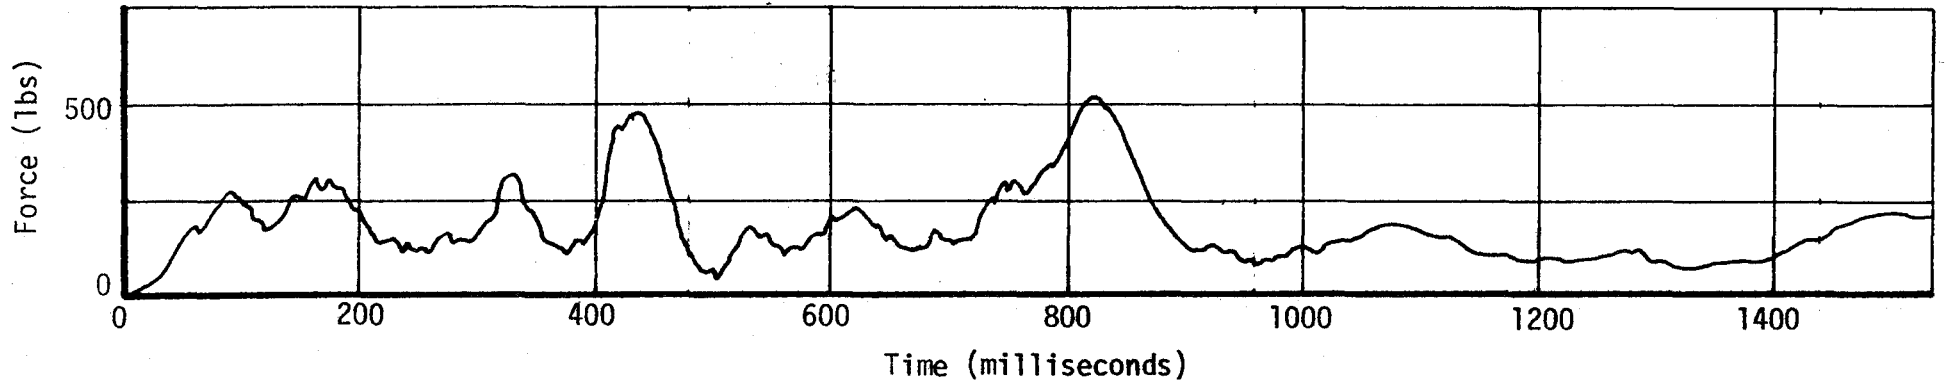
Figure C-6. Seat Belt Data for Test B2.

The vehicle impacted one of the simulated concrete piers at 0.647 sec after initial impact. At this time, the forward velocity of the vehicle had been reduced to such a level that the impact was entirely acceptable. Both longitudinal and transverse decelerations during impact with the simulated piers are evident in Figures C-4 and C-5. Deceleration peak values are about 5 g's, well within acceptable limits. Similar observations can be made from the seat belt force trace in Figure C-6.

The 3 g's deceleration experienced by the dummy ( $\frac{510 \text{ lb force}}{170 \text{ lb dummy}} = 3 \text{ g's}$ ) in Test B2 is well below the generally accepted level of 12 g's for a lap-belted occupant in a head-on collision and indicates a low probability of injury due to deceleration.
