## **CUSTOMER SATISFACTION NOTIFICATION K39 TRANSMISSION SHIFTER INTERLOCK LEVER**

**MODELS: 2007 (LX) Dodge Charger, Magnum and Chrysler 300**

**2005 - 2007 (LX) Dodge Charger, Magnum and Chrysler 300**

March 8, 2011

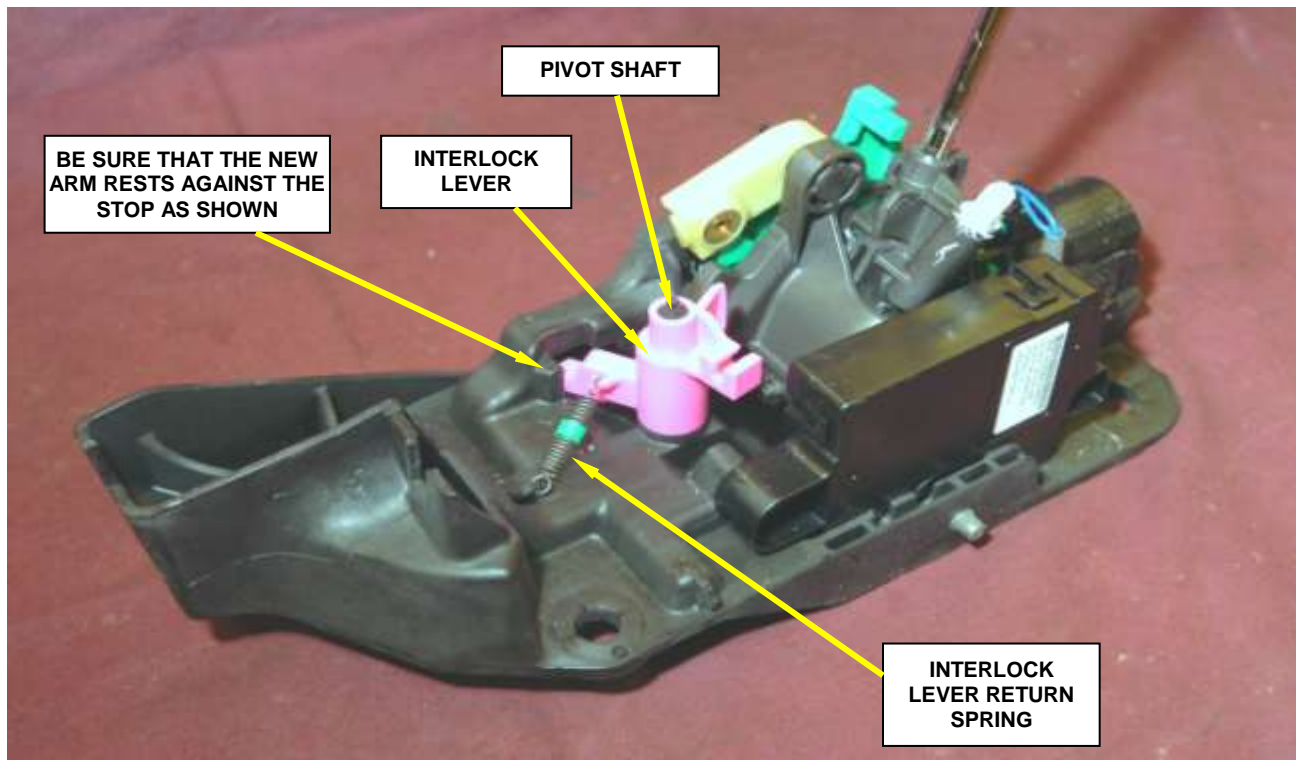
**Figure 6 – Interlock Lever and Interlock Lever Return Spring**

- The transmission gear shift lever interlock return spring hook on about 630 of the above vehicles may break. A broken interlock return spring hook will result in the inability to move the gear shift lever out of the “PARK” position.
- To correct this condition, a new interlock lever must be installed into the transmission gear shifter.

23. Disconnect the interlock lever return spring at the pivot arm (Figure 5).
24. Remove and discard the pink interlock lever.
25. Install the new interlock lever onto the pivot shaft.

**CAUTION: Do not apply any type of lubricant to the pivot shaft.**

26. Connect the interlock lever return spring.
27. Place the upper shift housing into position and connect the electrical connector located inside the shifter assembly.
28. Snap the upper shift housing into place on the lower shift housing.
