Customer Satisfaction Program

N192265660 Rear Window Defroster Thermal Events - US Only

Release Date: March 2020

Revision: 01

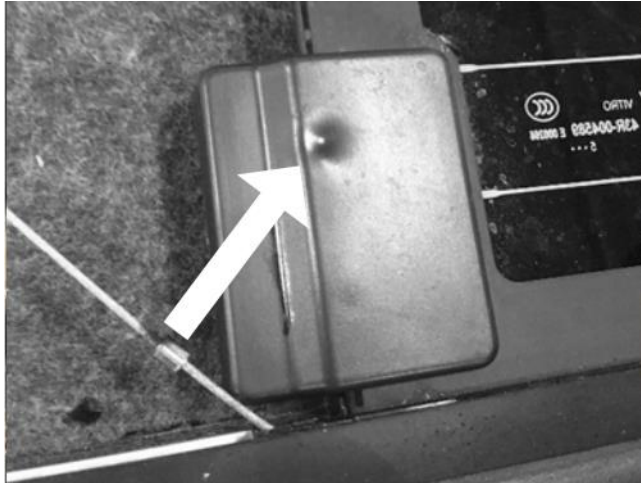
5423183

Cover showing heat damage

1. Inspect the heated rear window terminal cover for any indication of external heat related damage.
 - If **no heat damage** is indicated, proceed to step # 2.
 - If **heat damage** is indicated, replace the complete rear window assembly. Refer to *Rear Window Replacement* in SI.

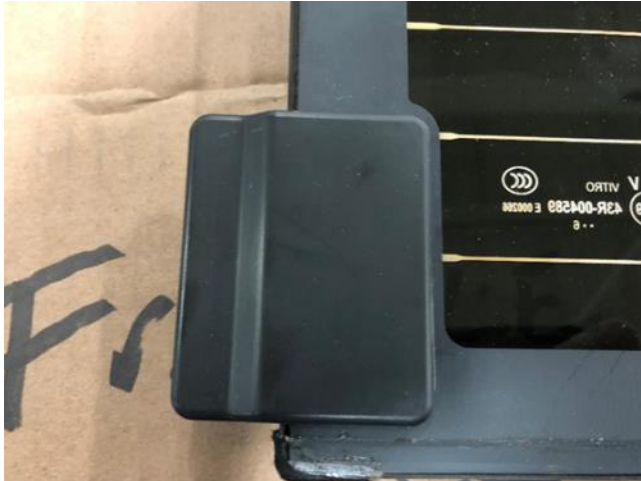
5423186

Cover showing no heat damage

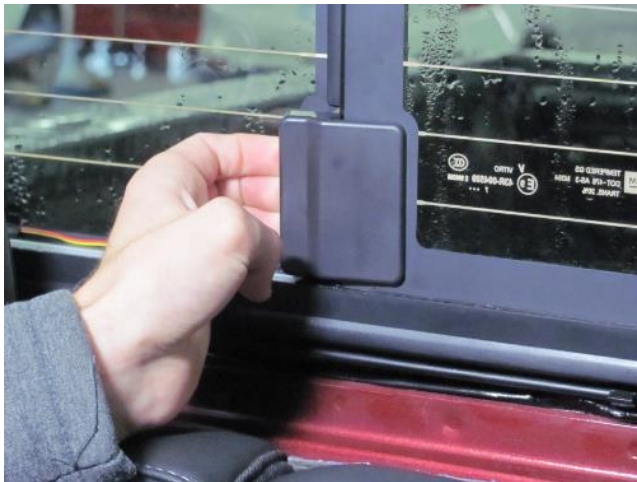
5423187

2. Remove the rear sliding window terminal cover. Place fingers under the outer edge of the cover and peel the cover toward the center of the vehicle. Inspect the back side of the terminal cover for heat damage.

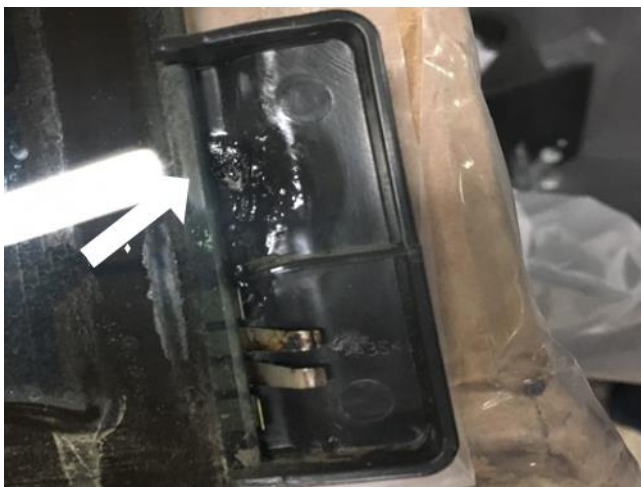
5423189

Cover showing heat damage

- If **no heat damage** is indicated, proceed to step # 3.
- If **heat damage** is indicated, replace the complete rear window assembly. Refer to *Rear Window Replacement* in SI.

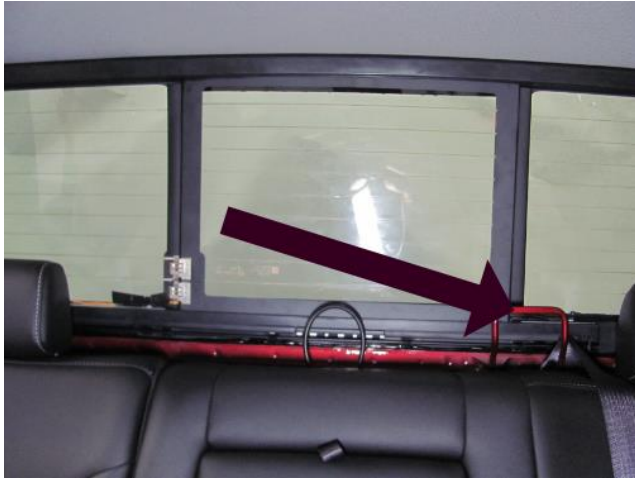
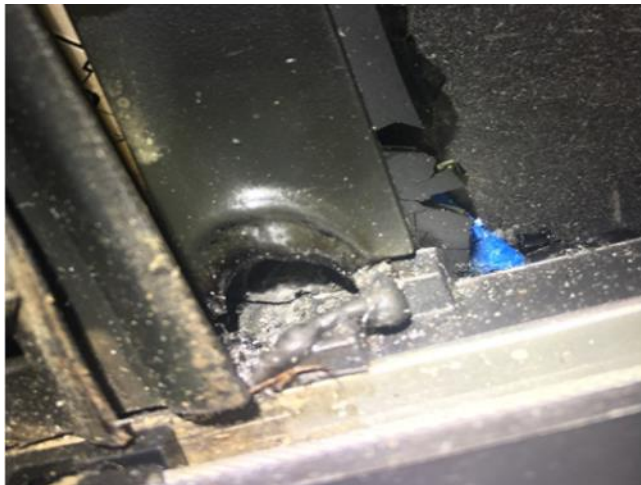
3. Inspect the lower edge of the driver side buss bar cover for heat damage.
 - If **no heat damage** is indicated, proceed to step # 4.
 - If **heat damage** is indicated, replace the complete rear window assembly. Refer to *Rear Window Replacement* in SI.

Note: Grease may be present and is acceptable. There may be some wear on the pedestal or debris caught in the grease, this is also acceptable.

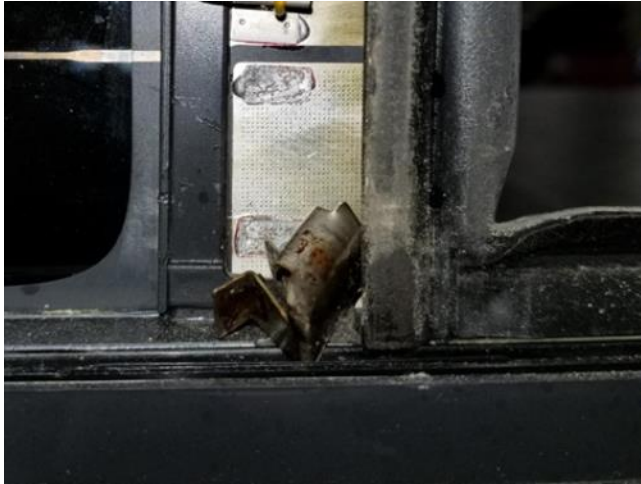
5423192

Pedestal showing damage.

4. Inspect the contact pedestals for distortion, out of alignment or loose conditions.

- If **no physical damage** is indicated, proceed to step #5.
- If **physical damage** is indicated, replace the complete rear window assembly. Refer to *Rear Window Replacement* in SI.

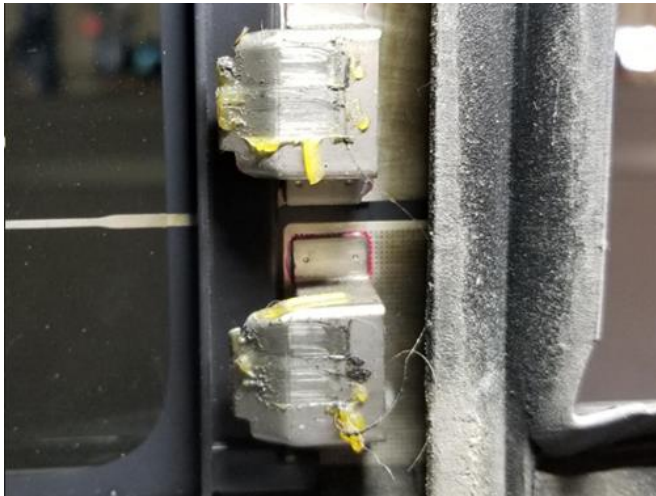
5423194

Pedestals showing no damage or distortion

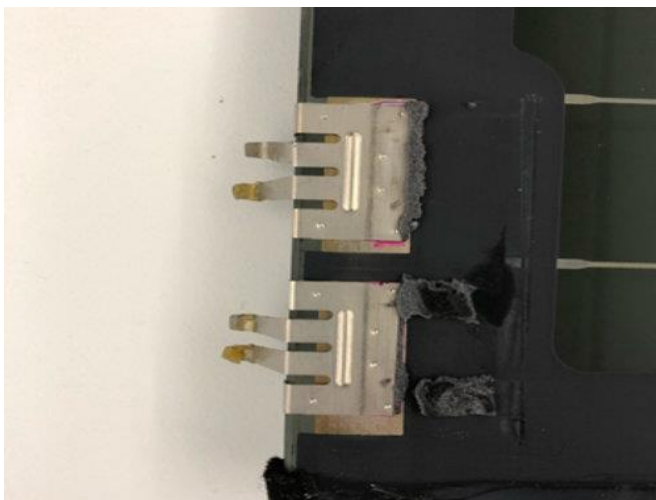
5423966

Fingers showing no damage

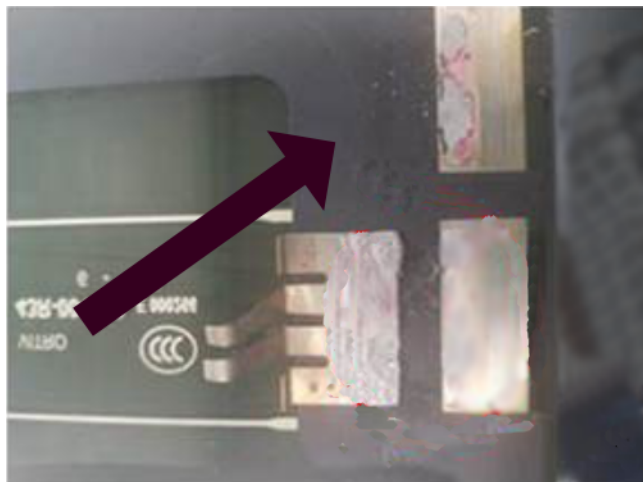
5423195

Finger damage, one set contact fingers missing

5. Inspect the contact fingers on the center glass section of the rear window for any indication of physical damage.
 - If **no damage** is indicated proceed to step #6.
 - If **damage** is indicated, replace the rear window center glass. Refer to *Rear Sliding Window Replacement (Center Glass)* in SI. Proceed to step #6.

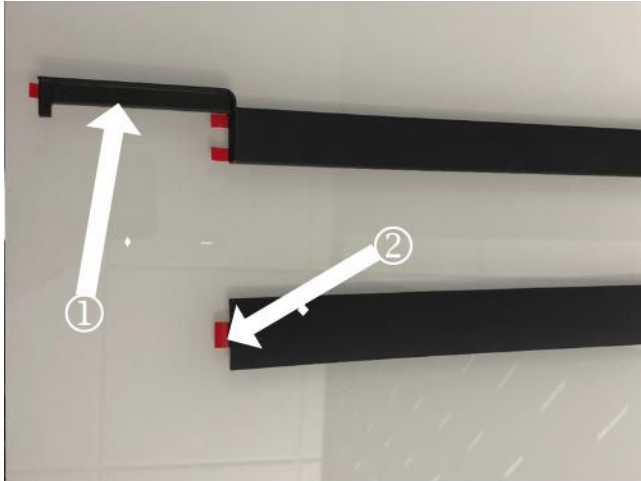
5423199

6. Inspect the rear window defroster buss bar covers and determine if the old or new style of buss covers are installed. The old-style buss bar cover will have a tab under the terminal pedestal area (1). The new style buss bar cover ends at the top of the terminal pedestal area (2).

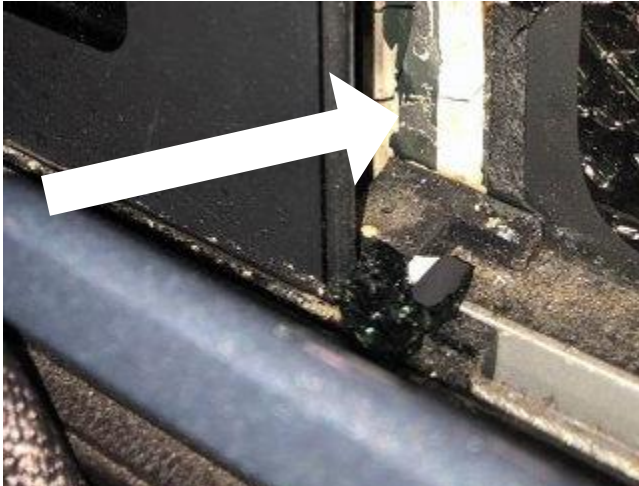
5551358

Buss Bar shown with material missing and delamination

7. With the buss bar covers removed, inspect the driver's side fixed window busbar for damage. Buss bar silver layer should not be removed when the busbar cover is removed.
 - If the **silver buss bar is intact** and shows no signs of peeling or missing material, proceed to step # 8.
 - If the **adhesive tape peels silver from the buss bar or the silver buss bar shows delamination, voids or missing material**, replace the complete rear window assembly. Refer to *Rear Window Replacement* in SI.
8. Install the two new buss bar covers.

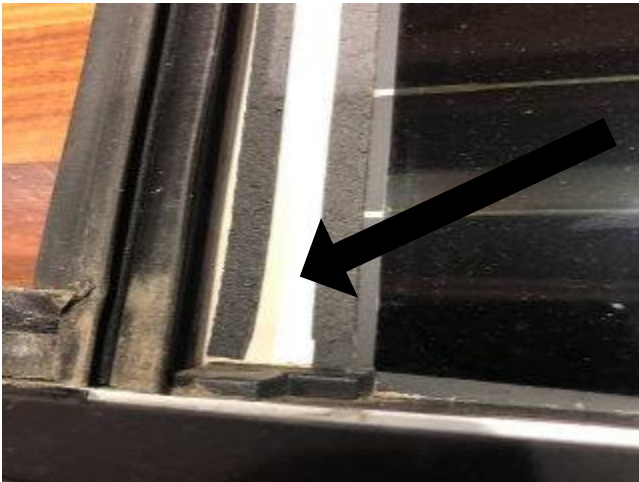
5551359

Buss Bar shown with material intact
