GLOBAL SAFETY FIELD INVESTIGATIONS  
DCS5117  
URGENT - DISTRIBUTE IMMEDIATELY

Subject: N182188250 - Special Coverage  
Loss of Continuity within Accelerator Pedal Position Sensor Circuit

Models: 2017-2018 Buick LaCrosse  
2018 Buick Regal  
2016-2018 Chevrolet Malibu

## N182188250 Loss of Continuity within Accelerator Pedal Position Sensor Circuit

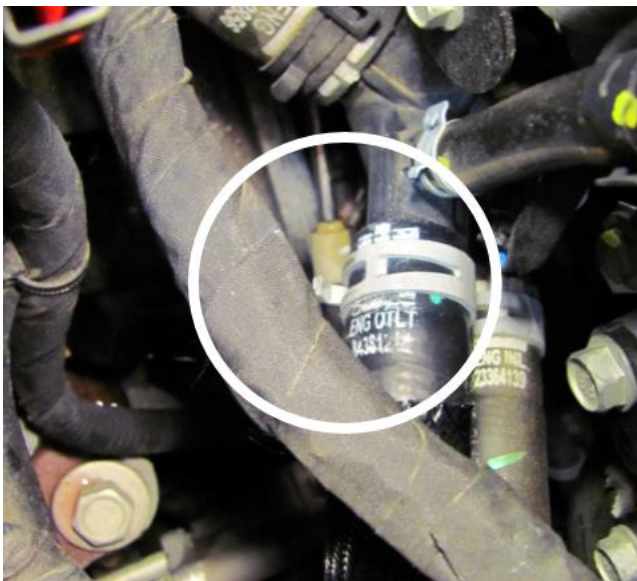
5309871

2. On Malibu (LFV engine) applications **only**, inspect the engine wire harness adjacent to the heater inlet hose for contact with the heater inlet hose clamp on the engine outlet portion of the hose as shown.

**Caution:** The heater hose clamp may be glued to the heater hose. If the clamp is glued to the heater hose, **do not** attempt to rotate the heater hose clamp, as heater hose damage may occur and clamp may have residual rubber material on it. Instead, replace the heater hose and both clamps.

3. If contact is observed between the heater hose clamp and the engine wire harness, attempt to rotate the heater hose clamp tabs away from the engine harness, ensuring the clamp stays within the alignment guide markings.

- If the heater inlet hose clamp is **not** glued to the heater inlet hose, rotate the heater inlet hose clamp so the tabs are facing away from the engine wire harness. Ensure the clamp stays within the alignment guide markings. There should be at least  $\frac{3}{4}$  inch (19mm) of clearance between the heater hose clamp tabs and the engine wire harness.

- If the heater hose clamp **is** glued to the heater hose, replace the heater inlet hose and both heater hose clamps, being sure to clock the heater inlet hose clamps so the tabs are facing away from any adjacent engine wire harnesses. Ensure the clamp stays within the alignment guide markings. Refer to *Heater Inlet Hose Replacement (LFV)* in SI.

- If any damage is observed to the engine harness, repair the harness and the affected circuits. Refer to *Wire to Wire Repair* in SI. Rewrap the harness in the affected area with PET tape in addition to clocking the hose clamp away from the harness to ensure another rub-through event is no longer possible.
